Release Notification

Beyond Petroleum #90

Site Characterization and Remediation Plan

30-045-30769

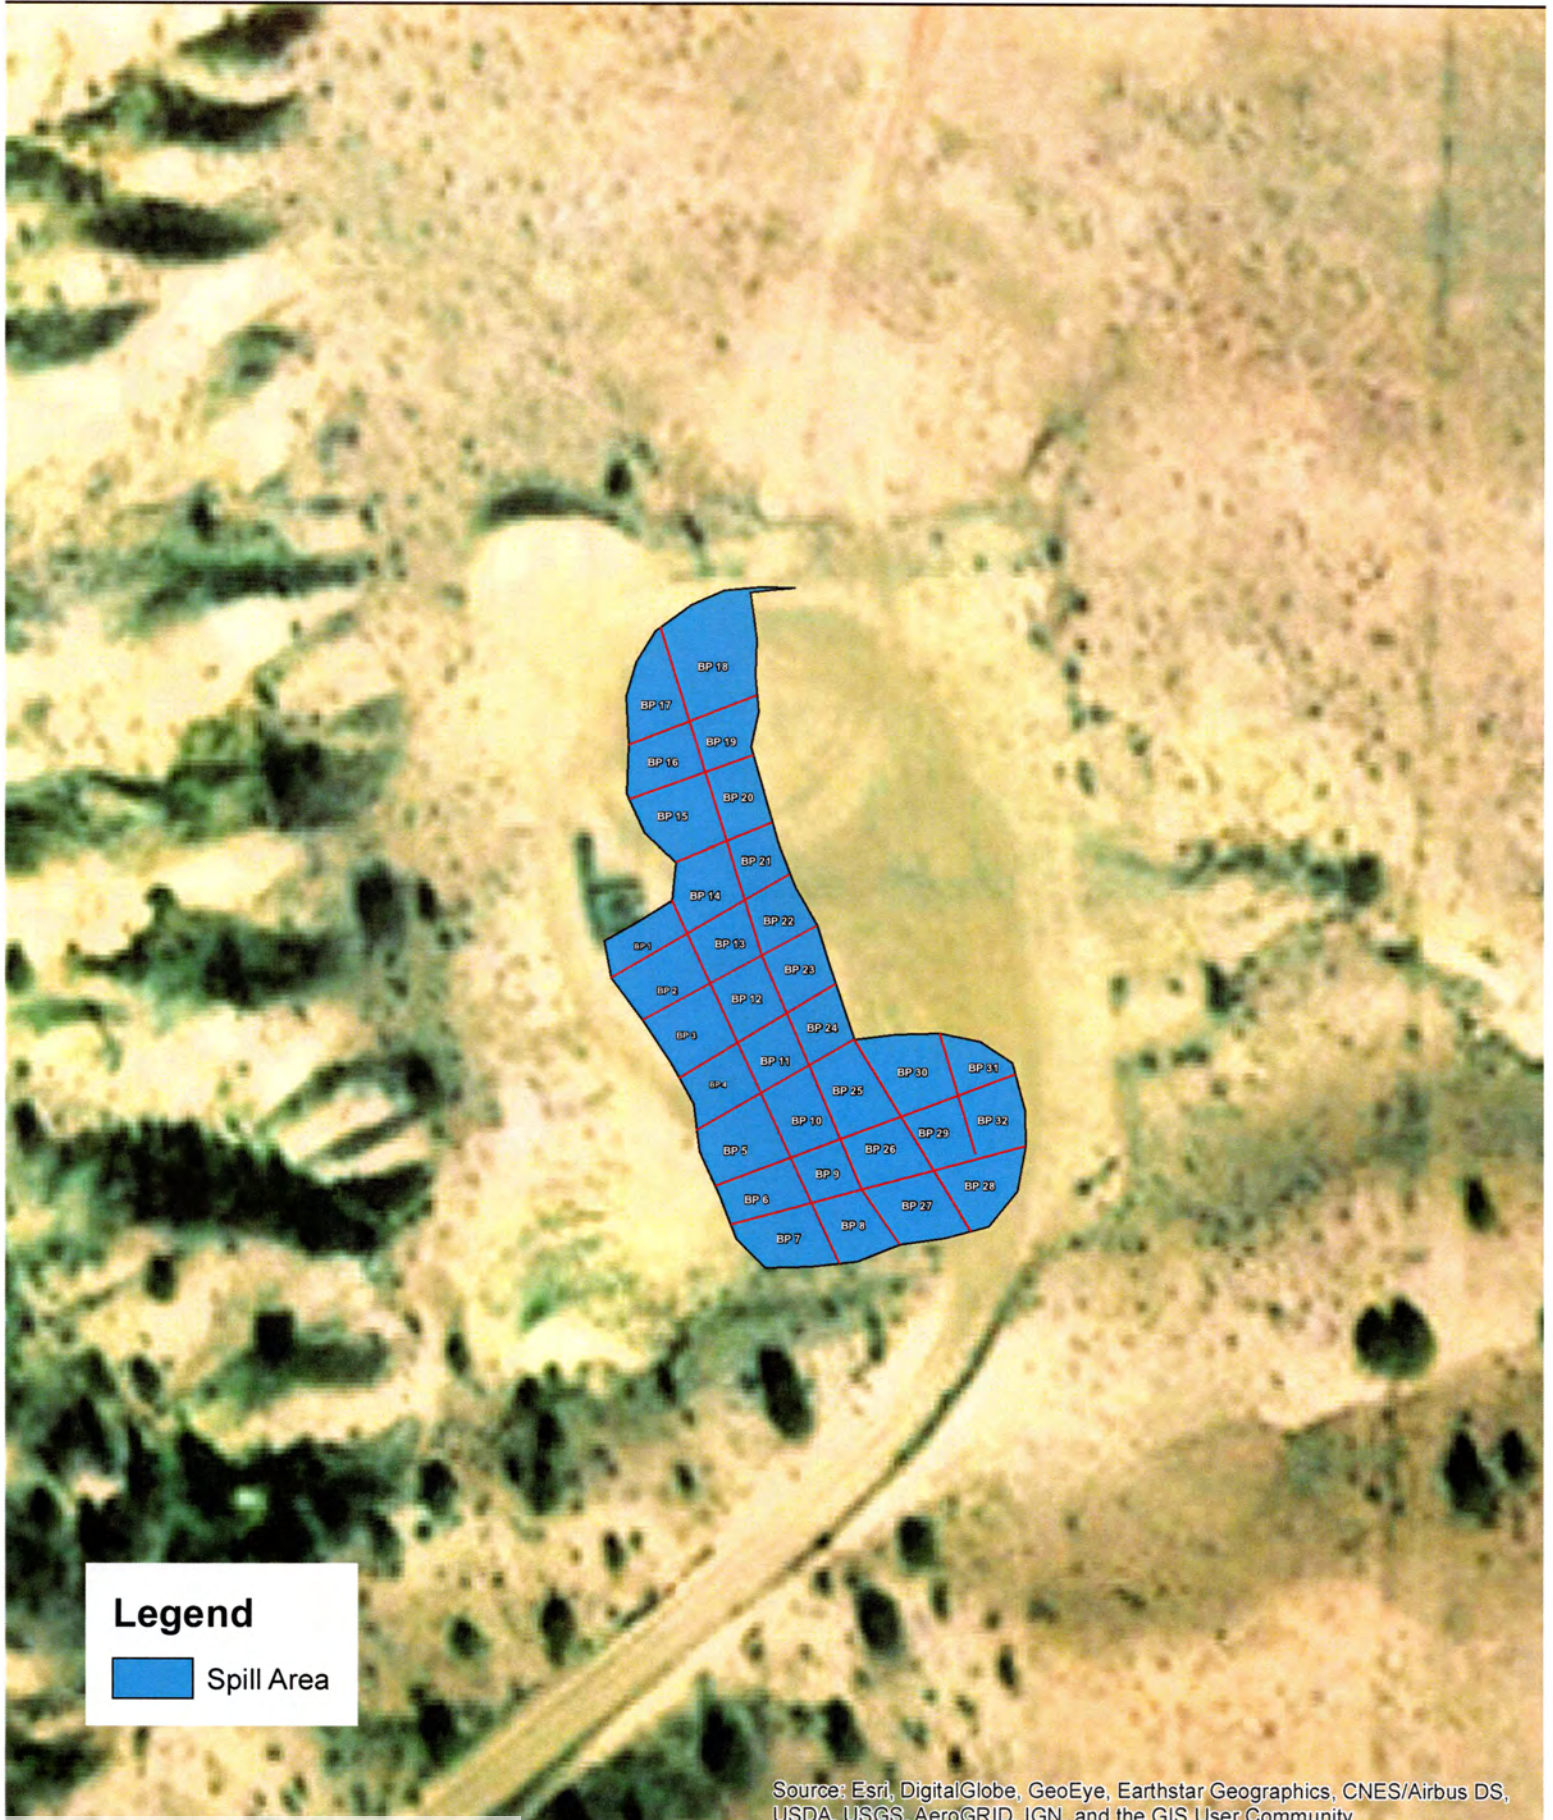
Map 7: Proposed Sampling Diagram

Map 7 is a map of the proposed sampling locations.

2. Once the treatment with gypsum and fresh water has been completed Dugan will collect 5-point composite samples. The samples will be taken to a local laboratory for analysis. Specifically, Dugan will test the samples for Chlorides, BTEX and TPH. Dugan will be collecting 14 samples within the spill area. The samples will be collected 1 ft below grade surface.

NMAC 19.15.29 stipulates an operator must acquire OCD written approval to use 5-point composite samples for areas larger than 200 square feet. Map 7 indicates we will collect 32 samples. This equates to 343.75 square feet per 5-point composite sample. Since the spill was contained to the well pad, it will present minimal danger to the public, wildlife or sources of water should OCD grant permission to use the larger sampling area.
