Responsible Party Dugan Production Corp.	OGRID 006515
Contact Name Kevin Smaka	Contact Telephone 505-325-1821 x1049
Contact email Kevin.Smaka@duganproduction.com	Incident # (assigned by OCD) nAPP2223445319
Contact mailing address PO Box 420, Farmington, NM 87499

Satchmo Com #2

Site Characterization and Remediation Plan

30-045-34425

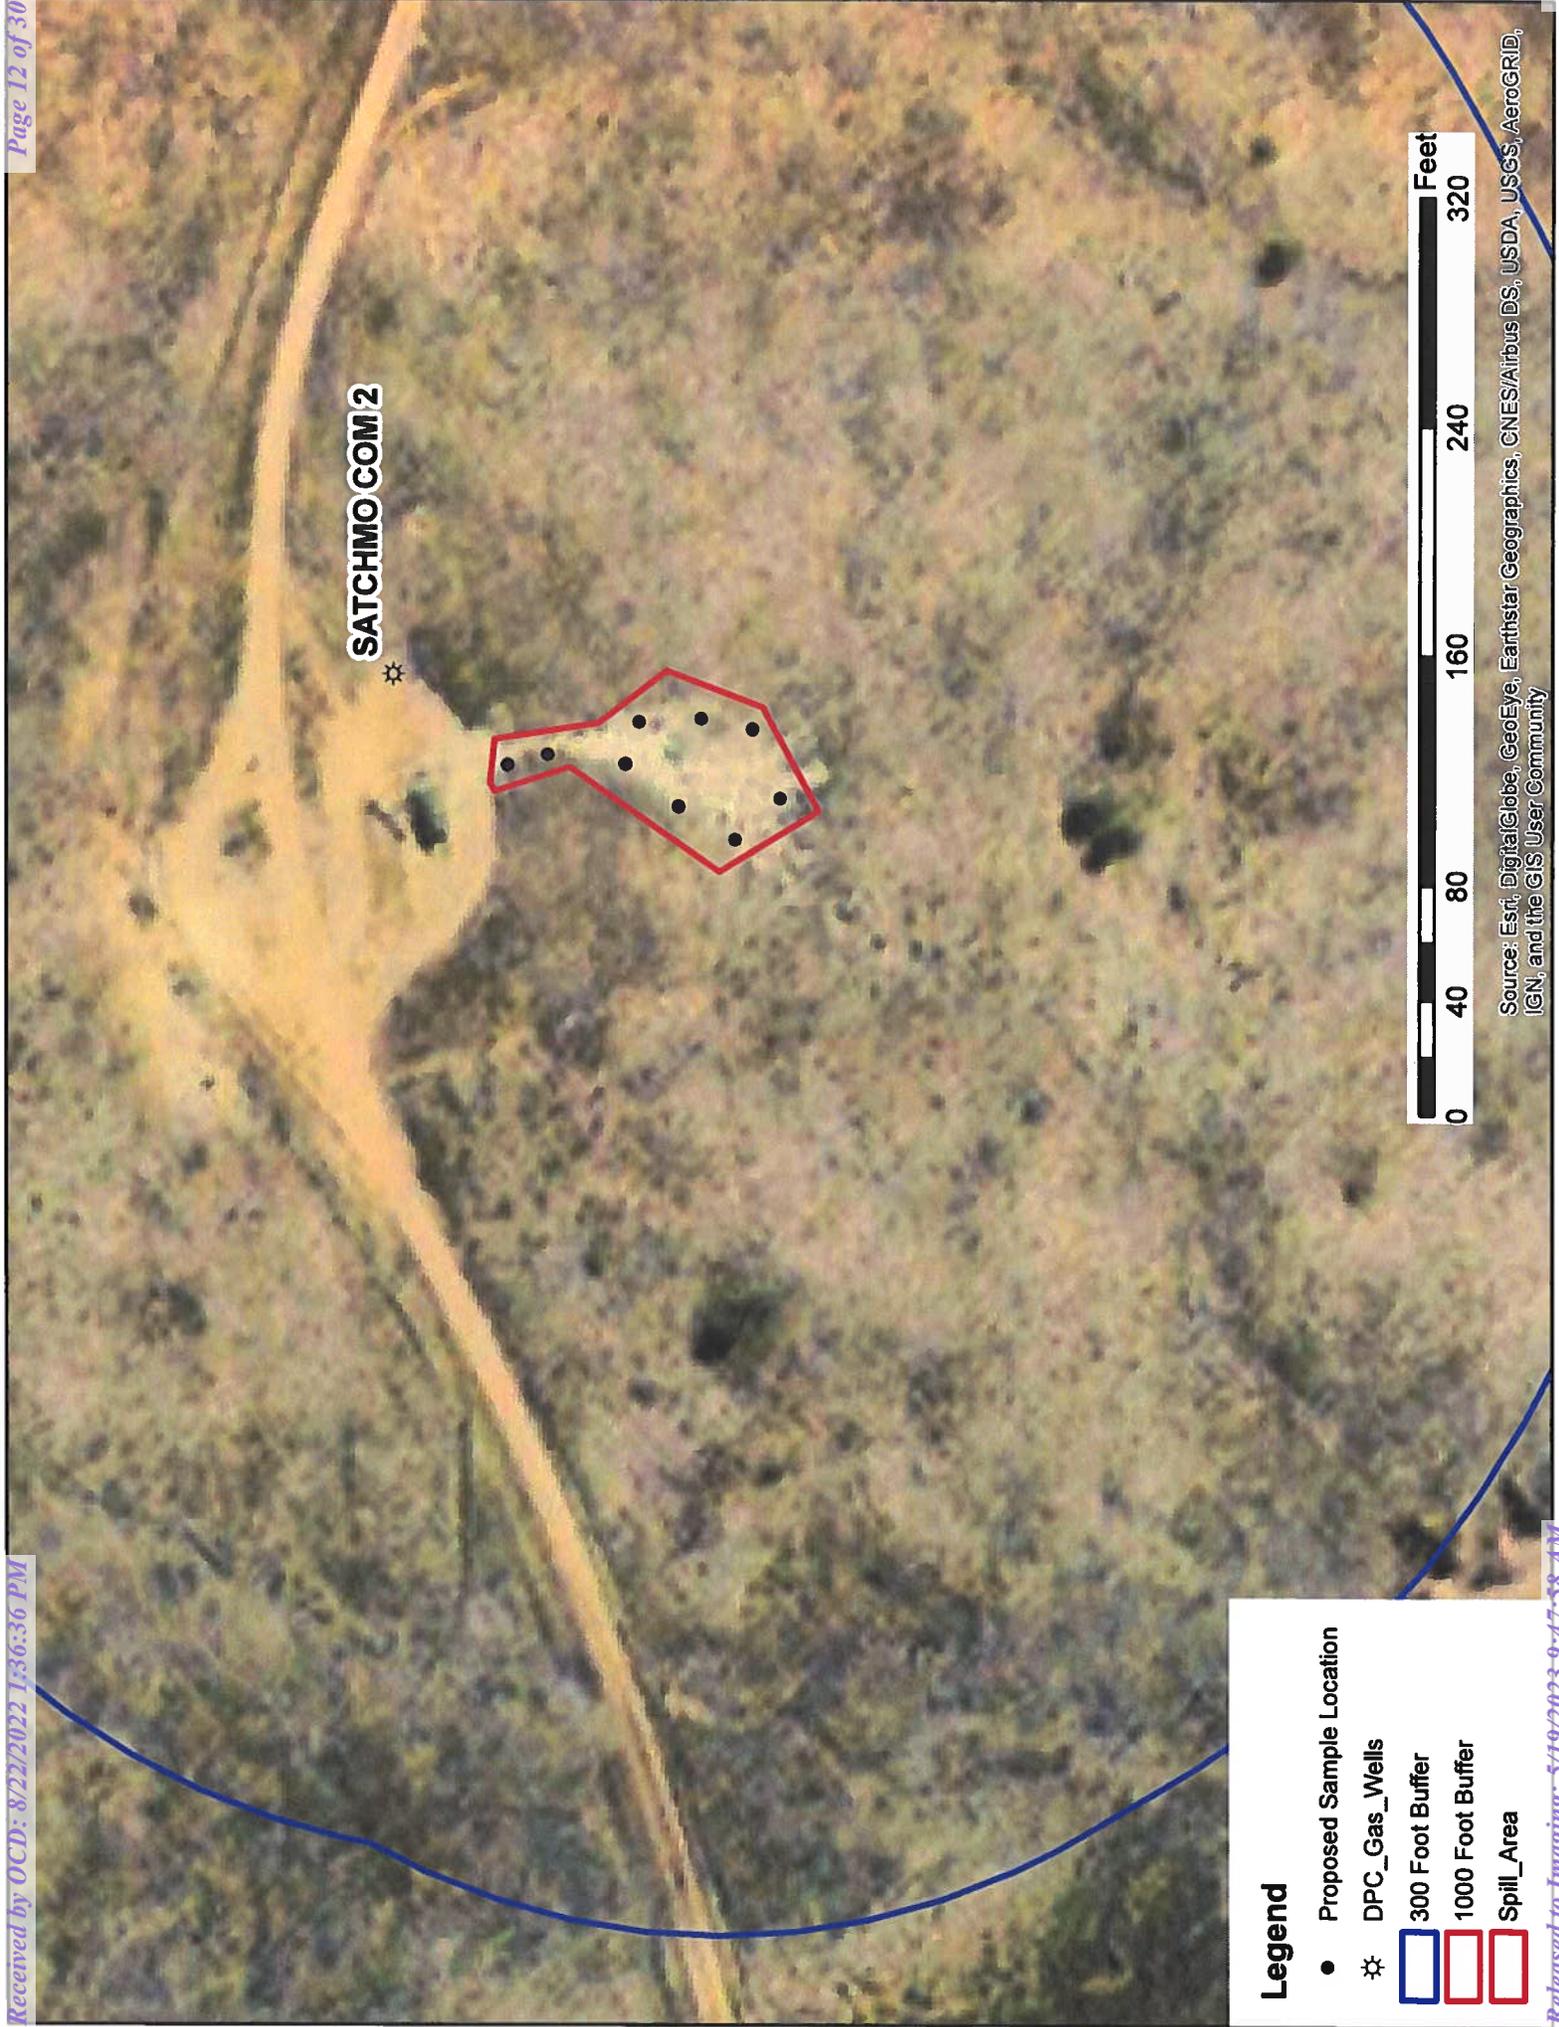
In this case Dugan requests permission to sample every 500 square feet with a 5 point composite sample. The spill is approximately 4500 square feet. We propose gathering 9 samples. A map is included showing the proposed locations.

After reviewing the needed maps and other data Dugan has determined the spill did not occur in one of the sensitives areas listed above. Dugan has included maps as evidence that supports this position. The nearest water course is a stock pond approximately 800 feet away. There are no homes or dwelling within 300 feet of the spill area. There are no wells or springs within 1000 feet of the spill. The spill did not occur within municipal boundaries. The spill is not near any wetlands, on top of a mine or lying in a flood plain.
