Release Notification

Tocito Dome Tank Battery
Produced Water Release
Incident# NAPP2233229843
Date of Release: 11/26/2022

REMEDIATION SUMMARY

TOCITO DOME TANK BATTERY
M - SEC. 21 - T27N - R13W
SAN JUAN COUNTY, NM

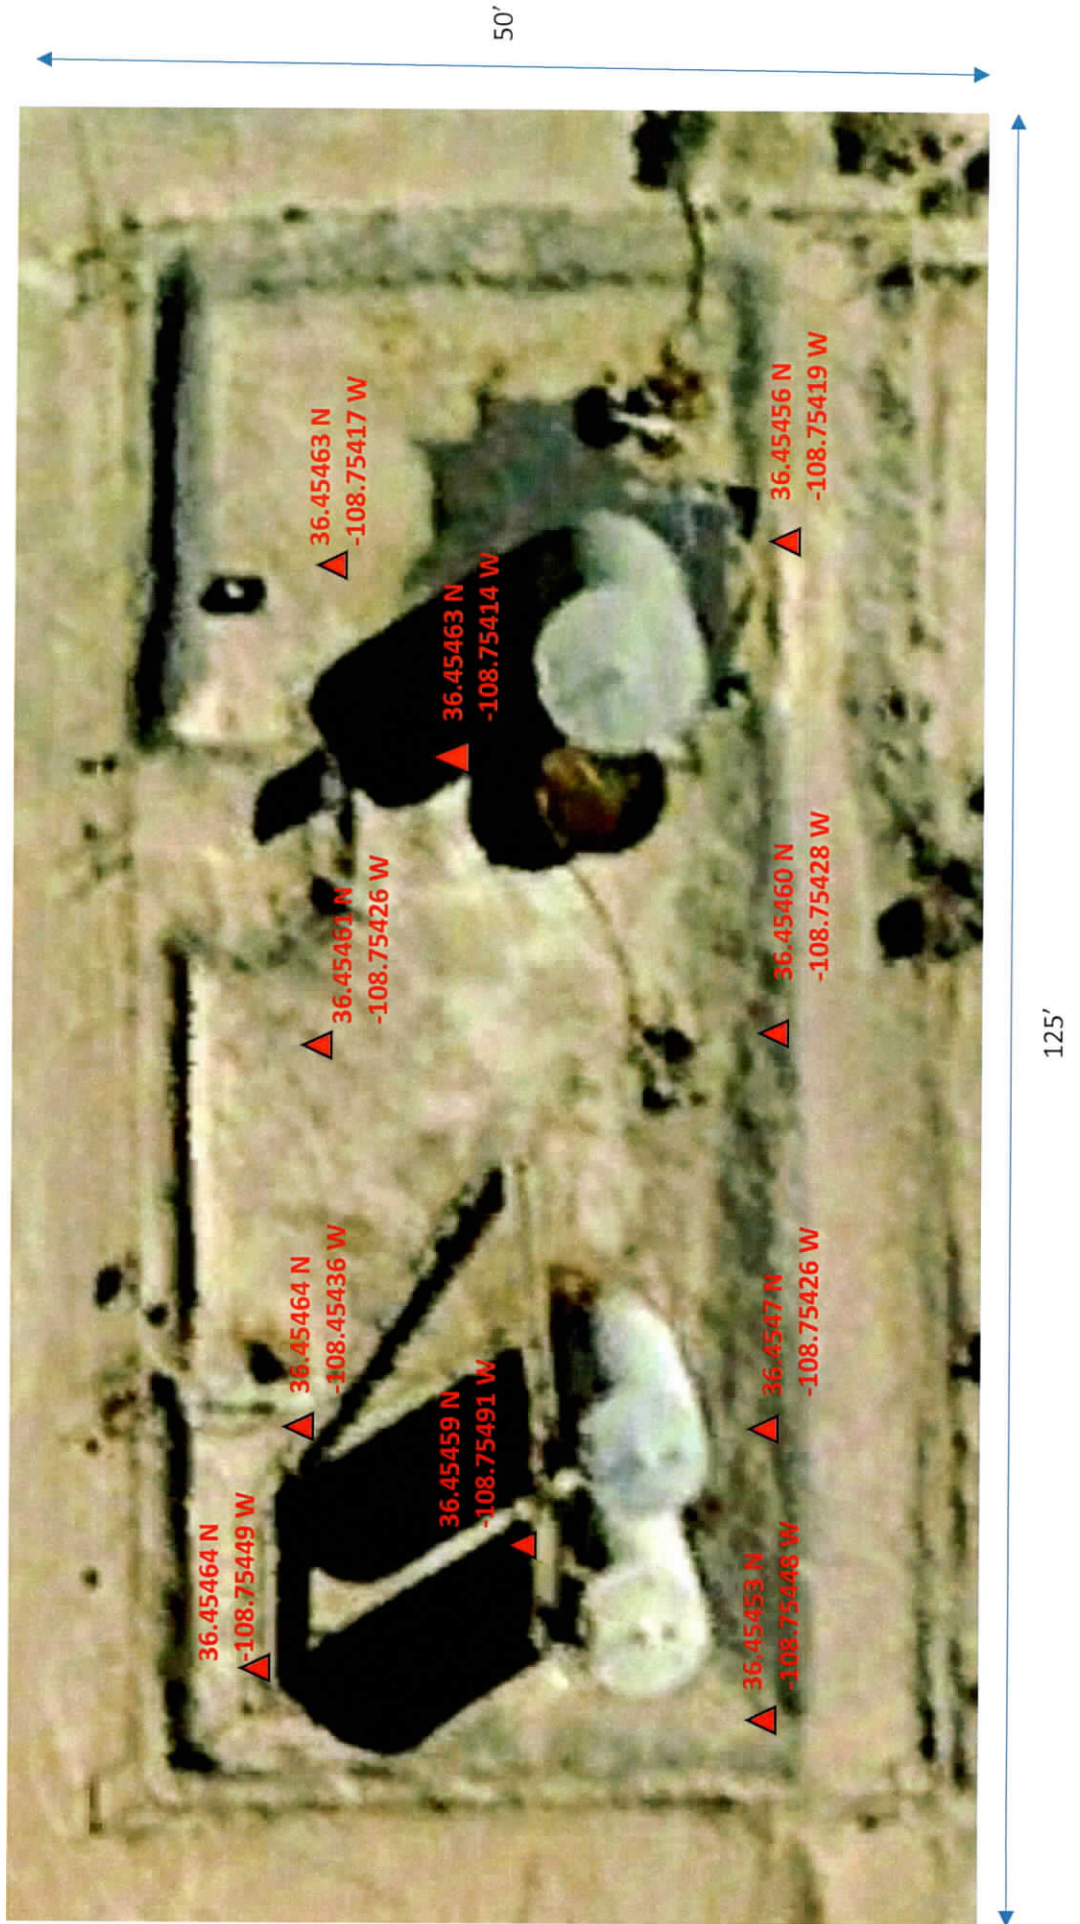
Tocito Dome Tank Battery Release Site
Sampling Map
Date of Release: 11/26/2022

On January 18, 2023, Walsh Engineering on behalf of NNOG, conducted a 5 pt composite sample. The sampling event consisted of sampling the impacted area in (2) 200 sq ft sections. (Map A) The sampling **did not meet** sampling requirements per 19.15.29.12D(1c) for Sample 1 and Sample 2 (Chloride, TPH, GRO+DRO, BTEX and Benzene). (Analytical Report – Appendix C)

On January 24, 2023, Walsh Engineering on behalf of NNOG, conducted a 5 pt composite sample. The sampling event consisted of sampling the impacted area in (2) 200 sq ft sections. (Map A) The sampling **did meet** sampling requirements per 19.15.29.12D(1c) for Sample 1 and Sample 2 (Chloride, TPH, GRO+DRO, BTEX and Benzene). (Analytical Report – Appendix D)

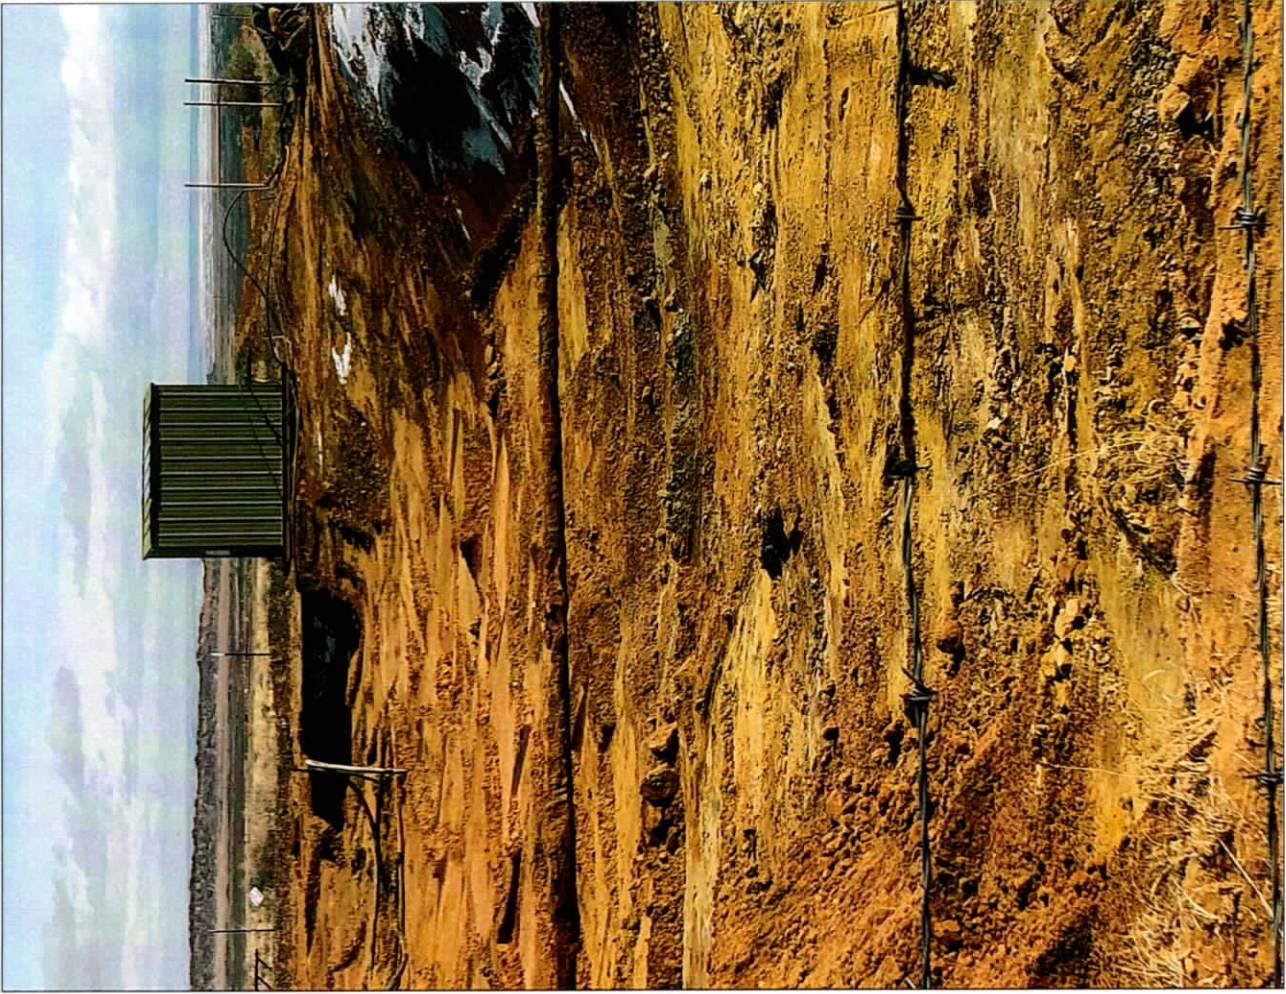
February 3, 2023 - Backfilled 850 yards

On February 3, 2023, Walsh Engineering on behalf of NNOG, backfilled the area with 850 yards of approved dirt from Envirotech.
