**Re: Site Assessment, Remediation, and Closure Report**  
**Jasper 32 State Com #004H**  
**API No. 30-015-38476**  
**GPS: Latitude 32.6235771 Longitude -104.0908356**  
**UL "A", Sec. 32, T19S, R29E**  
**Eddy County, NM**  
**NMOCD Ref. No. NAB1809357602**

Pima Environmental Services, LLC (Pima) has been contracted by Devon Energy to perform a spill assessment, remediation activities, and submit this closure report for a crude oil release that occurred at the Jasper 32 State Com 4H (Jasper). The initial C-141 was submitted on March 31<sup>st</sup>, 2018 (Appendix C). This incident was assigned Incident ID NAB1809357602, by the New Mexico Oil Conservation Division (NMOCD).

**NAB1809357602:** On March 17<sup>th</sup>, 2018, the fire tube gasket on the heater treater failed causing a release of oil and produced water. The heater treater was immediately shut off to prevent further release.

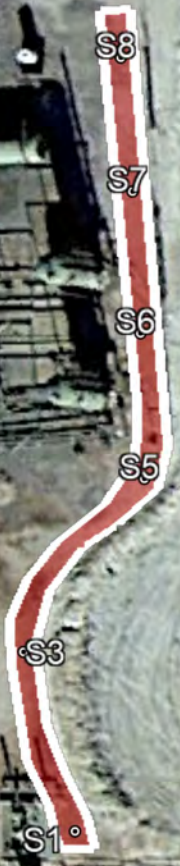
4-Site Map

On September 22<sup>nd</sup>, and October 11<sup>th</sup>, 2022, Pima Environmental mobilized personnel to the Jasper to re-assess the spill. Pima collected six bottom samples (S1, S3, S5, S6, S7, S8) and one background sample (BG3). Laboratory results of this sampling event can be found in the following data table. Horizontal delineation was completed during the confirmation sampling event.

Release Area
-

Soil Samples

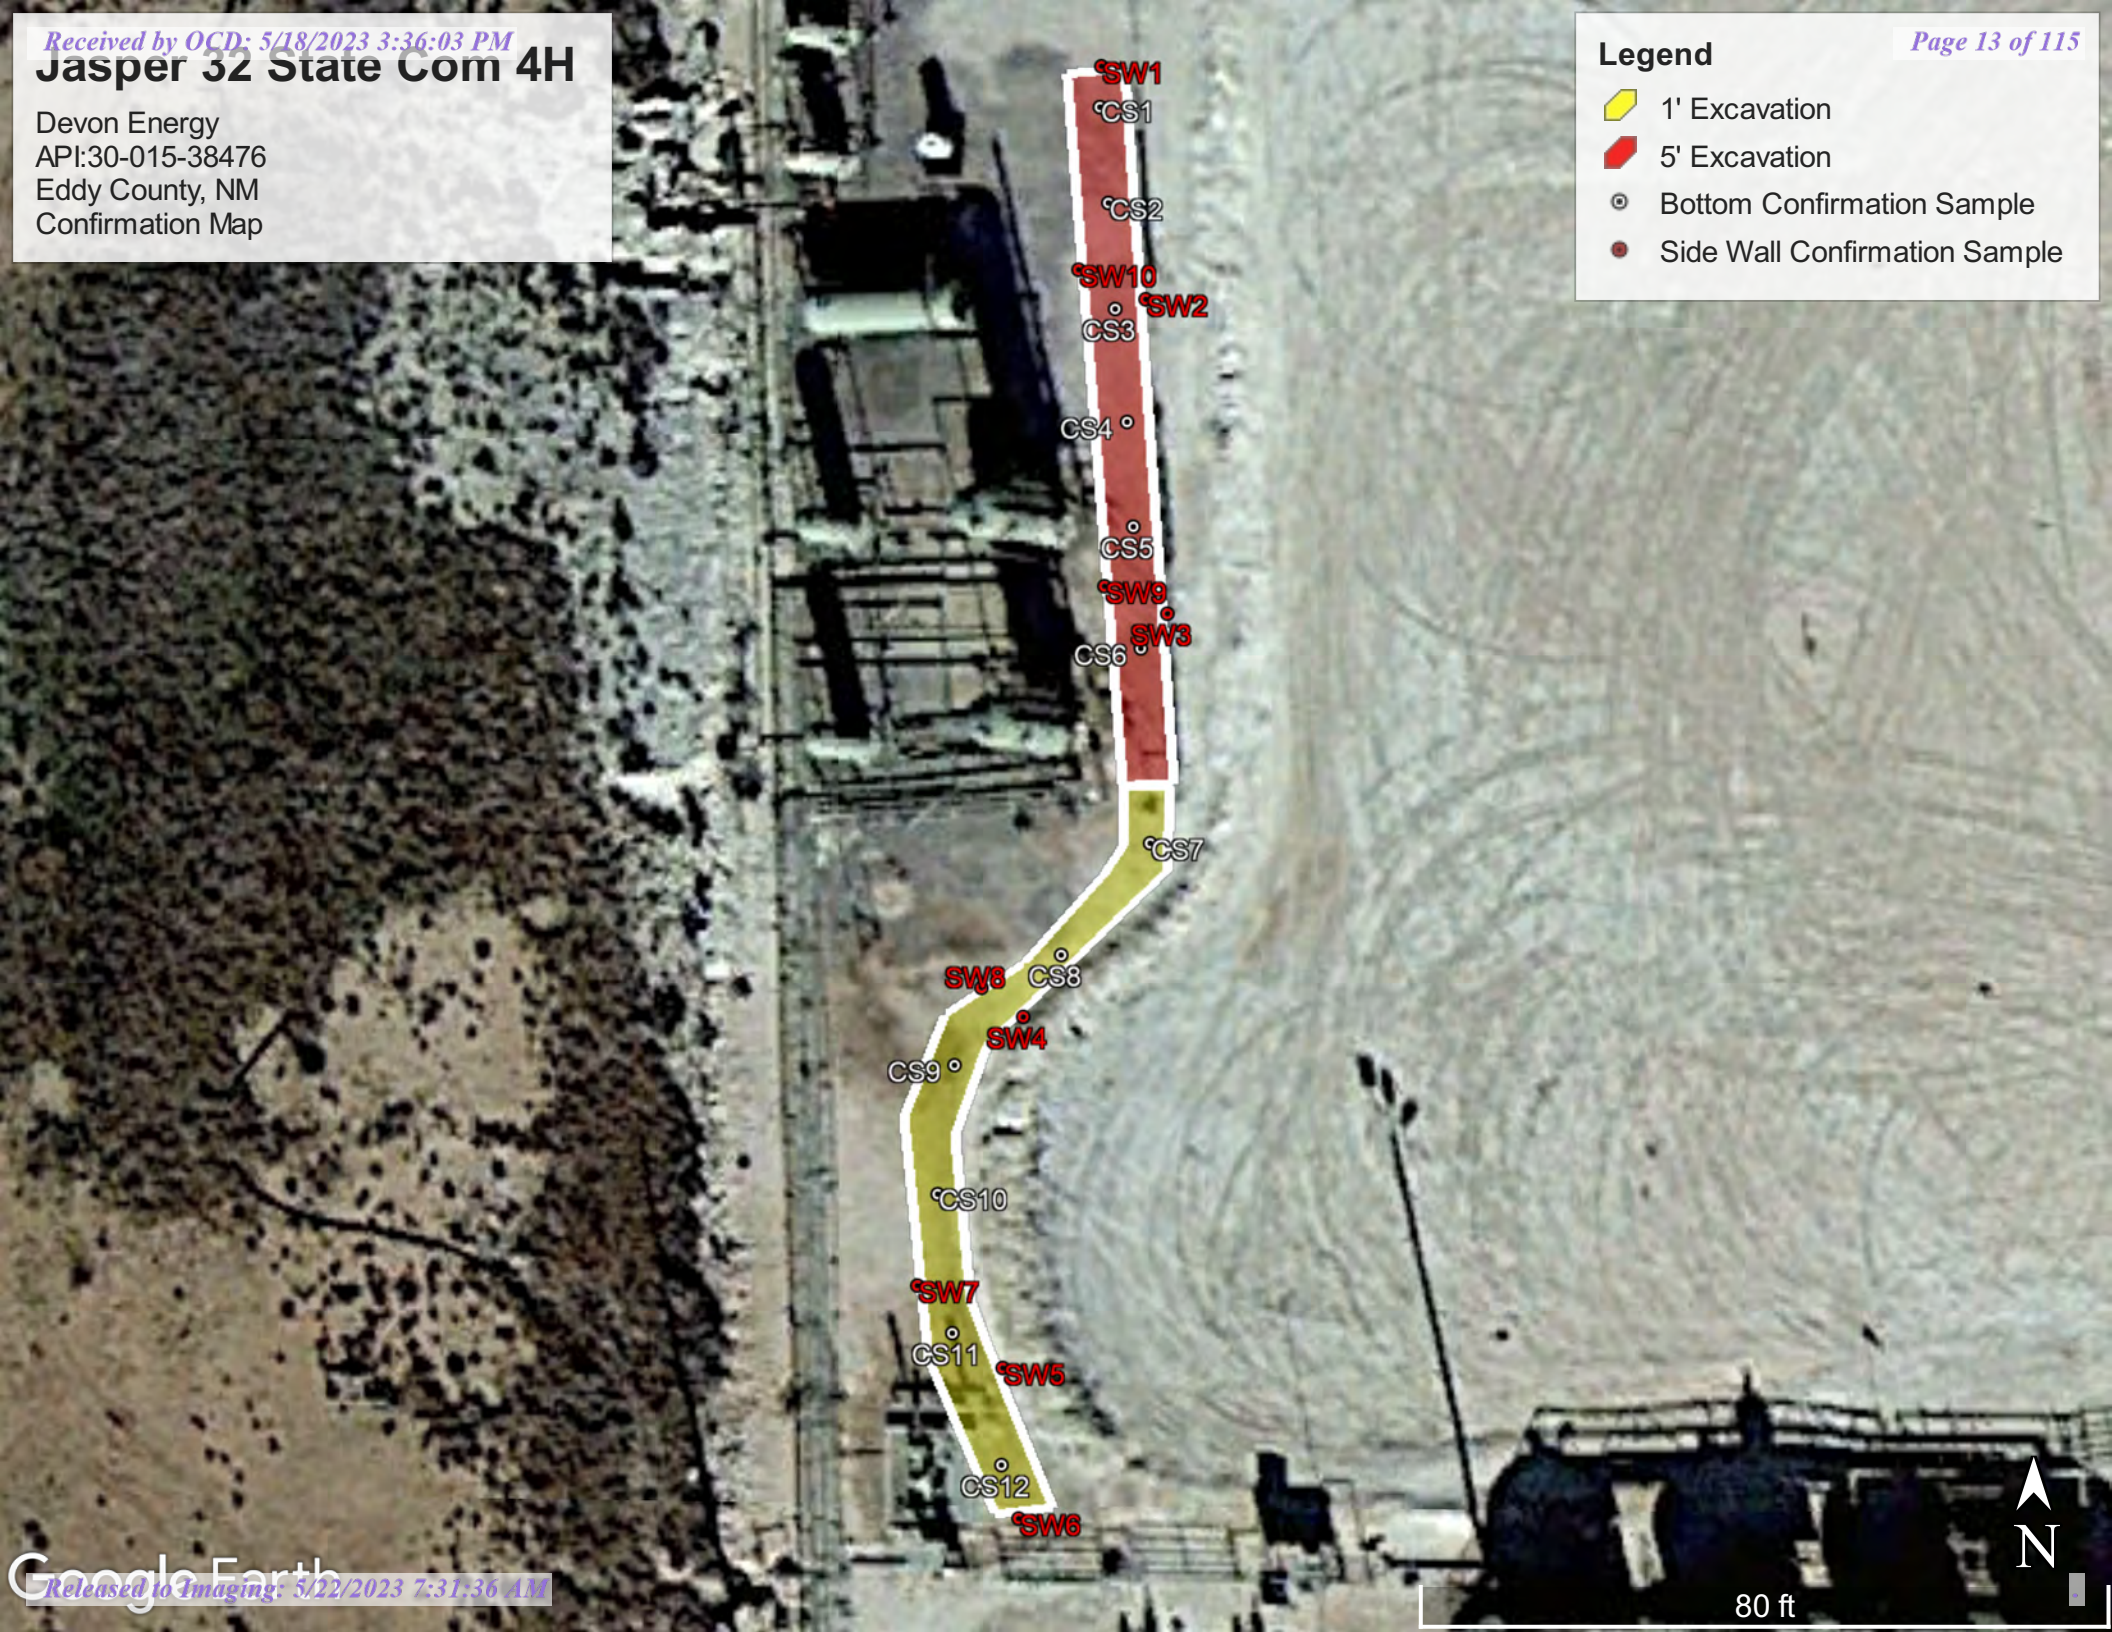
5-Confirmation Sample Map

On April 21<sup>st</sup>, 2023, Pima mobilized personnel and equipment to conduct remedial activities. We excavated the area overlapping soil sample (S1, S3, S5, and S8) to a depth of 1 foot, and the area overlapping (S6 and S7) was excavated to a depth of 5 feet bgs. The area overlapping BG-3 is under NMOCD Closure criteria, no further remediation is required. Photographic documentation can be found in Appendix D.

An area approximately 200 feet in length by 10 feet wide was excavated to various depths utilizing a backhoe.

On April 24<sup>th</sup>, 2023, after submitting the 48-hour notification (Appendix C), Pima collected confirmation samples. The laboratory results of this sampling event can be found in the following data table.

1' Excavation
-

5' Excavation
-

Bottom Confirmation Sample
-

Side Wall Confirmation Sample

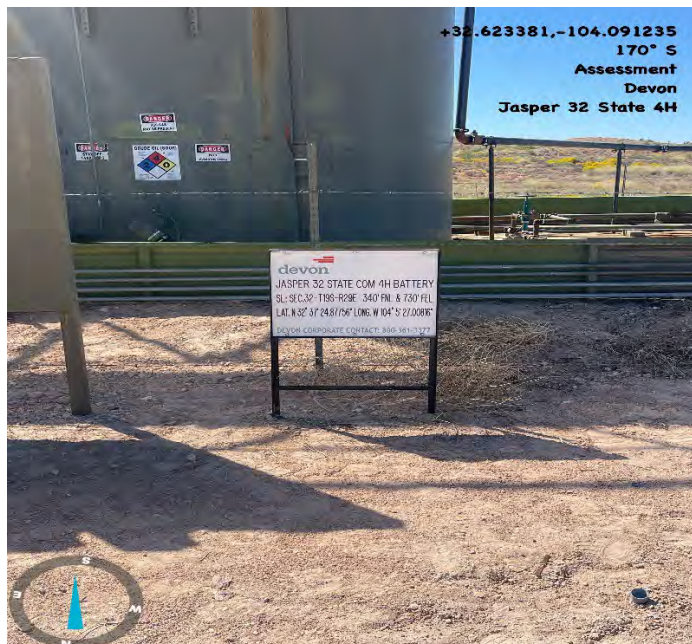
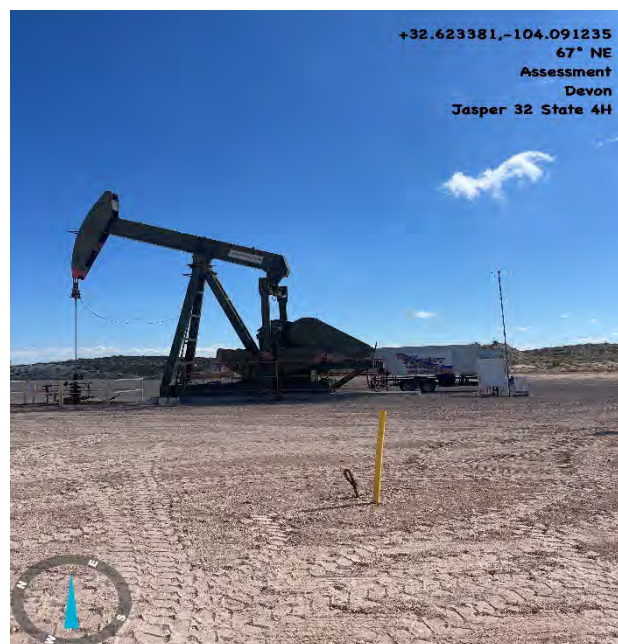
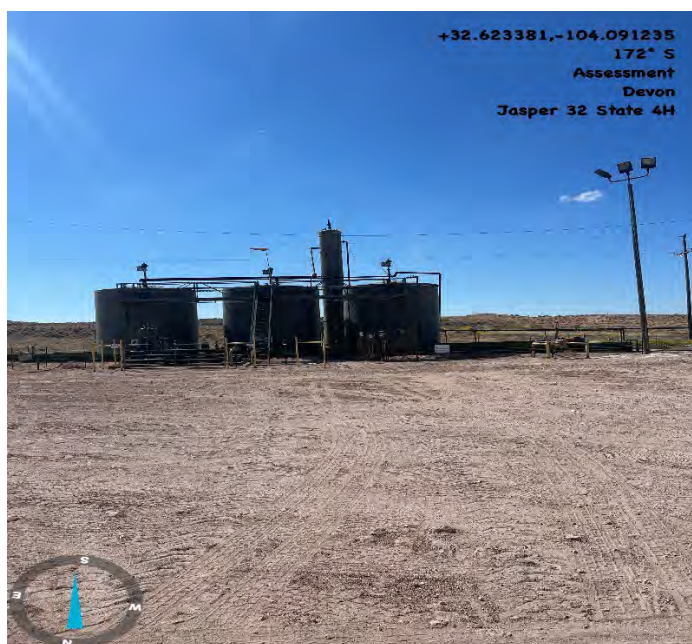
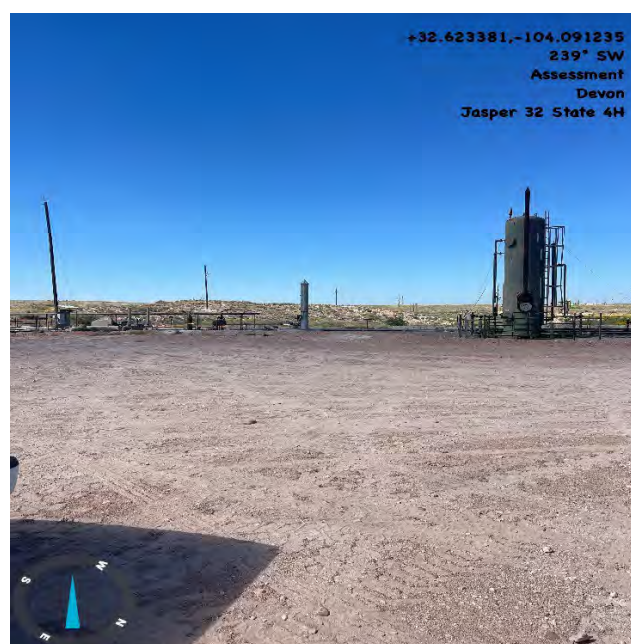
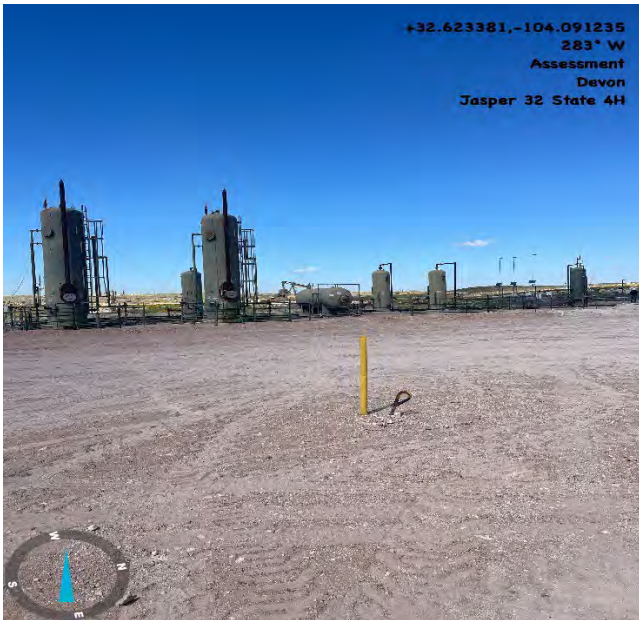
**Site Assessment**

A fire tube gasket on the heater treater failed, releasing approximately 17 bbls of oil and 73 bbls of produced water, all of which stayed on location, with 15 bbls of oil being recovered.
