Incident ID	nAPP2212962315
District RP	
Facility ID	
Application ID

## Closure

Based on laboratory analytical results and field activities conducted to date, Etech recommends Mewbourne Oil Company provide copies of this *Remediation Summary & Soil Closure Request* to the appropriate agencies and request closure be granted to the Parkway 26 SWD Line release site.

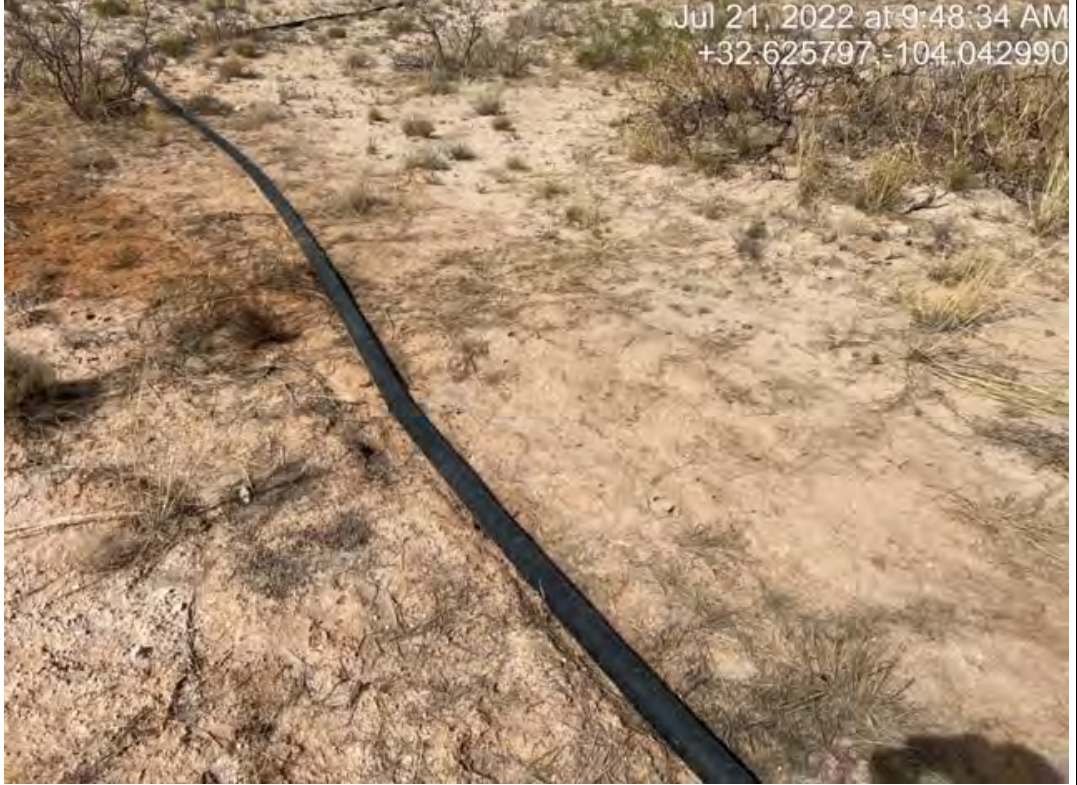
<b>Photo Number:</b> 1

Cause of Release:  
 A 4" poly SWD line developed a leak.

<b>Photo Direction:</b> Southwest	
<b>Photo Description:</b>  View of the point of release.

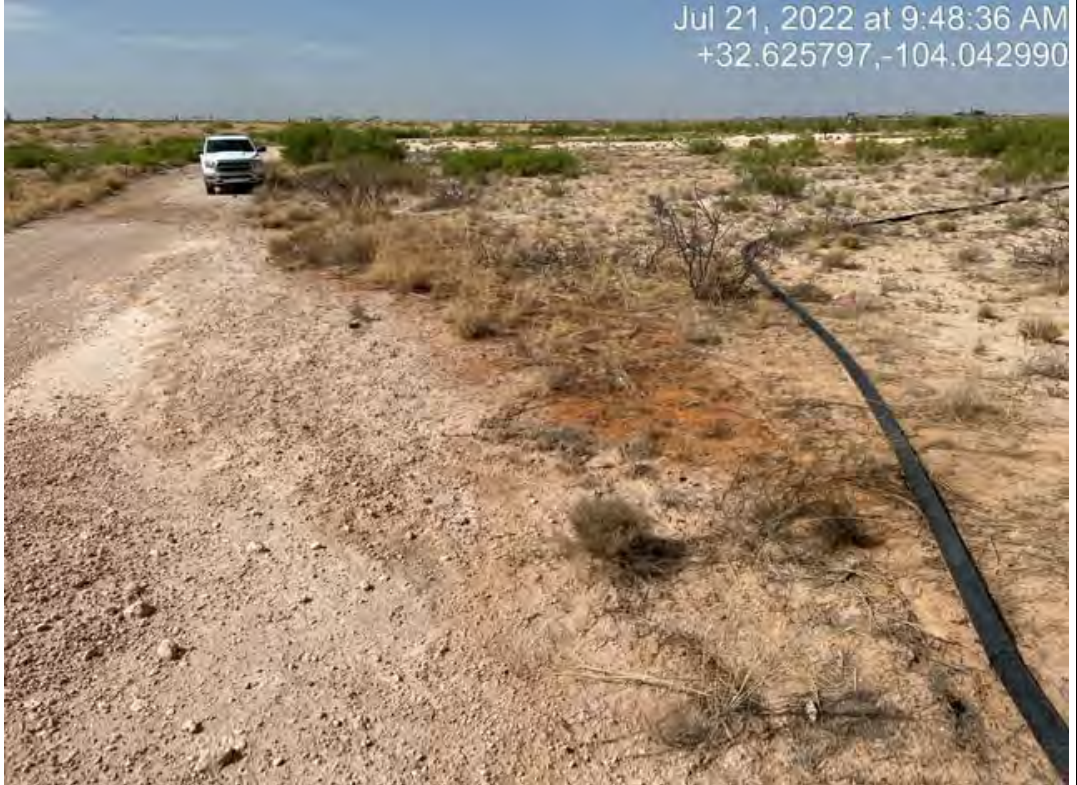
<b>Photo Number:</b> 2

<b>Photo Direction:</b> South	
<b>Photo Description:</b>  View of the affected area.

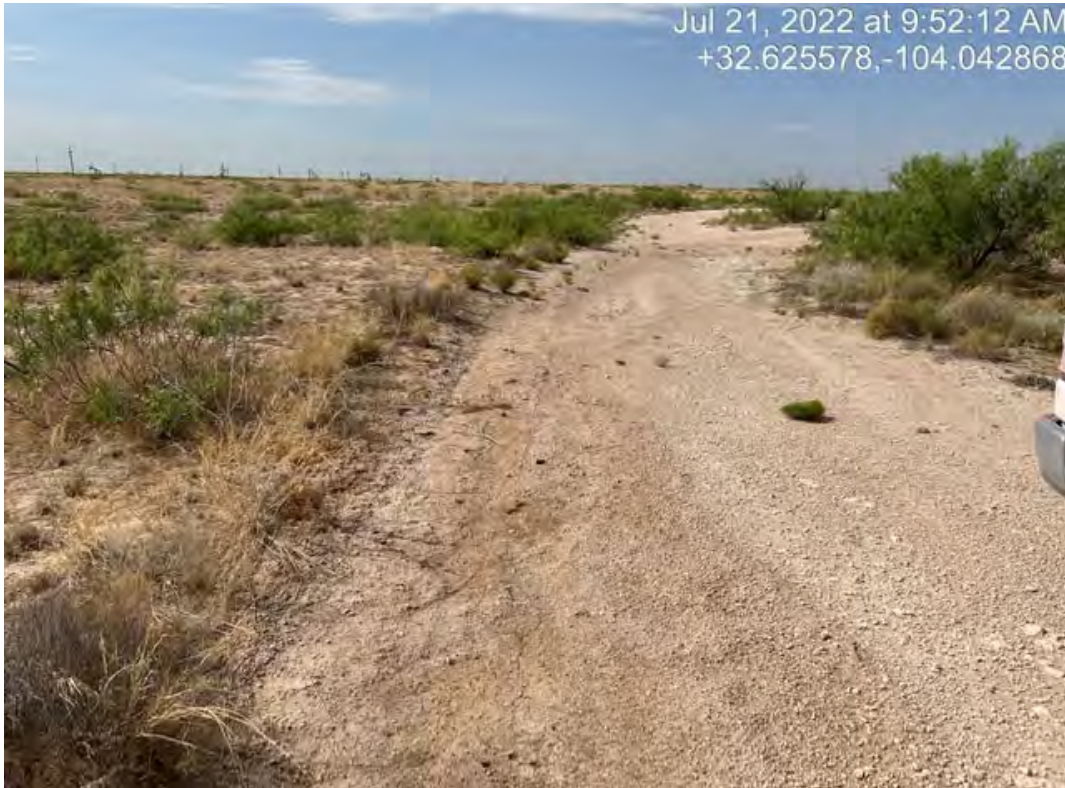
<b>Photo Number:</b> 5

<b>Photo Direction:</b> South	
<b>Photo Description:</b>  View of the affected area.

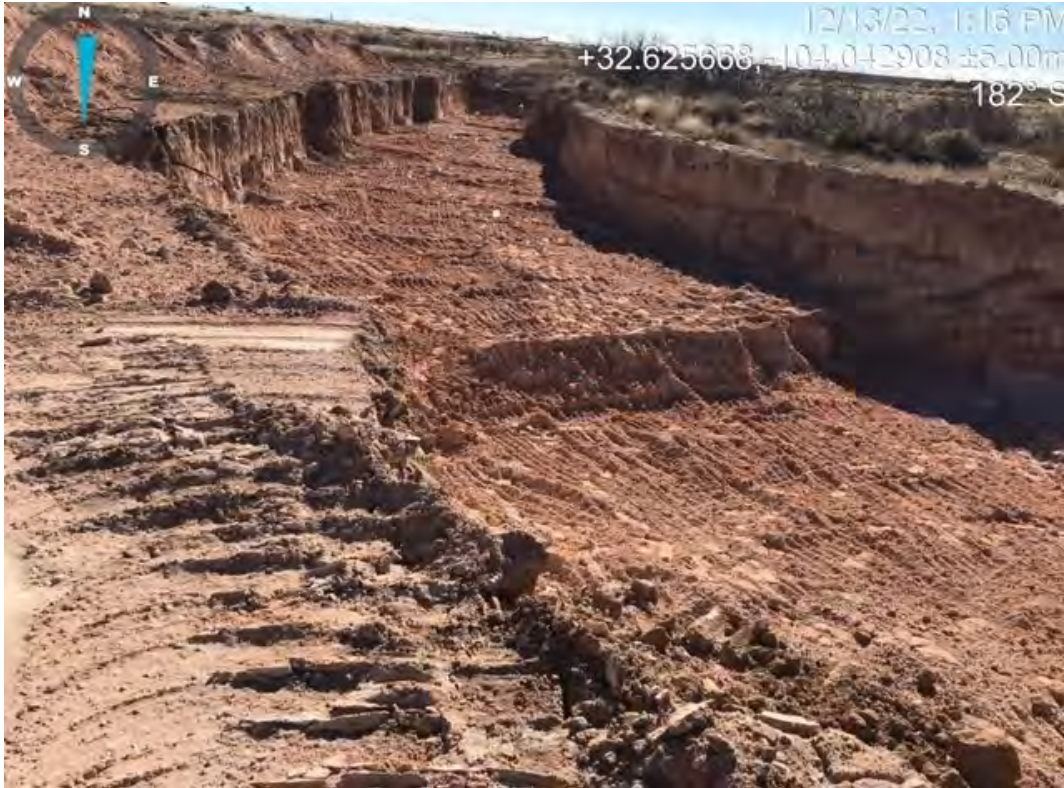
<b>Photo Number:</b> 8

<b>Photo Direction:</b> South	
<b>Photo Description:</b>  View of the excavated area.

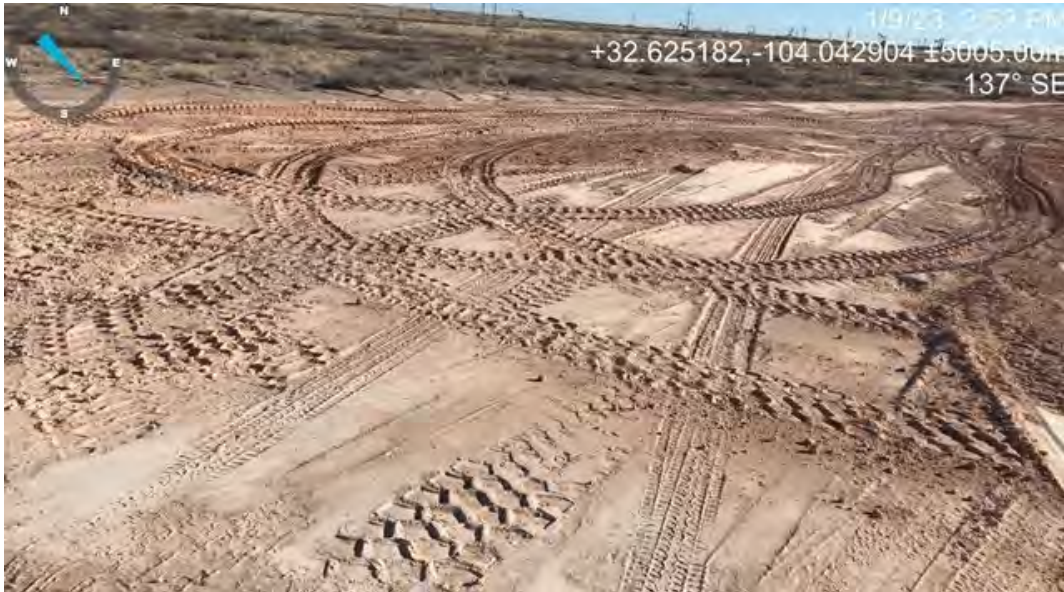
<b>Photo Number:</b> 10

<b>Photo Direction:</b> Southeast	
<b>Photo Description:</b>  View of the remediated area after backfill and regrading.

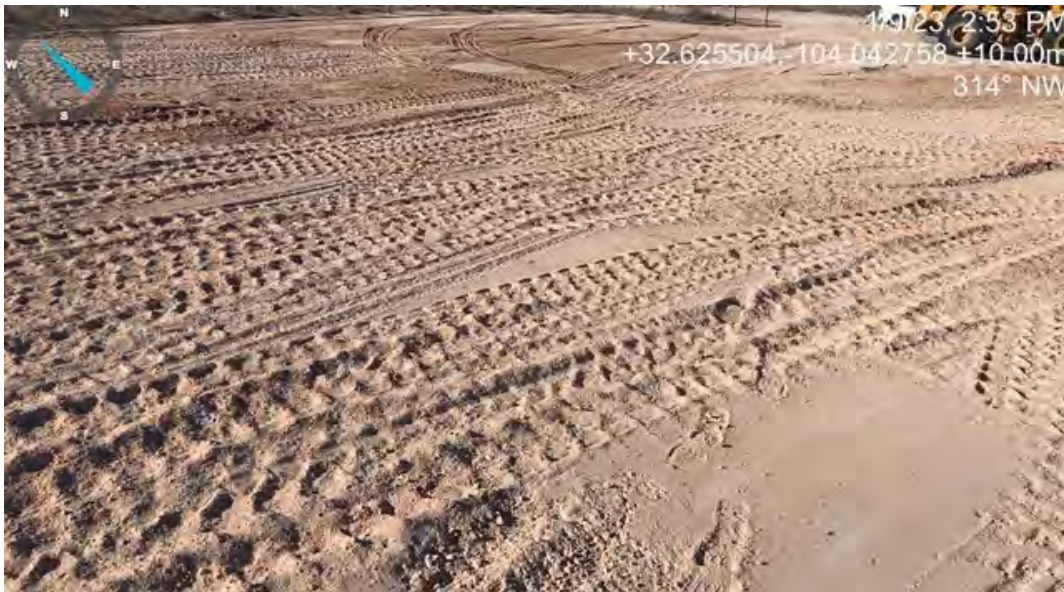
<b>Photo Number:</b> 12

<b>Photo Direction:</b> Northwest	
<b>Photo Description:</b>  View of the remediated area after backfill and regrading.
