**Re: Closure Report  
ConocoPhillips  
Tequiza Federal #001 Release  
Unit Letter O, Section 34, Township 21 South, Range 25 East  
Eddy County, New Mexico  
Incident ID# nAB1805142690  
2RP-4632**

Closure Report  
June 6, 2023

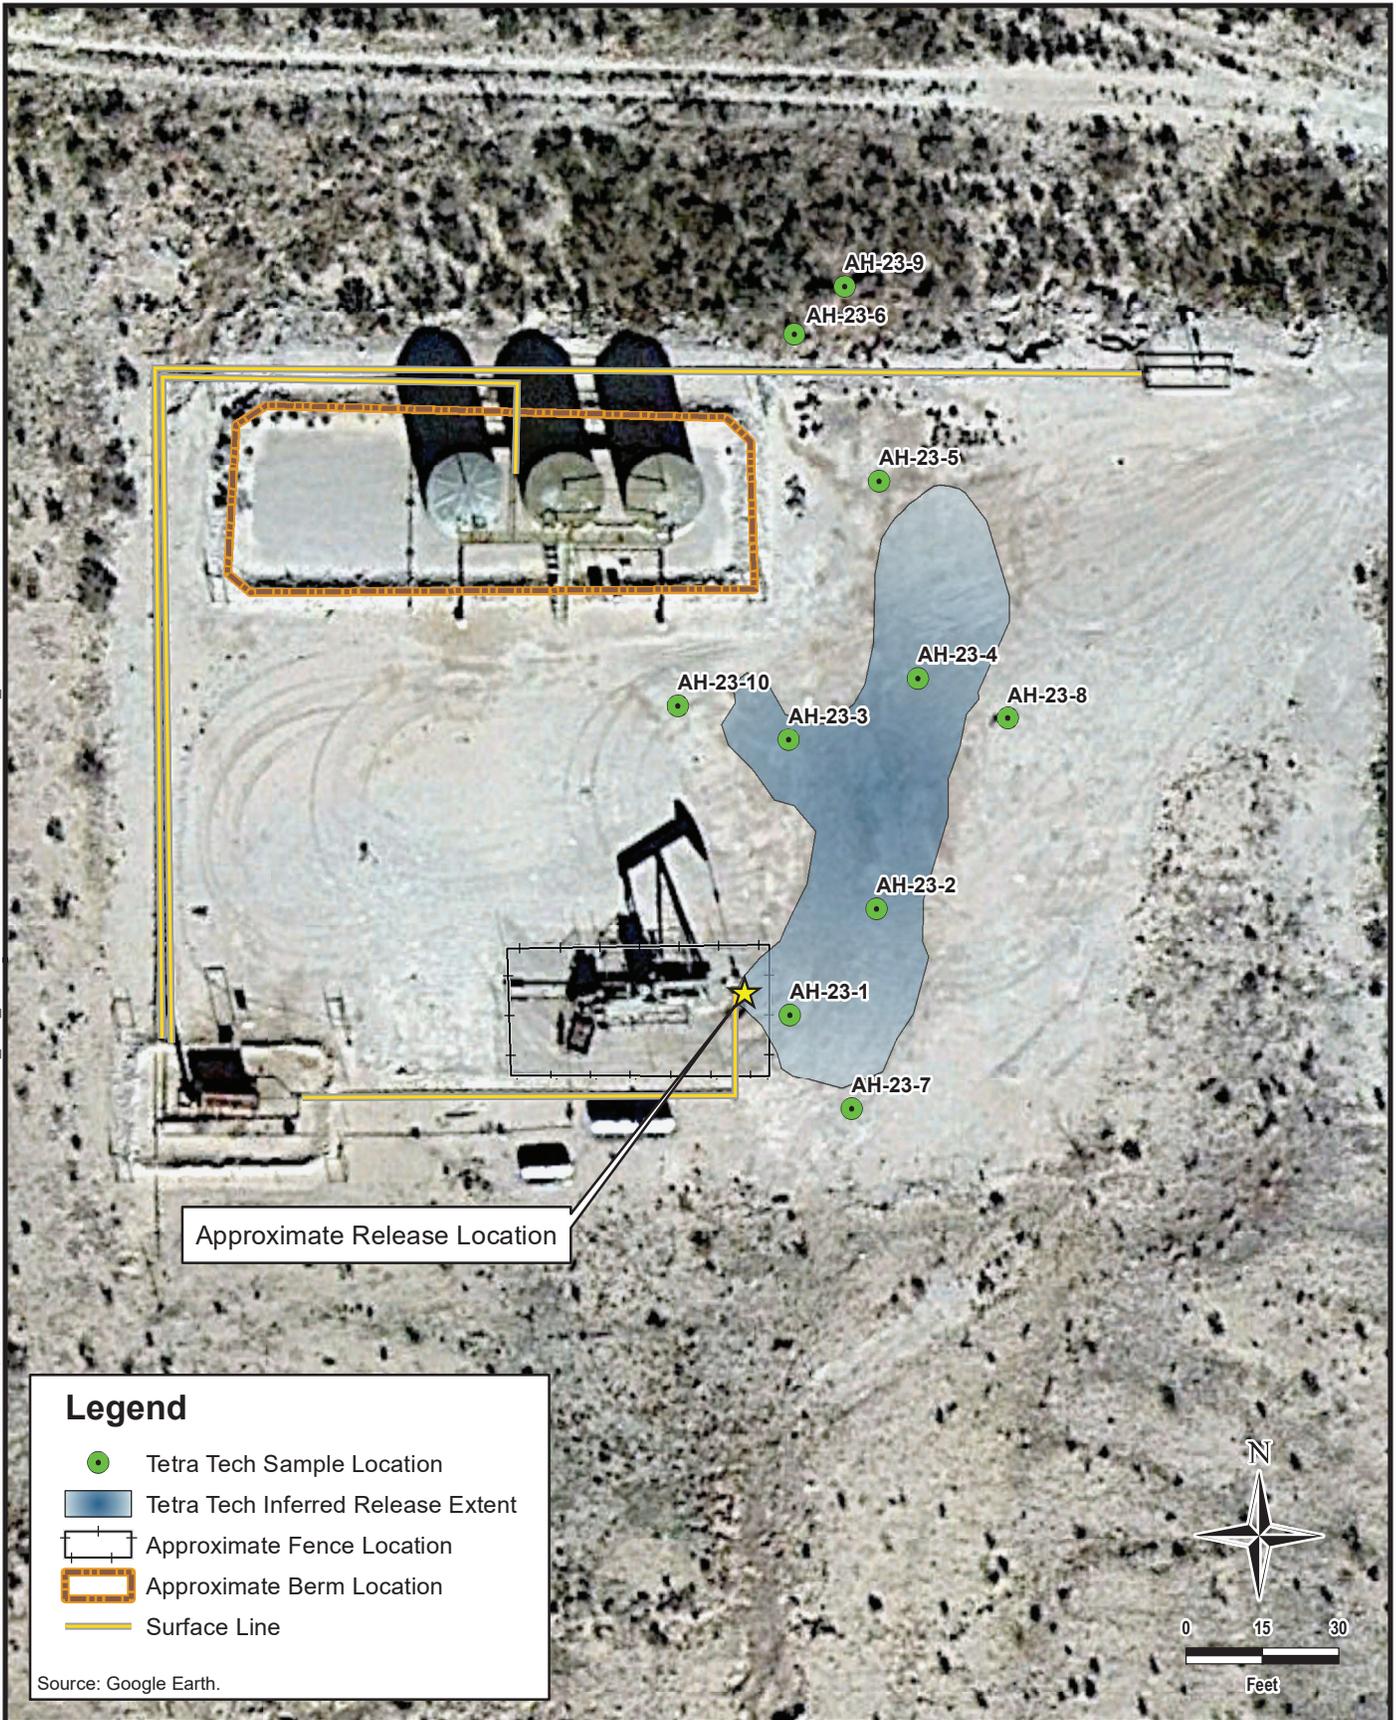
- Tetra Tech Sample Location
- Tetra Tech Inferred Release Extent
- Approximate Fence Location
- Approximate Berm Location
- Surface Line

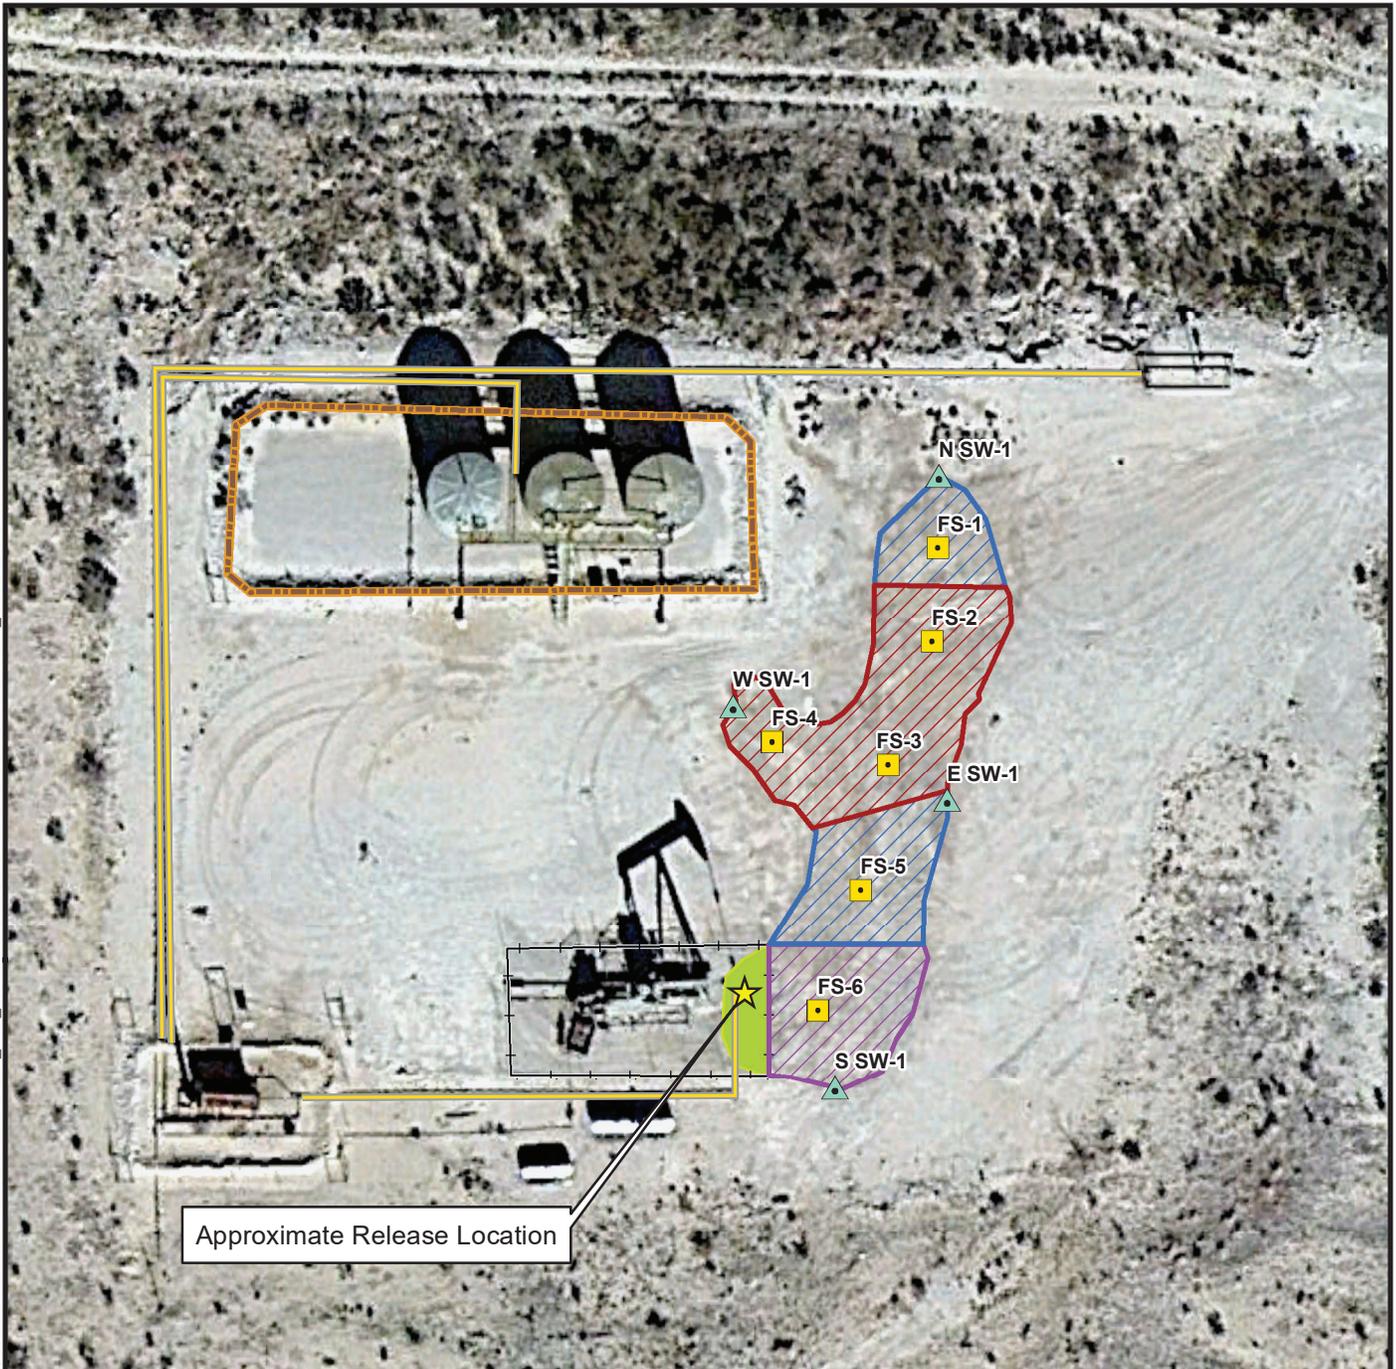
Approximate Release Location

Following excavation, confirmation floor and sidewall samples were collected and submitted for laboratory analysis to verify efficacy of remediation activities. The approximate on-pad impacted area was 3,700 square feet. Per the conditions of the Work Plan approval, confirmation samples were collected such that each discrete sample (sidewall and floor) was representative of no more than 400 square feet of excavated area. A total of six (6) confirmation floor samples and four (4) confirmation sidewall samples were collected during remedial activities. Confirmation sidewall sample locations were categorized with the cardinal direction (N, E, S, W) followed by SW-#. Confirmation floor sample locations were labeled with "FS"-#. Excavated areas and depths and confirmation sample locations are indicated in Figure 5.

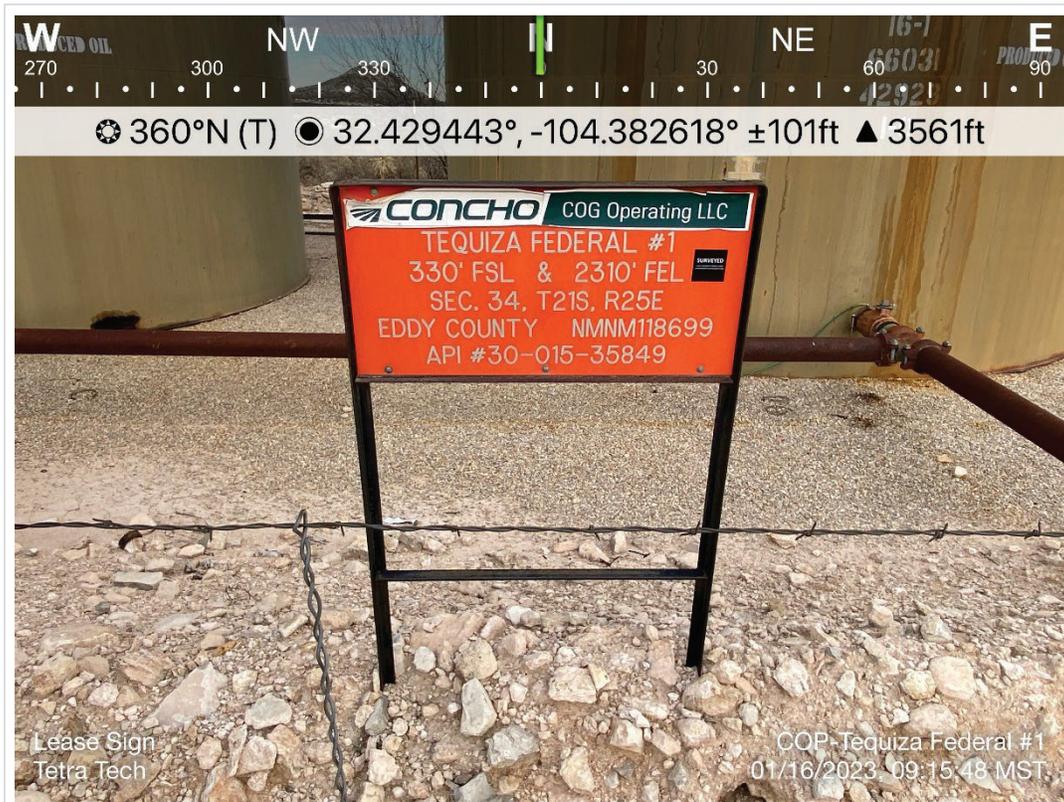
TETRA TECH, INC. PROJECT NO. 212C-MD-02881	DESCRIPTION	View northeast across pad with lease road to east.	1
	SITE NAME	Tequiza Federal #001 Release	1/16/2023

Based on the age of the release, Tetra Tech personnel conducted a visual Site inspection on January 16, 2023, to assess current Site conditions, document the observed impact, and photograph the area. Tetra Tech observed that no obvious signs of staining and/or residual impact were observed in the release area on or off pad.

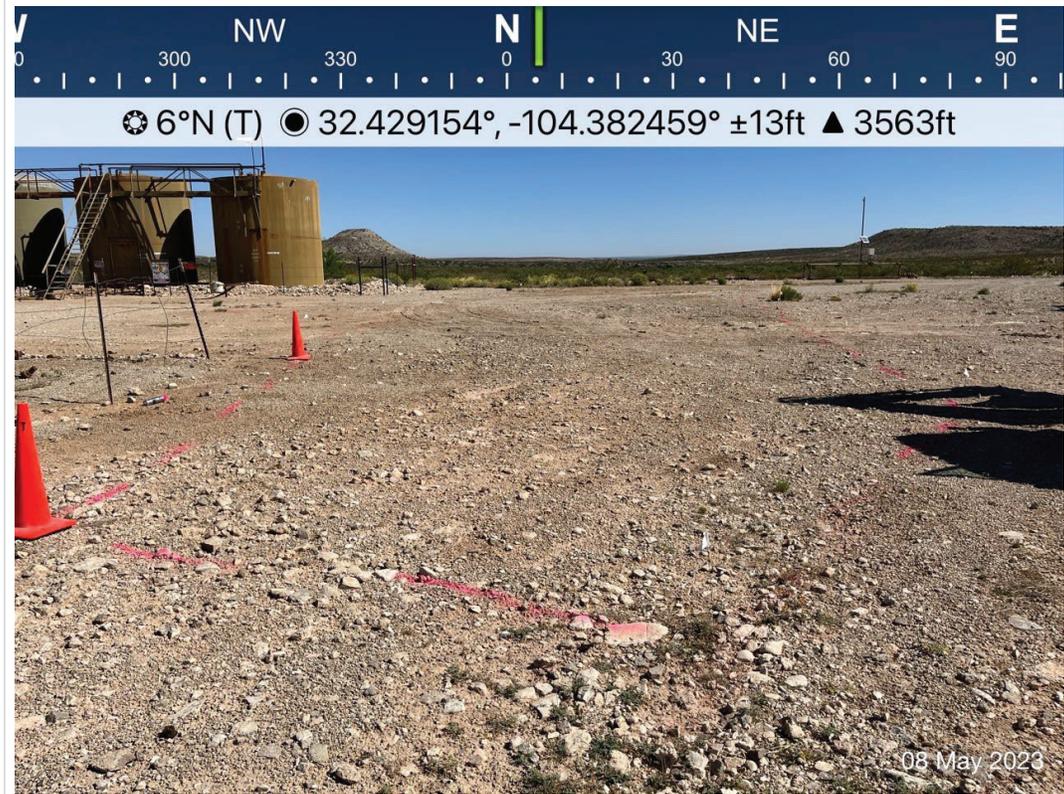
TETRA TECH, INC. PROJECT NO. 212C-MD-02881	DESCRIPTION	View north. Excavation area marked.	2
	SITE NAME	Tequiza Federal #001 Release	5/8/2023

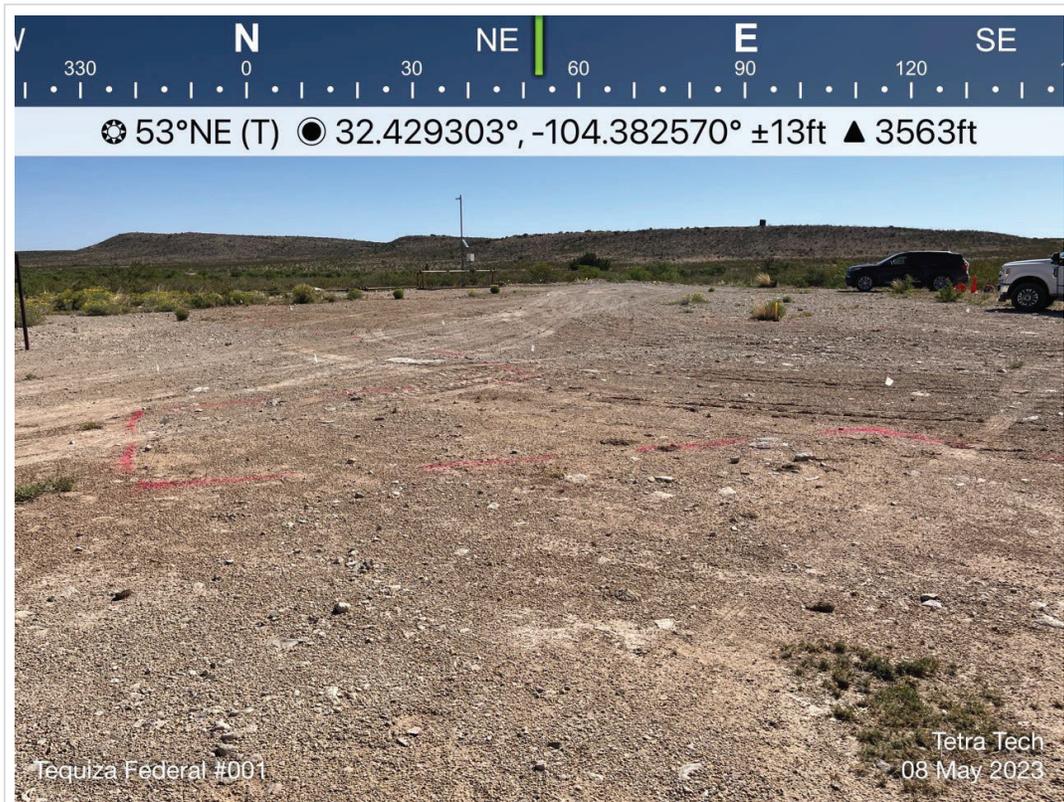
TETRA TECH, INC. PROJECT NO. 212C-MD-02881	DESCRIPTION	View northeast. Excavation area marked.	3
	SITE NAME	Tequiza Federal #001 Release	5/8/2023

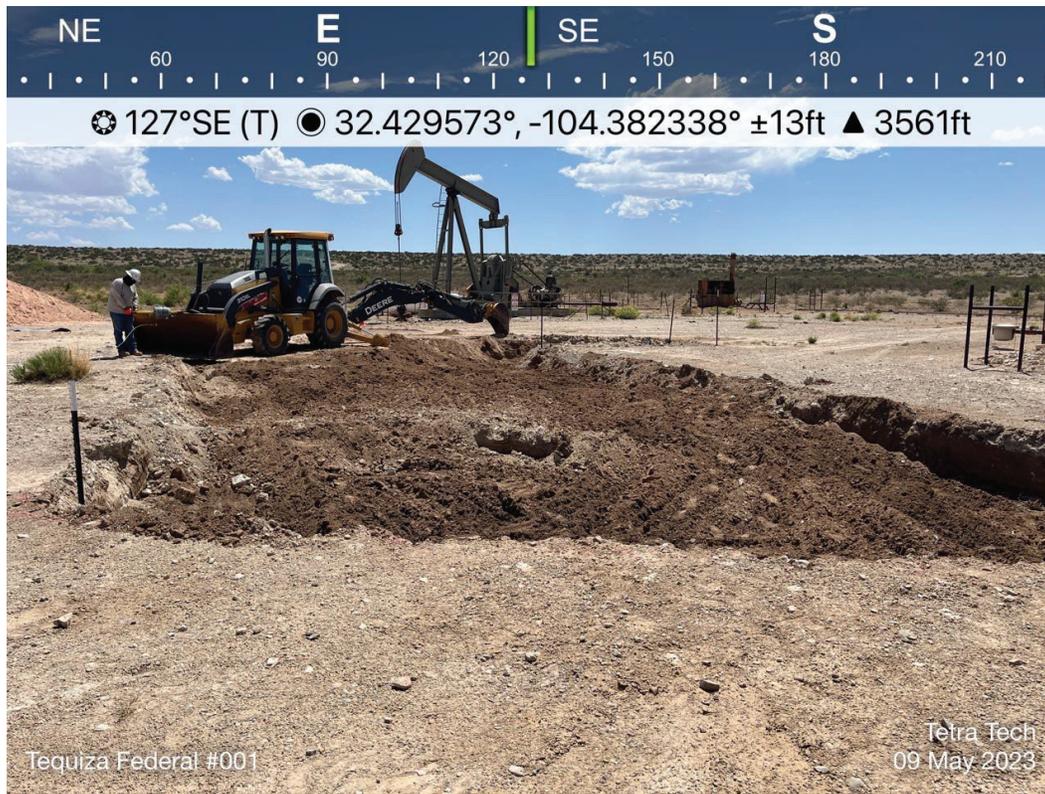
TETRA TECH, INC. PROJECT NO. 212C-MD-02881	DESCRIPTION	View southeast. Excavation activities.	4
	SITE NAME	Tequiza Federal #001 Release	5/9/2023

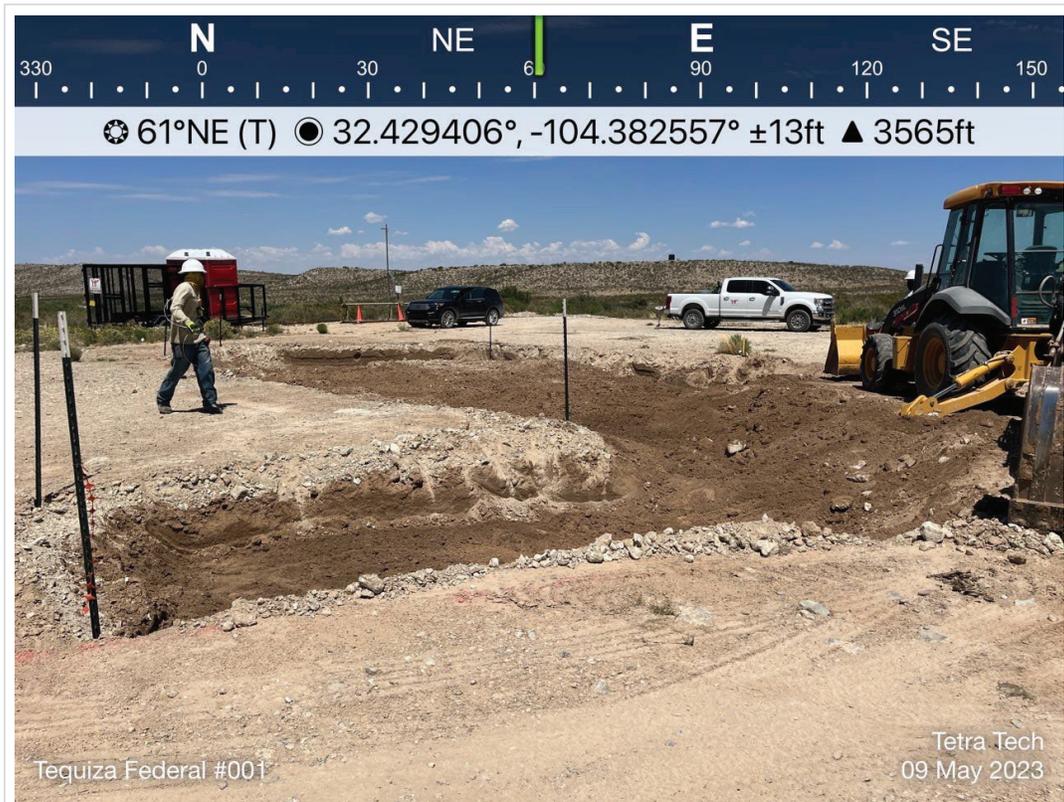
TETRA TECH, INC. PROJECT NO. 212C-MD-02881	DESCRIPTION	View northeast. Excavation activities.	5
	SITE NAME	Tequiza Federal #001 Release	5/9/2023

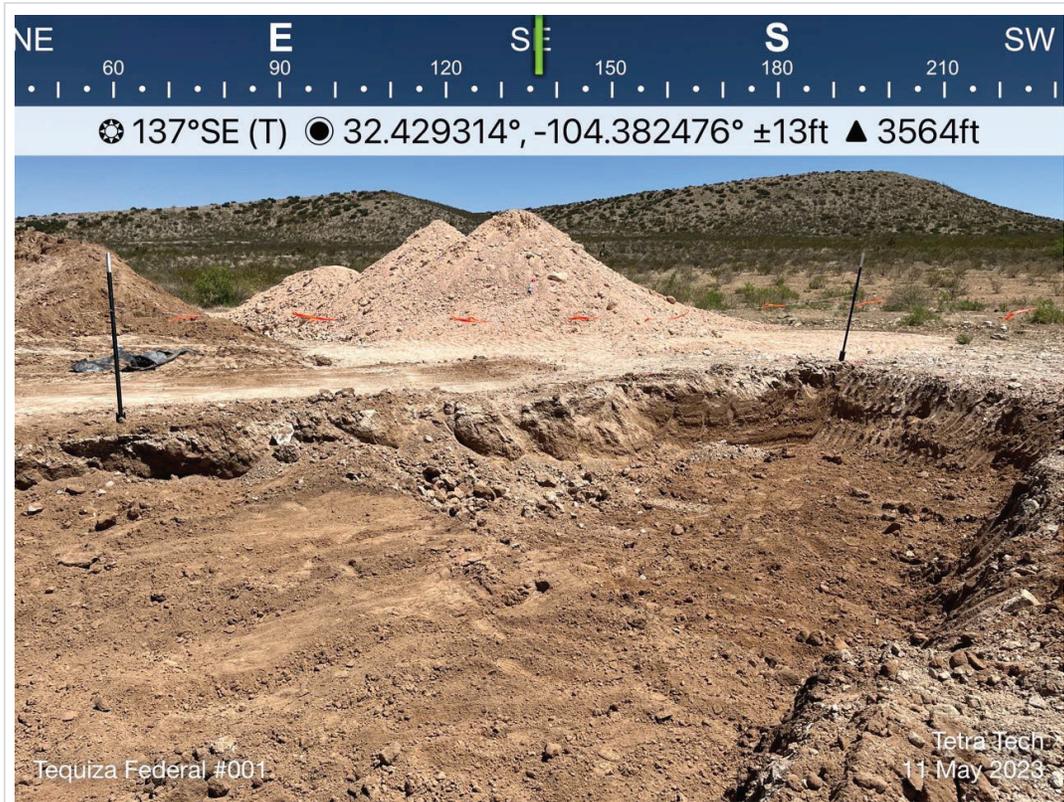
TETRA TECH, INC. PROJECT NO. 212C-MD-02881	DESCRIPTION	View southeast. Excavation activities.	6
	SITE NAME	Tequiza Federal #001 Release	5/11/2023

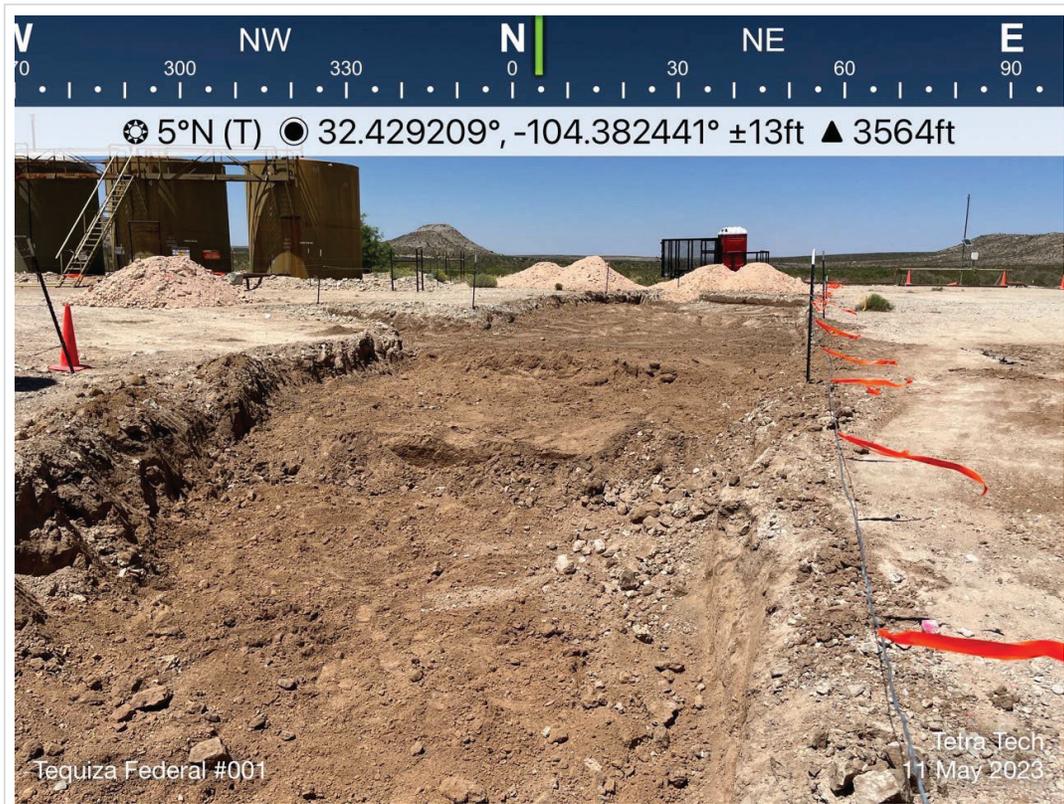
TETRA TECH, INC. PROJECT NO. 212C-MD-02881	DESCRIPTION	View north. Excavation activities.	7
	SITE NAME	Tequiza Federal #001 Release	5/11/2023

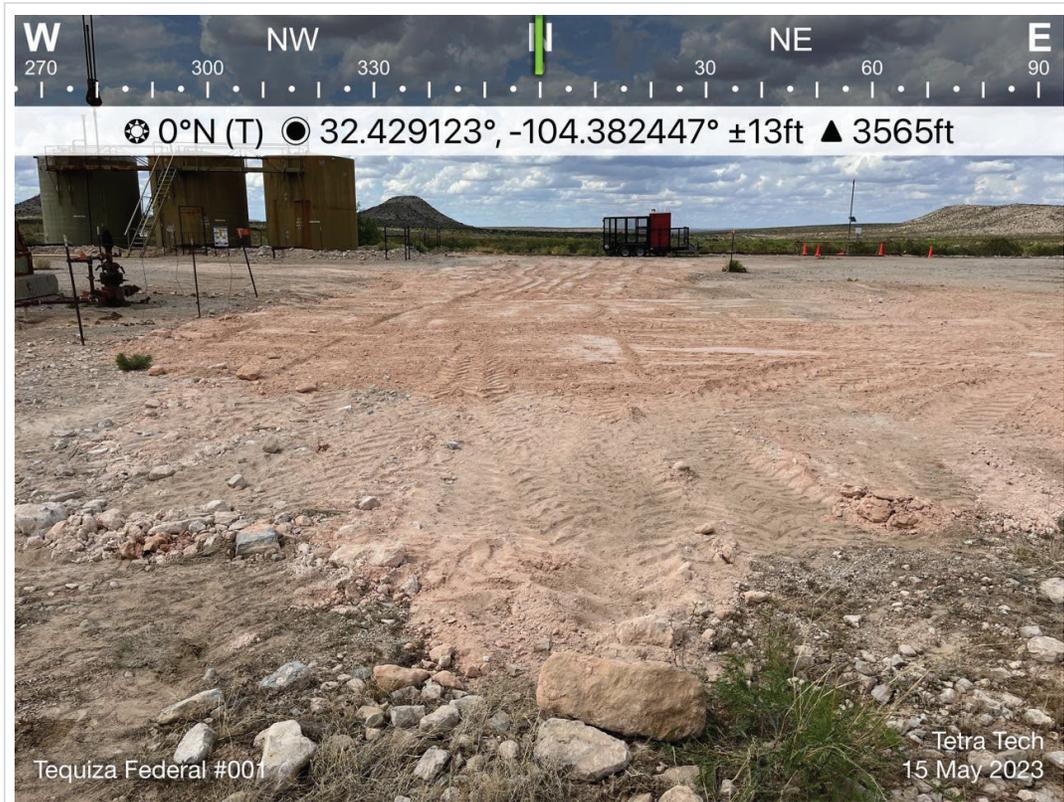
TETRA TECH, INC. PROJECT NO. 212C-MD-02881	DESCRIPTION	View north. Backfill activities following excavation.	8
	SITE NAME	Tequiza Federal #001 Release	5/15/2023

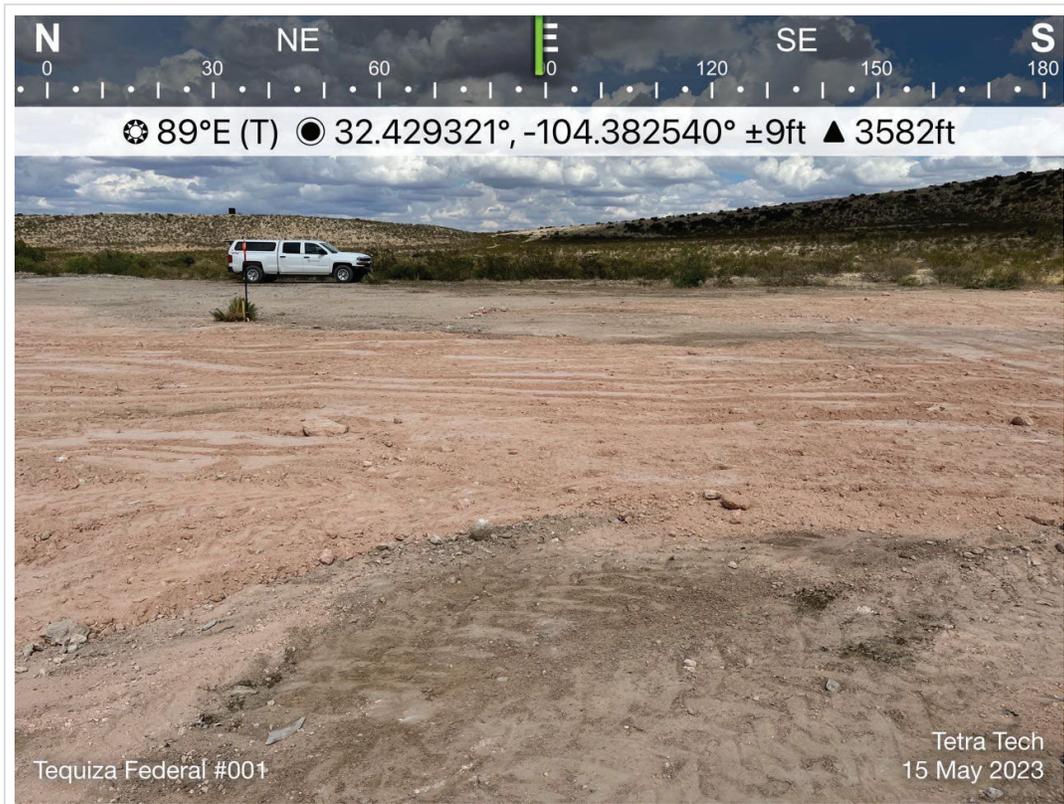
TETRA TECH, INC. PROJECT NO. 212C-MD-02881	DESCRIPTION	View east. Backfill activities following excavation.	9
	SITE NAME	Tequiza Federal #001 Release	5/15/2023

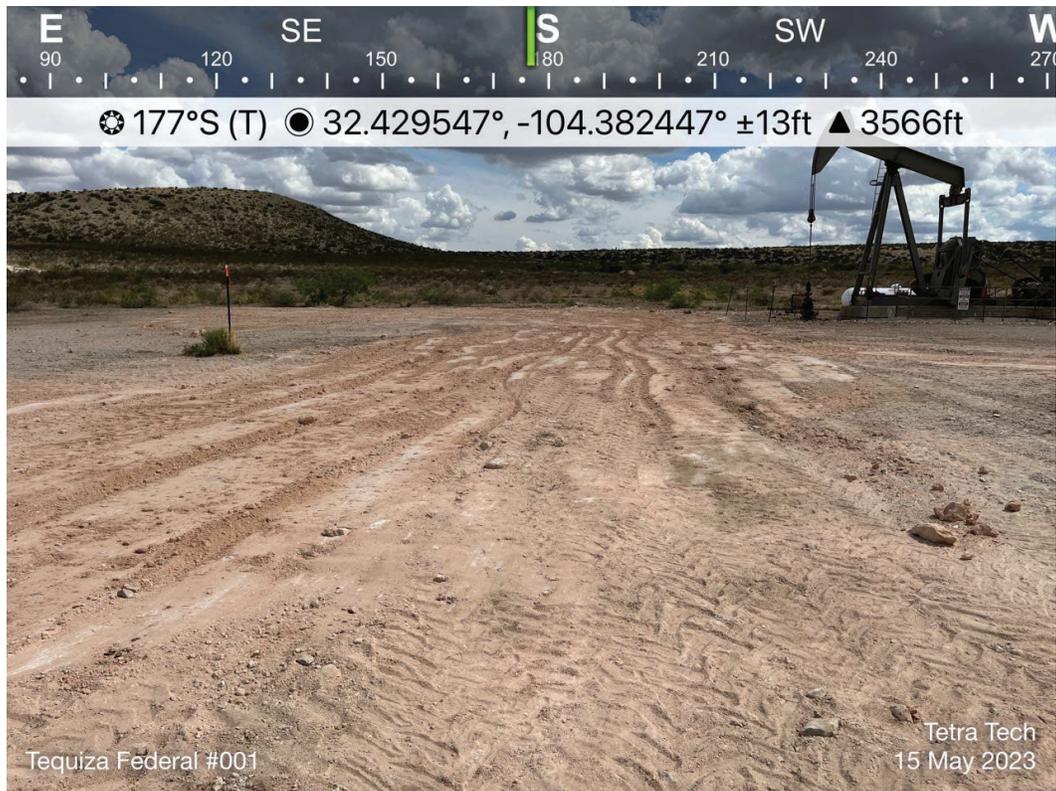
TETRA TECH, INC. PROJECT NO. 212C-MD-02881	DESCRIPTION	View south. Backfill activities following excavation.	10
	SITE NAME	Tequiza Federal #001 Release	5/15/2023
