RE: Incident Deferral Request
nAPP2229052016-NVA South Water Station Release

NVA South Water Station Release nAPP2229052016

On October 13, 2022 Cross Timbers Energy discovered a release of produced water from a 300bbl produced water storage tank at the NVA South Water Station. Failure of a corroded valve caused the 35bbl release that all remained within the tank berm. A vacuum truck picked up approximately all 35bbls of water and calculated the volume based on its return to an onsite storage tank where measurements were taken. The release was reported to the OCD on October 16, 2022 on Form C-141 as required.

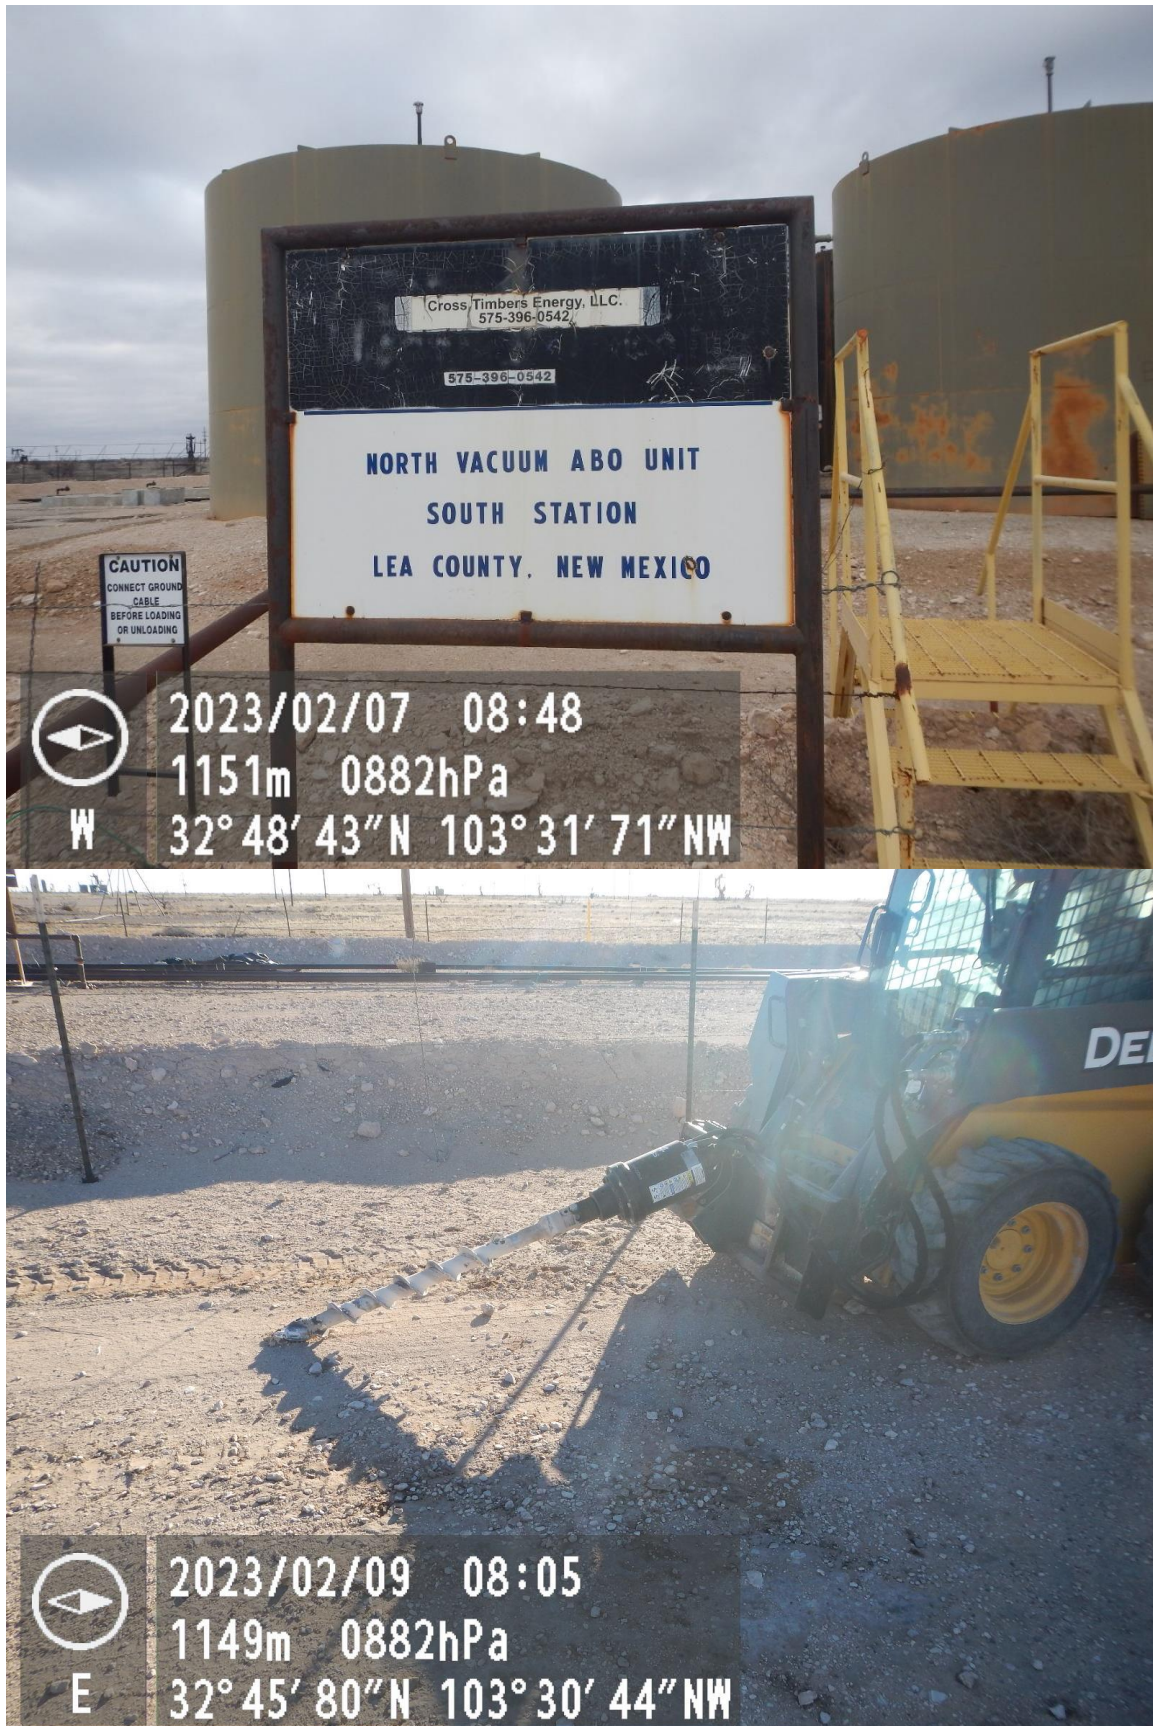
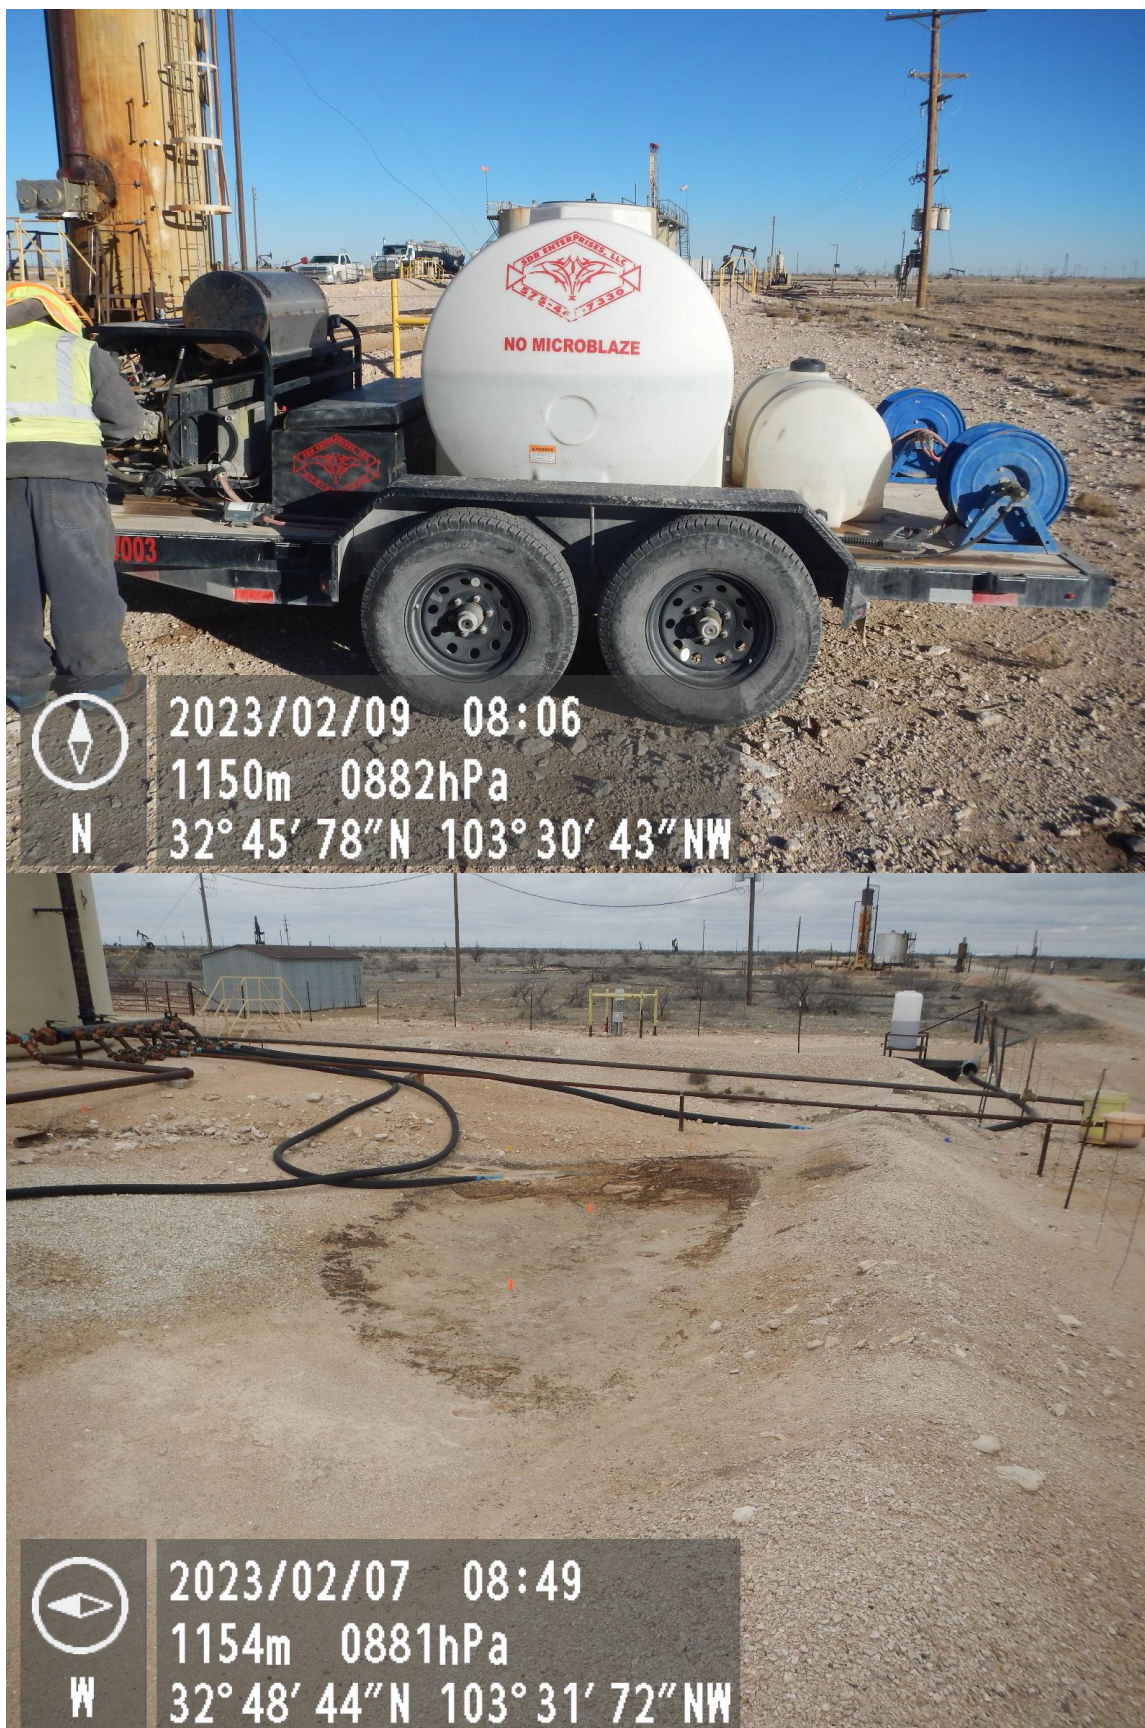
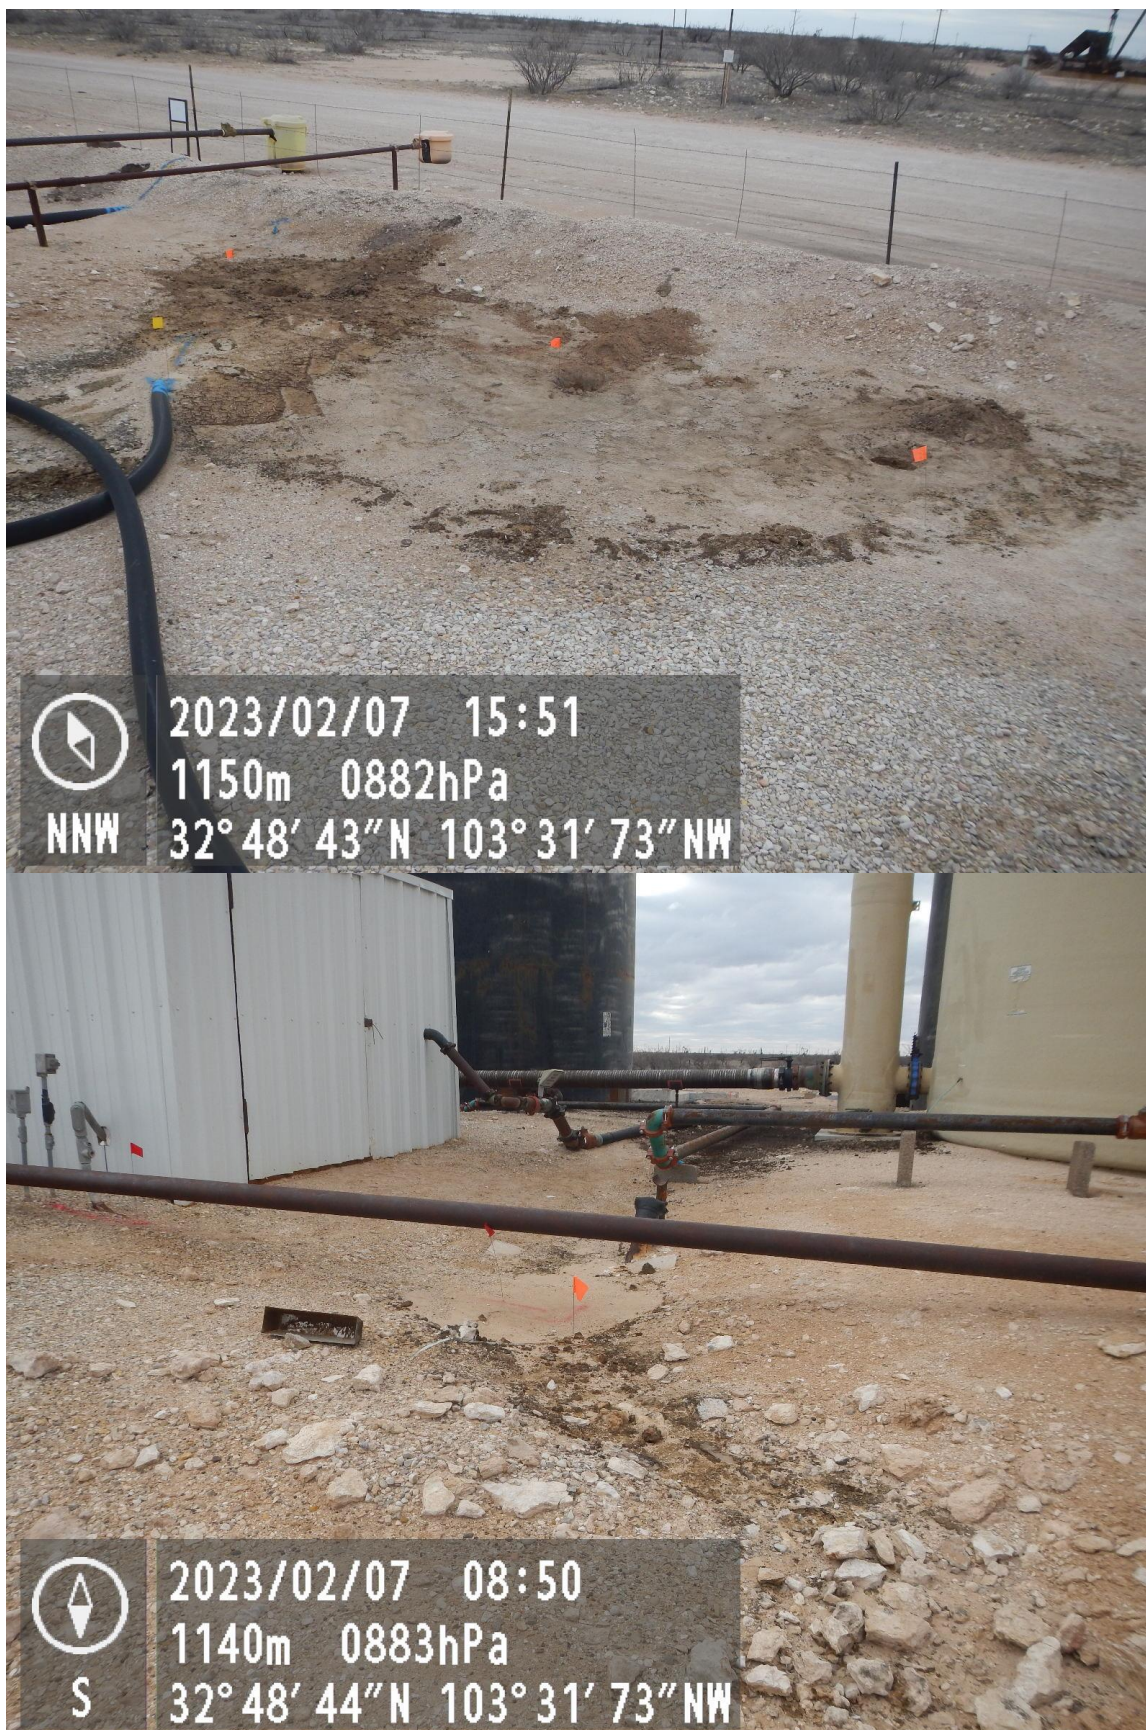
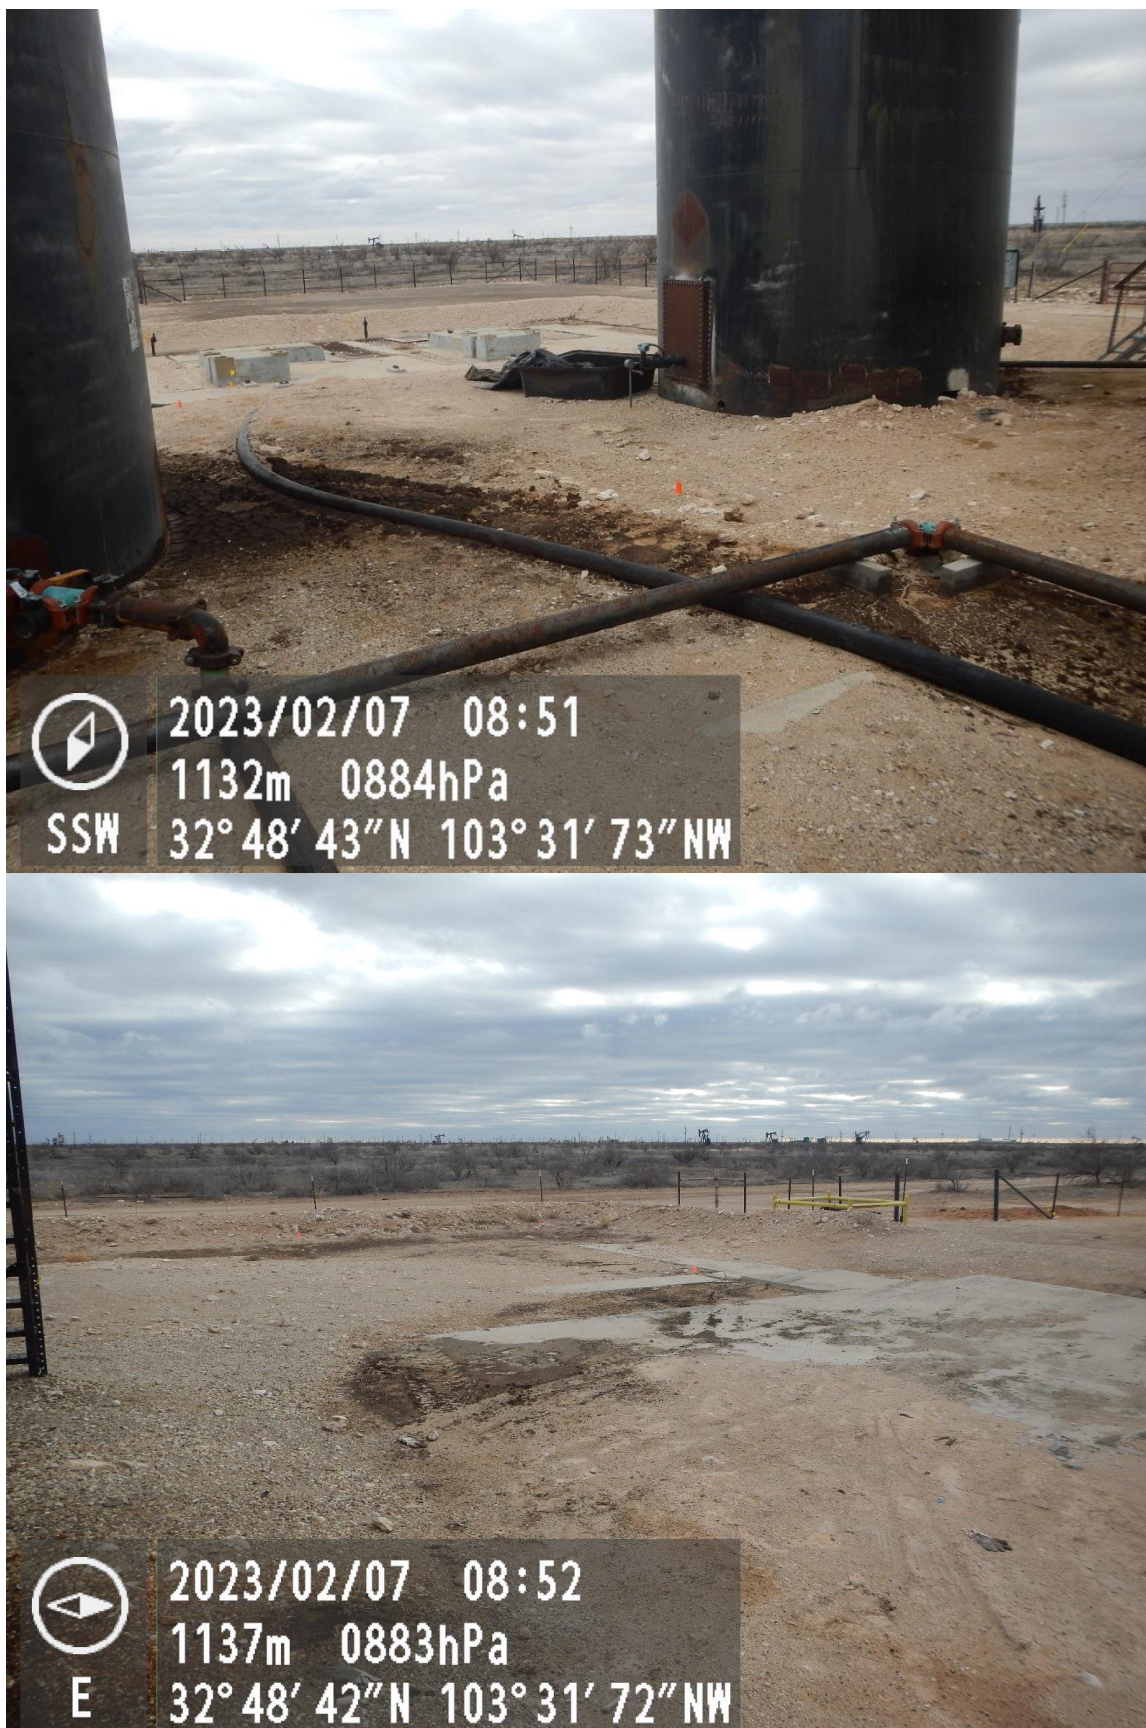
Appendix B -Sampling Event Photographs

Provided photographs (**Appendix B**) demonstrate the contaminated soil is located in areas immediately under or around production equipment allowing deferral in accordance with 19.15.29.12 NMAC (C)(2) and where remediation could cause a major facility deconstruction. Additionally, this document reflects that the contamination is fully delineated and does not cause an imminent risk to human health, the environment, or ground water. Final remediation and reclamation shall take place in accordance with 19.15.29.12 and 19.15.29.13 NMAC once the site is no longer being used for oil and gas operations.
