**RE: Closure Report
ConocoPhillips
Heritage Concho
Mas Federal Com #002H Release
Unit Letter A, Section 34, Township 20 South, Range 34 East
Lea County, New Mexico
Incident ID: nCH1821237385**

Closure Report
June 7, 2023

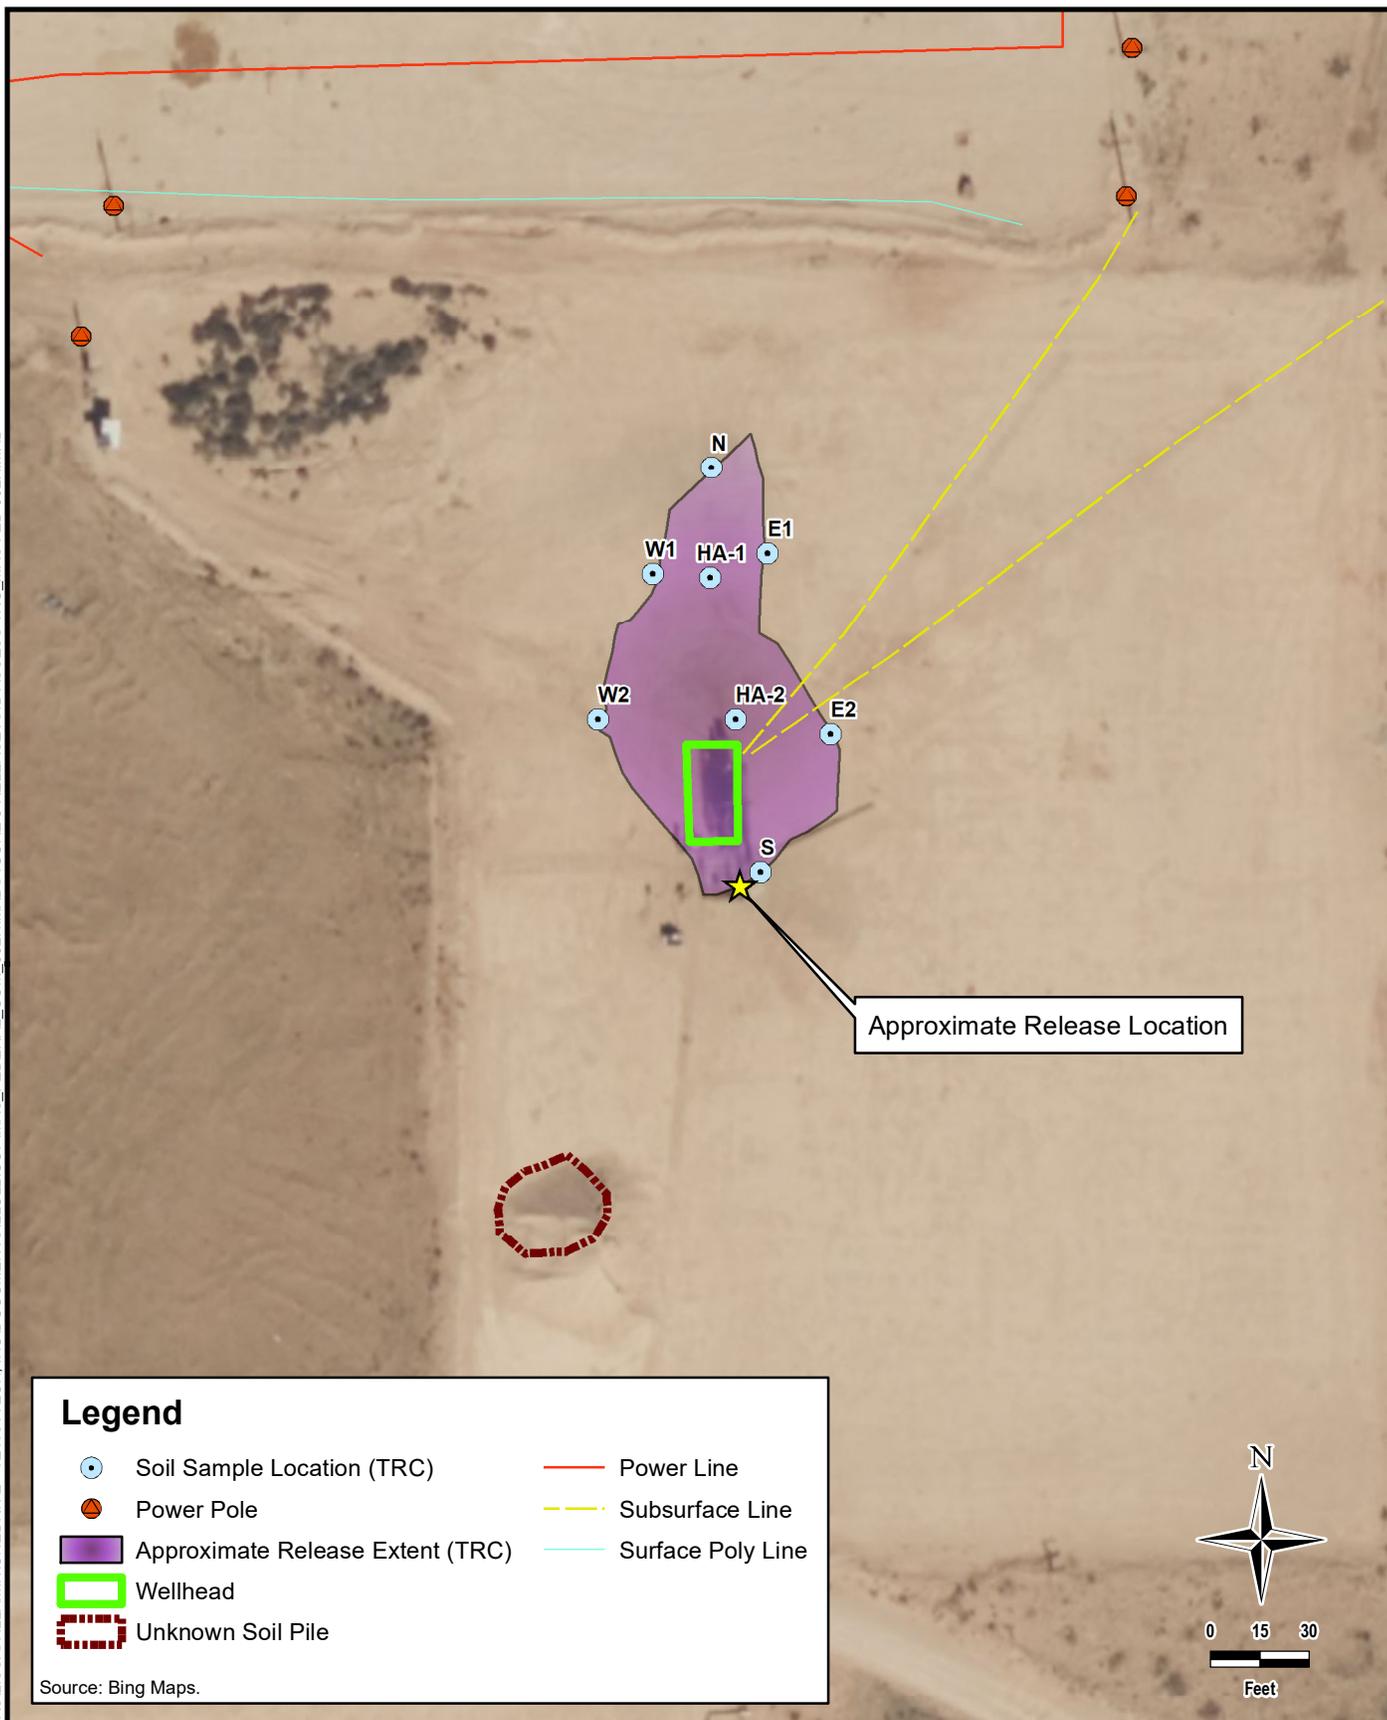
TRC Environmental Corporation (TRC) submitted a Site Assessment Summary and Proposed Remediation Plan dated November 9, 2018, which described the initial site assessment activities. On June 20, 2018, TRC was onsite and collected soil samples from eight (8) locations within and surrounding the release extent, as shown on Figure 3.

A total of twelve (12) samples were sent to Xenco Laboratories in Midland, Texas and analyzed for TPH, BTEX and chloride. The analytical results from the initial site assessment are summarized in Table 1. Analytical results associated with the 6-inch sampling interval at HA-2 exceeded the RRAL for TPH of 2,500 mg/kg. There were no other analytical results that exceeded the Site RRALs. TRC proposed excavating impacted soils in the vicinity of sample point HA-2 to a depth of 2 feet or until confirmation soil samples indicated concentrations of TPH and chloride below NMOCD Closure Criteria.

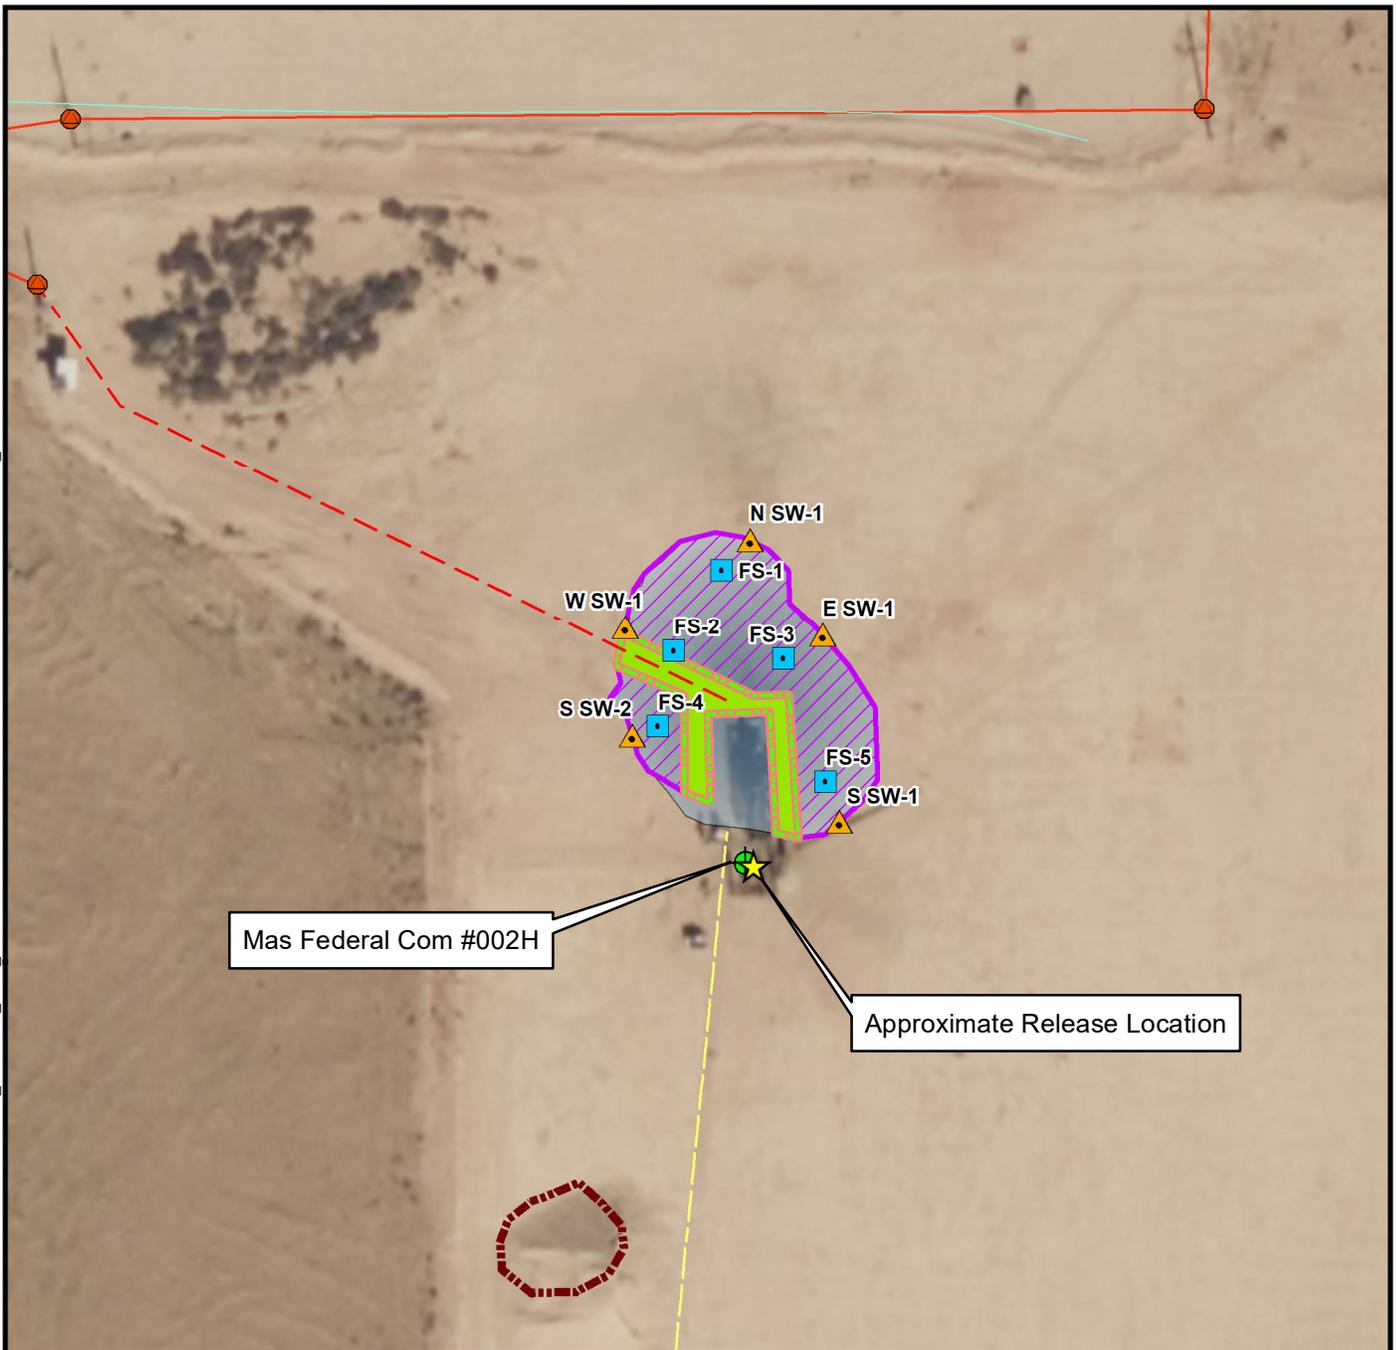
Per the conditions of the NMOCD approval of the Work Plan, confirmation samples were collected such that each discrete sample (sidewall and floor) were representative of no more than 400 square feet of excavated area. A total of five (5) floor sample locations and five (5) sidewall sample locations were used during the remedial activities. Confirmation sidewall sample locations were labeled with "SW"-#, and confirmation floor sample locations were labeled with "FS"-#. Analytical results for all confirmation soil samples (floor and sidewall) were below the respective RRALs for chloride, BTEX, and TPH. The results of the May 2023 confirmation sampling events are summarized in Table 2. Laboratory analytical data is included in Appendix F. Excavated areas, depths and confirmation sample locations are shown in Figure 4.

In May 2023, Tetra Tech personnel were onsite to remediate the release as proposed in the approved Work Plan, including excavation, disposal and backfill. The extent of impacted soils was redefined with field soil screening data and then excavated to 1-foot bgs. A 4-foot exclusion zone was established around energized lines in the release area. Photographs from the excavated areas prior to backfill are provided in Appendix D.

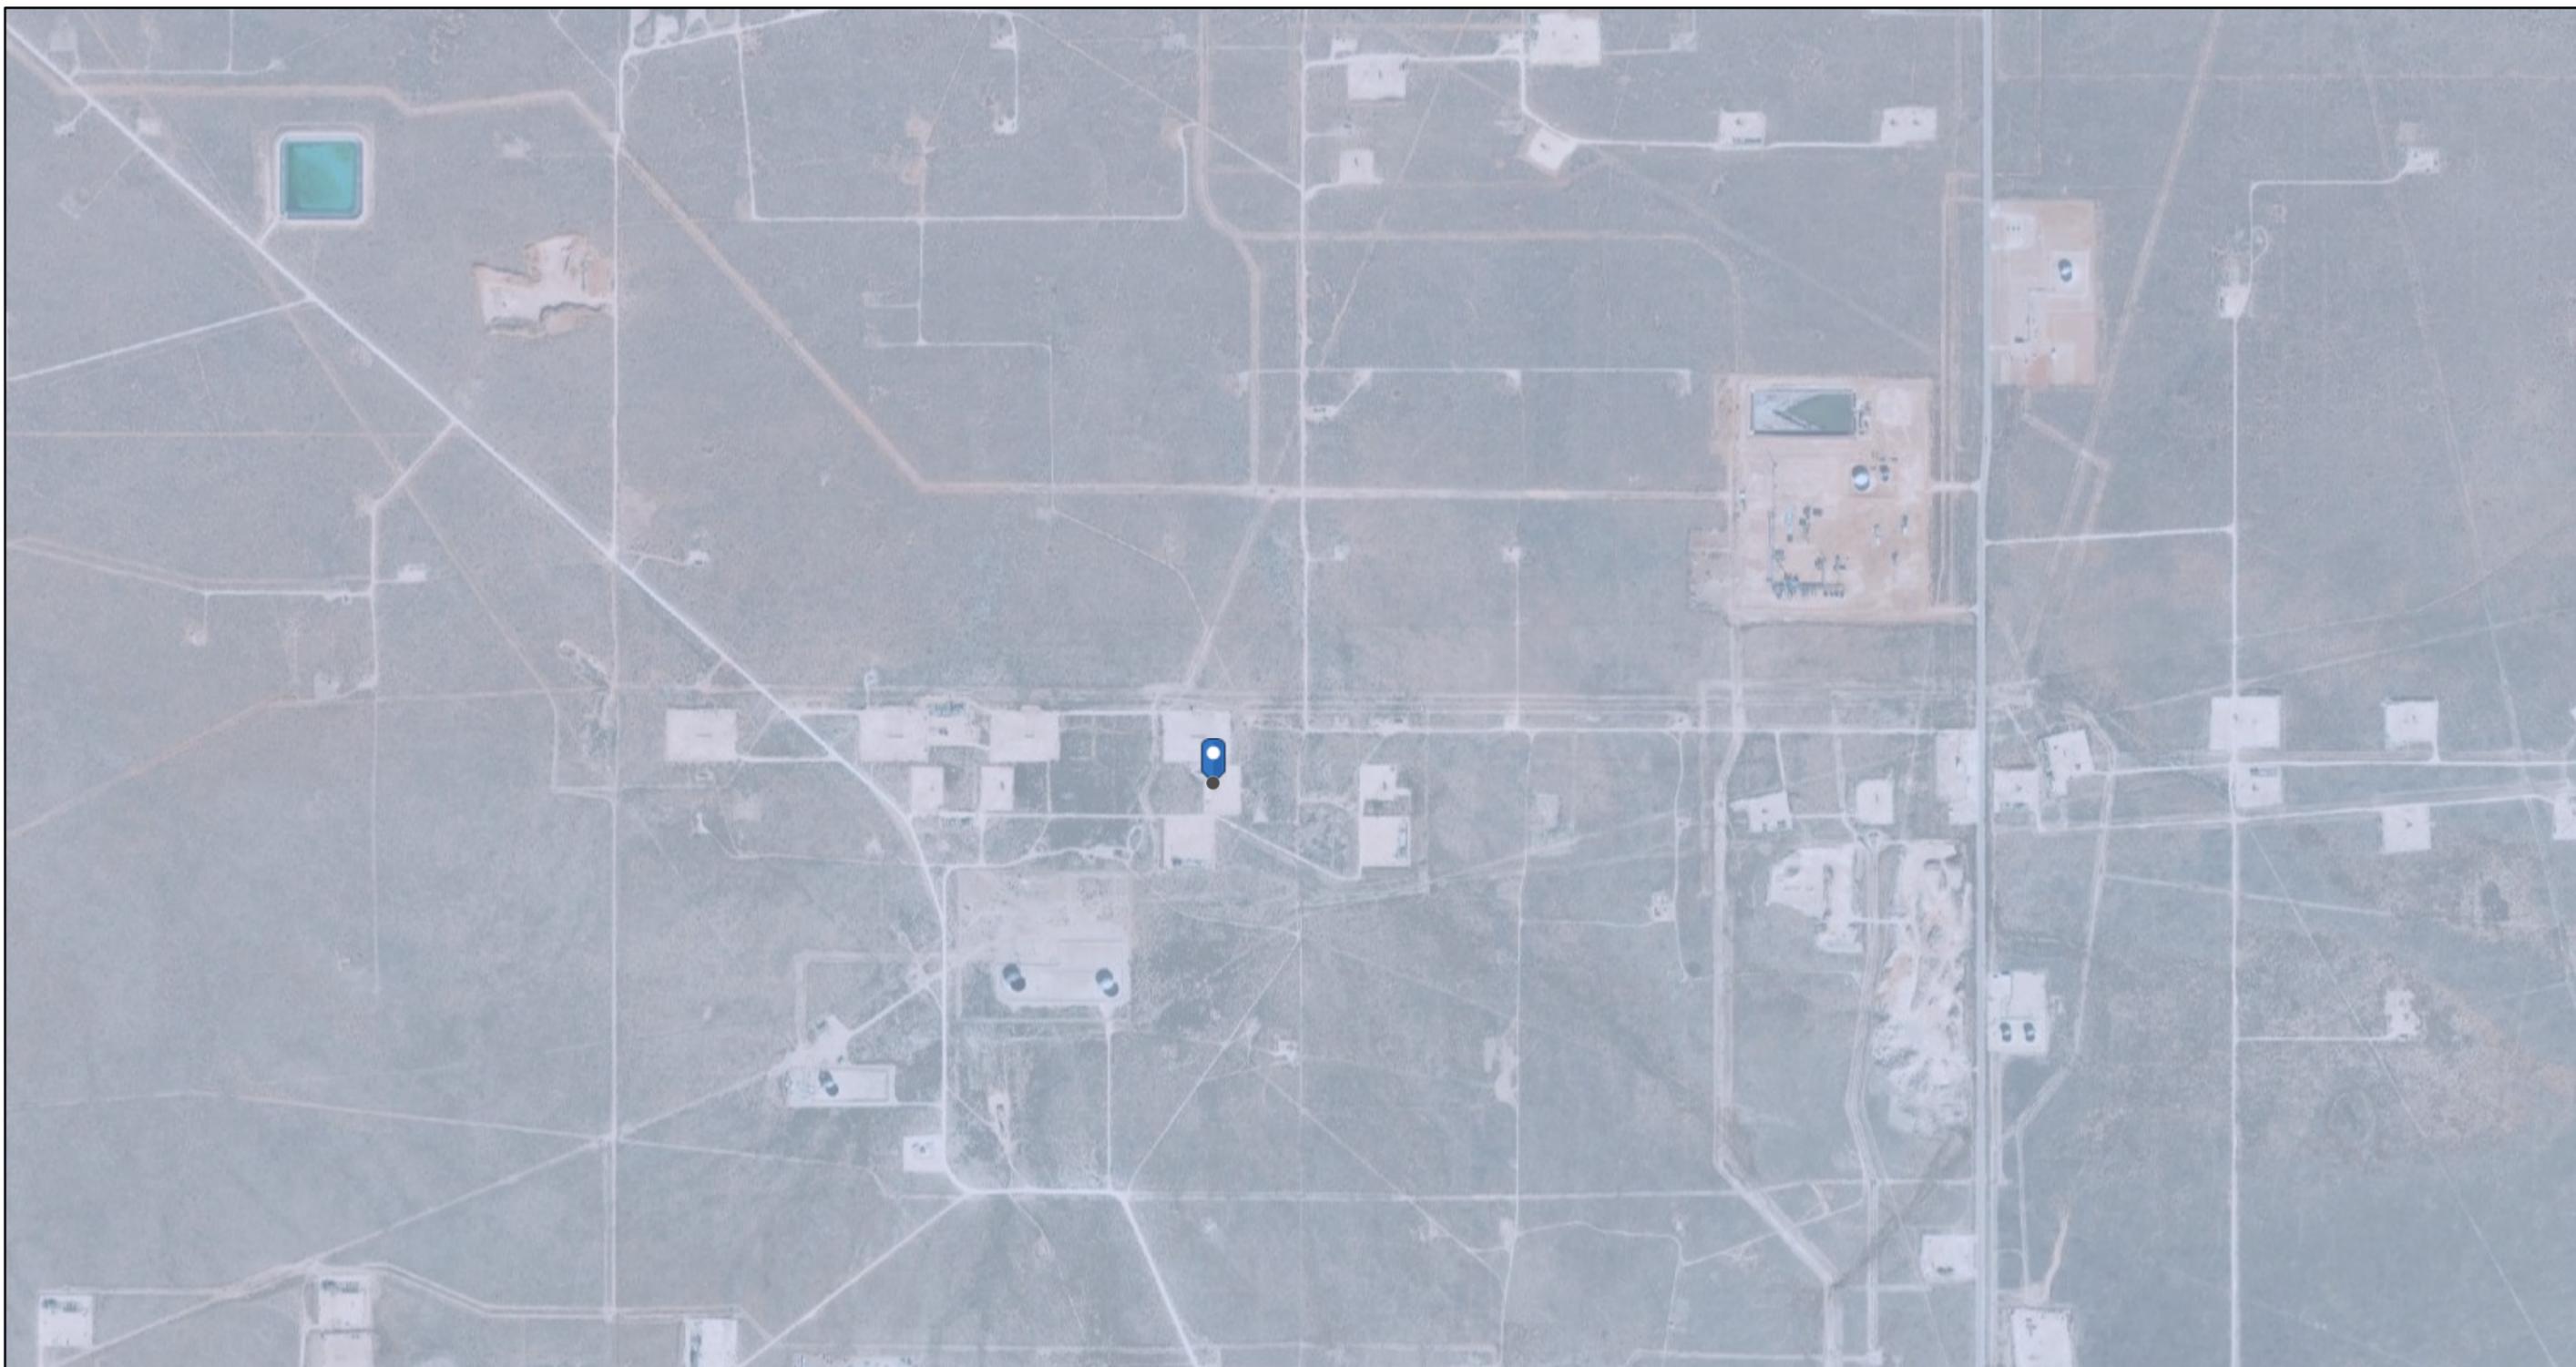
OCD Karst Map

Karst Occurrence Potential

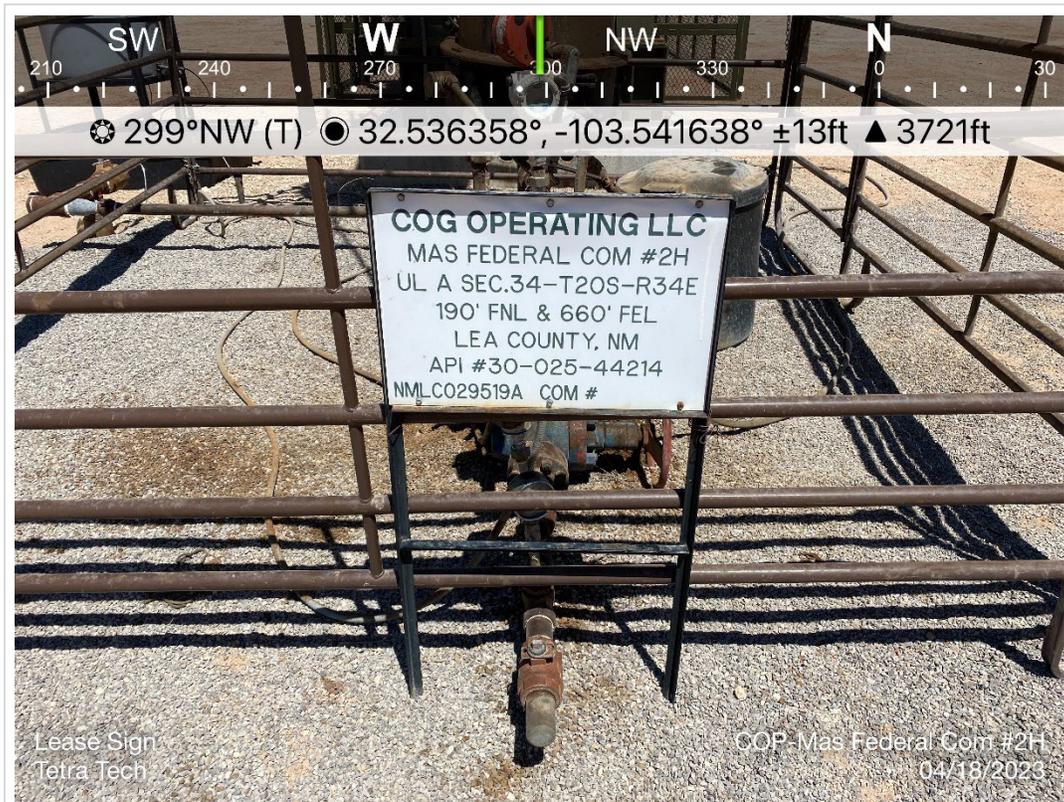
TETRA TECH, INC. PROJECT NO. 212C-MD-03069	DESCRIPTION	View west. Site signage.	1
	SITE NAME	Mas Federal Com #002H Release	4/18/2023

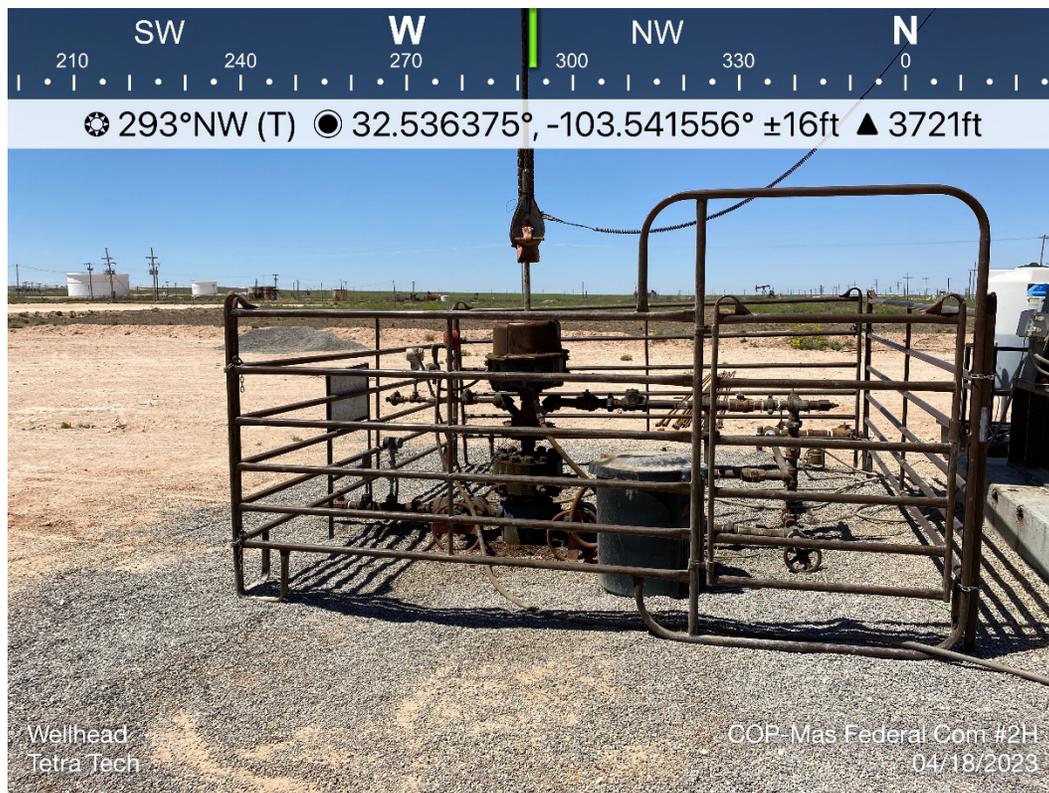
TETRA TECH, INC. PROJECT NO. 212C-MD-03069	DESCRIPTION	View west northwest. View of wellhead and approximate release area.	2
	SITE NAME	Mas Federal Com #002H Release	4/18/2023

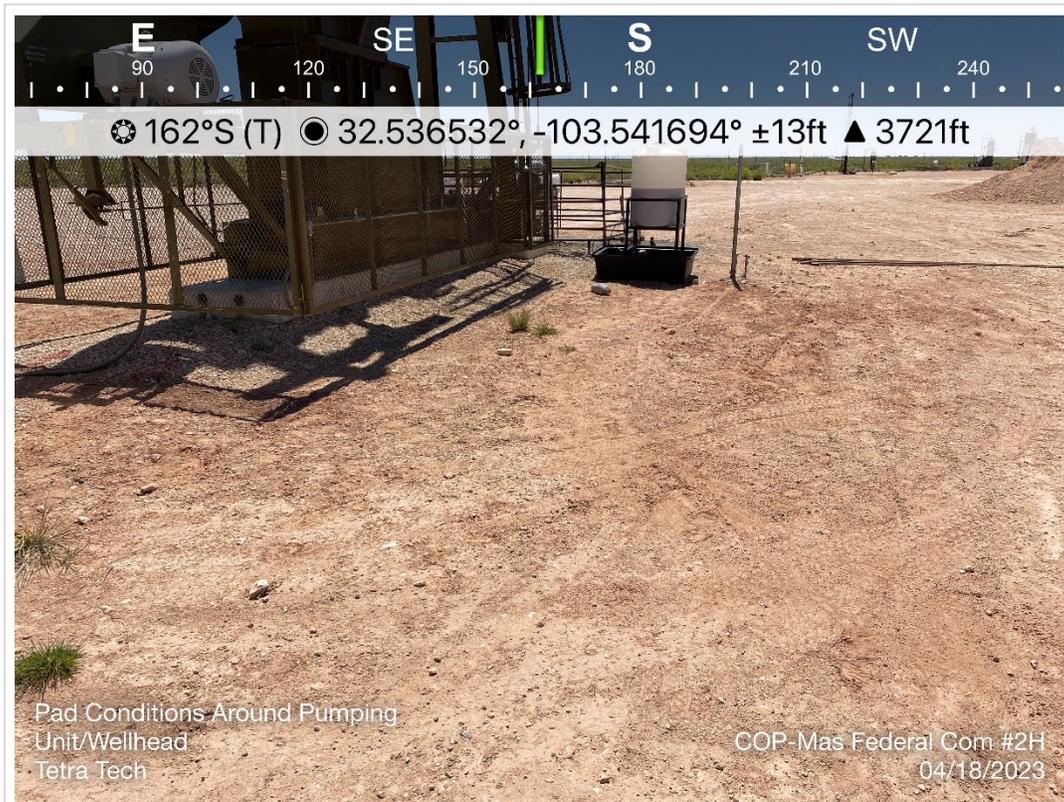
TETRA TECH, INC. PROJECT NO. 212C-MD-03069	DESCRIPTION	View southeast. Approximate release area. Pumping unit equipment.	3
	SITE NAME	Mas Federal Com #002H Release	4/18/2023

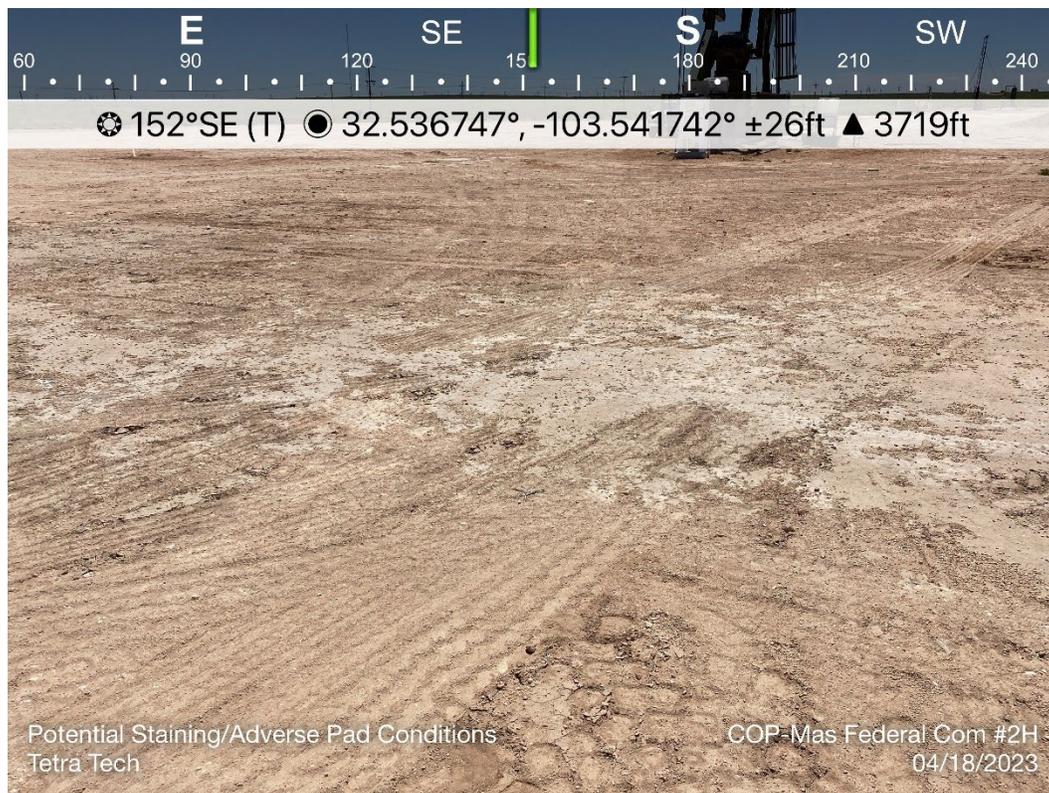
TETRA TECH, INC. PROJECT NO. 212C-MD-03069	DESCRIPTION	View southeast. View of pad conditions, approximate release area.	4
	SITE NAME	Mas Federal Com #002H Release	4/18/2023

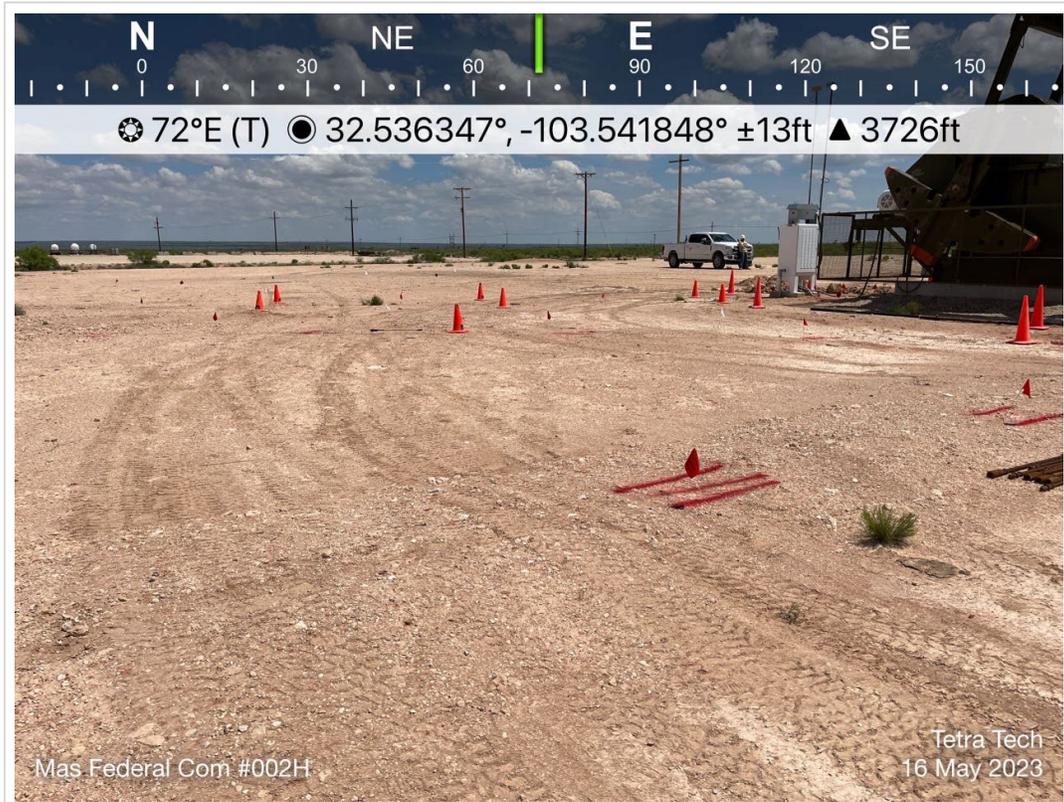
TETRA TECH, INC. PROJECT NO. 212C-MD-03069	DESCRIPTION	View east. Excavation area marked.	5
	SITE NAME	Mas Federal Com #002H Release	5/16/2023

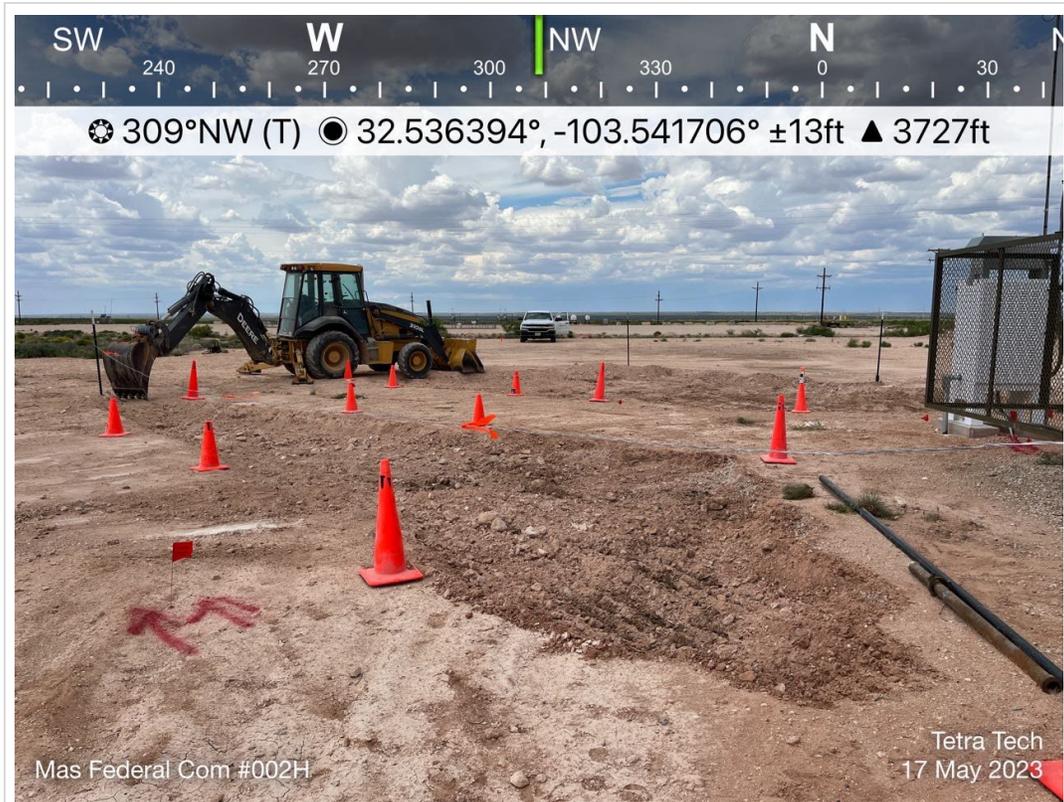
TETRA TECH, INC. PROJECT NO. 212C-MD-03069	DESCRIPTION	View northwest. Excavation activities depicted.	6
	SITE NAME	Mas Federal Com #002H Release	5/17/2023

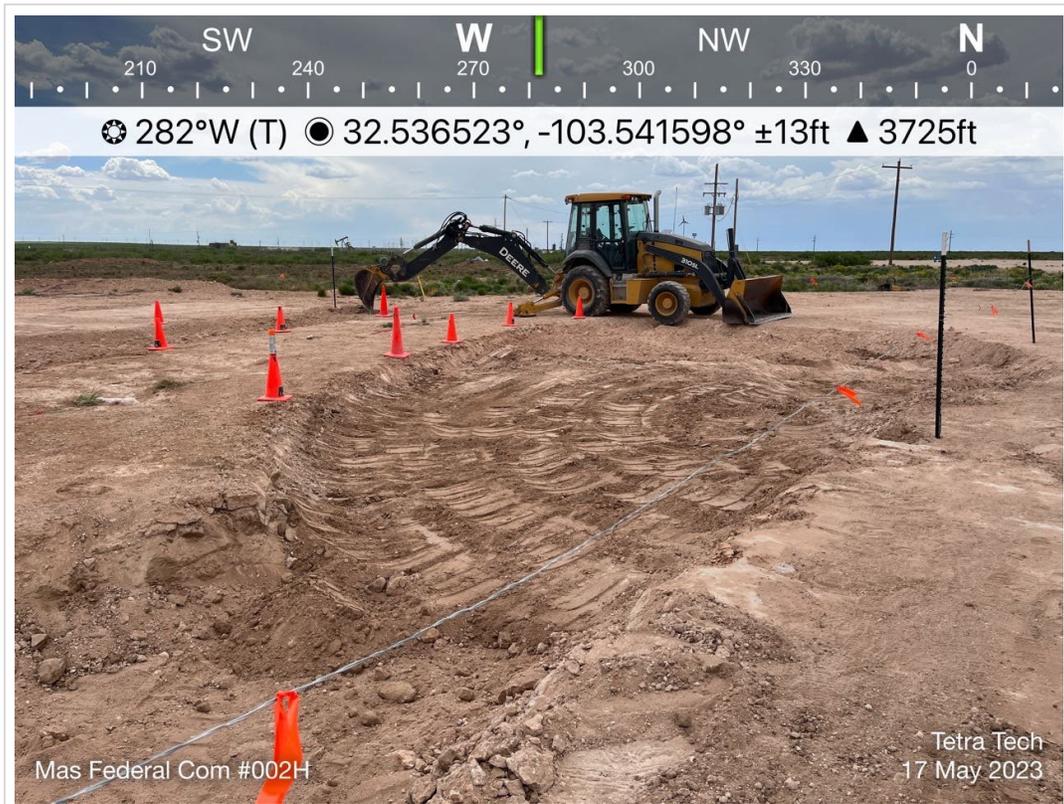
TETRA TECH, INC. PROJECT NO. 212C-MD-03069	DESCRIPTION	View west. Excavation activities depicted.	7
	SITE NAME	Mas Federal Com #002H Release	5/17/2023

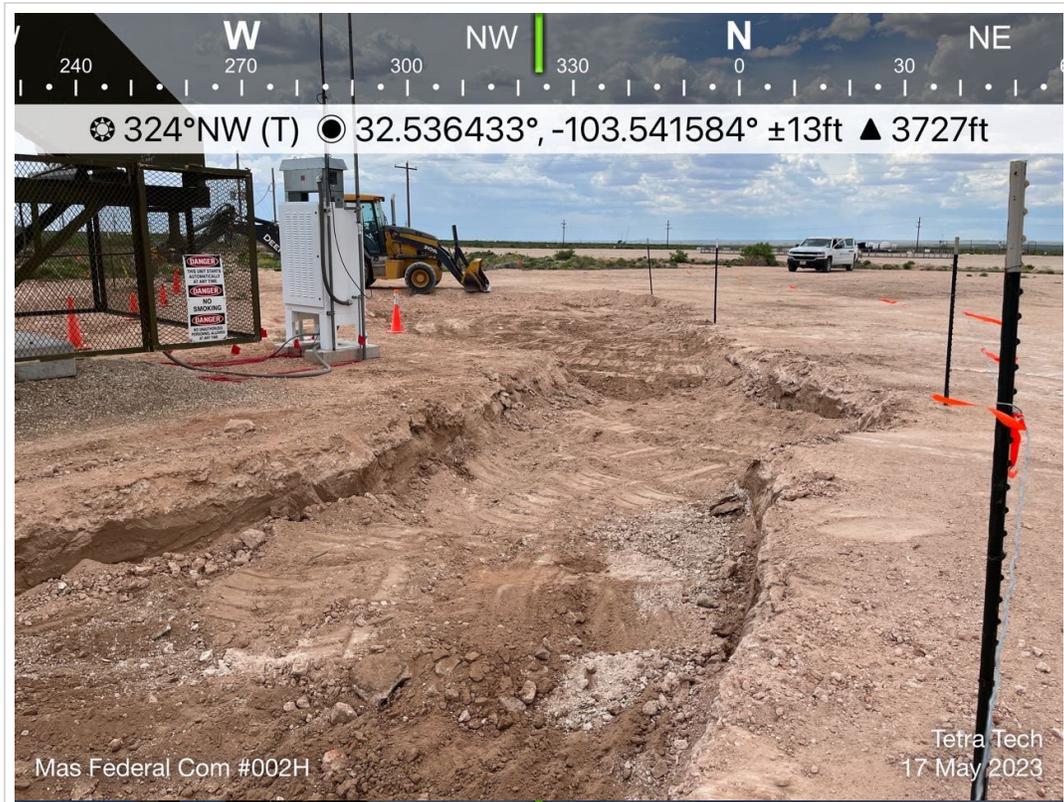
TETRA TECH, INC. PROJECT NO. 212C-MD-03069	DESCRIPTION	View northwest. Excavation activities depicted.	8
	SITE NAME	Mas Federal Com #002H Release	5/17/2023

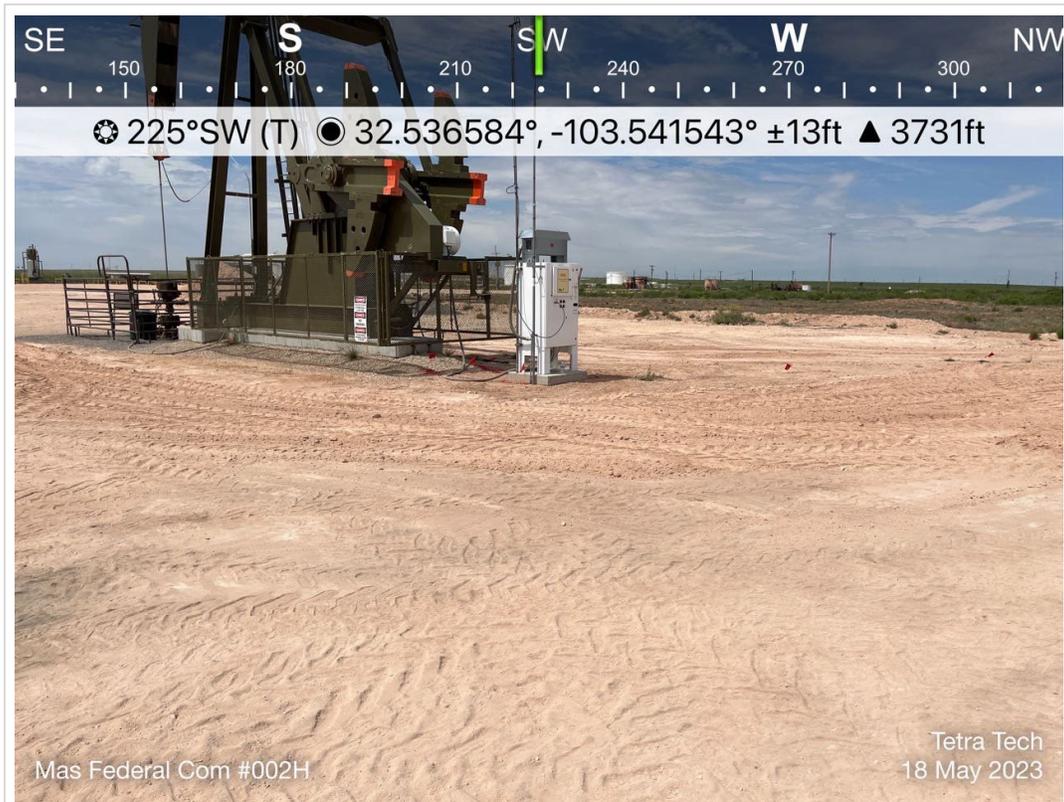
TETRA TECH, INC. PROJECT NO. 212C-MD-03069	DESCRIPTION	View southwest. Backfill completed following excavation.	9
	SITE NAME	Mas Federal Com #002H Release	5/18/2023

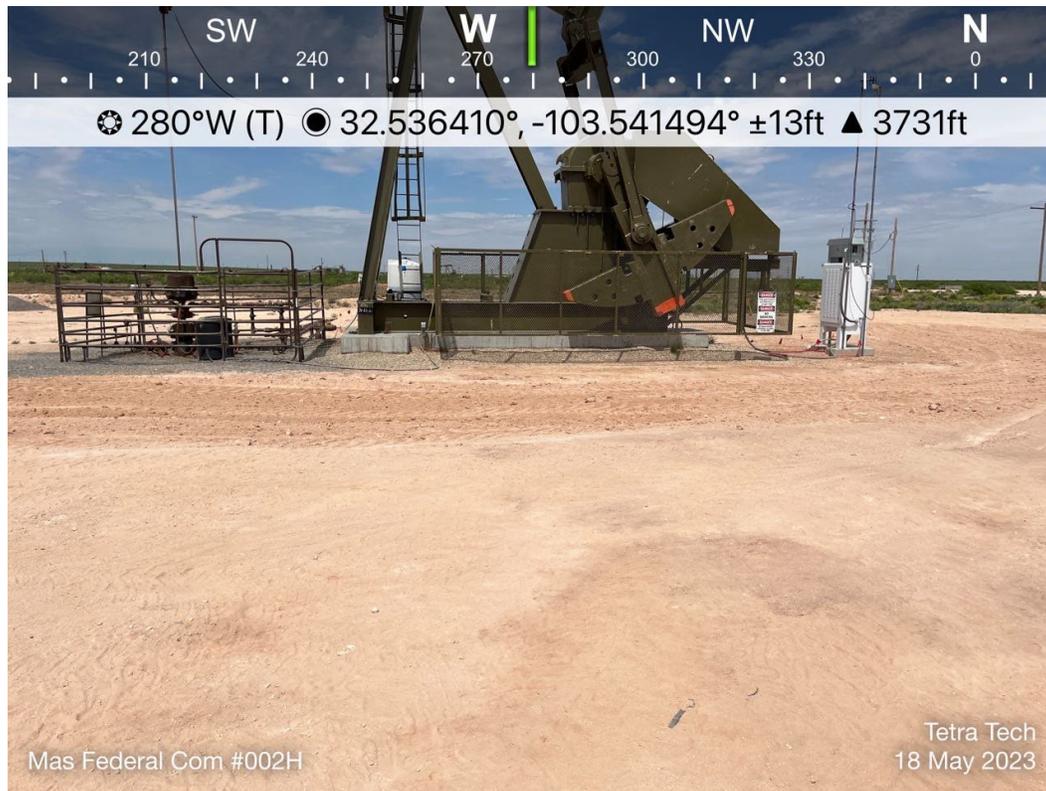
TETRA TECH, INC. PROJECT NO. 212C-MD-03069	DESCRIPTION	View west. Backfill completed following excavation.	10
	SITE NAME	Mas Federal Com #002H Release	5/18/2023
