Re: Clark #11 Release – Remediation Plan

CLOSURE REQUEST

COMPANY	San Juan Resources, Inc
LOCATION	Clark #11
API	30-039-23631
LOCATION	H-05-24N-03W
GPS	36.3420448, -107.1728363
INCIDENT ID	nAPP2302456413

SITE PHOTOS

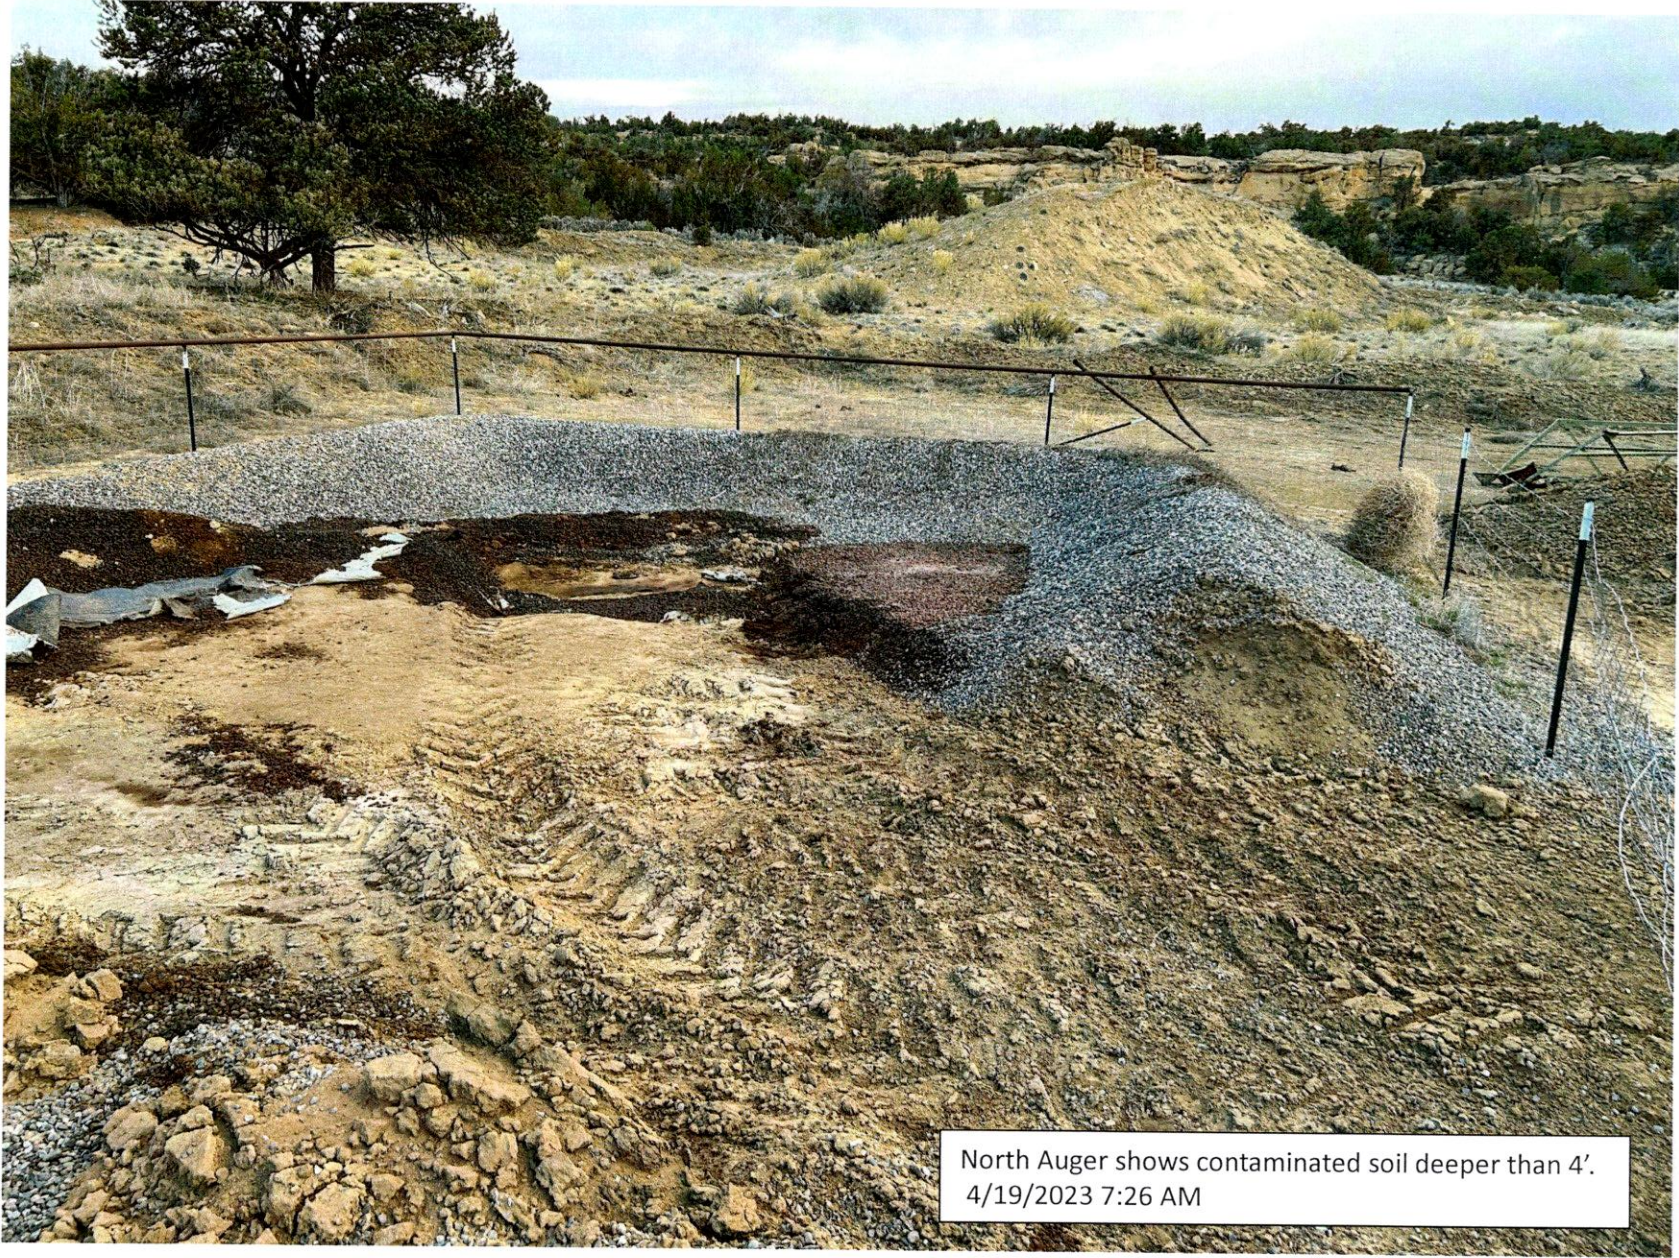
North Auger shows contaminated soil deeper than 4'.
4/19/2023 7:26 AM

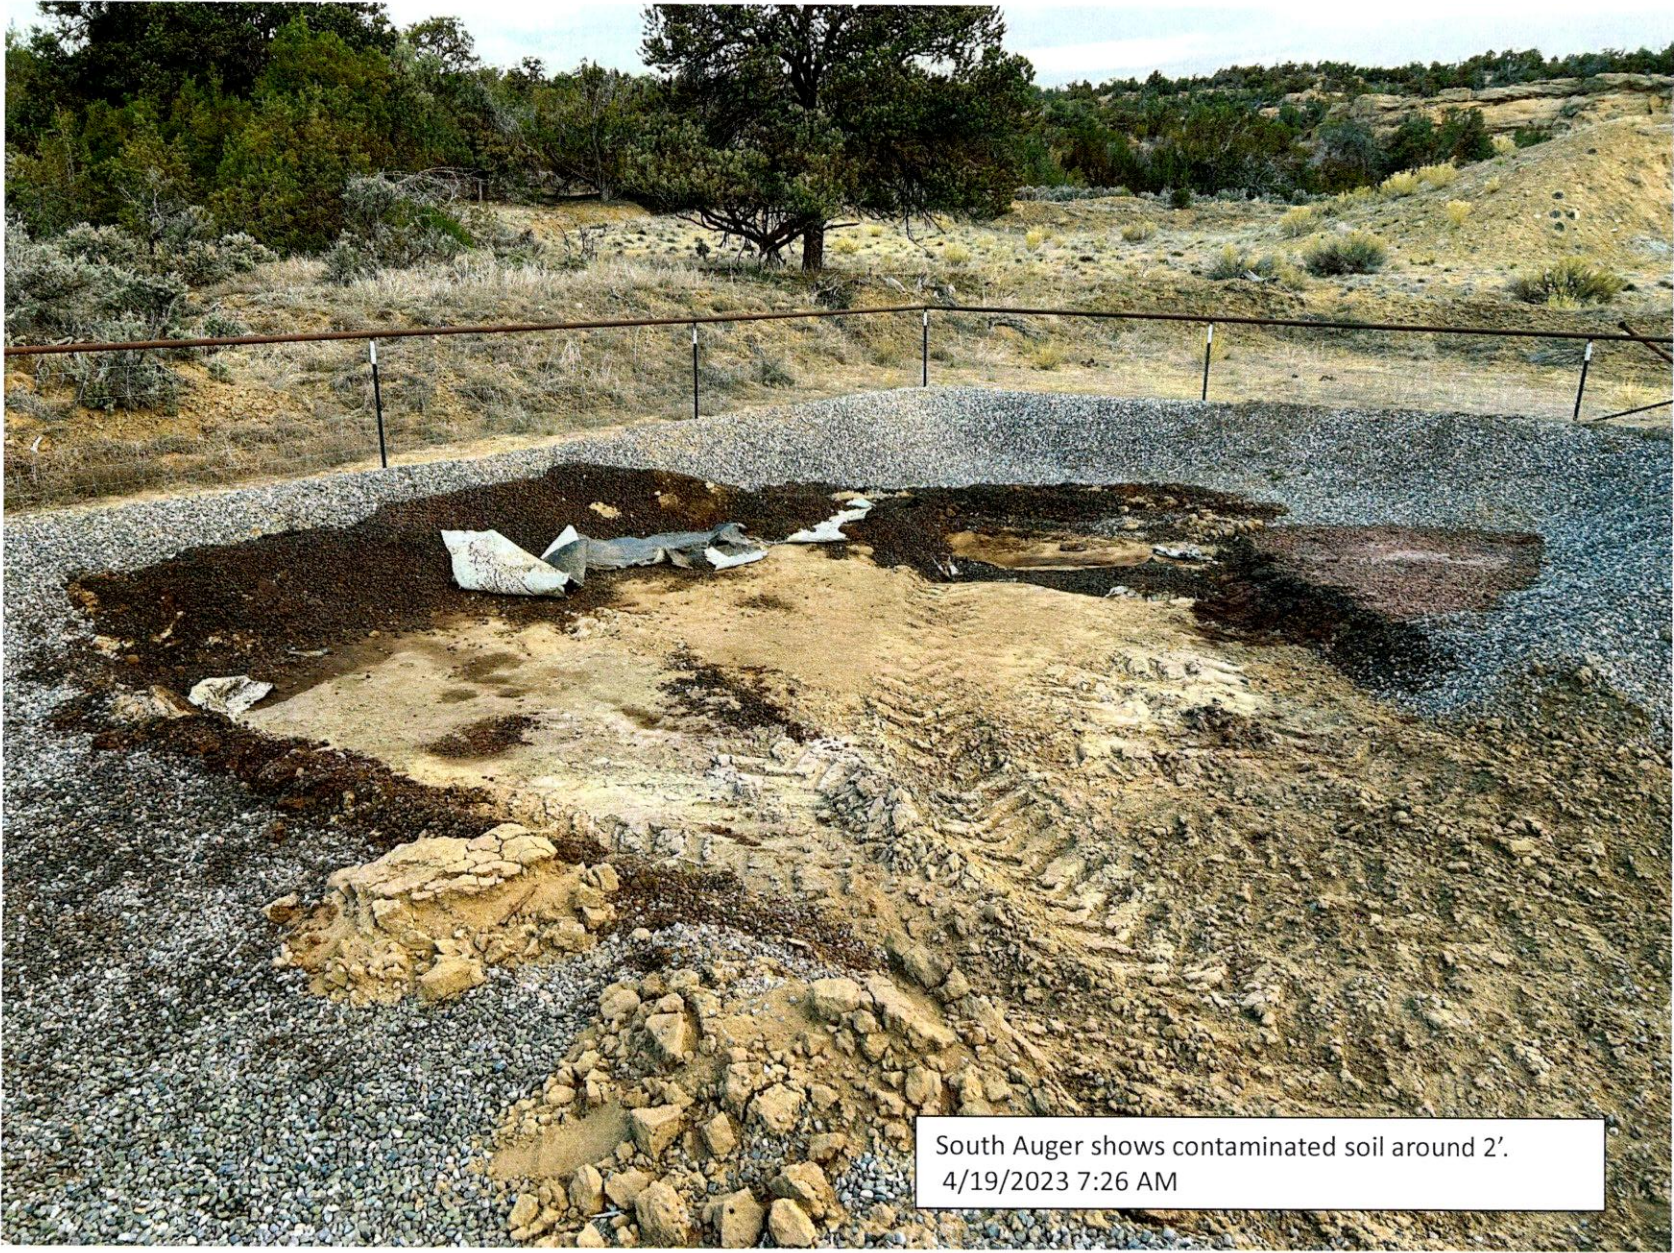
South Auger shows contaminated soil around 2'.
4/19/2023 7:26 AM

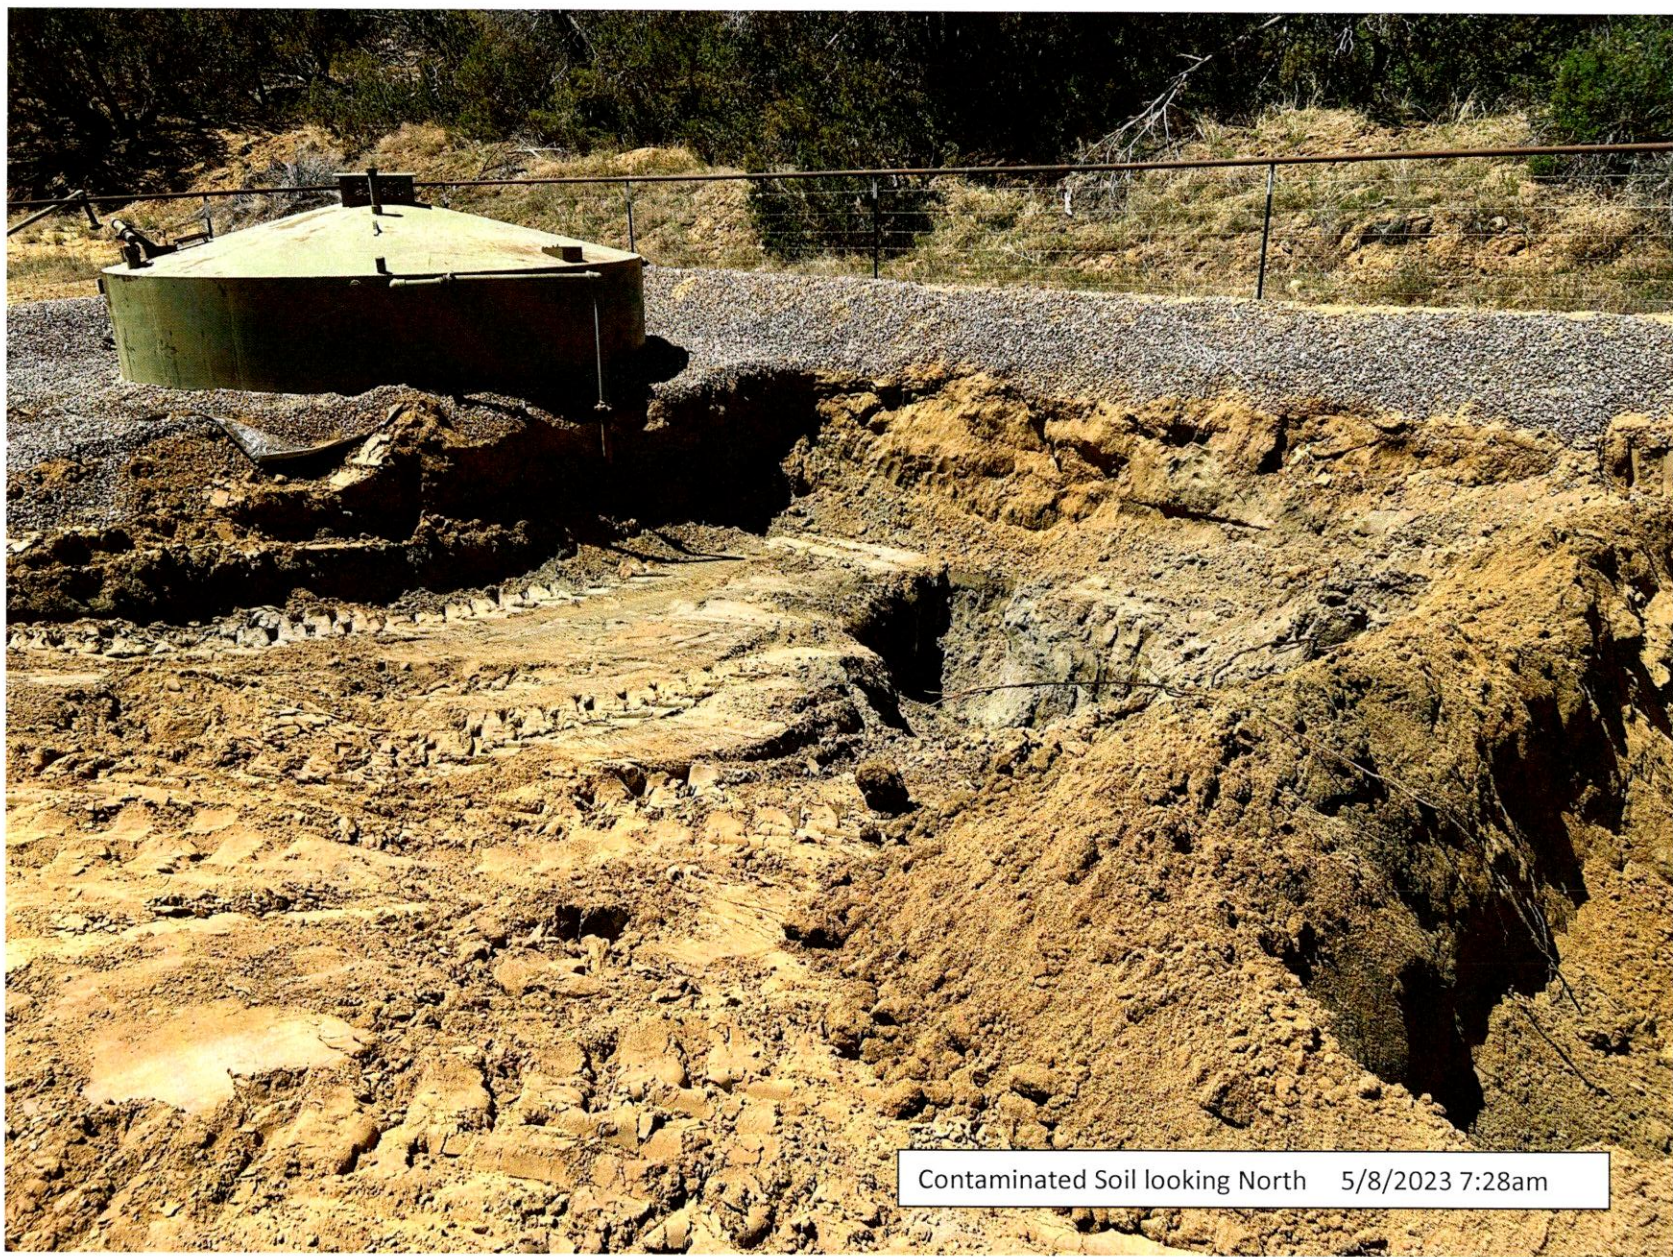
Contaminated Soil looking North 5/8/2023 7:28am

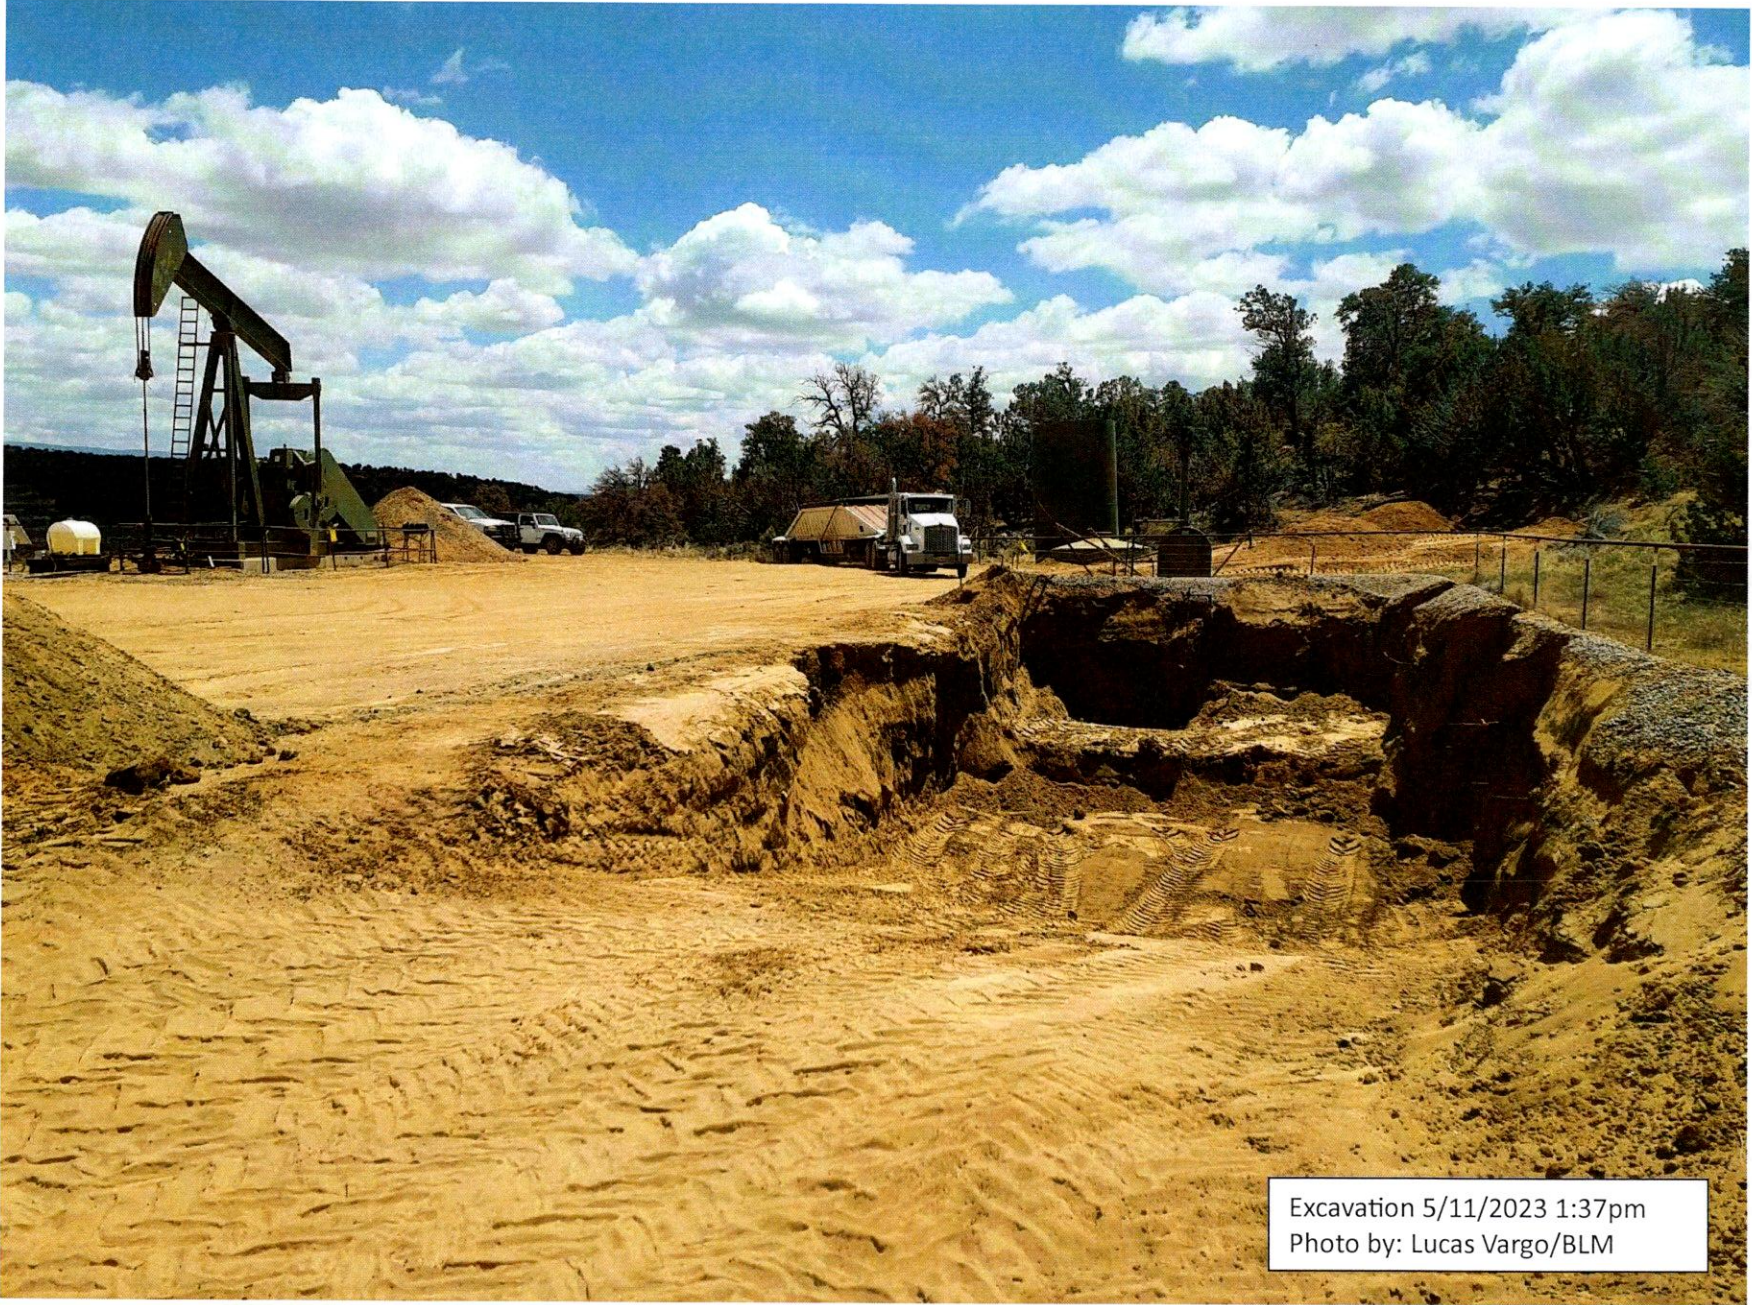
Excavation 5/11/2023 1:37pm
Photo by: Lucas Vargo/BLM

On May 11, Lucas Vargo with BLM was in the area. Excavation of contaminated soils is underway. A general estimate was approximately 1100 yards of soil removed so far, and counting. Trucks are hauling in clean fill and hauling out impacted soil. Please see photos taken this afternoon for reference. (Attachment A)

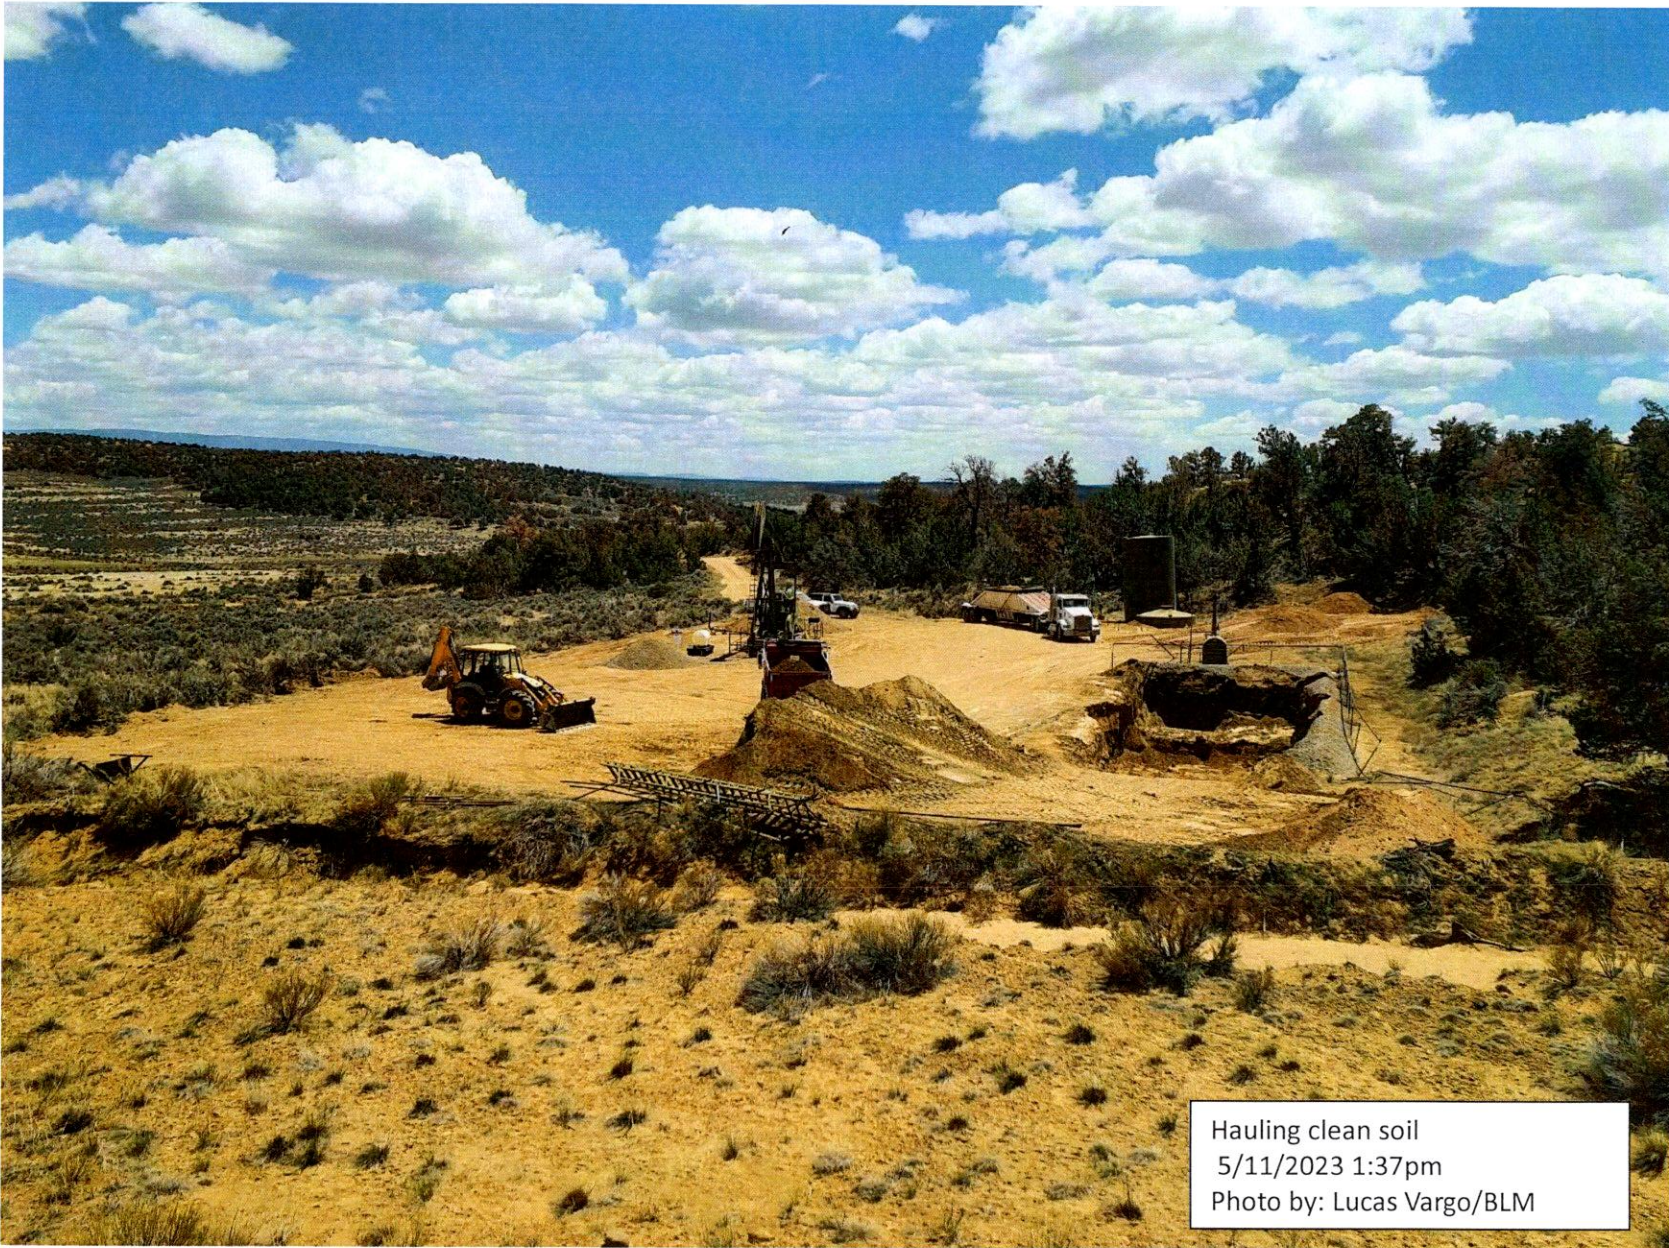
Hauling clean soil
5/11/2023 1:37pm
Photo by: Lucas Vargo/BLM

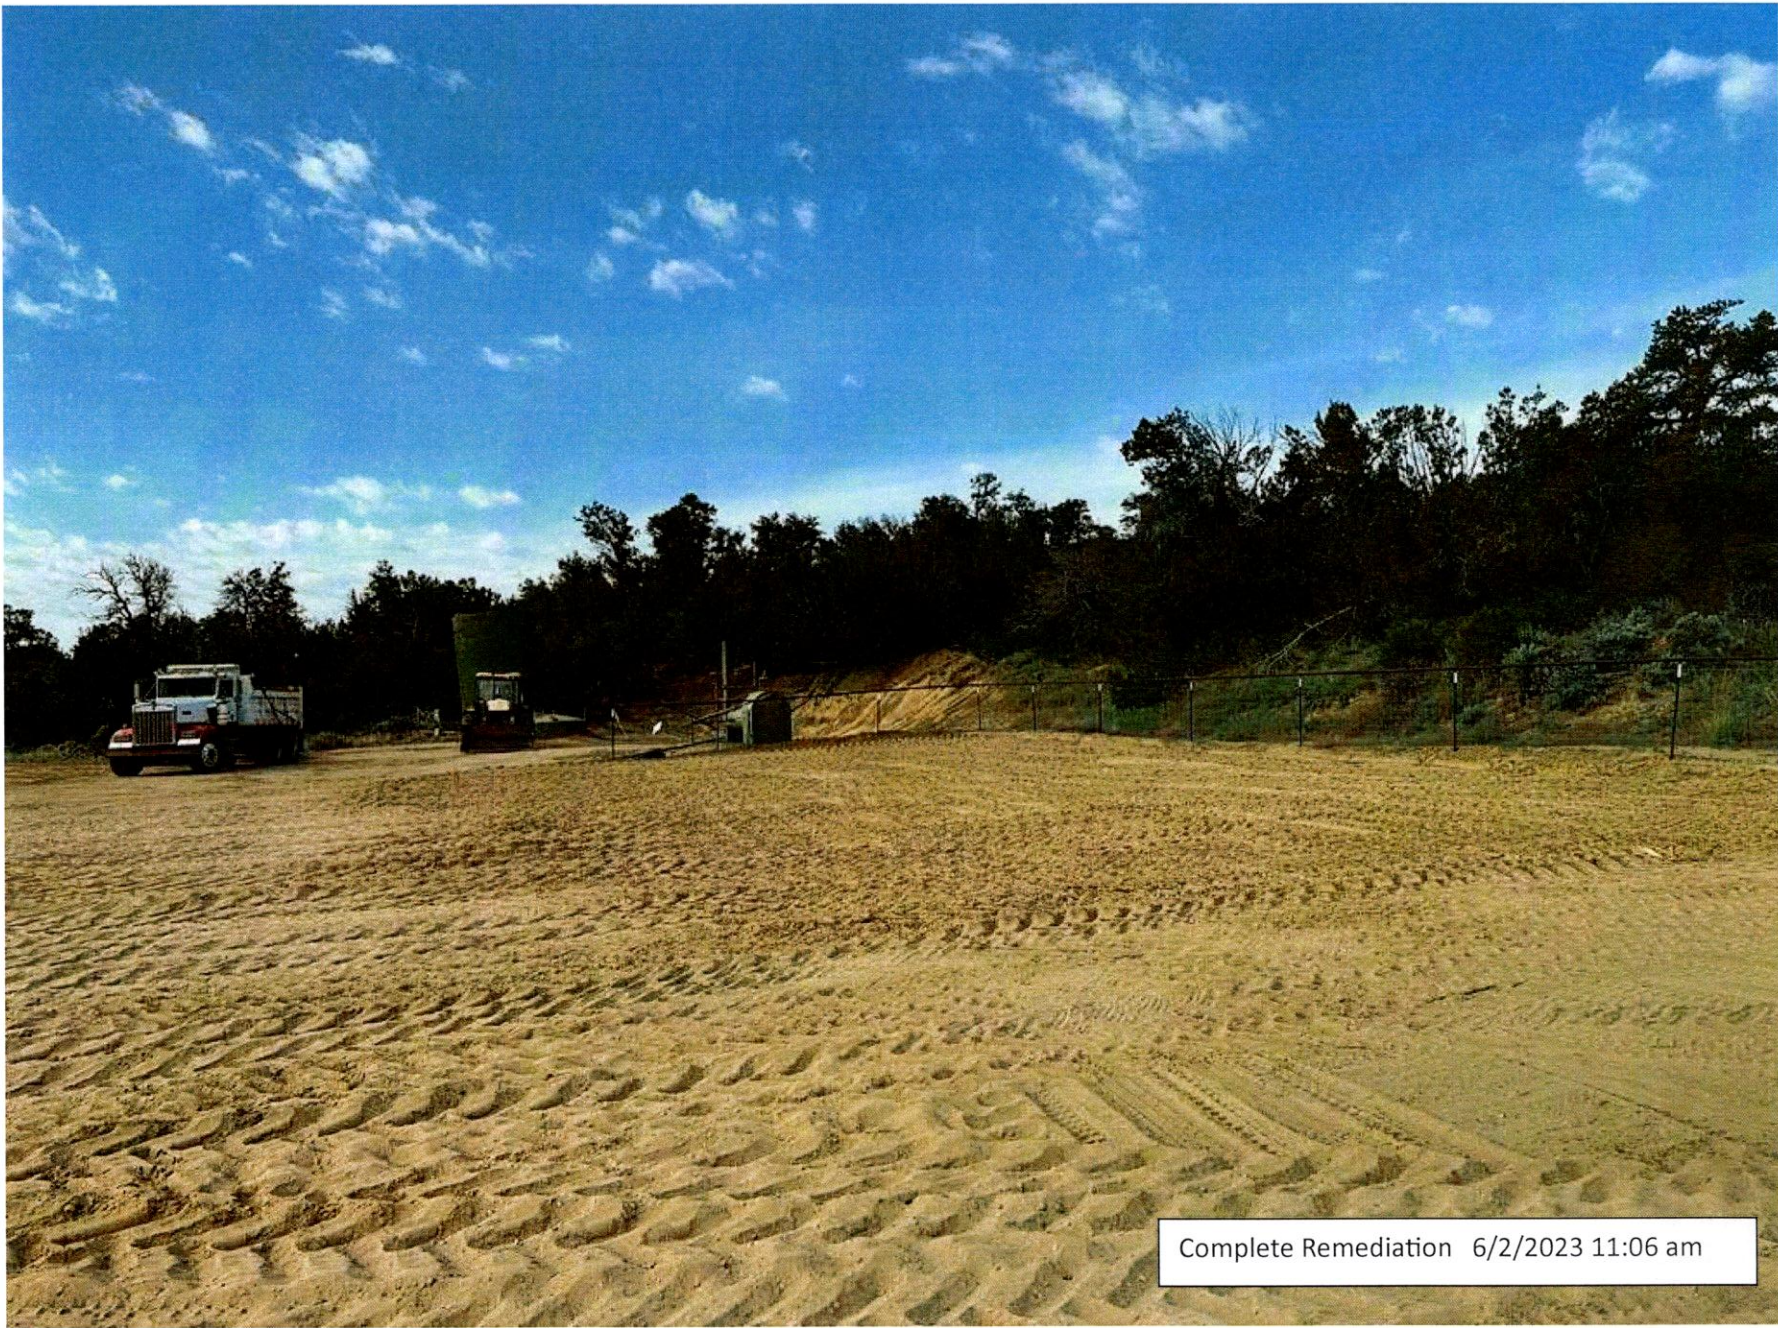
Complete Remediation 6/2/2023 11:06 am
