### Remediation Summary Closure Report

Date of report:	3/11/2021	Incident #	nRM2013931703
Site Name:	BKU 33 flowline	Subgroup:	Storage
Site GPS:	Latitude 32.833600	County:	Eddy, NM
	Longitude -104.022600°	Terracon Job #	AR207091

Spur Energy Partners, LLC ■ BKU 33 flowline  
March 11, 2021 ■ Project No. AR207091

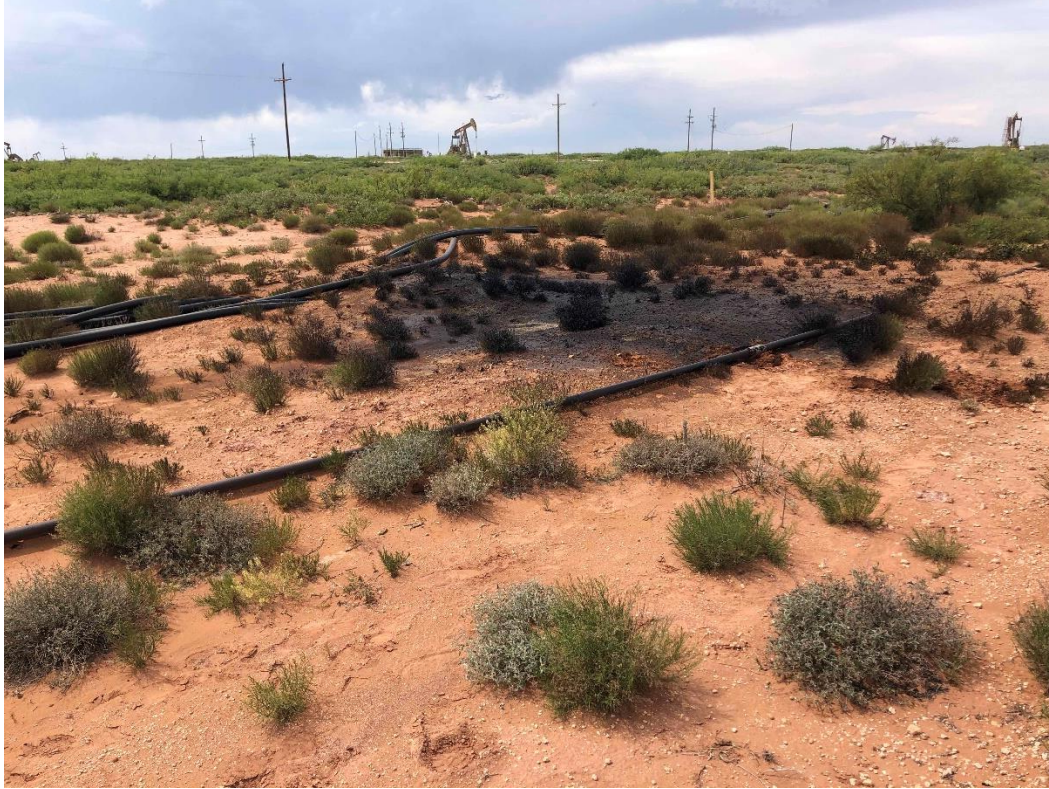
**PHOTO 1:** View of inferred area of impact, facing south. 5/11/2020

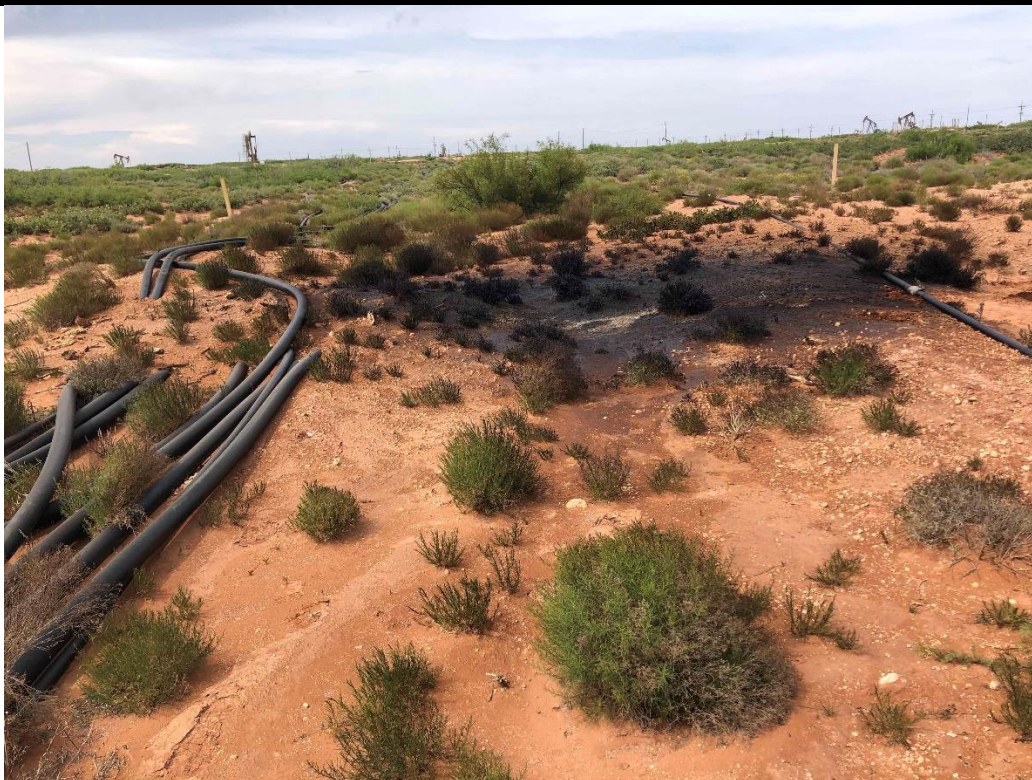
**PHOTO 2:** View of inferred area of impact, facing north. 5/11/2020

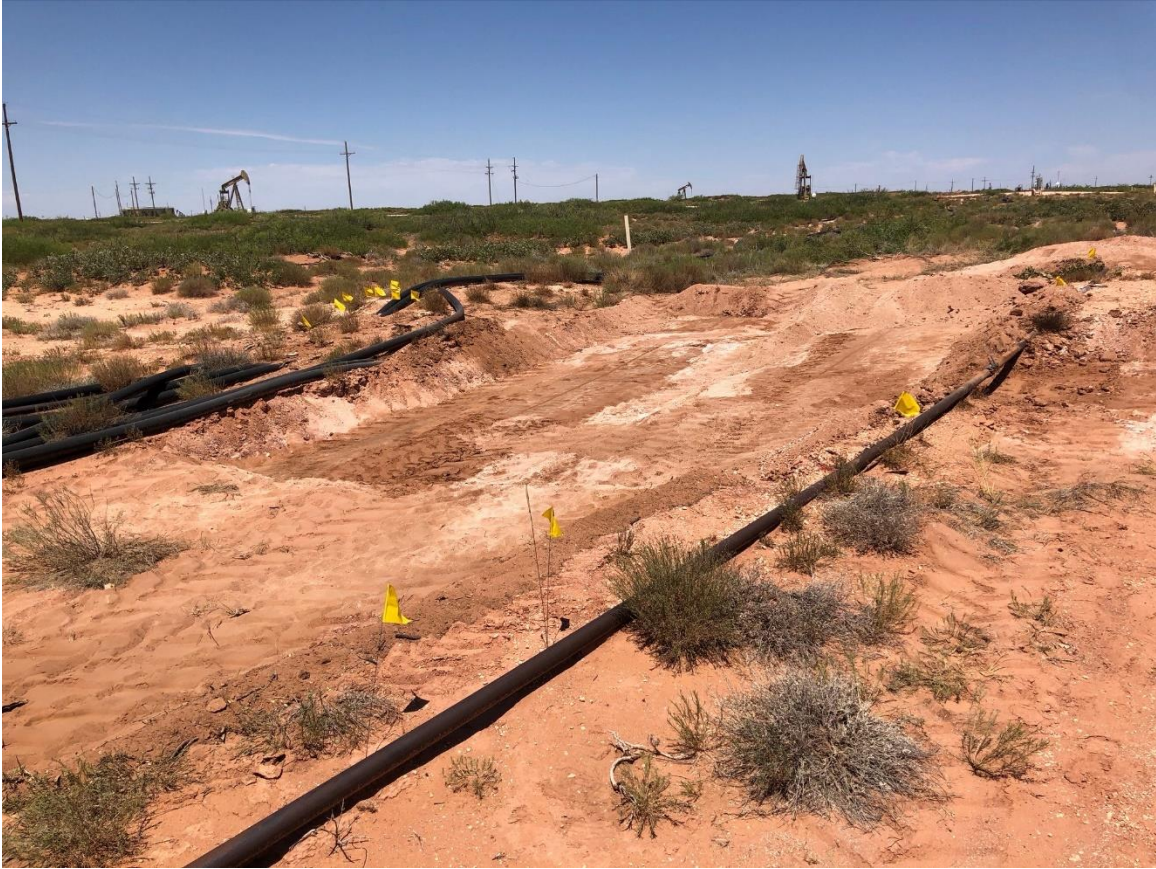
**PHOTO 3:** View of remediation, facing northwest. 08/25/2020

- August 25, 2021** Terracon returned to the location to conduct the remedial actions and collect confirmation samples. Approximately 80 cubic yards of impacted material was excavated and disposed of at the Lea Land landfill. Two five-point composite samples were collected

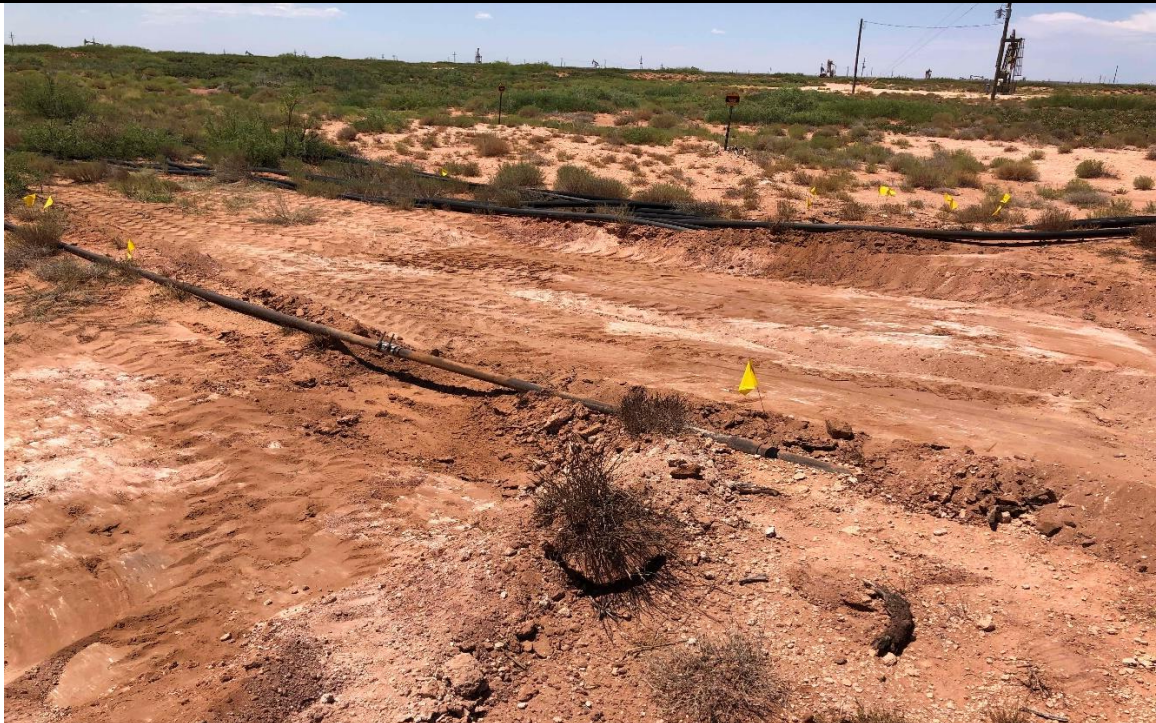
**PHOTO 4:** View of remediation, facing southwest. 08/25/2020
