## Remediation Summary and Closure Request

**Frontier Field Services, LLC**

**Texmack 6"**

**NMOCD Incident # nAPP2222824753**

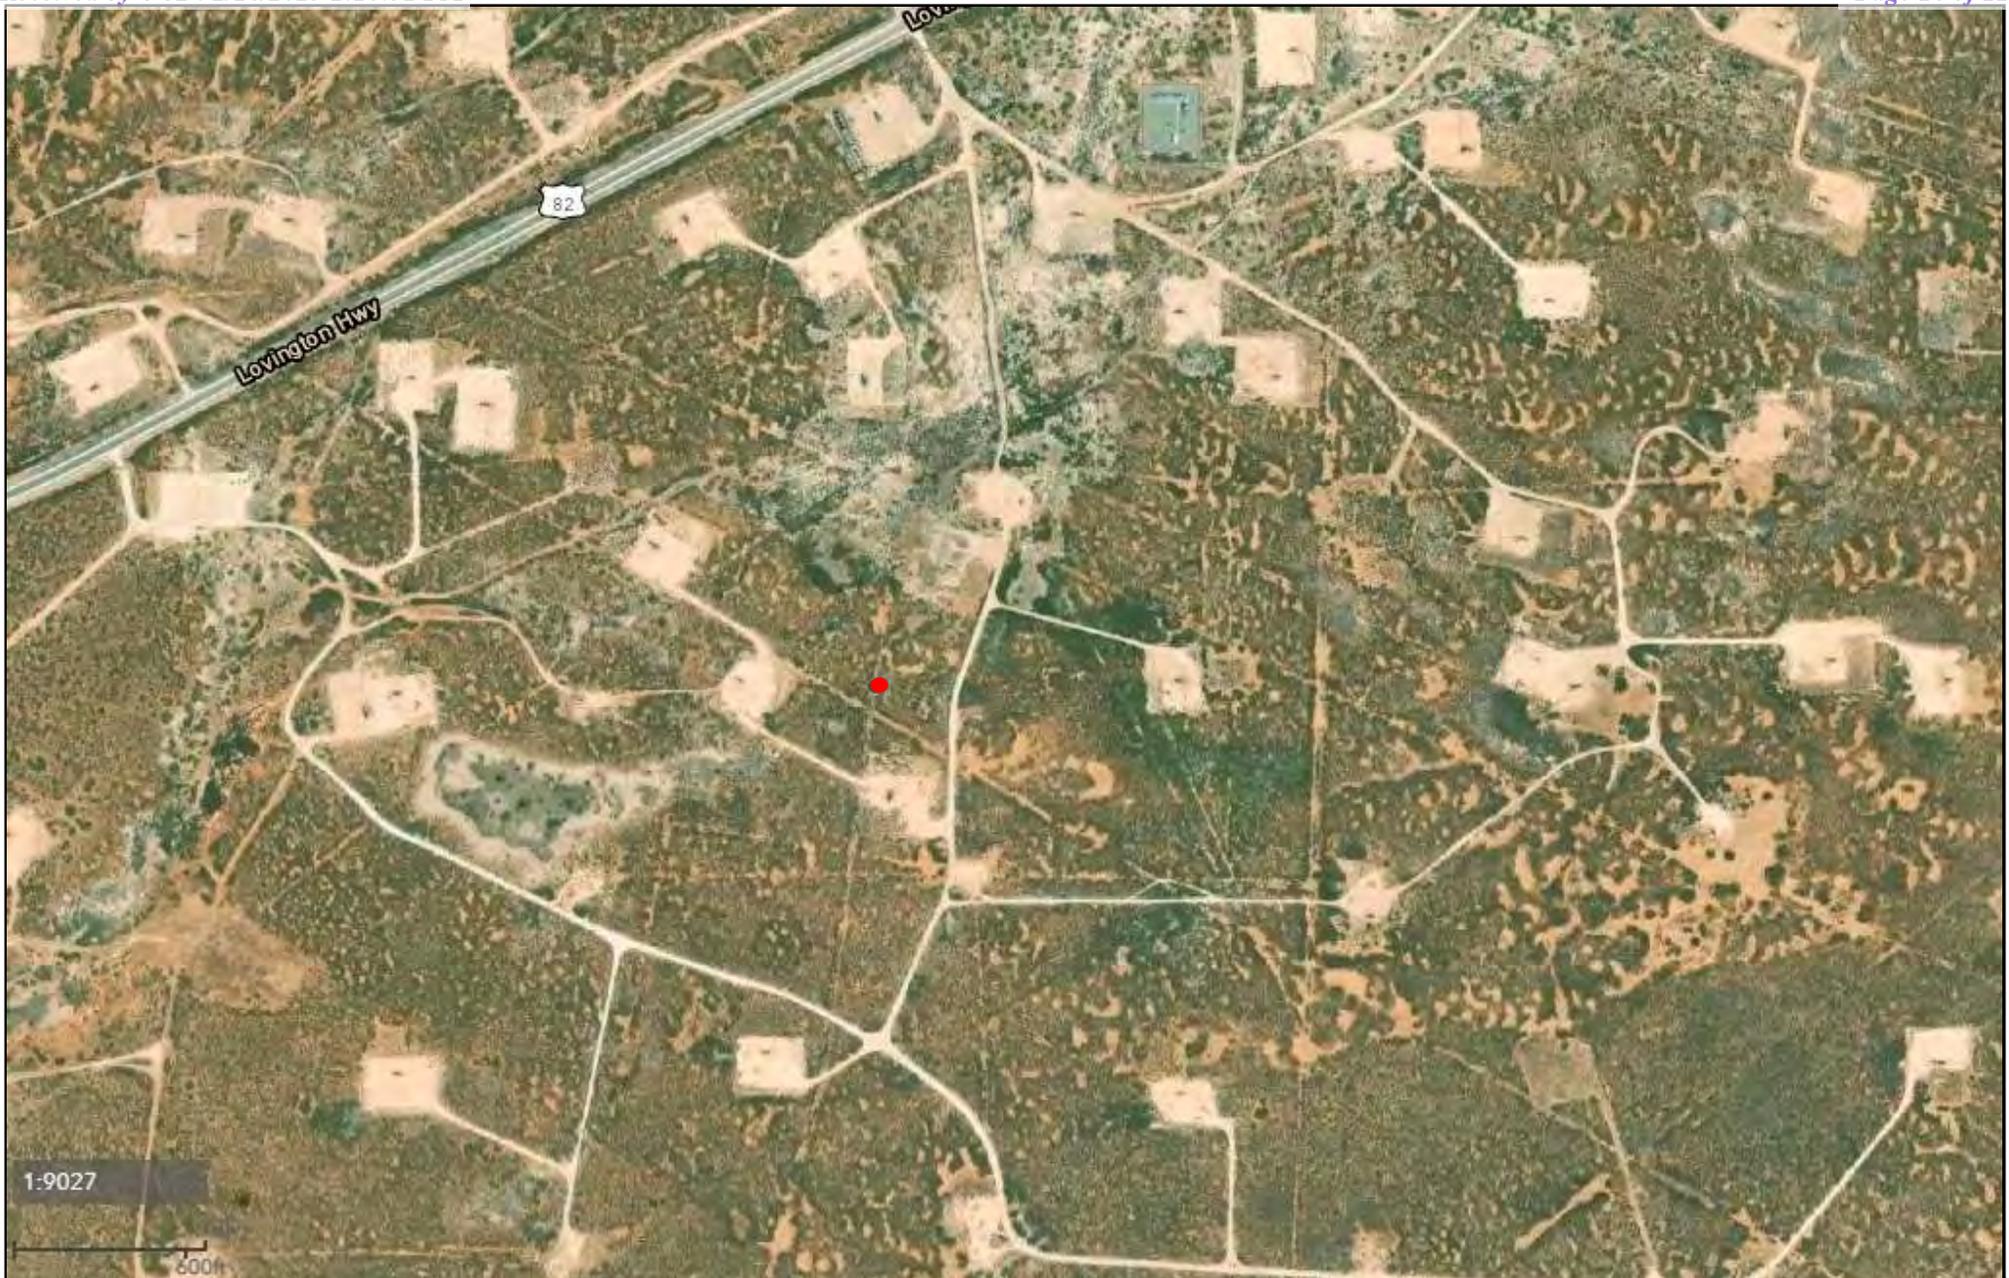
**Figure 2**

OSE POD Locations Map  
Frontier Field Services, LLC  
6" Texmack  
GPS: 32.816483, -103.843553  
Eddy County

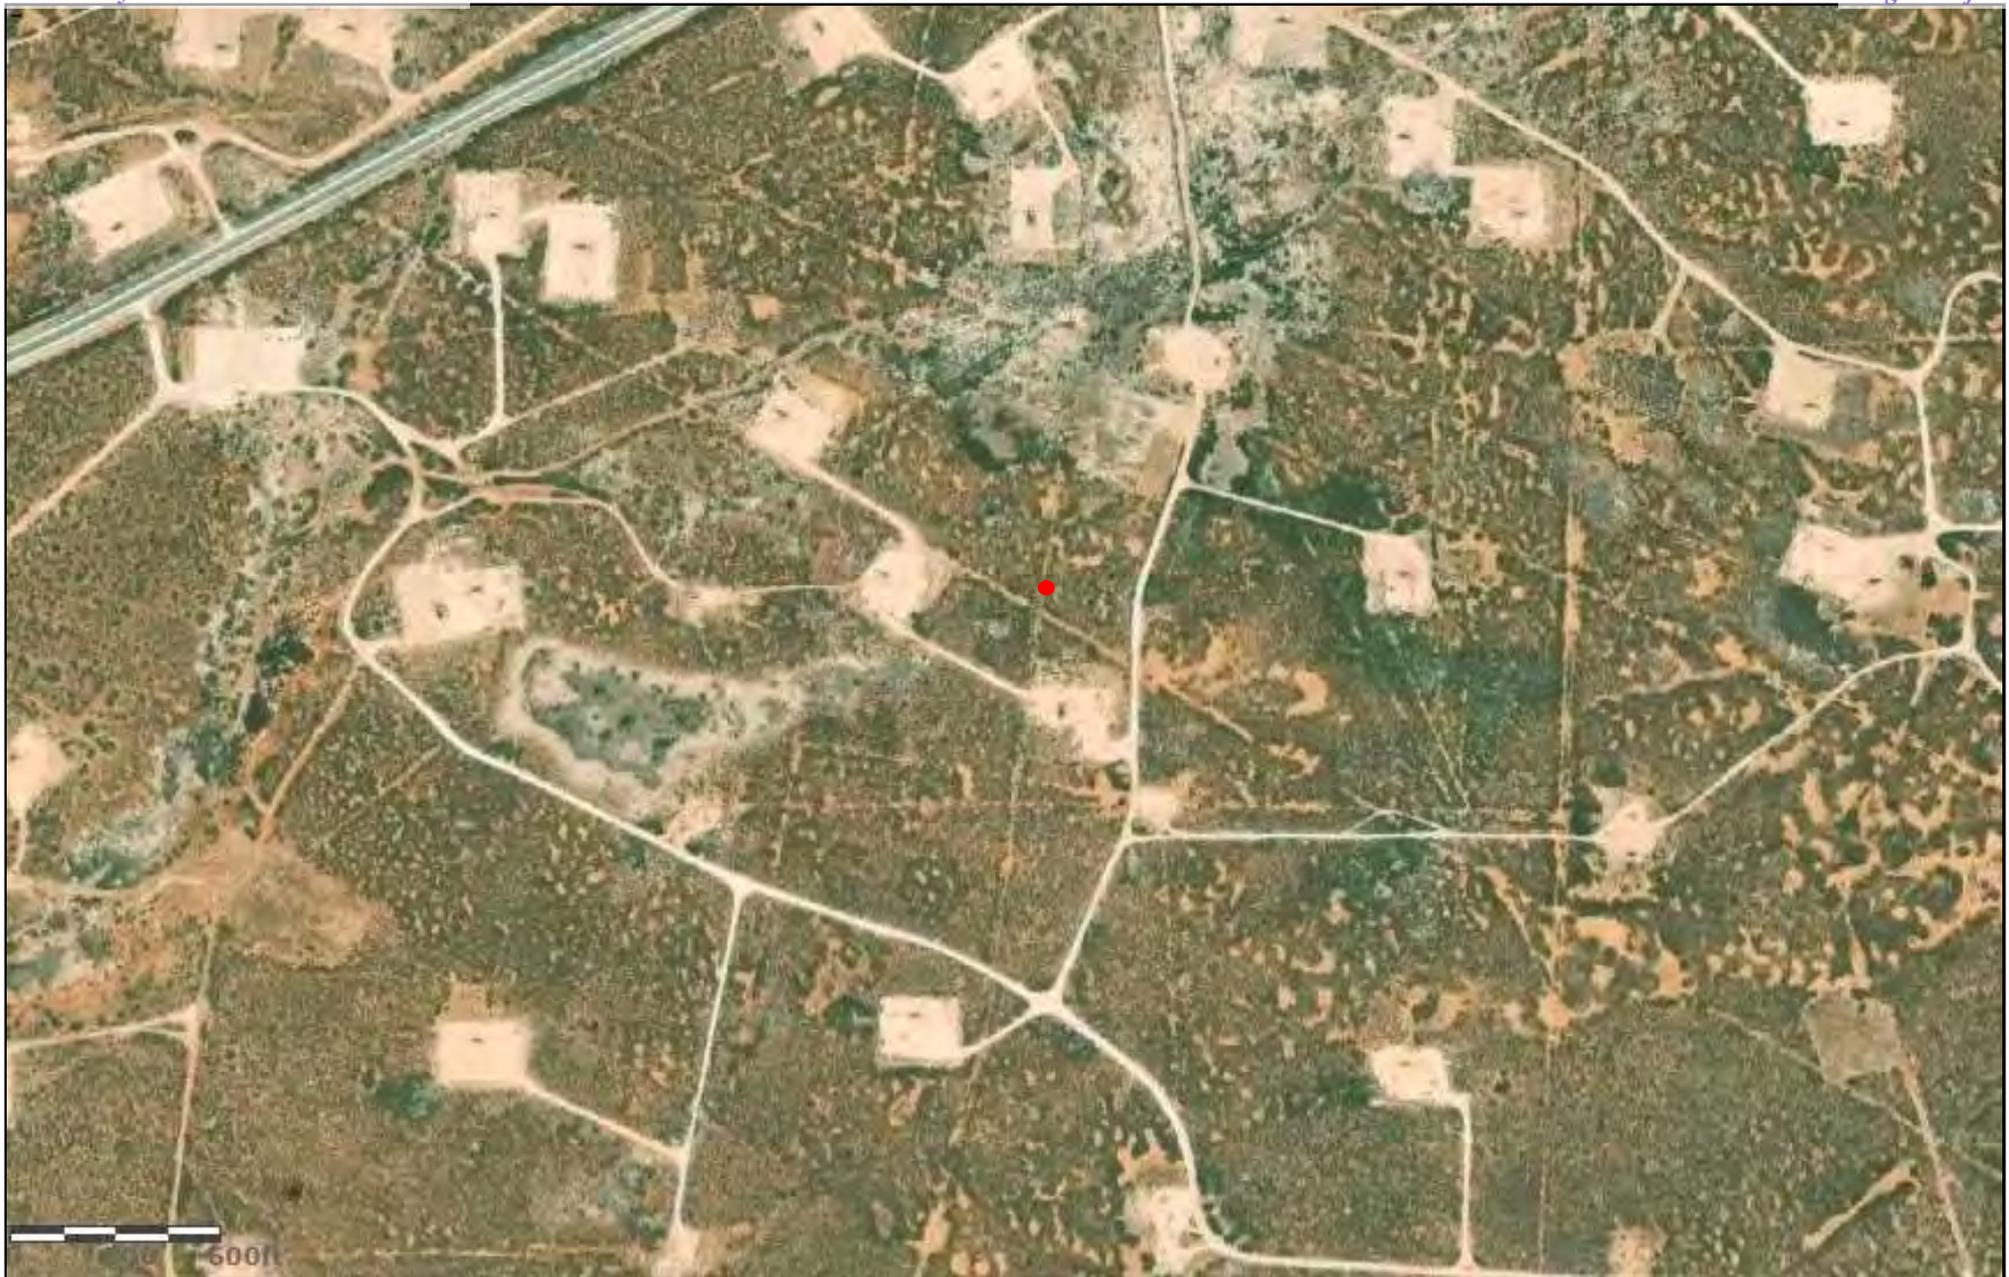
**Figure 3**

USGS Well Locations Map  
Frontier Field Services, LLC  
6" Texmack  
GPS: 32.816483, -103.843553  
Eddy County

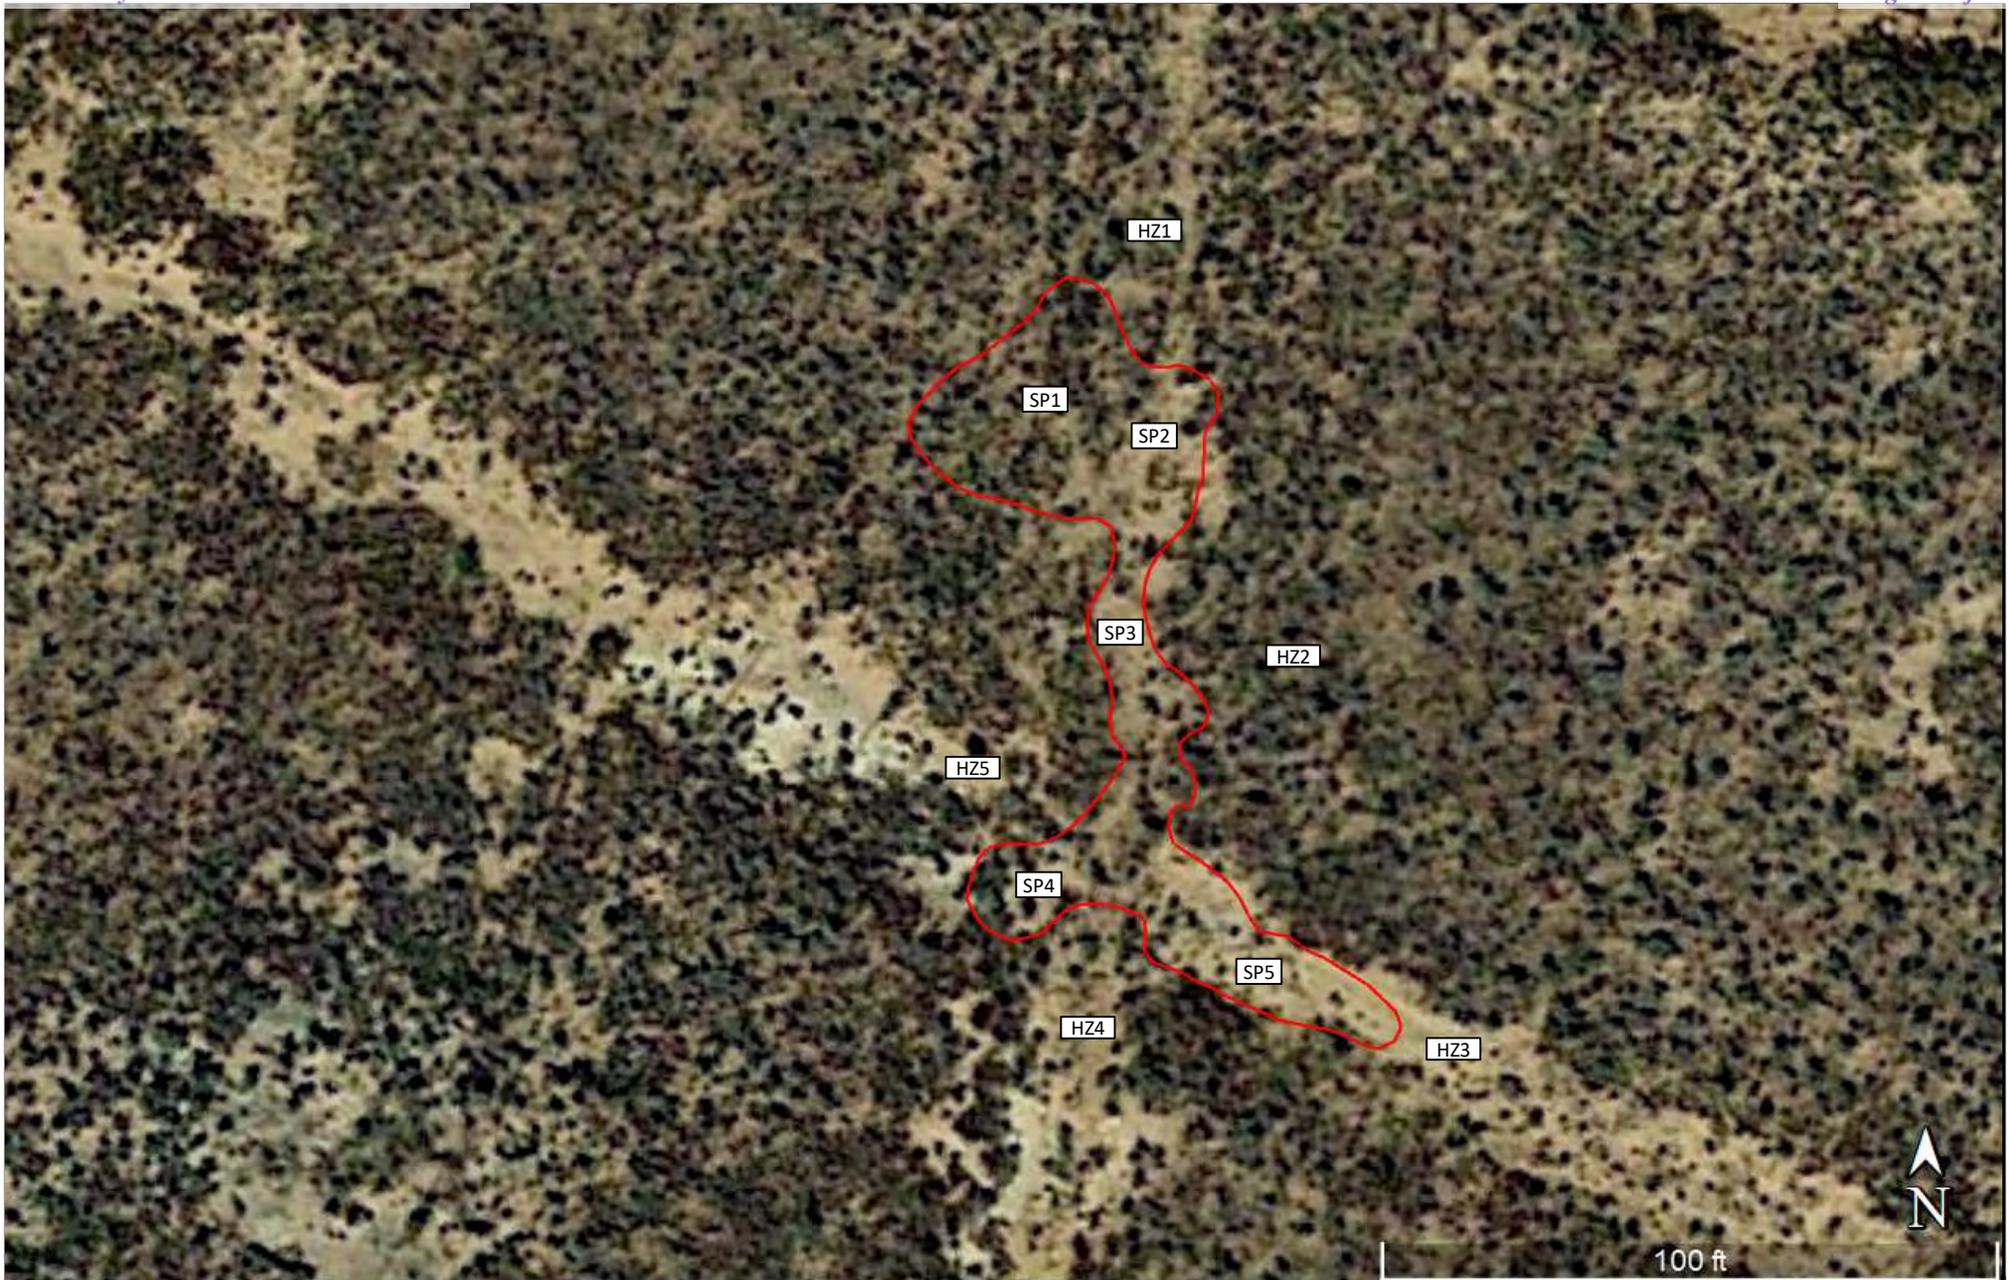
**Figure 4**

Delineation Sample Map  
Frontier Field Services, LLC  
6" Texmack  
GPS: 32.816483, -103.843553  
Eddy County

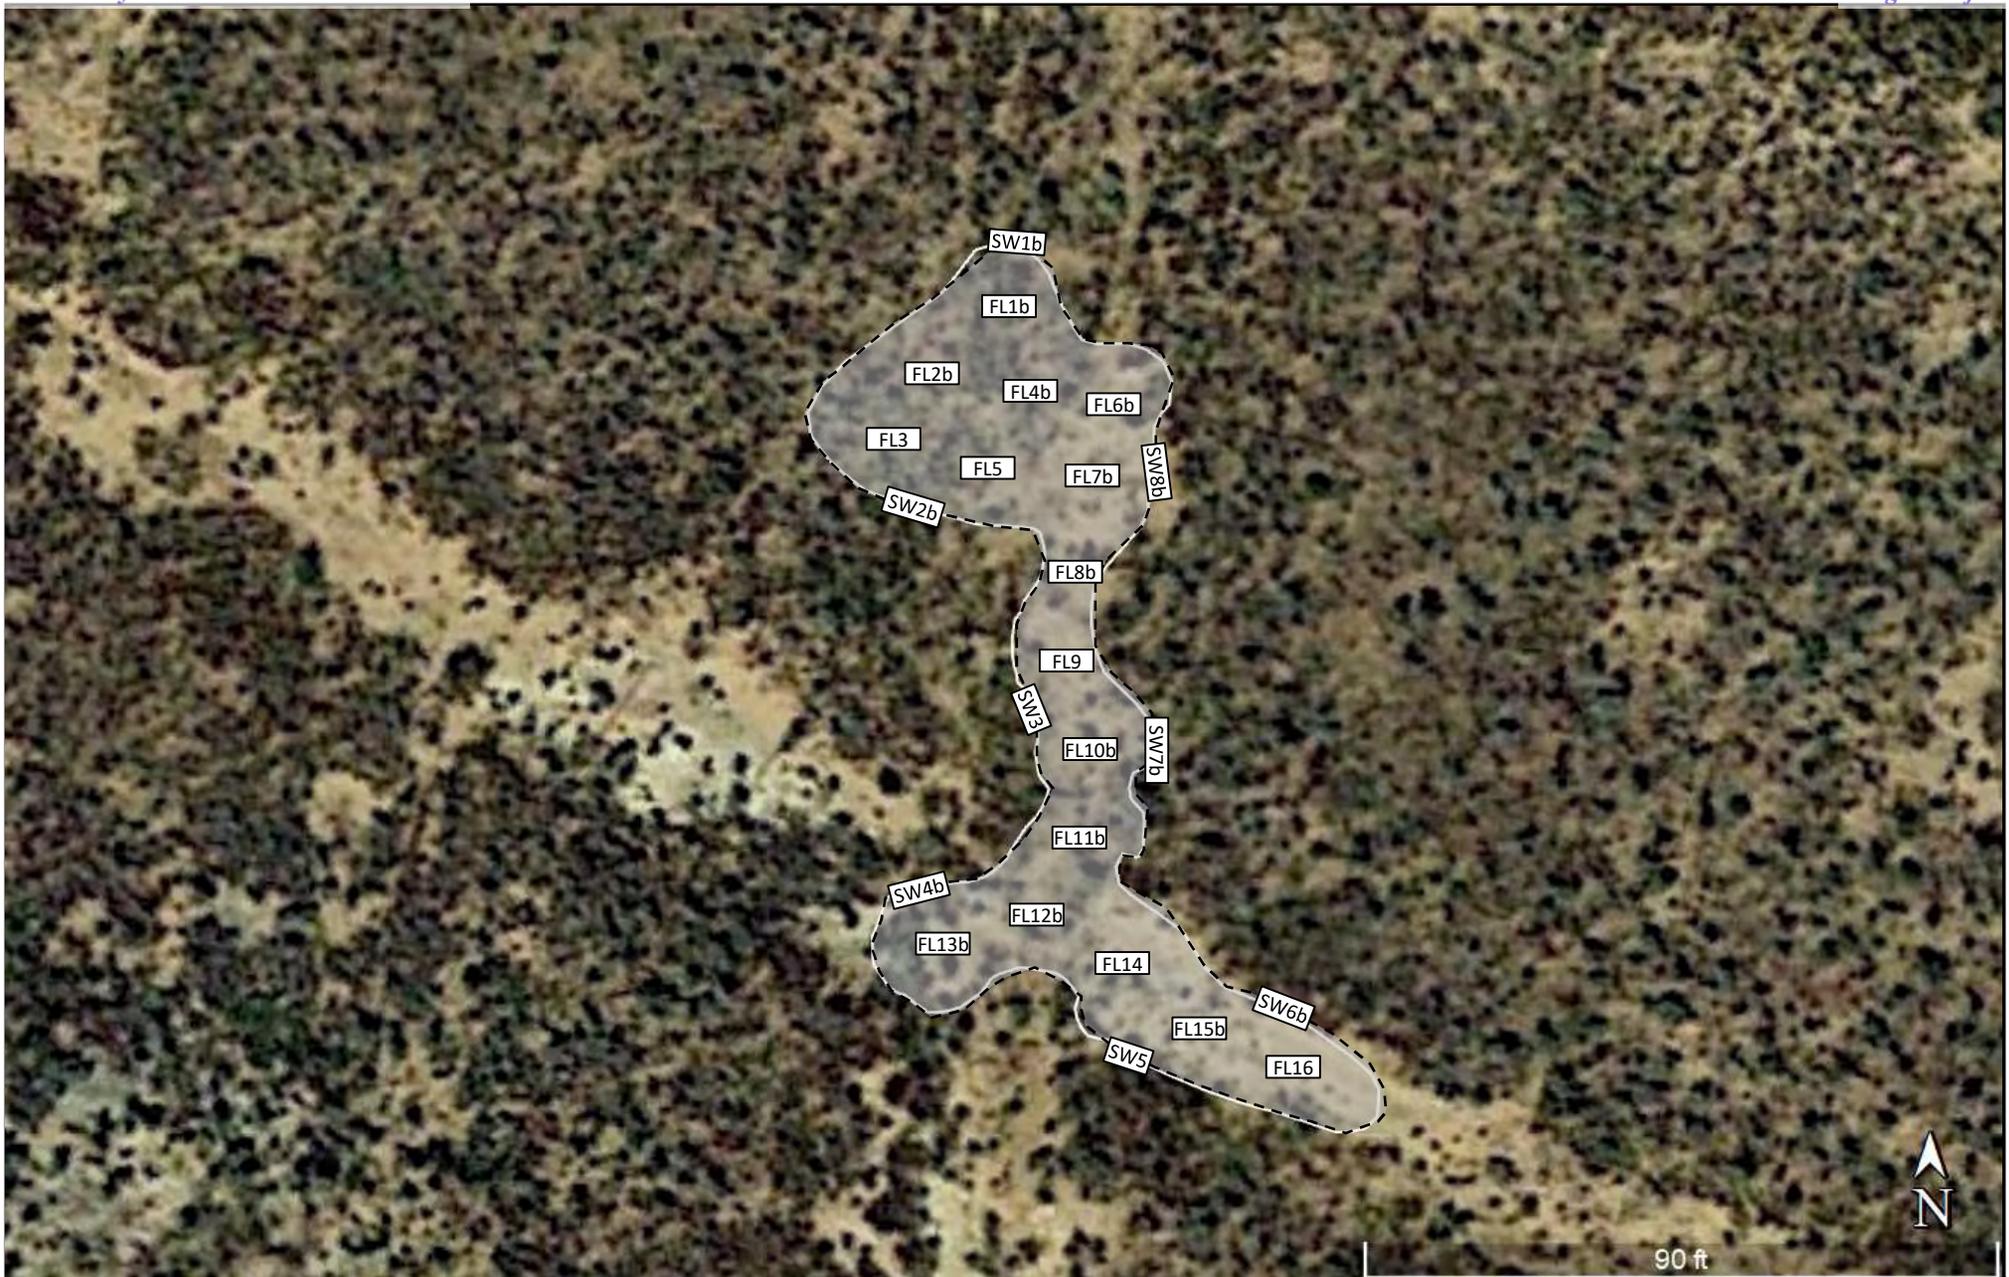
**Figure 5**

Excavation Sample Map  
 Frontier Field Services, LLC  
 Texmack 6" Steel Line  
 GPS: 32.816483, -103.843553  
 Eddy County
