## Release Notification and Corrective Action

| Facility Name: Poker Lake Unit 184 Battery (Delaware C)<br>(API for PLU #184) | Facility Type: Exploration and Production |

LT Environmental, Inc. (LTE), on behalf of XTO Energy, Inc. (XTO), presents the following Closure Request report detailing site assessment, soil sampling, and excavation activities at the Poker Lake Unit 184 Battery (Delaware C) (Site) in Unit G, Section 6, Township 24 South, Range 30 East, in Eddy County, New Mexico (Figure 1). The purpose of the site assessment, soil sampling, and excavation activities was to address impacts to soil following three separate events that caused the release of produced water and crude oil at the Site. Based on the excavation activities and results of the soil sampling events, XTO is submitting this Closure Request, describing remediation that has occurred and requesting no further action for the release events.

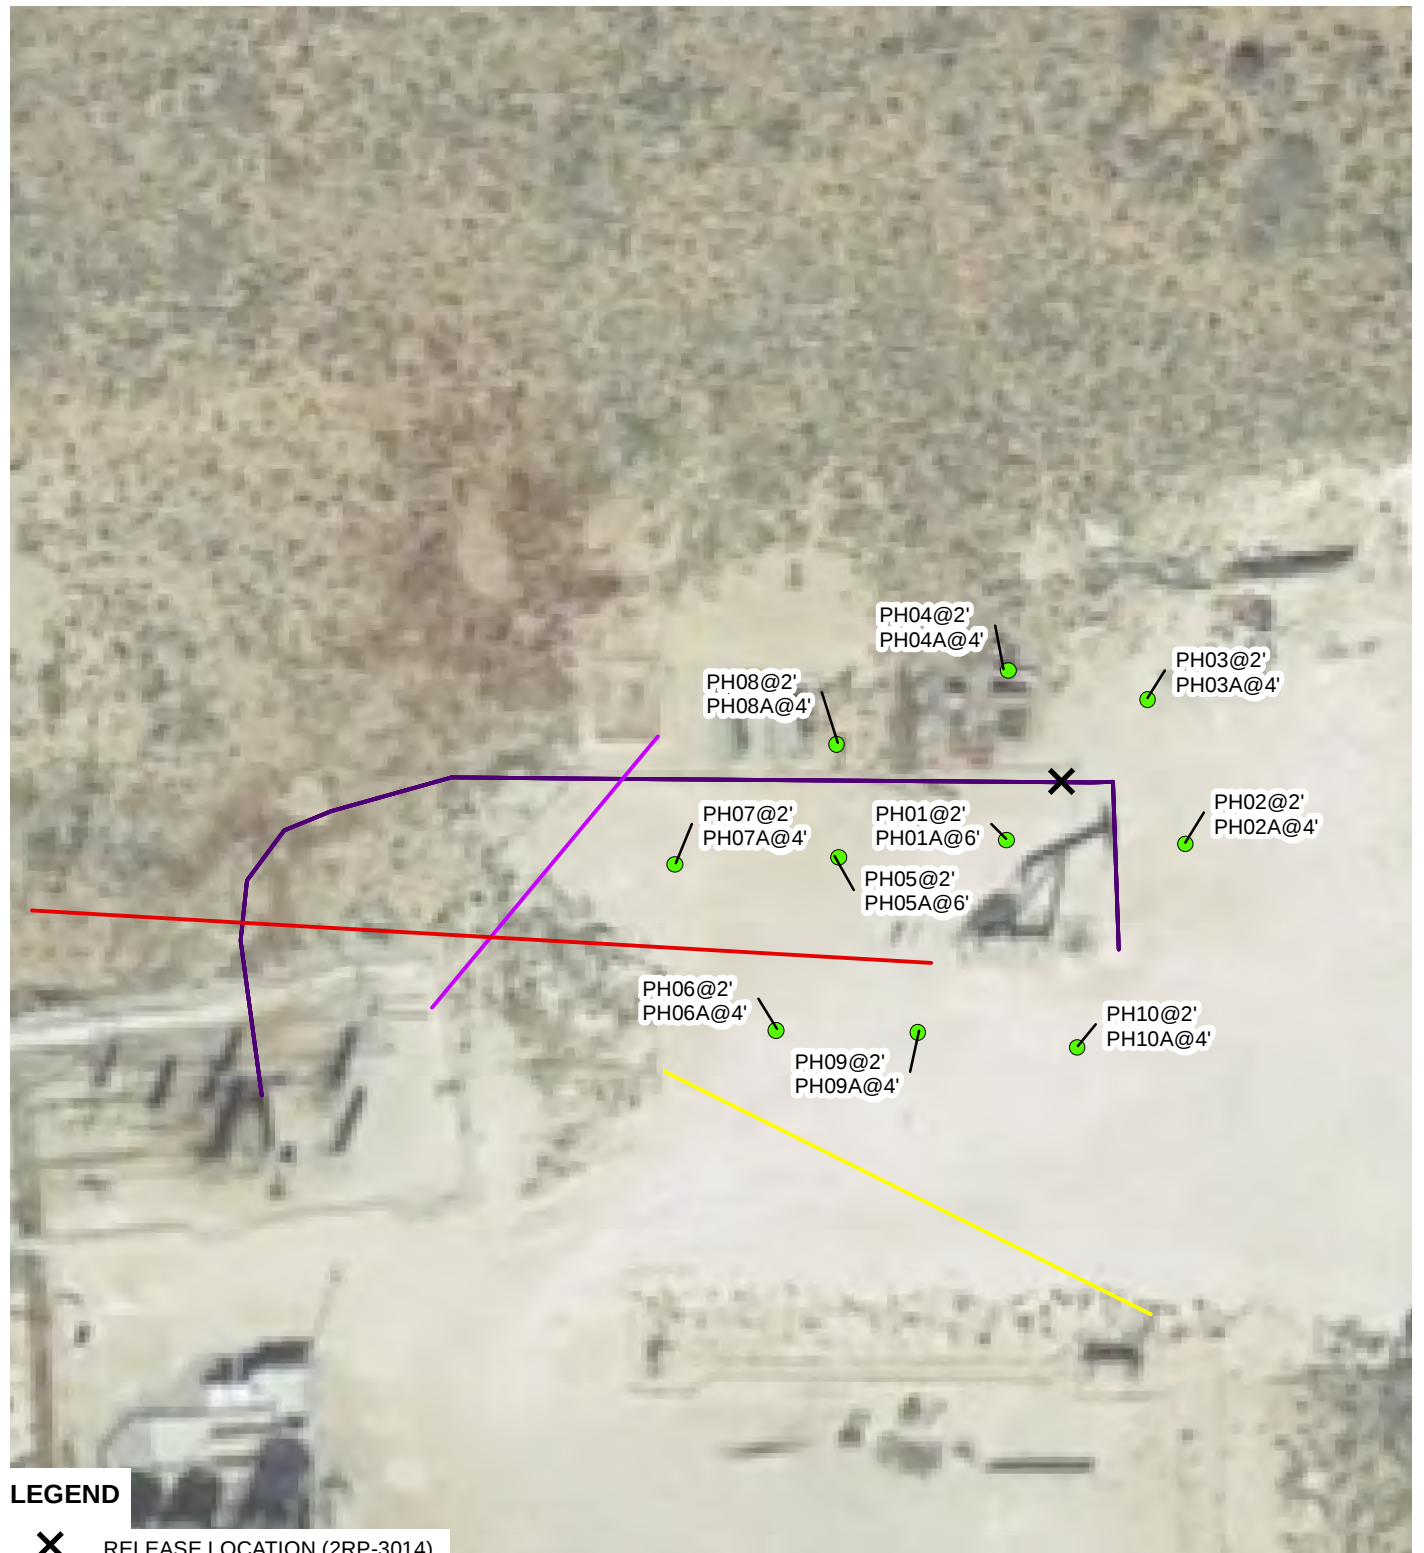
**FIGURE 3**  
DELINEATION SOIL SAMPLE LOCATIONS  
POKER LAKE UNIT 184 BATTERY (DELAWARE C)  
UNIT G SEC 6 T24S R30E  
EDDY COUNTY, NEW MEXICO  
**XTO ENERGY, INC.**

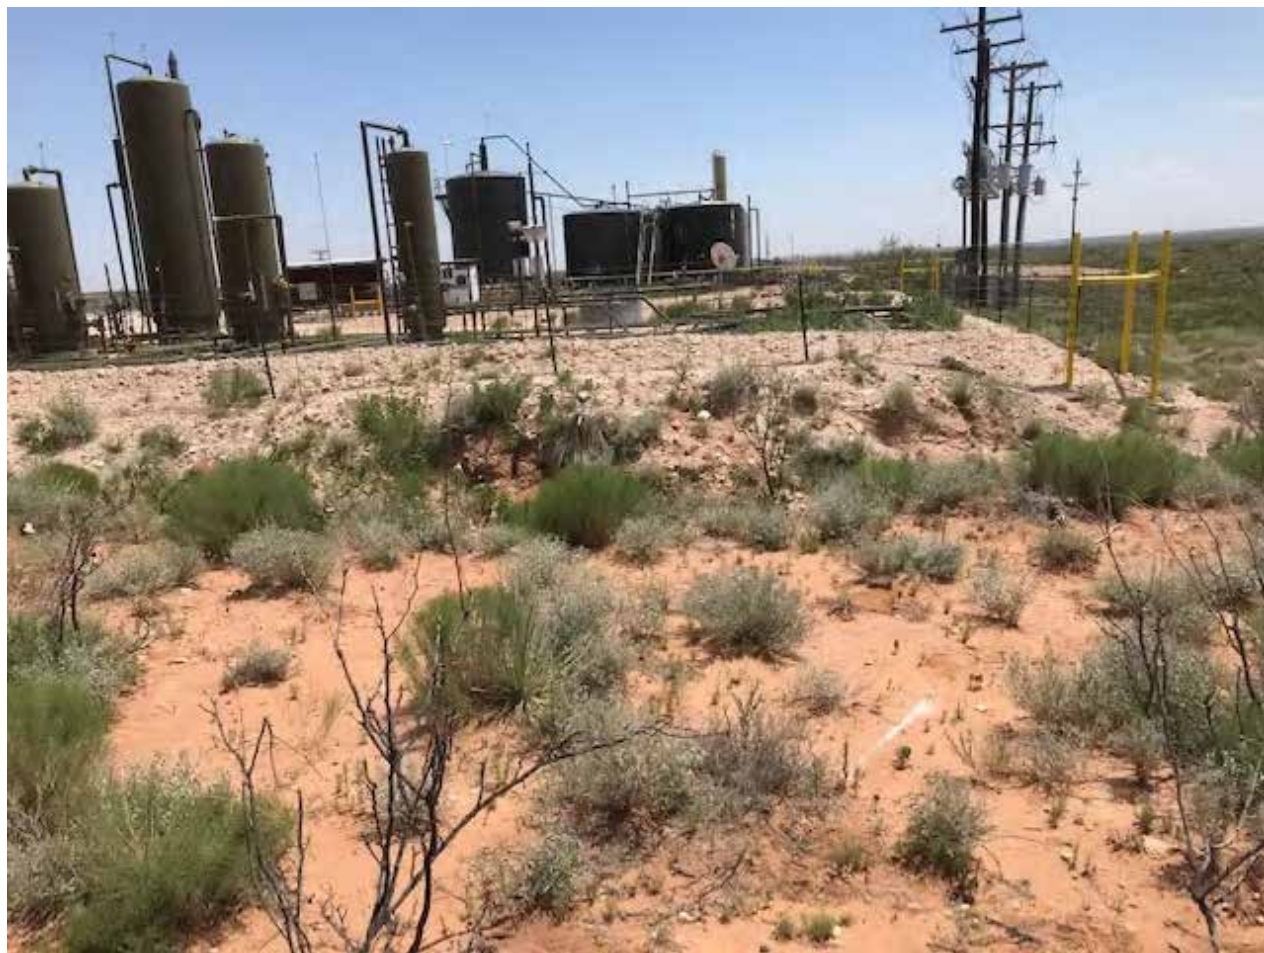
South facing view of release/assessment area (2RP-4396, 2RP-4397).

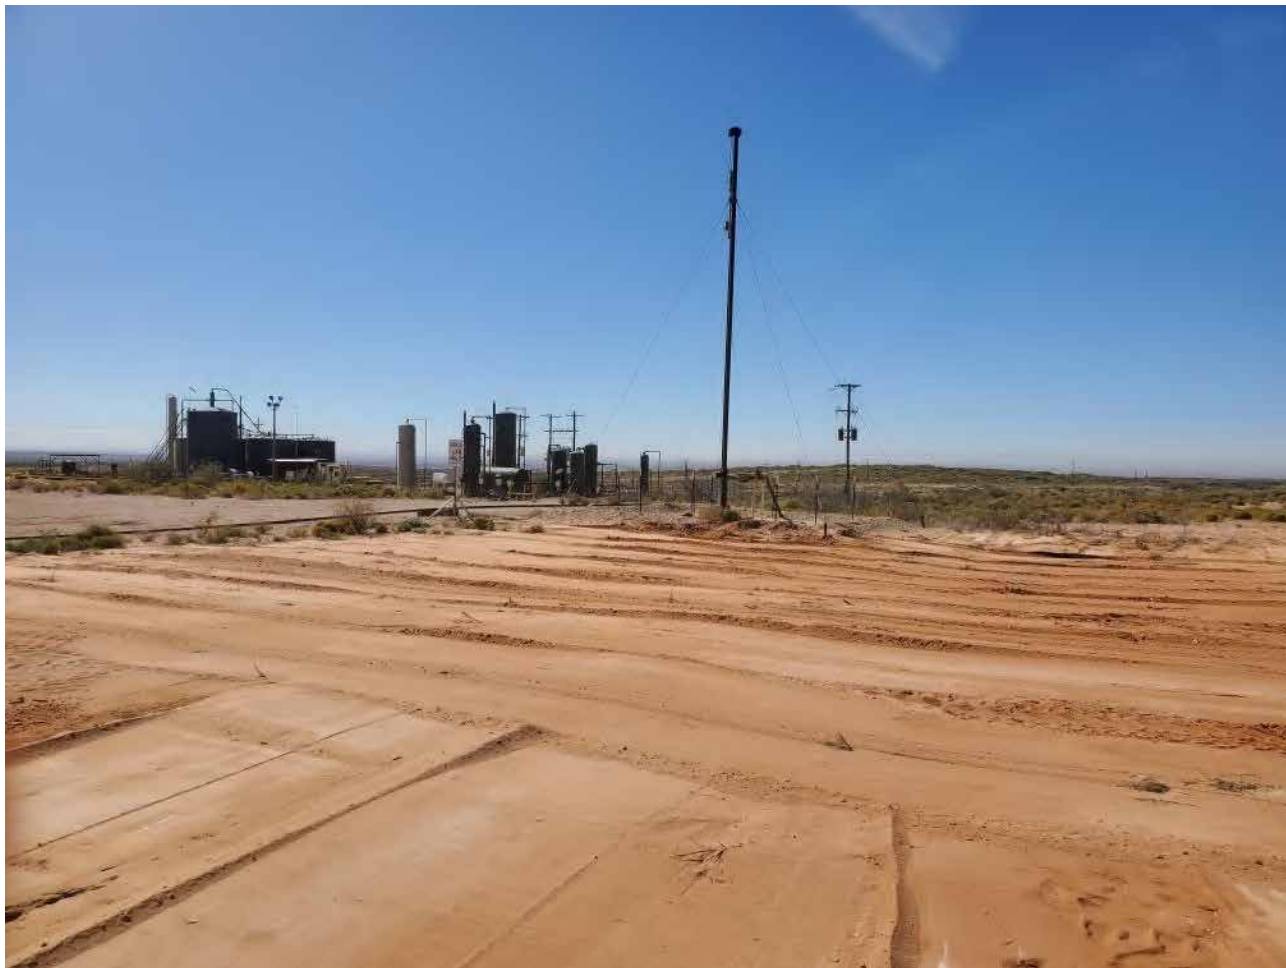
**Backfilled/contoured excavation area (2RP-4396, 2RP-4397).**

Initial response efforts, natural attenuation, and excavation of impacted soil have mitigated impacts at this Site. XTO requests no further action for RP Numbers 2RP-3014, 2RP-4396, and 2RP-4397. XTO backfilled the excavation with material purchased locally and recontoured the Site to match pre-existing site conditions. An updated NMOCD Form C-141 for each release is included in Attachment 1.
