**Re: Variance Request
 Riser 37
 API No. N/A
 GPS: Latitude 32.8410149 Longitude -104.0705795
 UL "C", Sec. 15, T17S, R29E
 Eddy County, NM
 NMOCD Ref. No. NAPP2301536710**

Paragon Environmental, LLC (Paragon) has been contracted by Spur Energy Partners (Spur) to perform a spill assessment, conduct remediation activities, and request this variance for the Riser 37 (Riser).

Riser 37
API # N/A
Eddy County, NM
Site Map

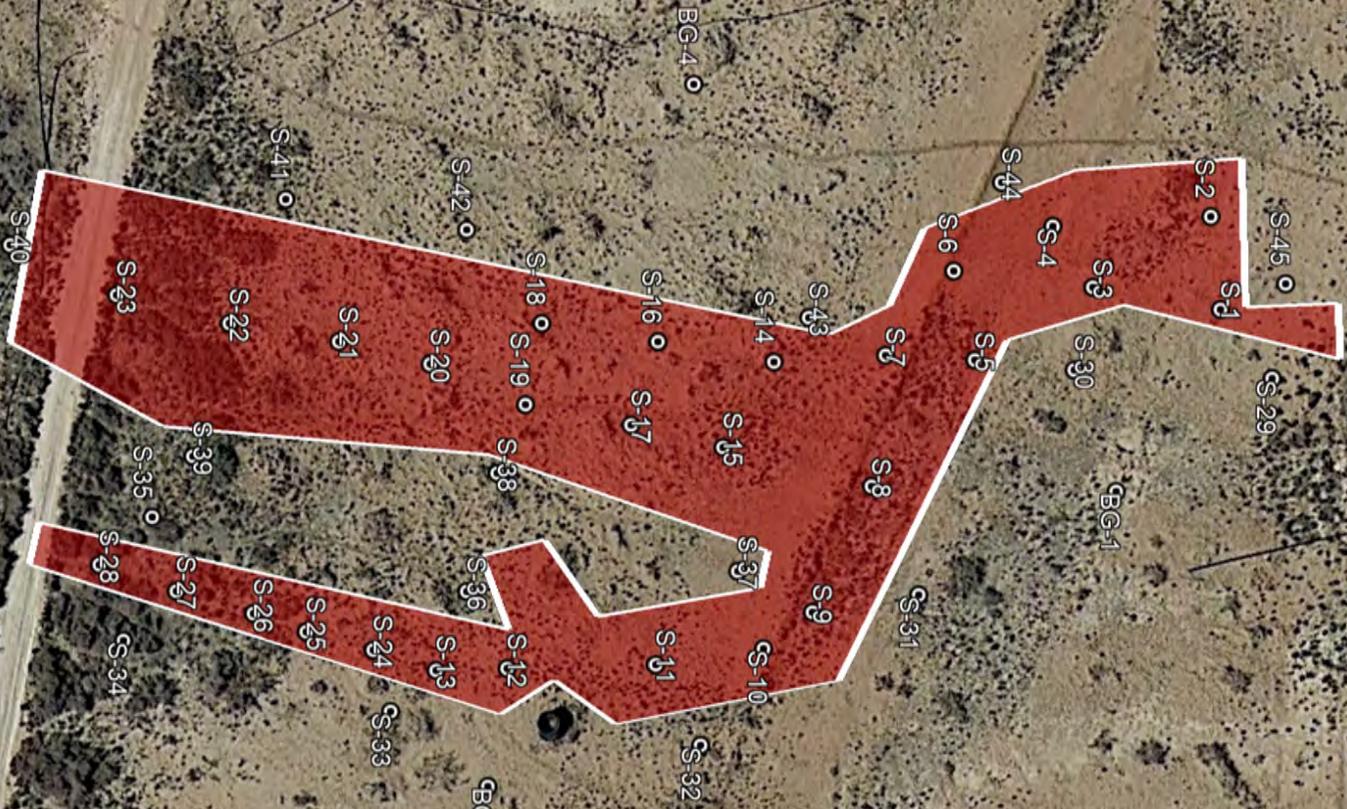
We recommend installing a bentonite clay liner at a 4-foot excavation. This is where the source of the spill occurred and the area that was impacted by the incident. A site map (Figure 1) illustrates the impact area from this release. The area affected measures approximately 400 feet long and 70 feet at its widest point. The liner is proposed to encapsulate the remaining chloride impacts below 4-feet deep. The nearest groundwater was determined to be greater than 100 feet below grade surface in the area outside of Loco Hills.

- 32.84139, -104.06718
- Feature 1
- Spill Area

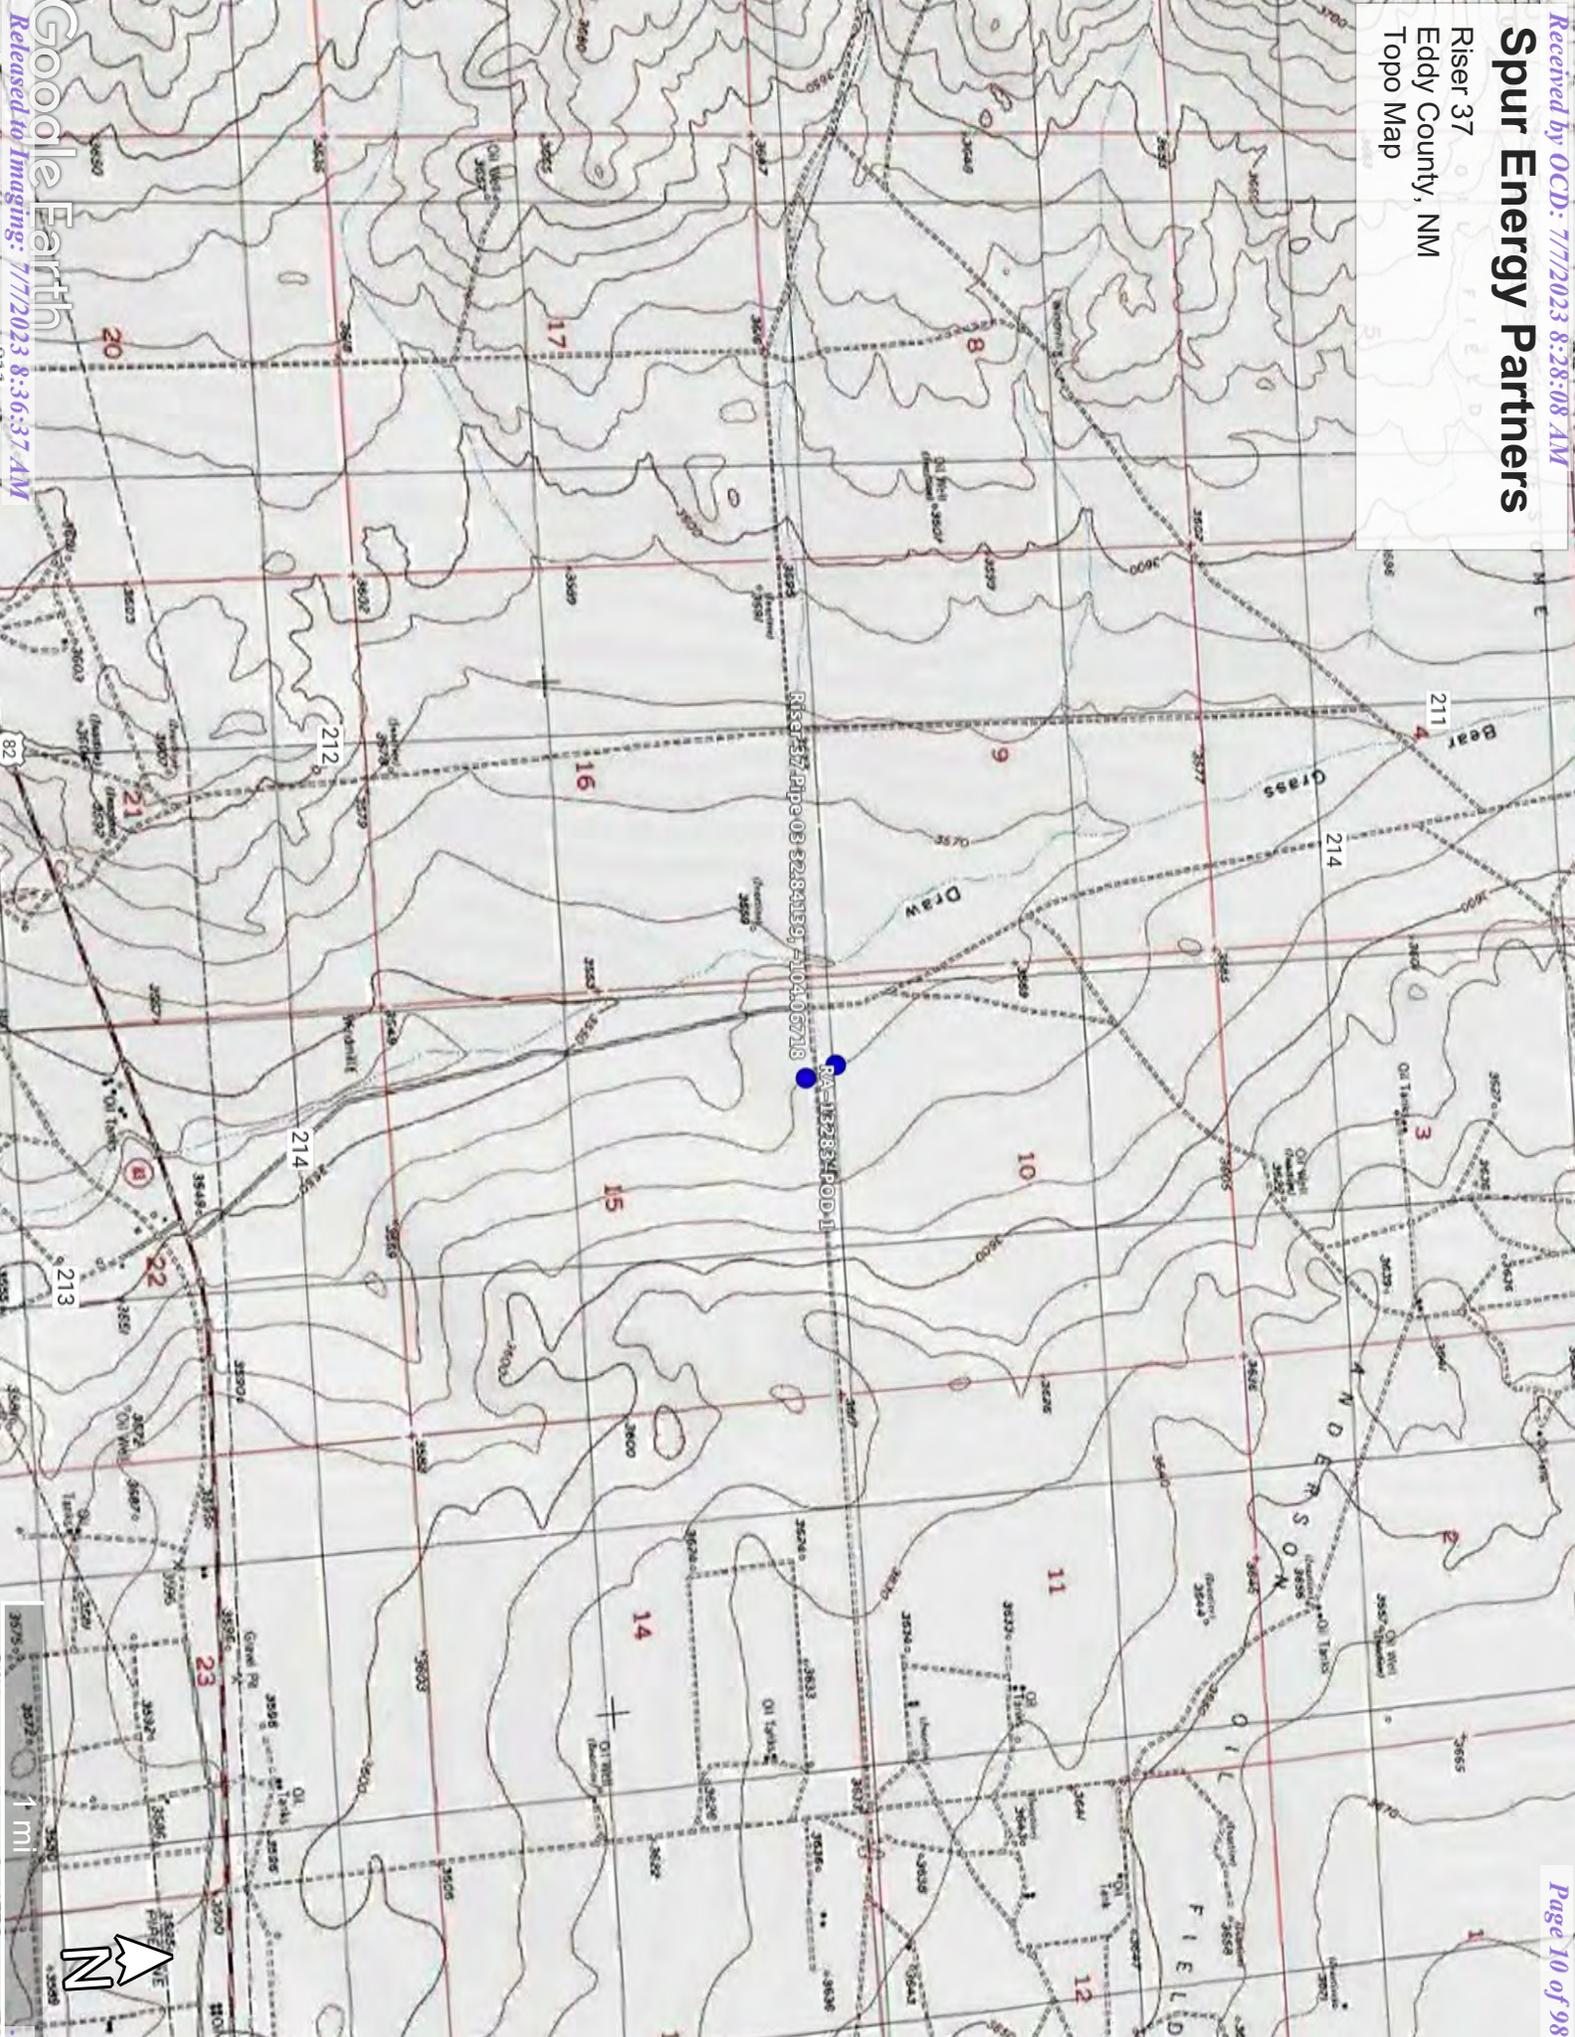
Riser 37
Eddy County, NM
Topo Map

Topographical and Aerial Maps are provided in Figures #2 and #4. A copy of the Initial Release Notification and Corrective Action (NMOCD Form C-141) can be found in Appendix C.

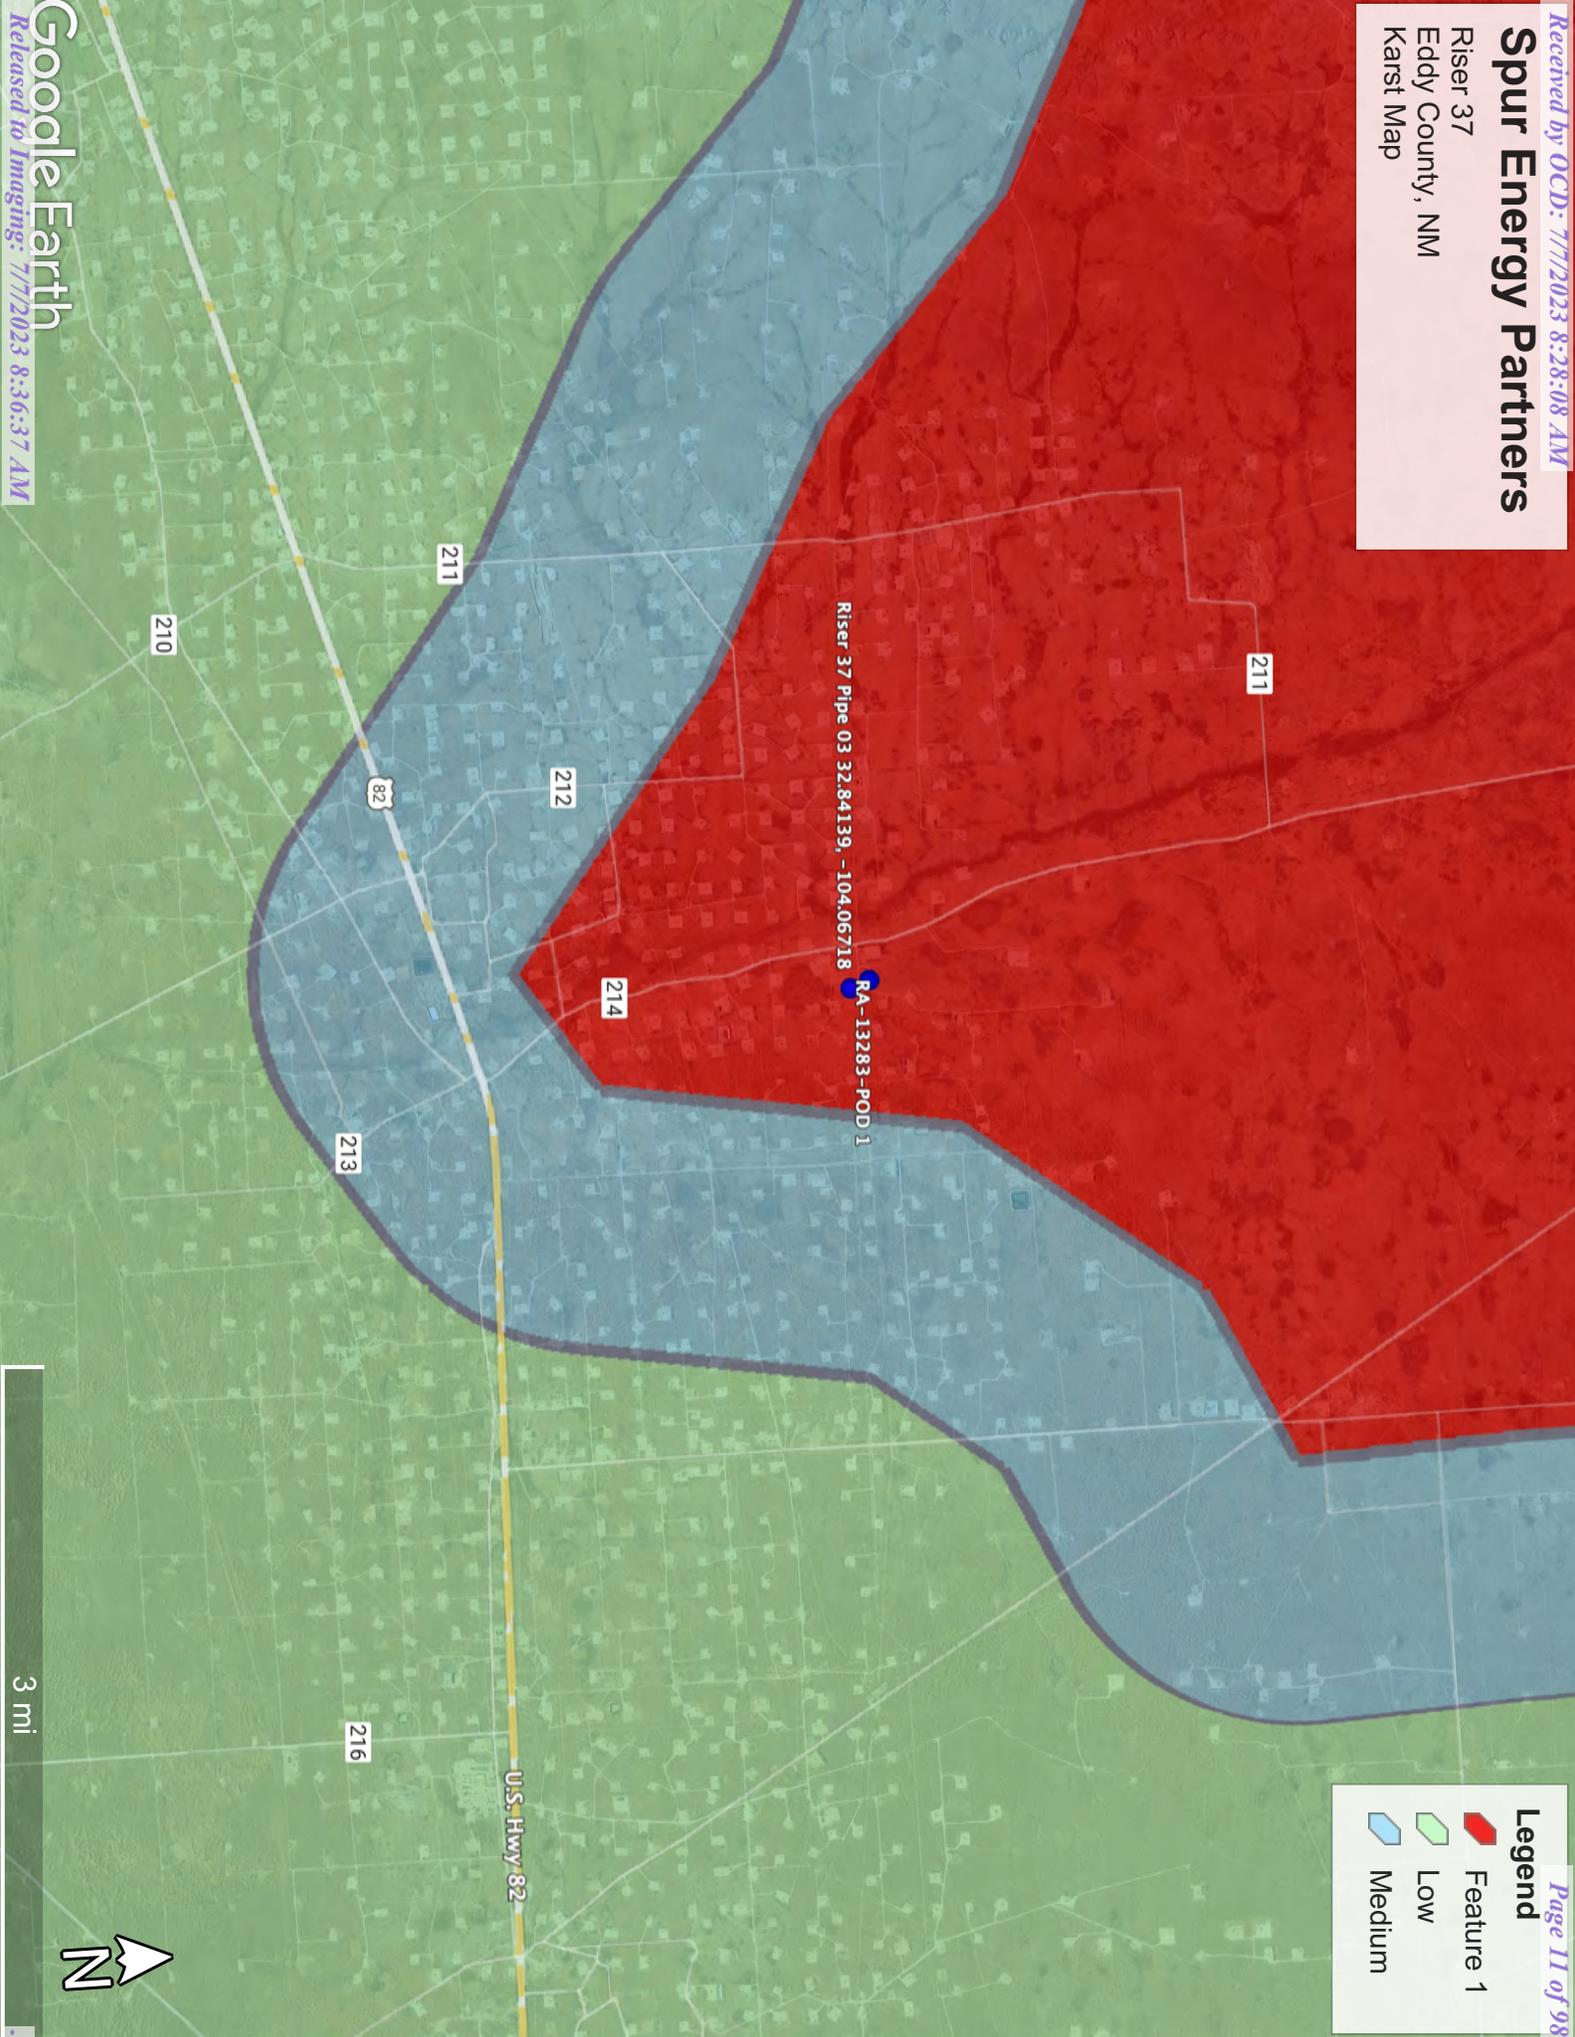
Riser 37
Eddy County, NM
Karst Map

The Soil Survey and FEMA Flood Map are provided in Appendix B. A Karst Map is provided in Figure #3.

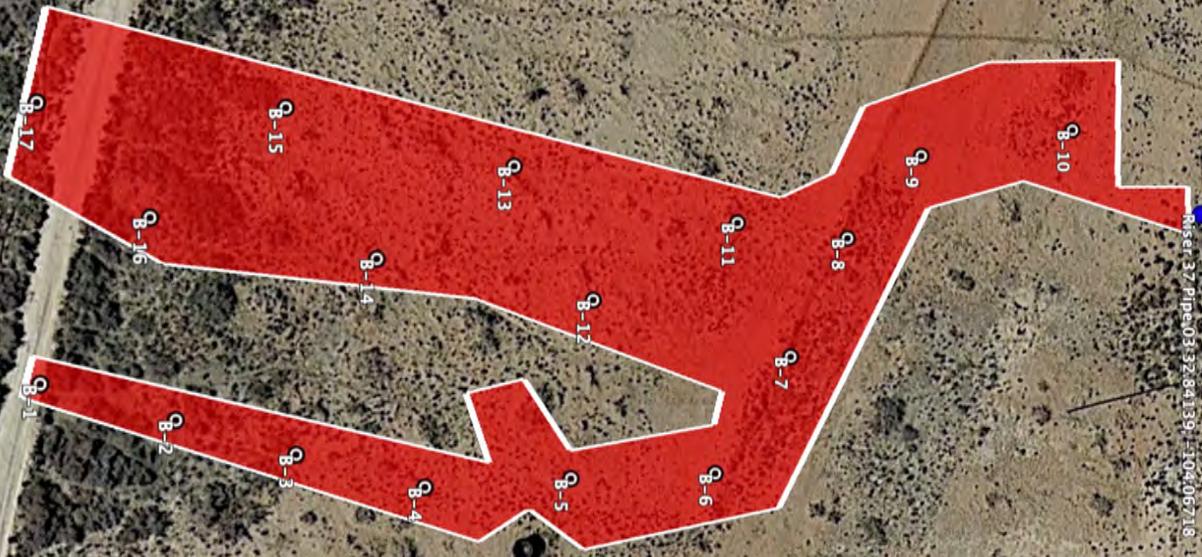
Riser 37 Pipe 03
Eddy County, NM
Boring Map

We then scheduled to utilize a geoprobe to advance our vertical samples in order to obtain vertical delineation. This data was necessary in order for us to ask for this variance. We obtained samples starting at 7 feet, each soil boring obtained 4 feet of soil. We field titrated the bottom sample of each boring to determine if we needed to advance additional samples. We advanced the boring until clean results were found. We sent these samples to the lab for final analysis, those results are in the following data table. A Bore Hole Map is also attached in Figure 5.

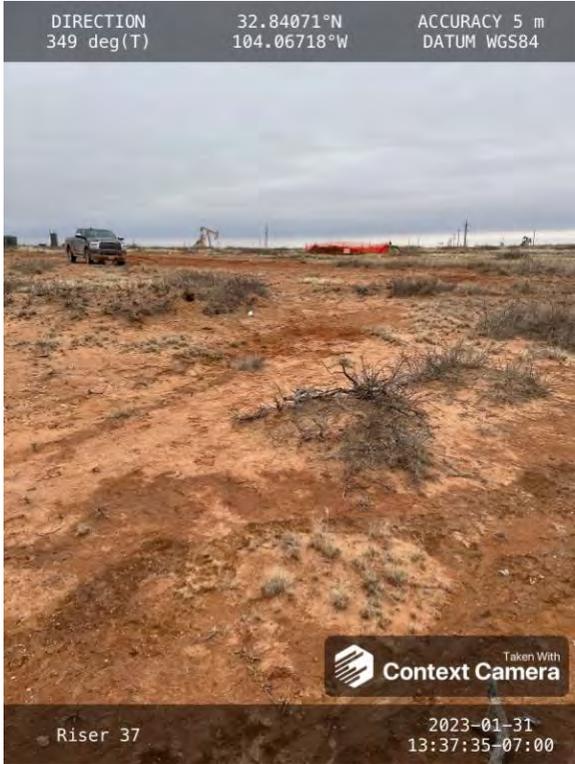
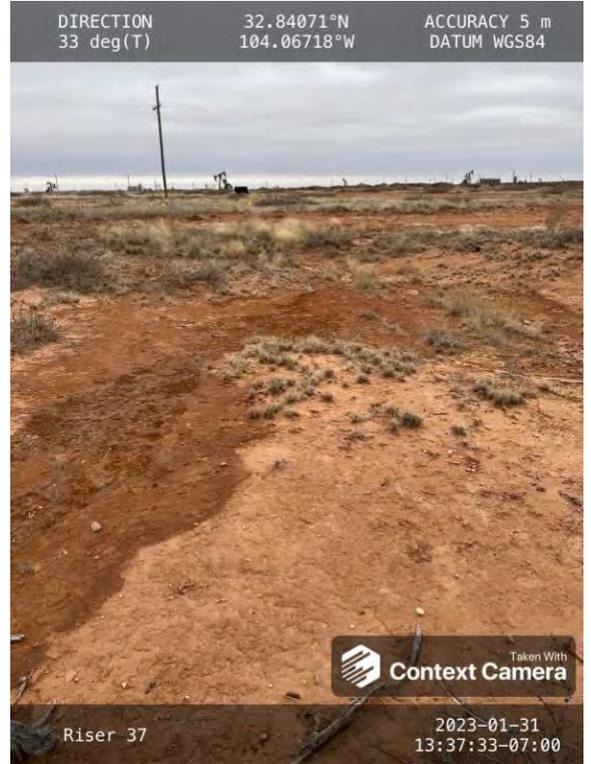
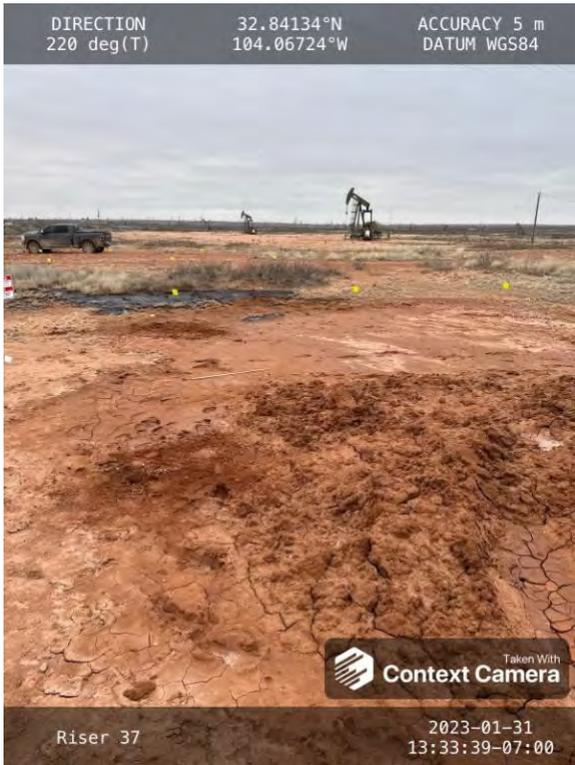
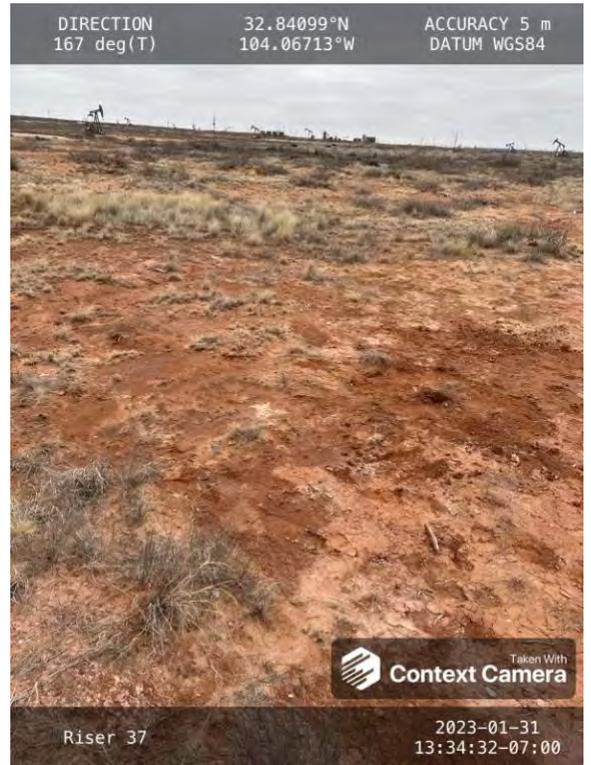
Photographic Documentation Before

Release Details			
Type of Release:	Produced Water	Volume of Release:	160 bbls
		Volume Recovered:	40 bbls
Source of Release:	Steel Line	Date of Release:	01/13/23
Was Immediate Notice Given?	Yes	If, Yes, to Whom?	OCD Online
Was a Watercourse Reached?	No	If Yes, Volume Impacting Watercourse:	N/A
Surface Owner:	State	Mineral Owner:	Unknown
A hole developed in the steel line riser releasing produced water into the right of way and the pasture.
