Release Notification and Corrective Action

Name of Company: BOPCO, L.P. **8/20/2015** Contact: Amy Ruth
Address: 522 W. Mermod, Suite 704 Carlsbad, N.M. 88220 Telephone No. 575-887-7329
Facility Name: Big Eddy Unit #156 Tank Battery Facility Type: Exploration and Production

Site Receptor Map
XTO Energy, Inc
Big Eddy Unit #156 Tank Battery
Incident Number: nAB1521254720
Unit D, Sec 11, T22S, R28E
Eddy County, New Mexico

Project: 012918074	XTO Energy, Inc. Big Eddy Unit #156 Tank Battery

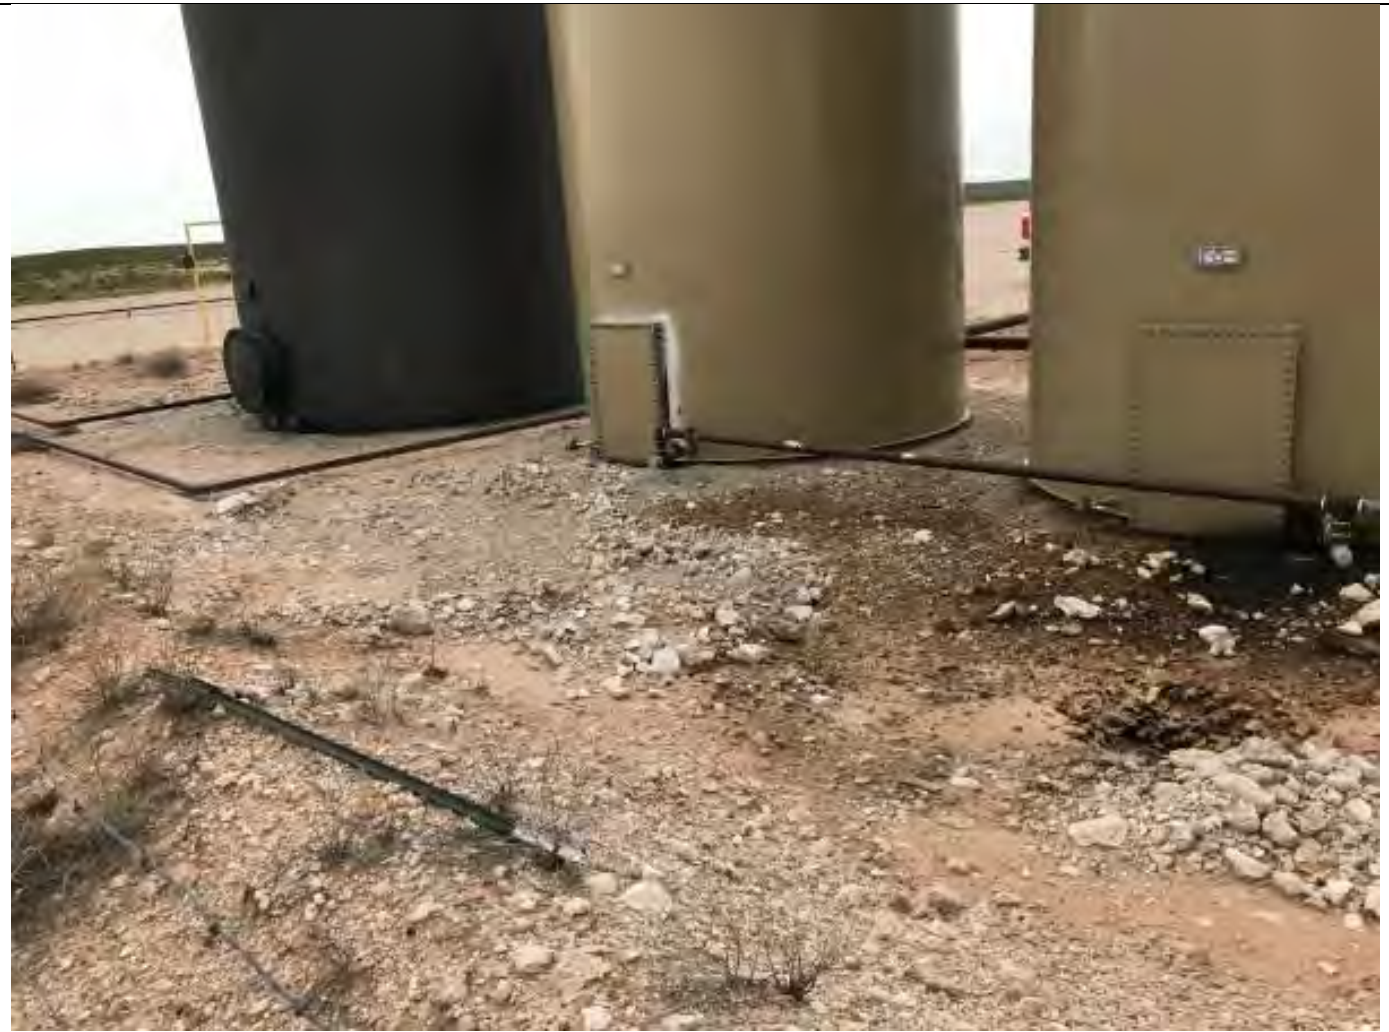
Northwestern view of the release area from the south side of tank battery prior to excavation activities.

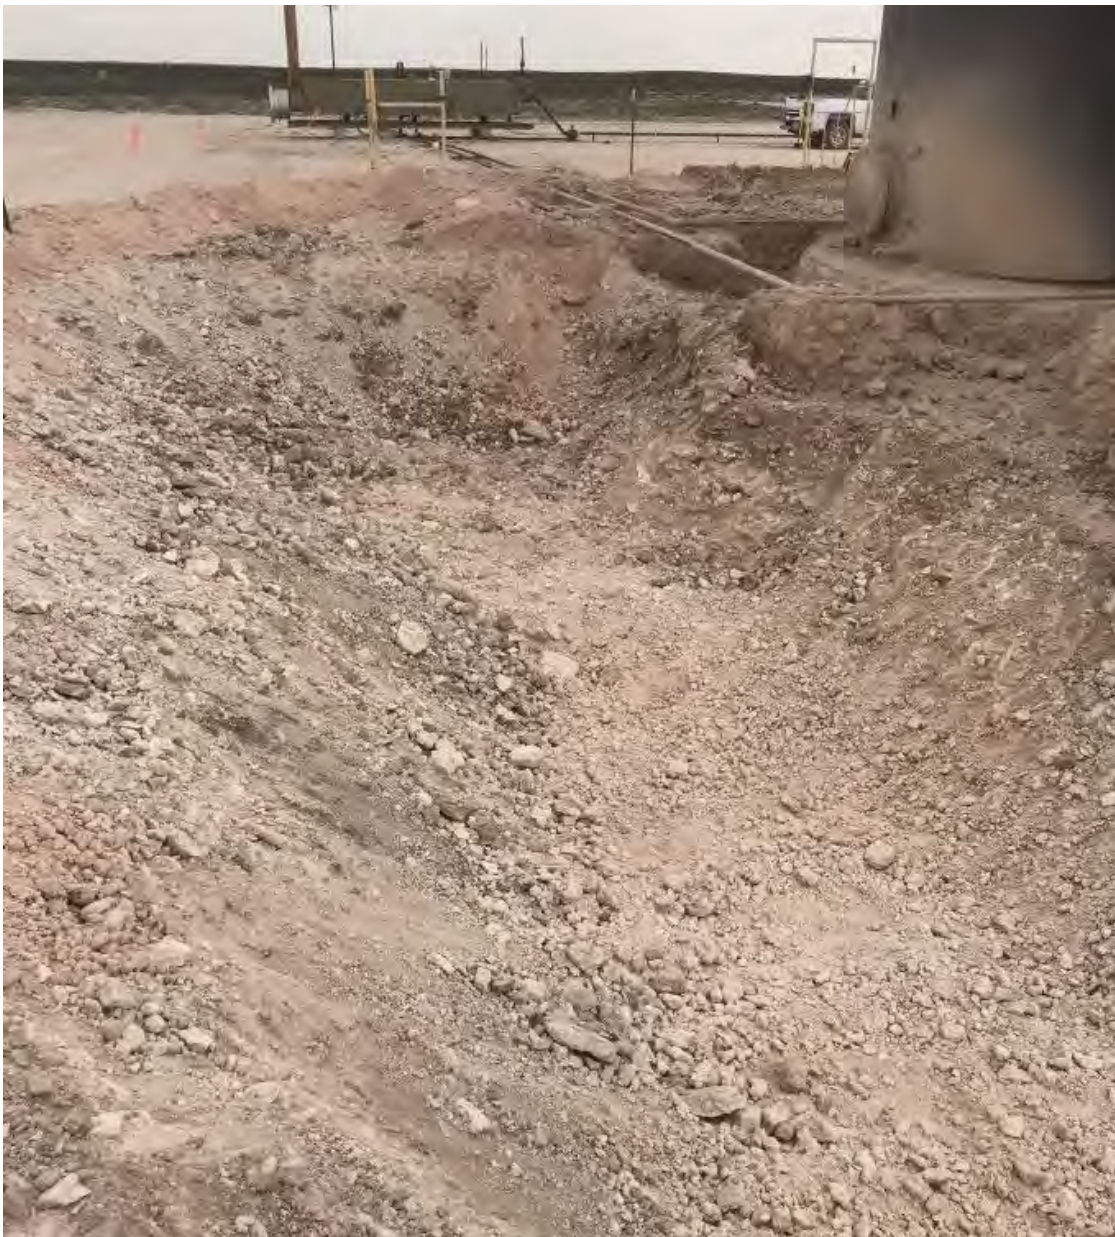
Western view of the excavation extent from the south side of the tank battery.
