Site Assessment/Characterization

Closure

Re: Site Assessment, Liner Inspection and Closure Report
Right Meow 31 CTB 7
API No. N/A
GPS: Latitude 32.265592, Longitude -103.710909
UL "B", Sec.31, T23S, R32E
Eddy County, NM
NMOCD Ref. No. NAPP2306640670

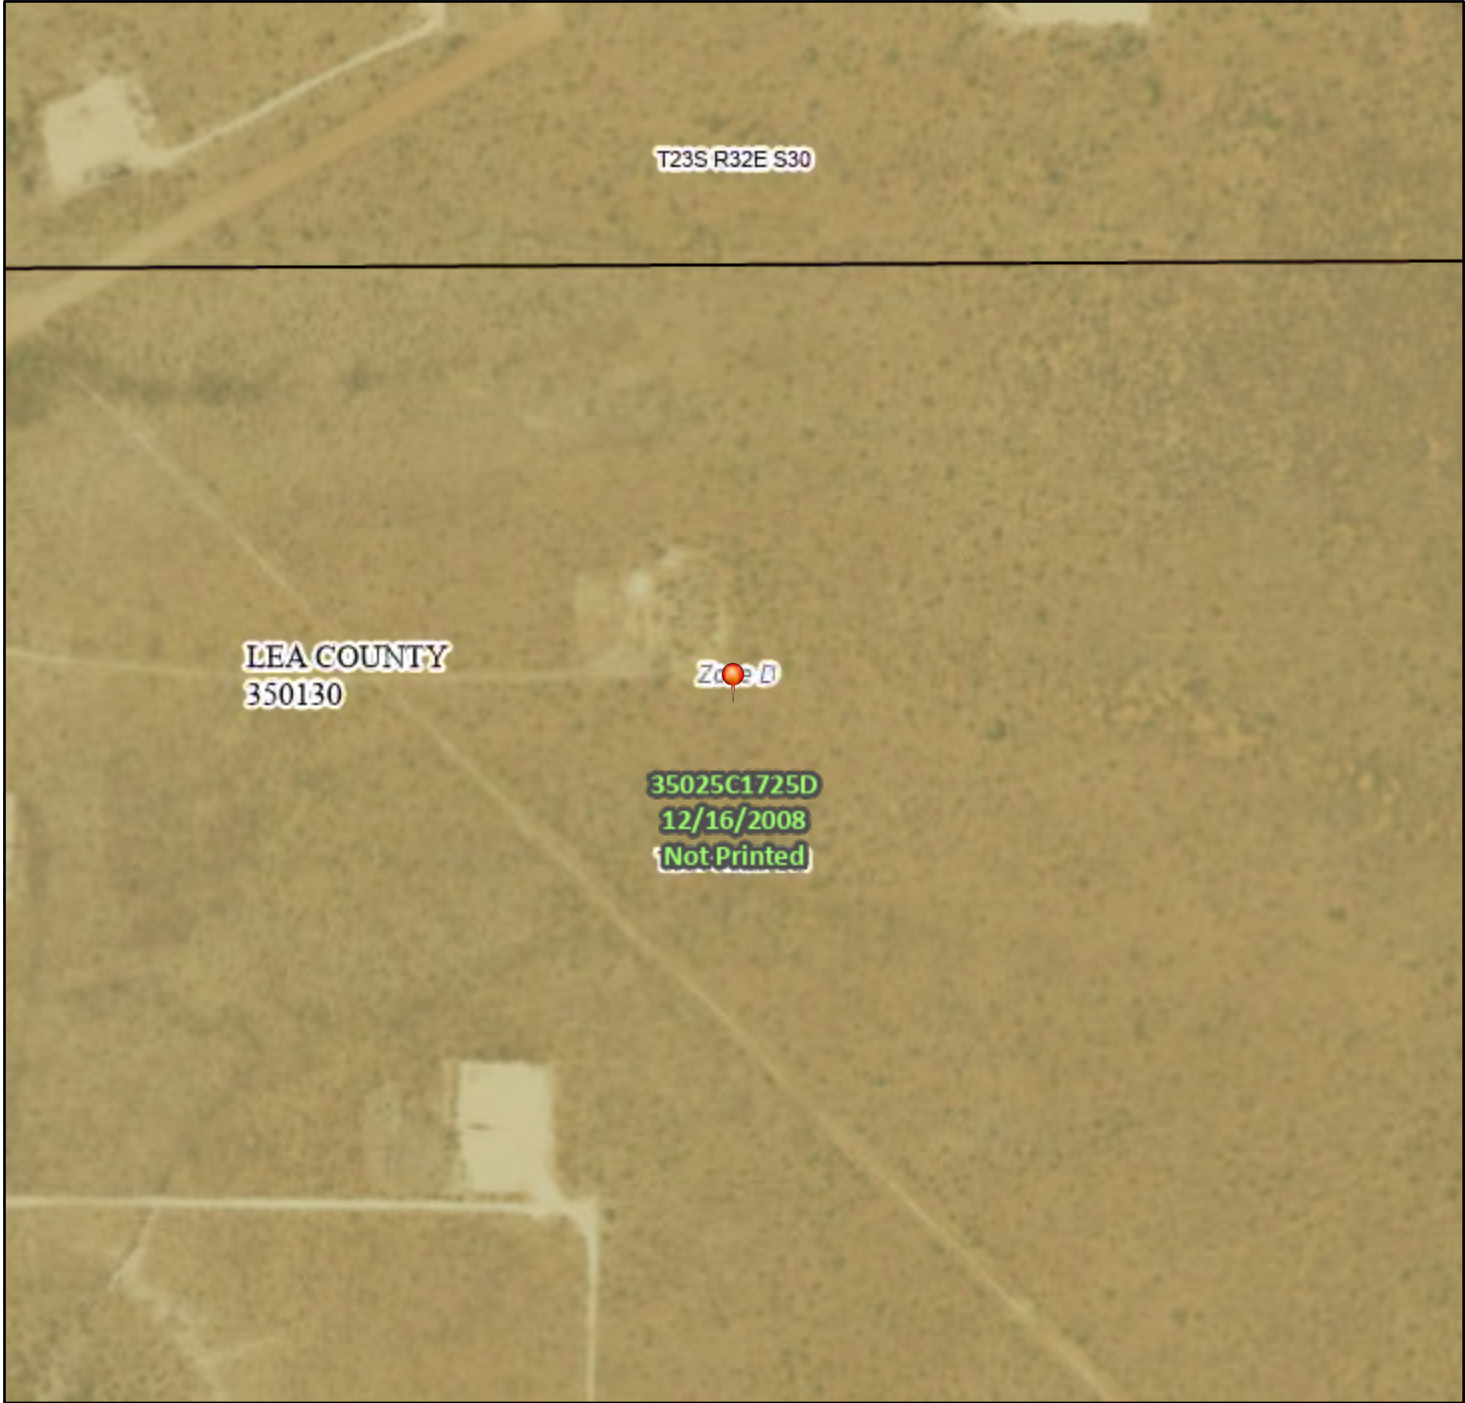
National Flood Hazard Layer FIRMette

The flood hazard information is derived directly from the authoritative NFHL web services provided by FEMA. This map was exported on 3/8/2023 at 1:37 PM and does not reflect changes or amendments subsequent to this date and time. The NFHL and effective information may change or become superseded by new data over time.

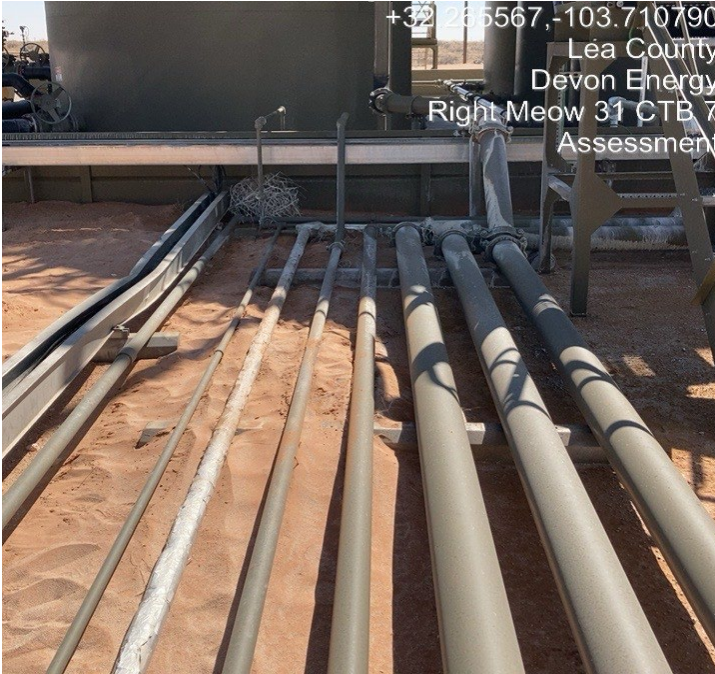
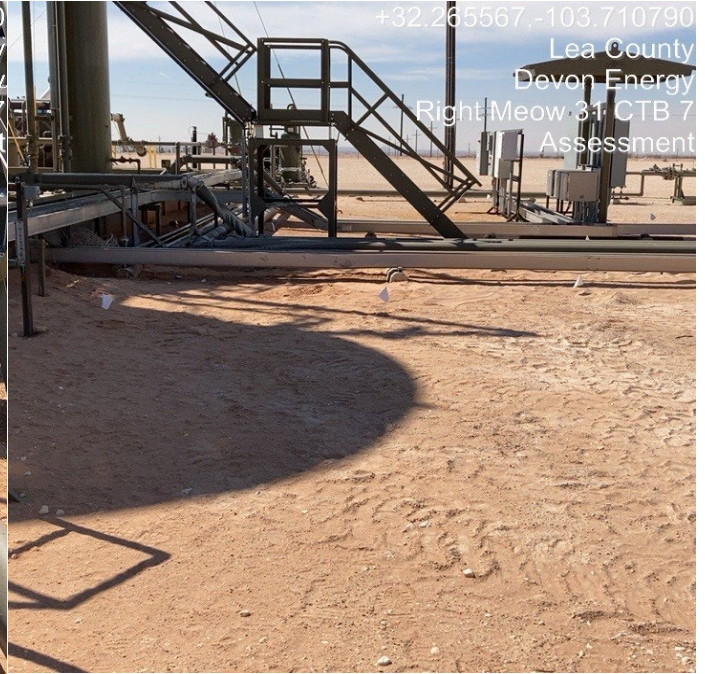
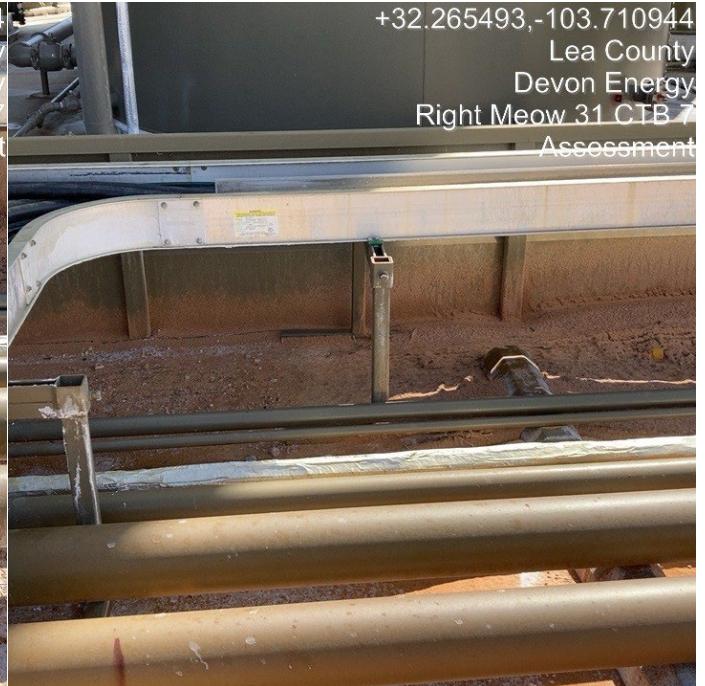
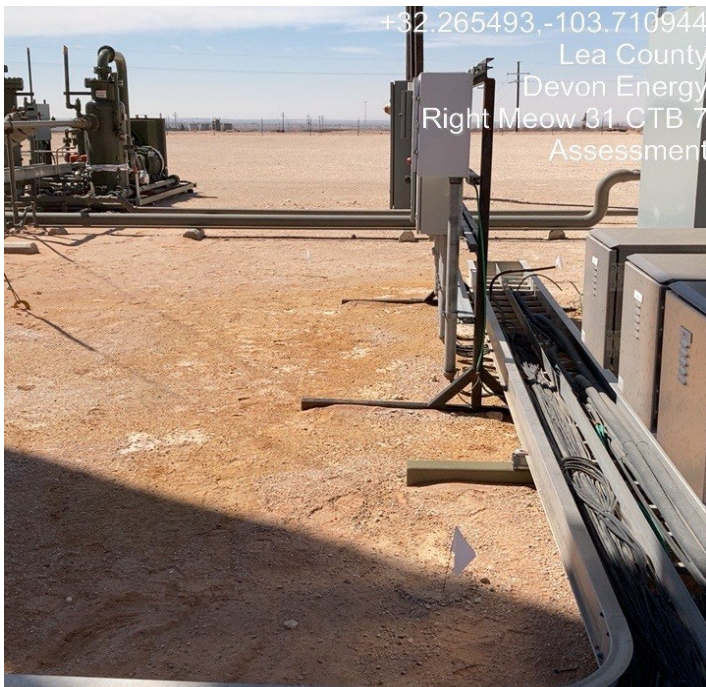
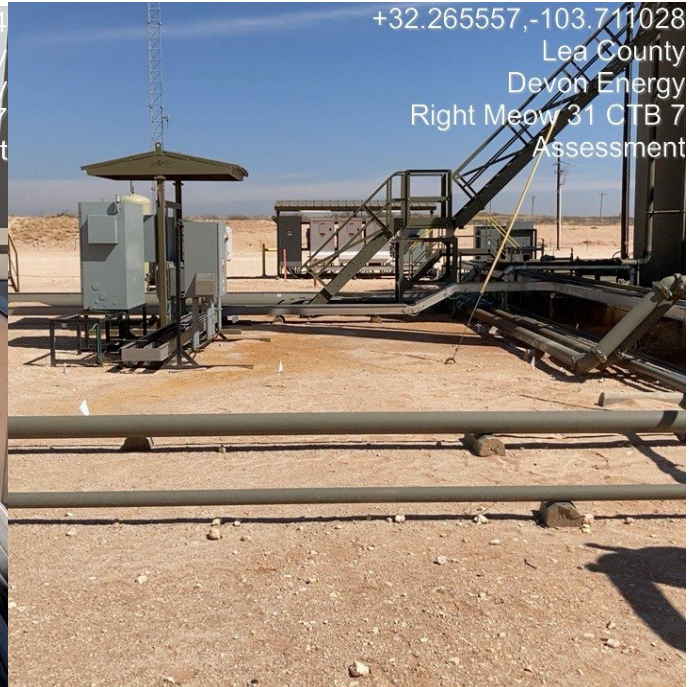
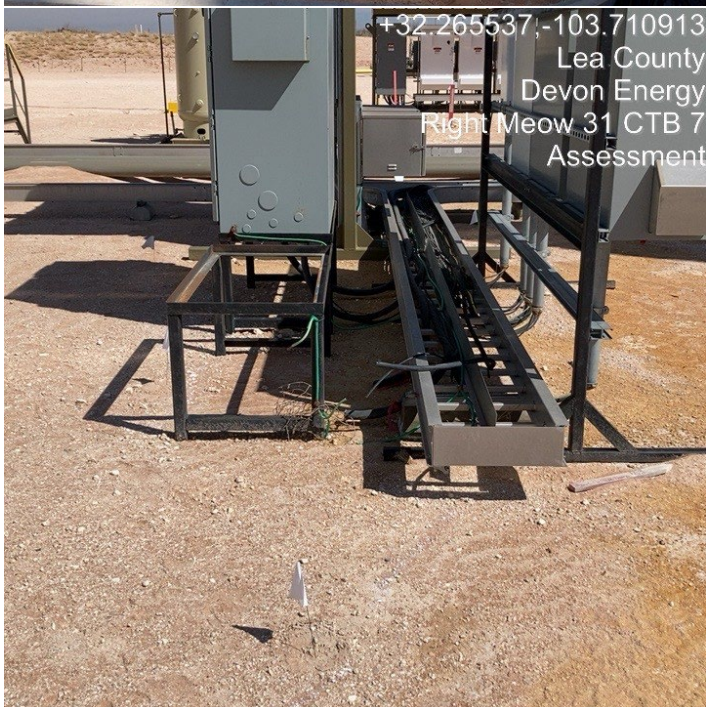
Site Assessment

On March 18, 2023, Pima mobilized personnel to the site to begin collecting soil samples from spill area. The laboratory results of this sampling event can be found in the following data table. A Site Map can be found in Figure 4.

Based on the soil sample results, the contamination levels are already less than the regulatory limits of the most stringent criteria in Table 1 of NMAC 19.15.29.1. Devon construction department will remove any surface staining as necessary.

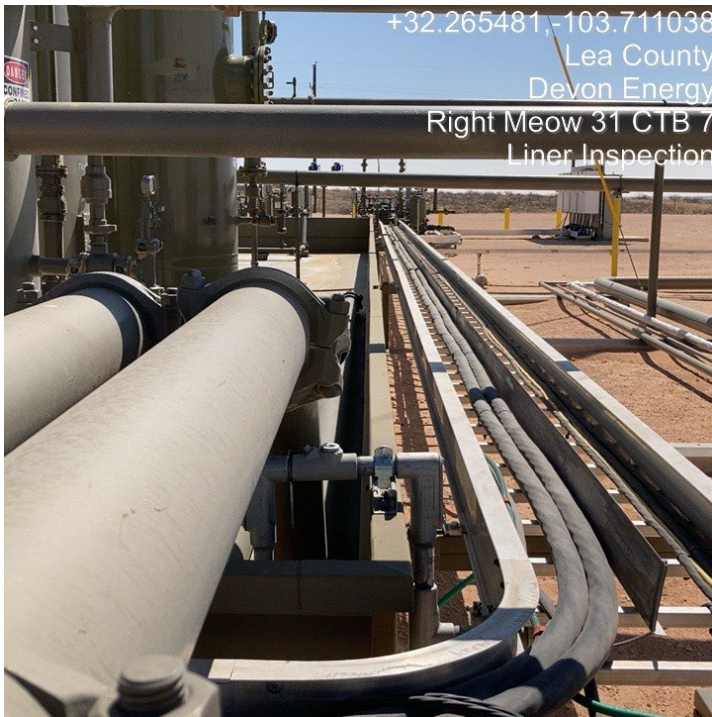
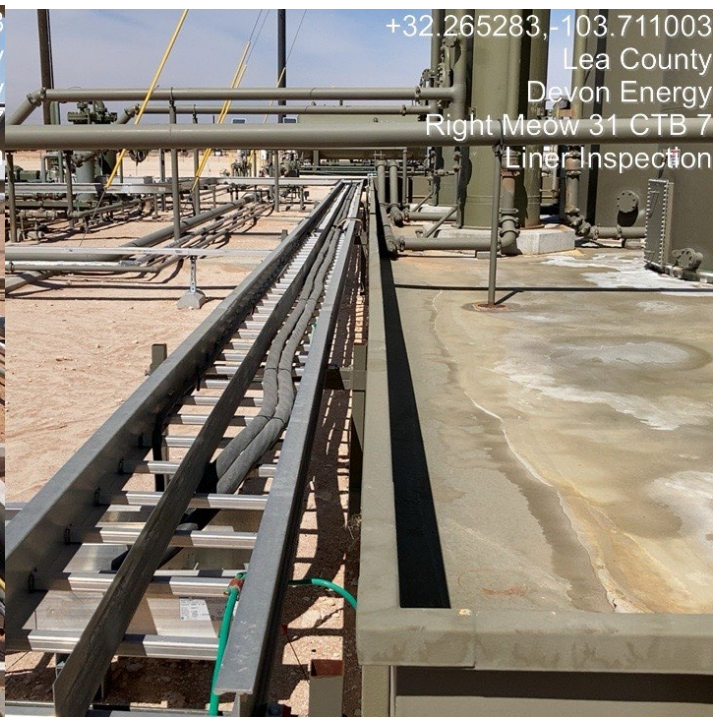
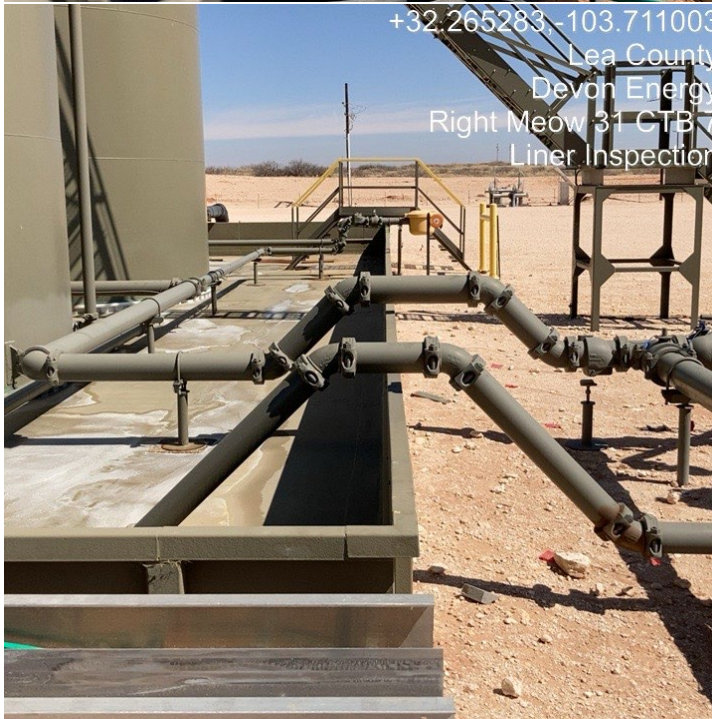
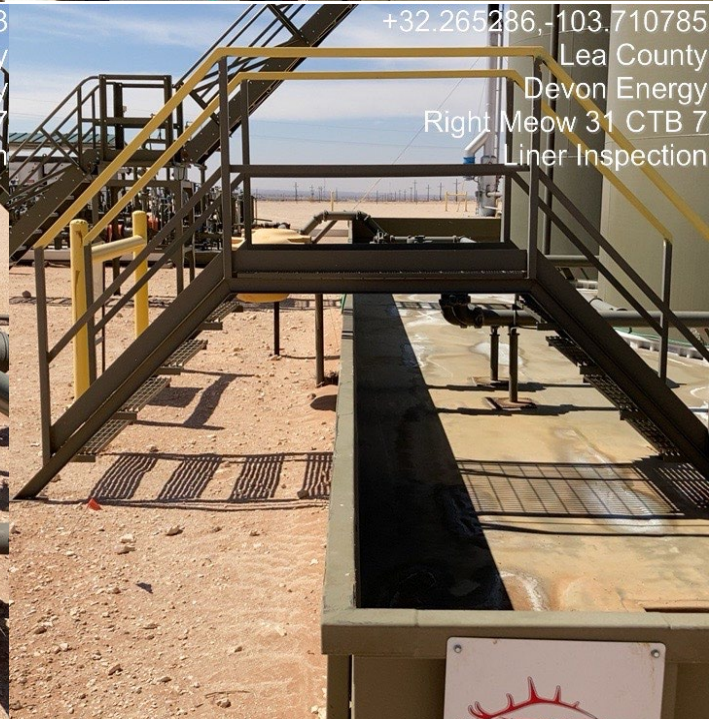
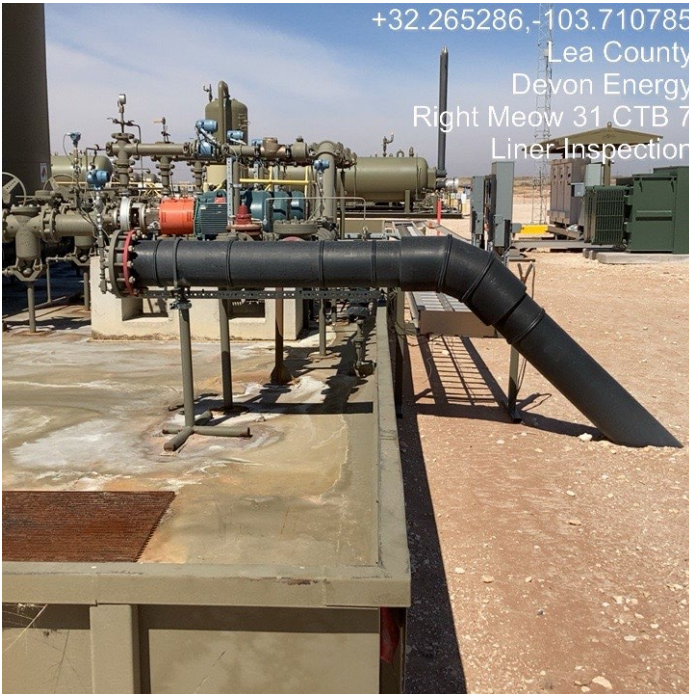
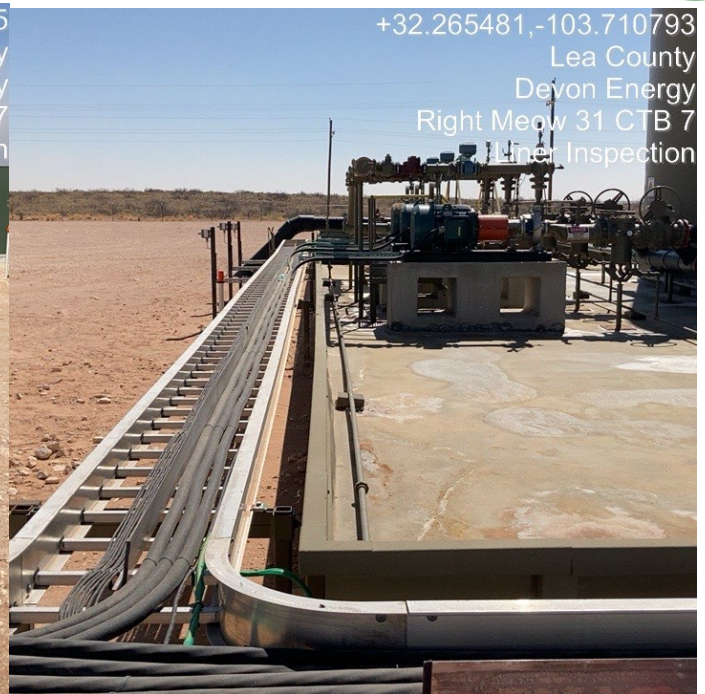
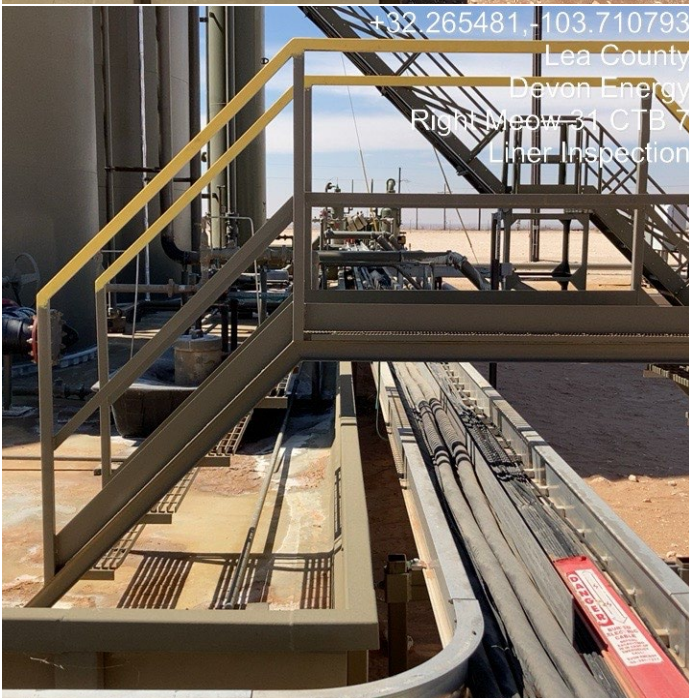
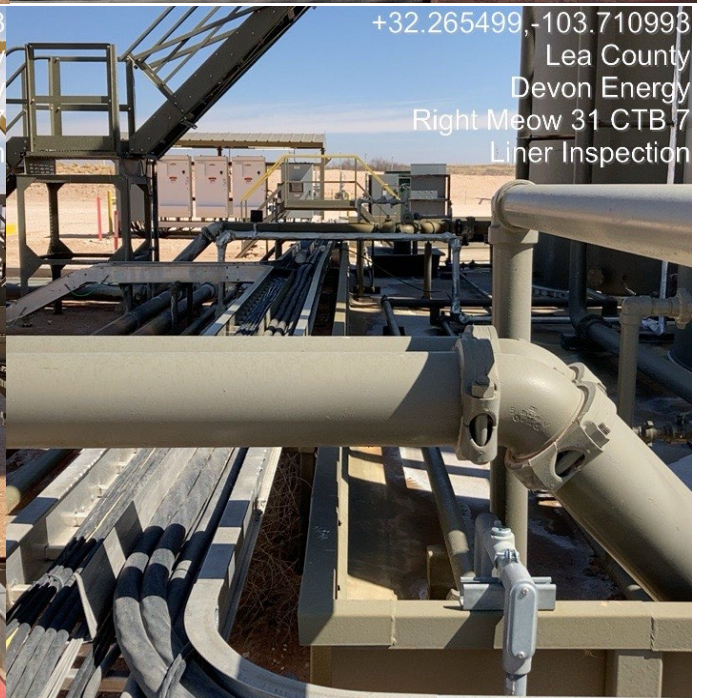
On March 11, 2023, after sending the 48-hour Notification (Appendix C) via email, Pima Environmental conducted a liner inspection at this location. We concluded that this liner and containment maintained its integrity and was able to retain the fluids. The Liner Inspection Form and photographic documentation can be found in Appendix D. Laboratory Reports can be found in Appendix E.
