Assessment and Closure Closure

Sawbuck Water Transfer Section 23, Township 20 South, Range 24 East County: Eddy Vertex File Number: 22E-00123-03

Prepared for: EOG Resources, Inc.

Prepared by: Vertex Resource Services Inc.

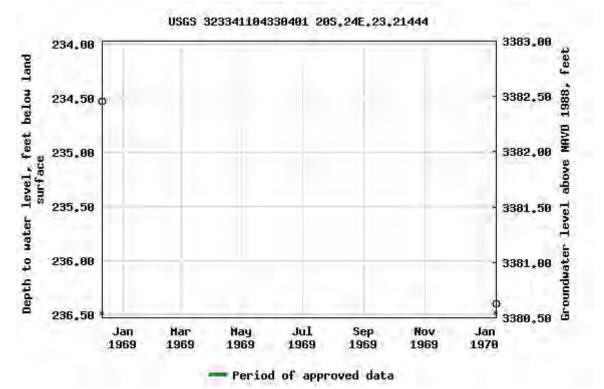
This well is completed in the Rustler Formation (312RSLR) local aquifer.

Breaks in the plot represent a gap of at least one year between field measurements. <u>Download a presentation-quality graph</u>
