**Closure Report**  
**Hornsby 35 Federal Com #003H**  
**Incident ID: NAB1530140875**  
**Eddy County, New Mexico**  
**Unit E Sec 35 T26S R27E**  
**32.0005684°, -104.1651154°**

**Point of Release:**  
**Poly line ruptured due to pressure.**  
**Release Date: 07/26/2015**  
**Volume Released: 59 Barrels of Produced Water**  
**Volume Recovered: 55 Barrels of Produced Water**

**Re: Closure Report**  
**Hornsby 35 Federal Com #003H**  
**Incident ID: NAB1530140875**  
**Cimarex Energy Co.**  
**Site Location: Unit E, S35, T26S, R27E**  
**(Lat 32.0005684°, Long -104.1651154°)**  
**Eddy County, New Mexico**

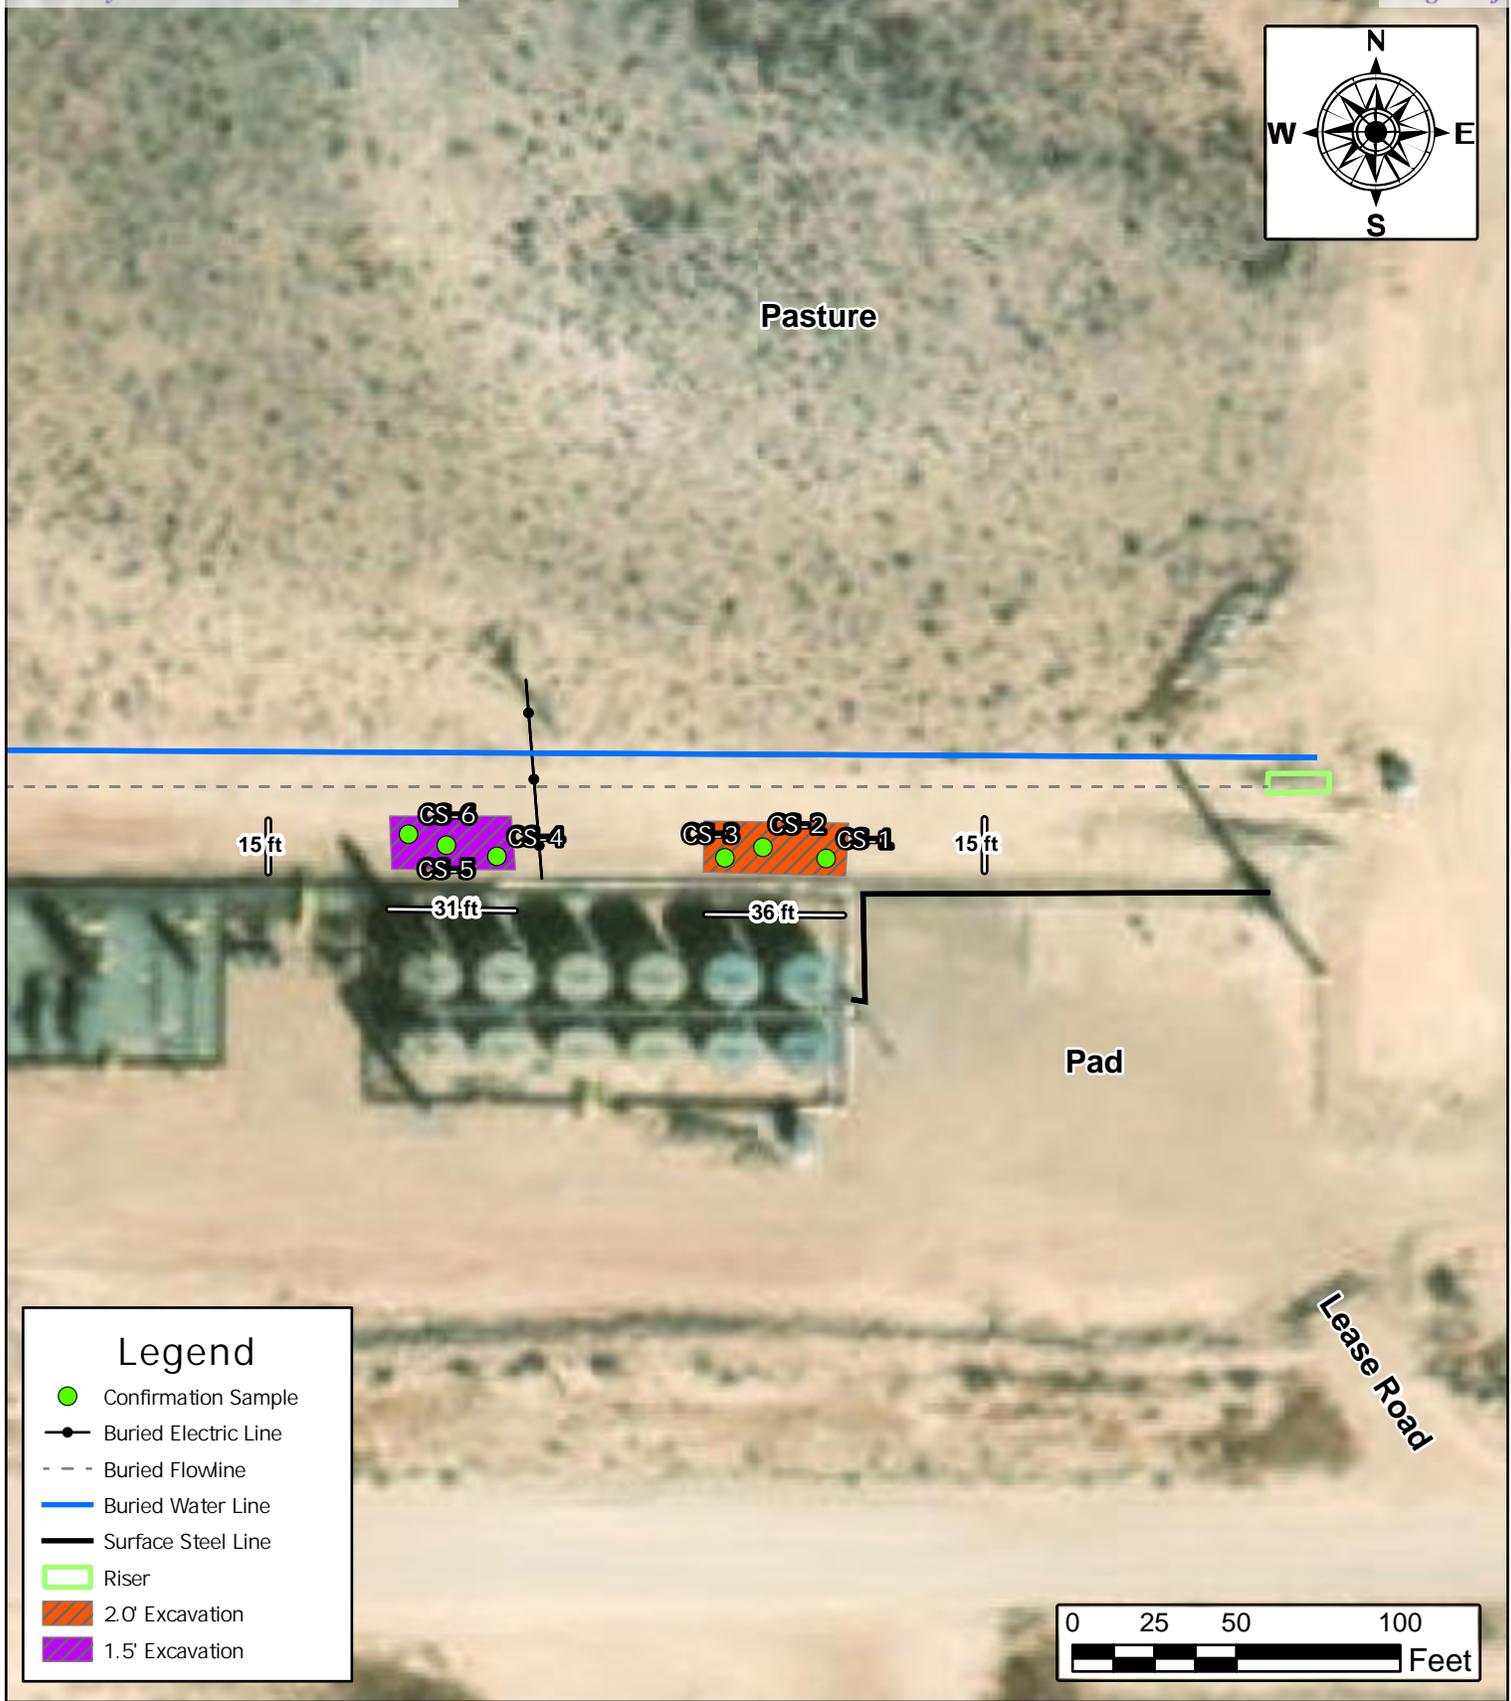
DRAWING NUMBER:  
**FIGURE 4A**

- Confirmation Sample
- Buried Electric Line
- Buried Flowline
- Buried Water Line
- Surface Steel Line
- Riser
- 2.0' Excavation
- 1.5' Excavation

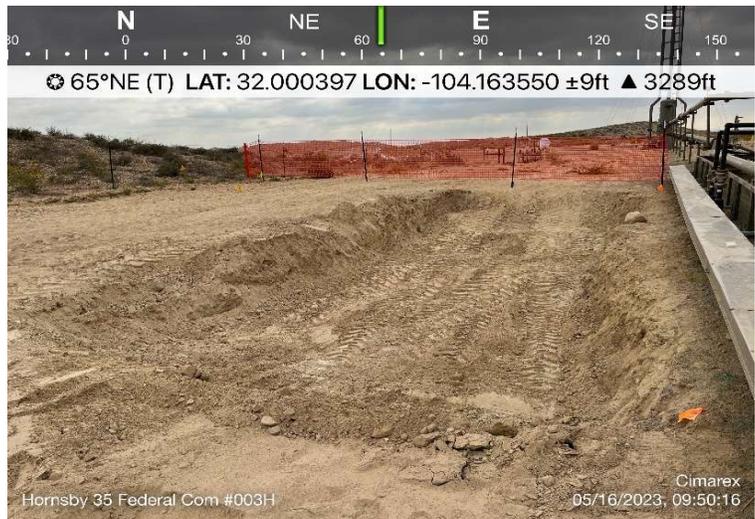
View Northeast, area of CS-1 through CS-3.

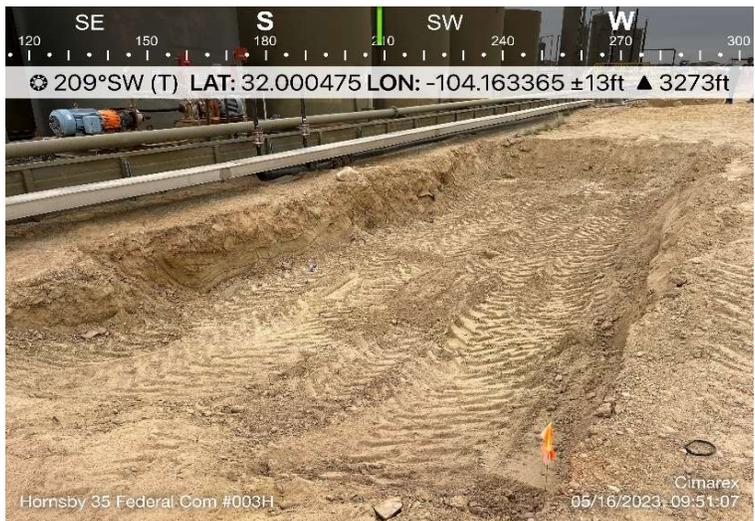
## Photograph No. 2

View Southwest, area of CS-1 through CS-3.

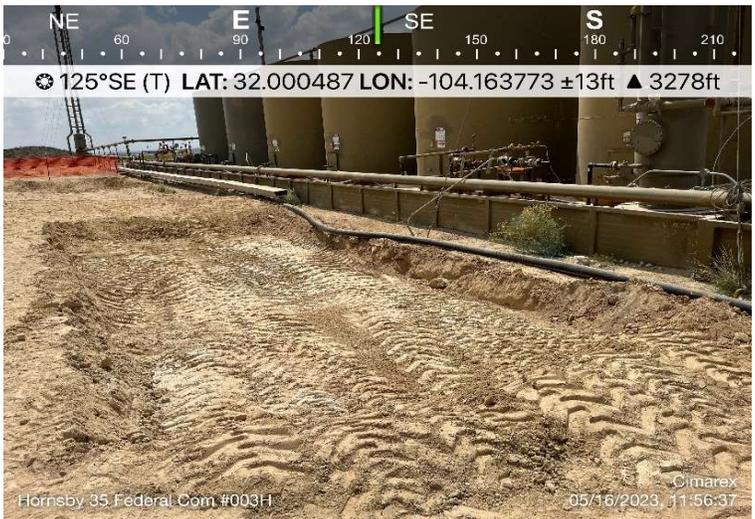
## Photograph No. 3

View Southeast, area of CS-4 through CS-6.
