# CLOSURE REQUEST REPORT

**Benson Shugart Waterflood Unit #015  
Eddy County, New Mexico  
Incident Number nMLB0526441458**

**Prepared For:  
Chevron USA, Inc.  
6301 Deauville Blvd.  
Midland, TX 79706**

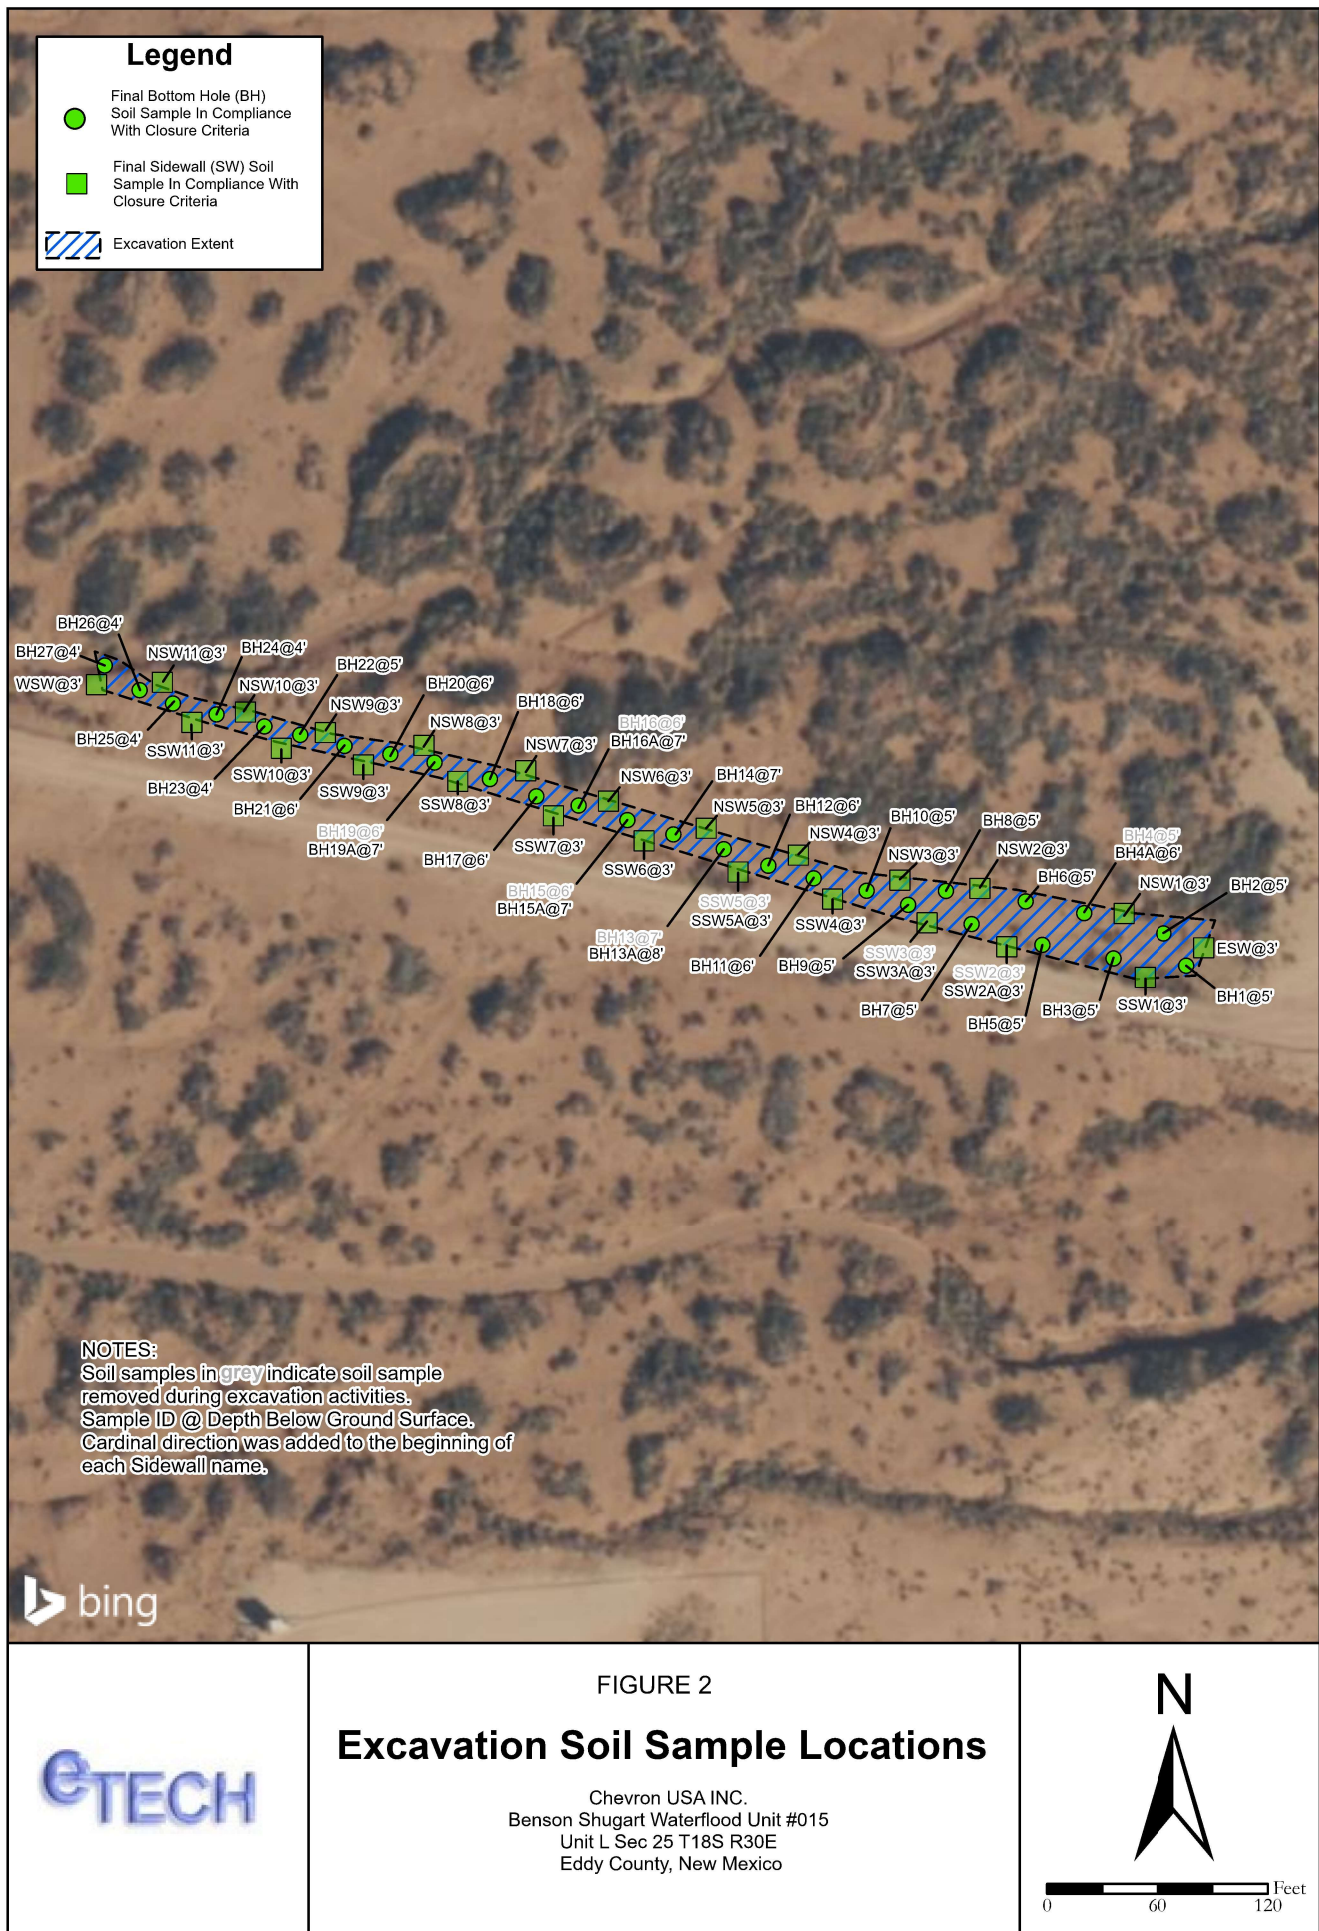
Following the removal of soil, Etech collected 5-point composite confirmation excavation soil samples at a sampling frequency of 200 square feet from the excavation floor and sidewalls. The 5-point composite samples were comprised of five equivalent aliquots homogenized in a 1-gallon, resealable plastic bag. Each sidewall sample depth represents the approximate average depth from which the five aliquots were collected. Floor samples were collected from a depth range of 4 feet and 8 feet bgs. The samples were then placed into lab provided pre-cleaned glass jars, packaged with minimal void space, labeled, and immediately placed on ice. The soil samples were transported under strict chain-of-custody procedures to Permian Basin Environmental Laboratory (PBELAB) in Midland, Texas, for analysis of COCs. The location of confirmation excavation soil samples is shown in **Figure 2** in **Appendix A**.

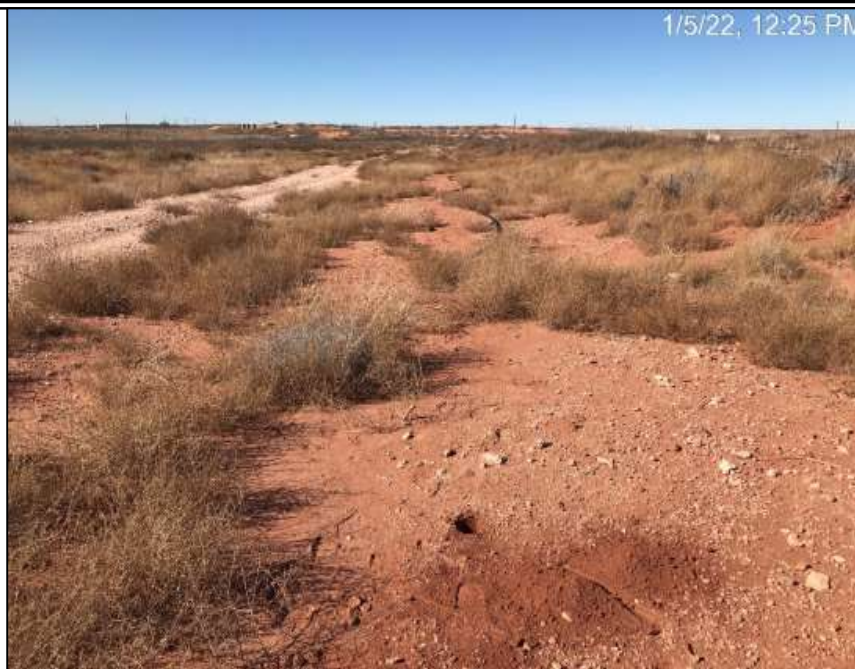
**Photograph 1****Date: 01/05/2022**

Description: Western view during Site assesment and delineation event.

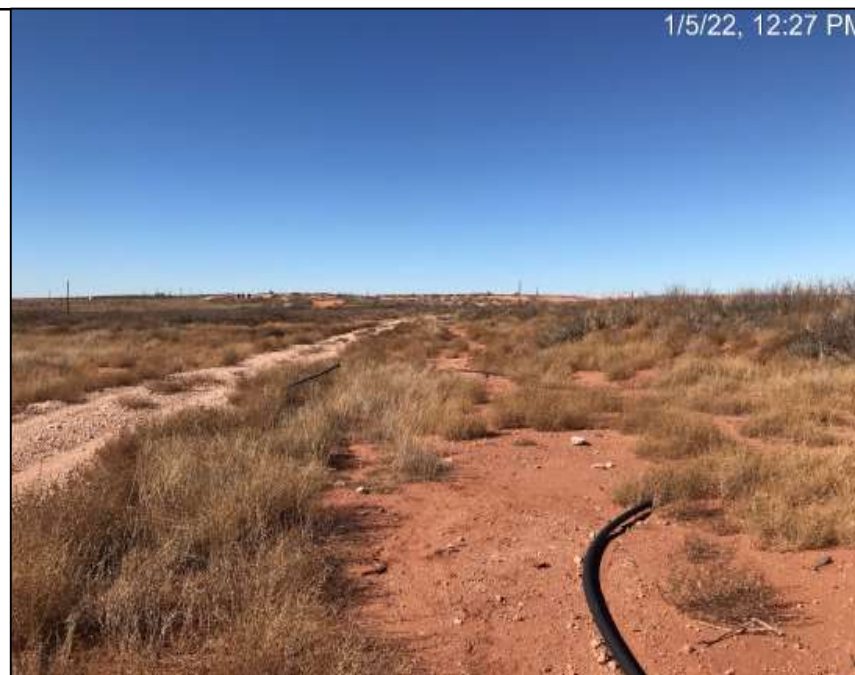
**Photograph 2****Date: 01/05/2022**

Description: Western view during Site assesment and delineation event.

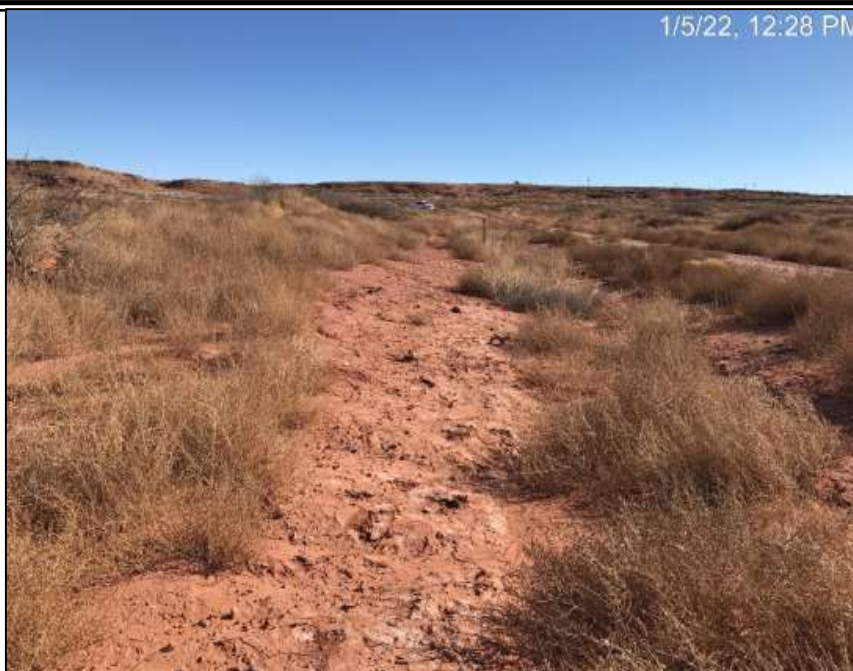
**Photograph 3****Date: 01/05/2022**

Description: Eastern view during Site assessment and delineation event.

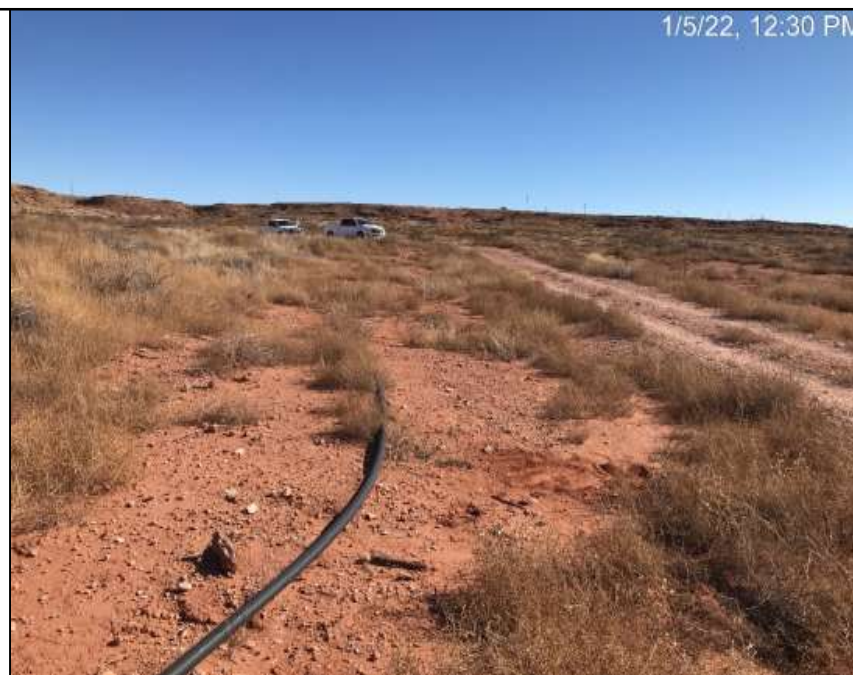
**Photograph 4****Date: 01/05/2022**

Description: Eastern view during Site assessment and delineation event.

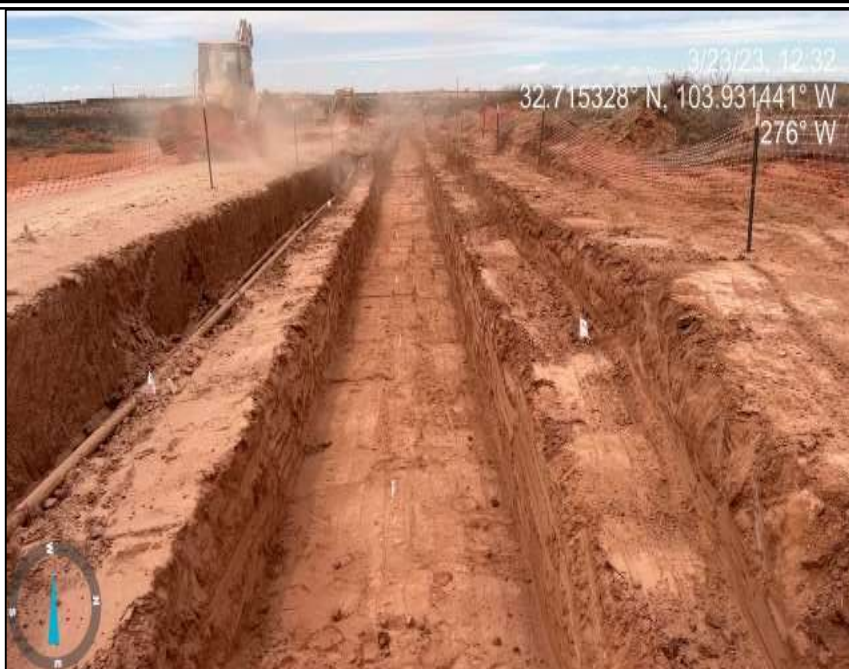
**Photograph 5****Date: 03/23/2023**

Description: Western view during excavation activities.

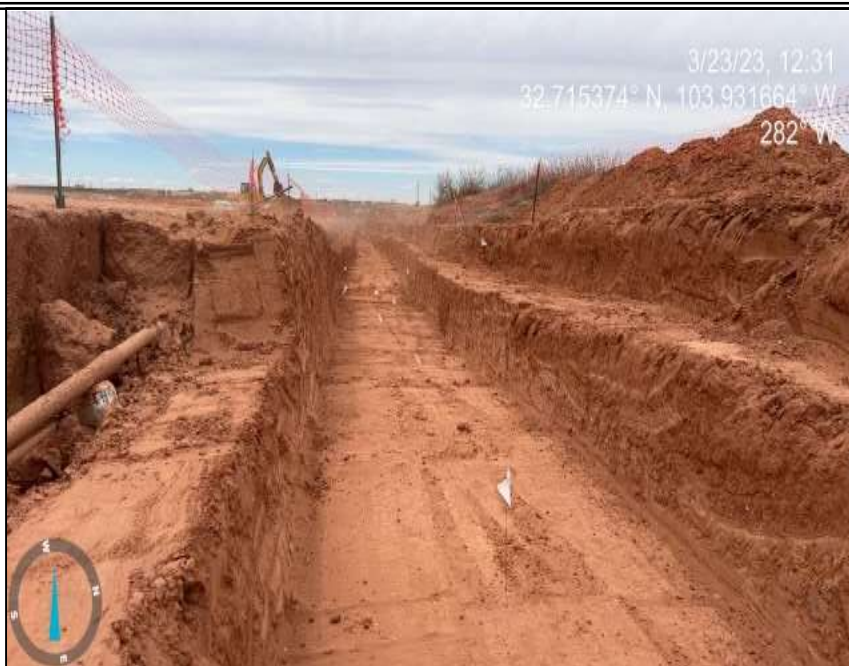
**Photograph 6****Date: 03/23/2023**

Description: Western view during excavation activities.

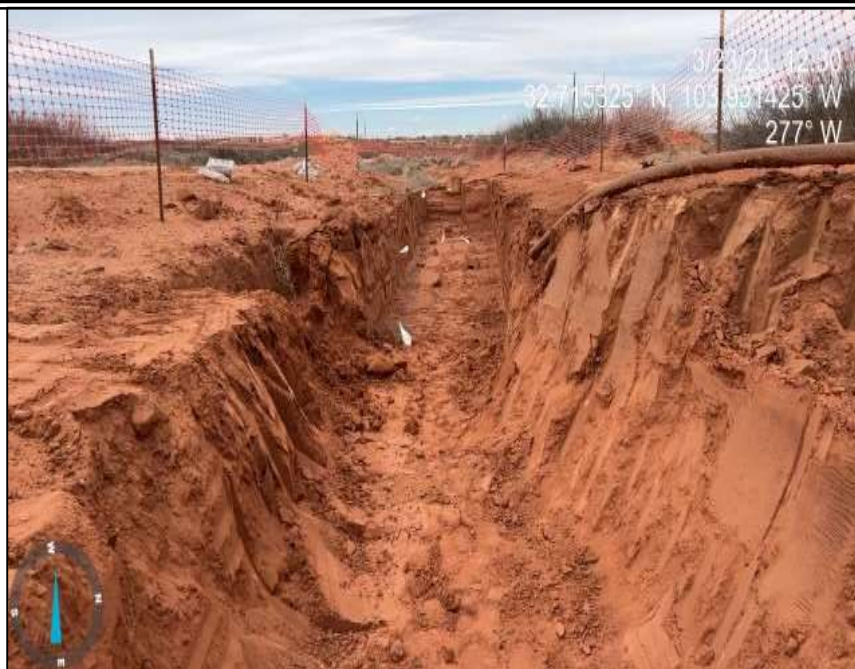
**Photograph 7****Date: 03/23/2023**

Description: Western view during excavation activities.

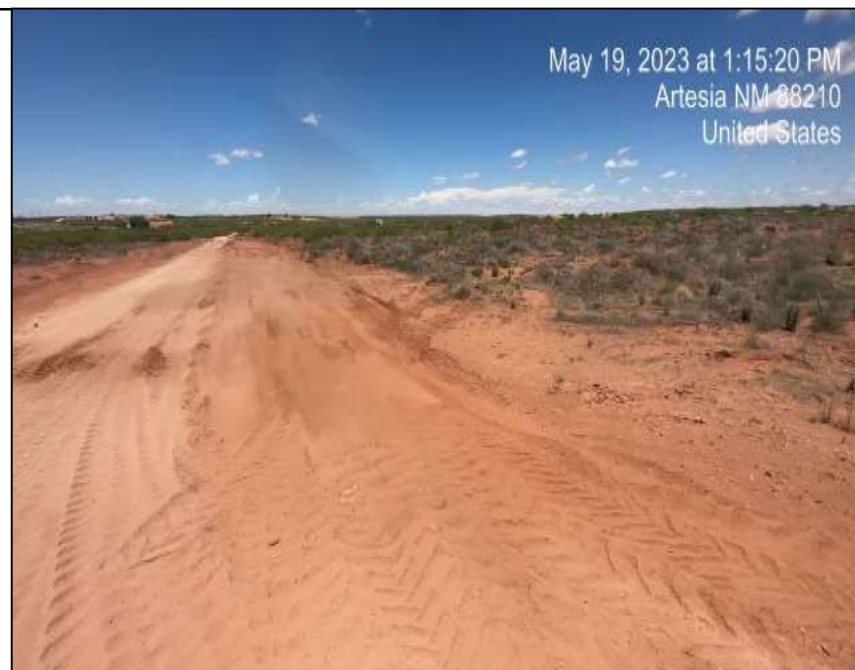
**Photograph 8****Date: 05/19/2023**

Description: Western view following remediation activities.

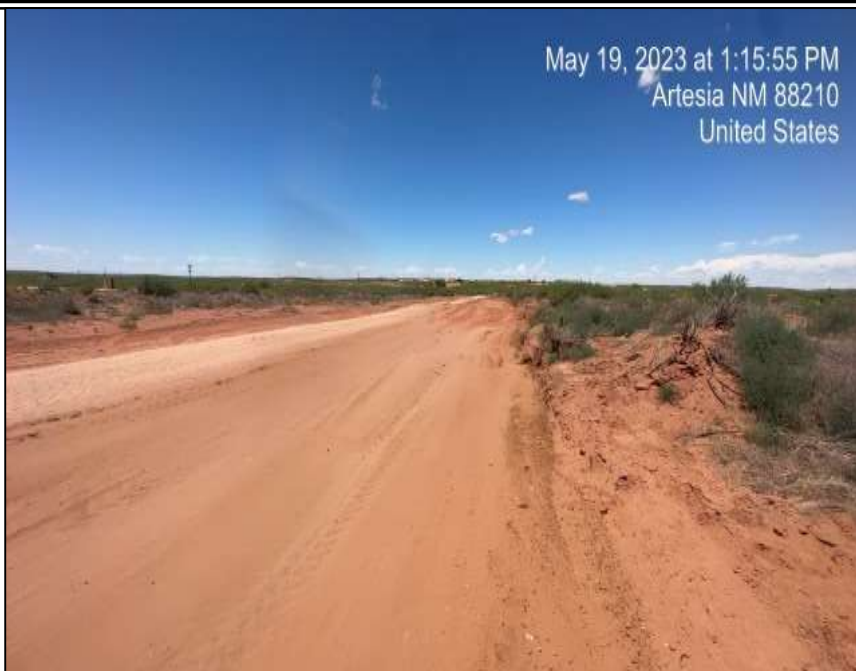
**Photograph 9****Date: 05/19/2023**

Description: Western view following remediation activities.

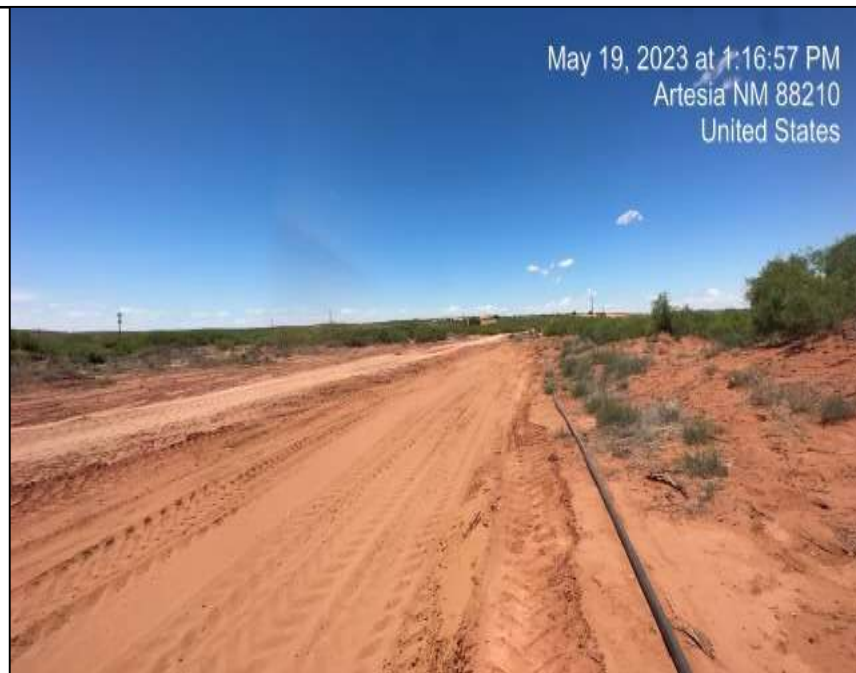
**Photograph 10****Date: 05/19/2023**

Description: Western view following remediation activities.

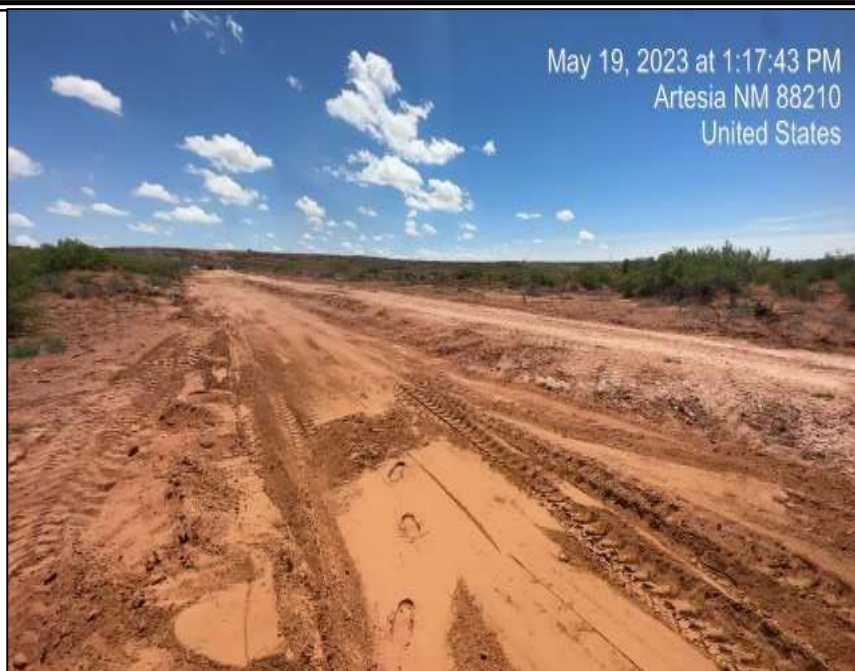
**Photograph 11****Date: 05/19/2023**

Description: Eastern view following remediation activities.

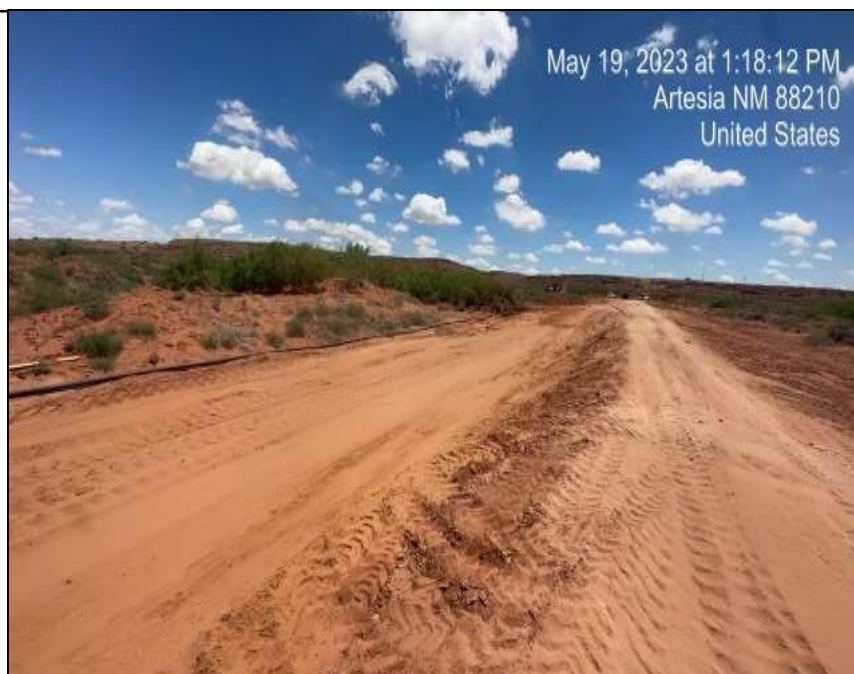
**Photograph 12****Date: 05/19/2023**

Description: Eastern view following remediation activities.

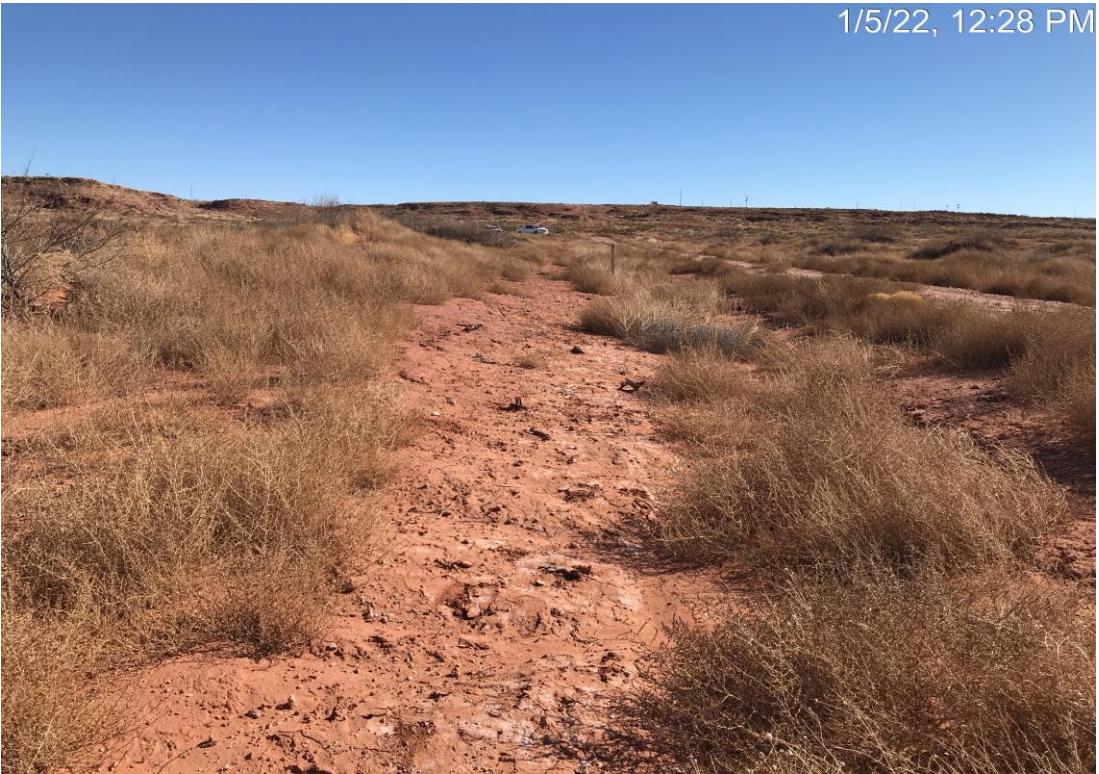
| <b>Photo No:</b><br><b>3.</b> | <p>1/5/22, 12:28 PM</p> |

| <b>Direction Taken:</b><br><br>East | |
| <b>Description:</b><br><br>View during assessment and delineation event. | |

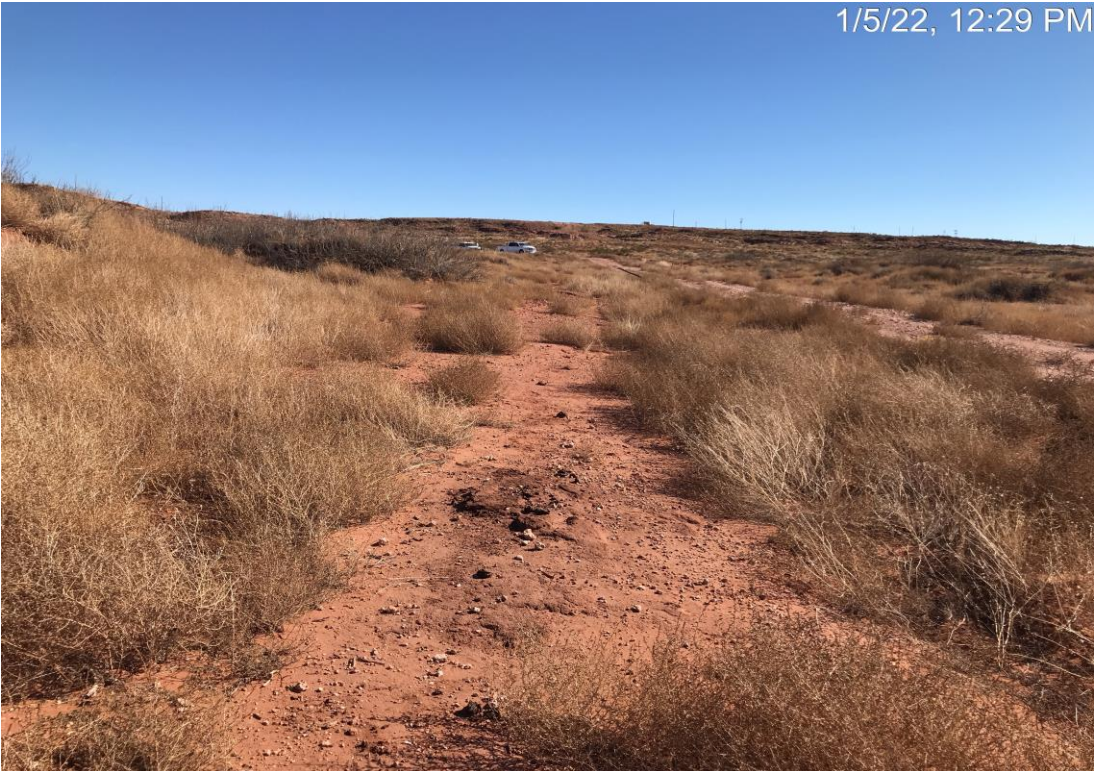
| <b>Photo No:</b><br><b>4.</b> | <p>1/5/22, 12:29 PM</p> |

| <b>Direction Taken:</b><br><br>East | |
| <b>Description:</b><br><br>View during assessment and delineation event. | |
