August 25, 2023

**Re: Closure Report
ConocoPhillips - Heritage COG Operating, LLC
Roy Batty Federal Com #003H Flange Release
Unit Letter O, Section 11, Township 24 South, Range 33 East
Lea County, New Mexico
Incident ID# NOY1811735138
1RP-5029**

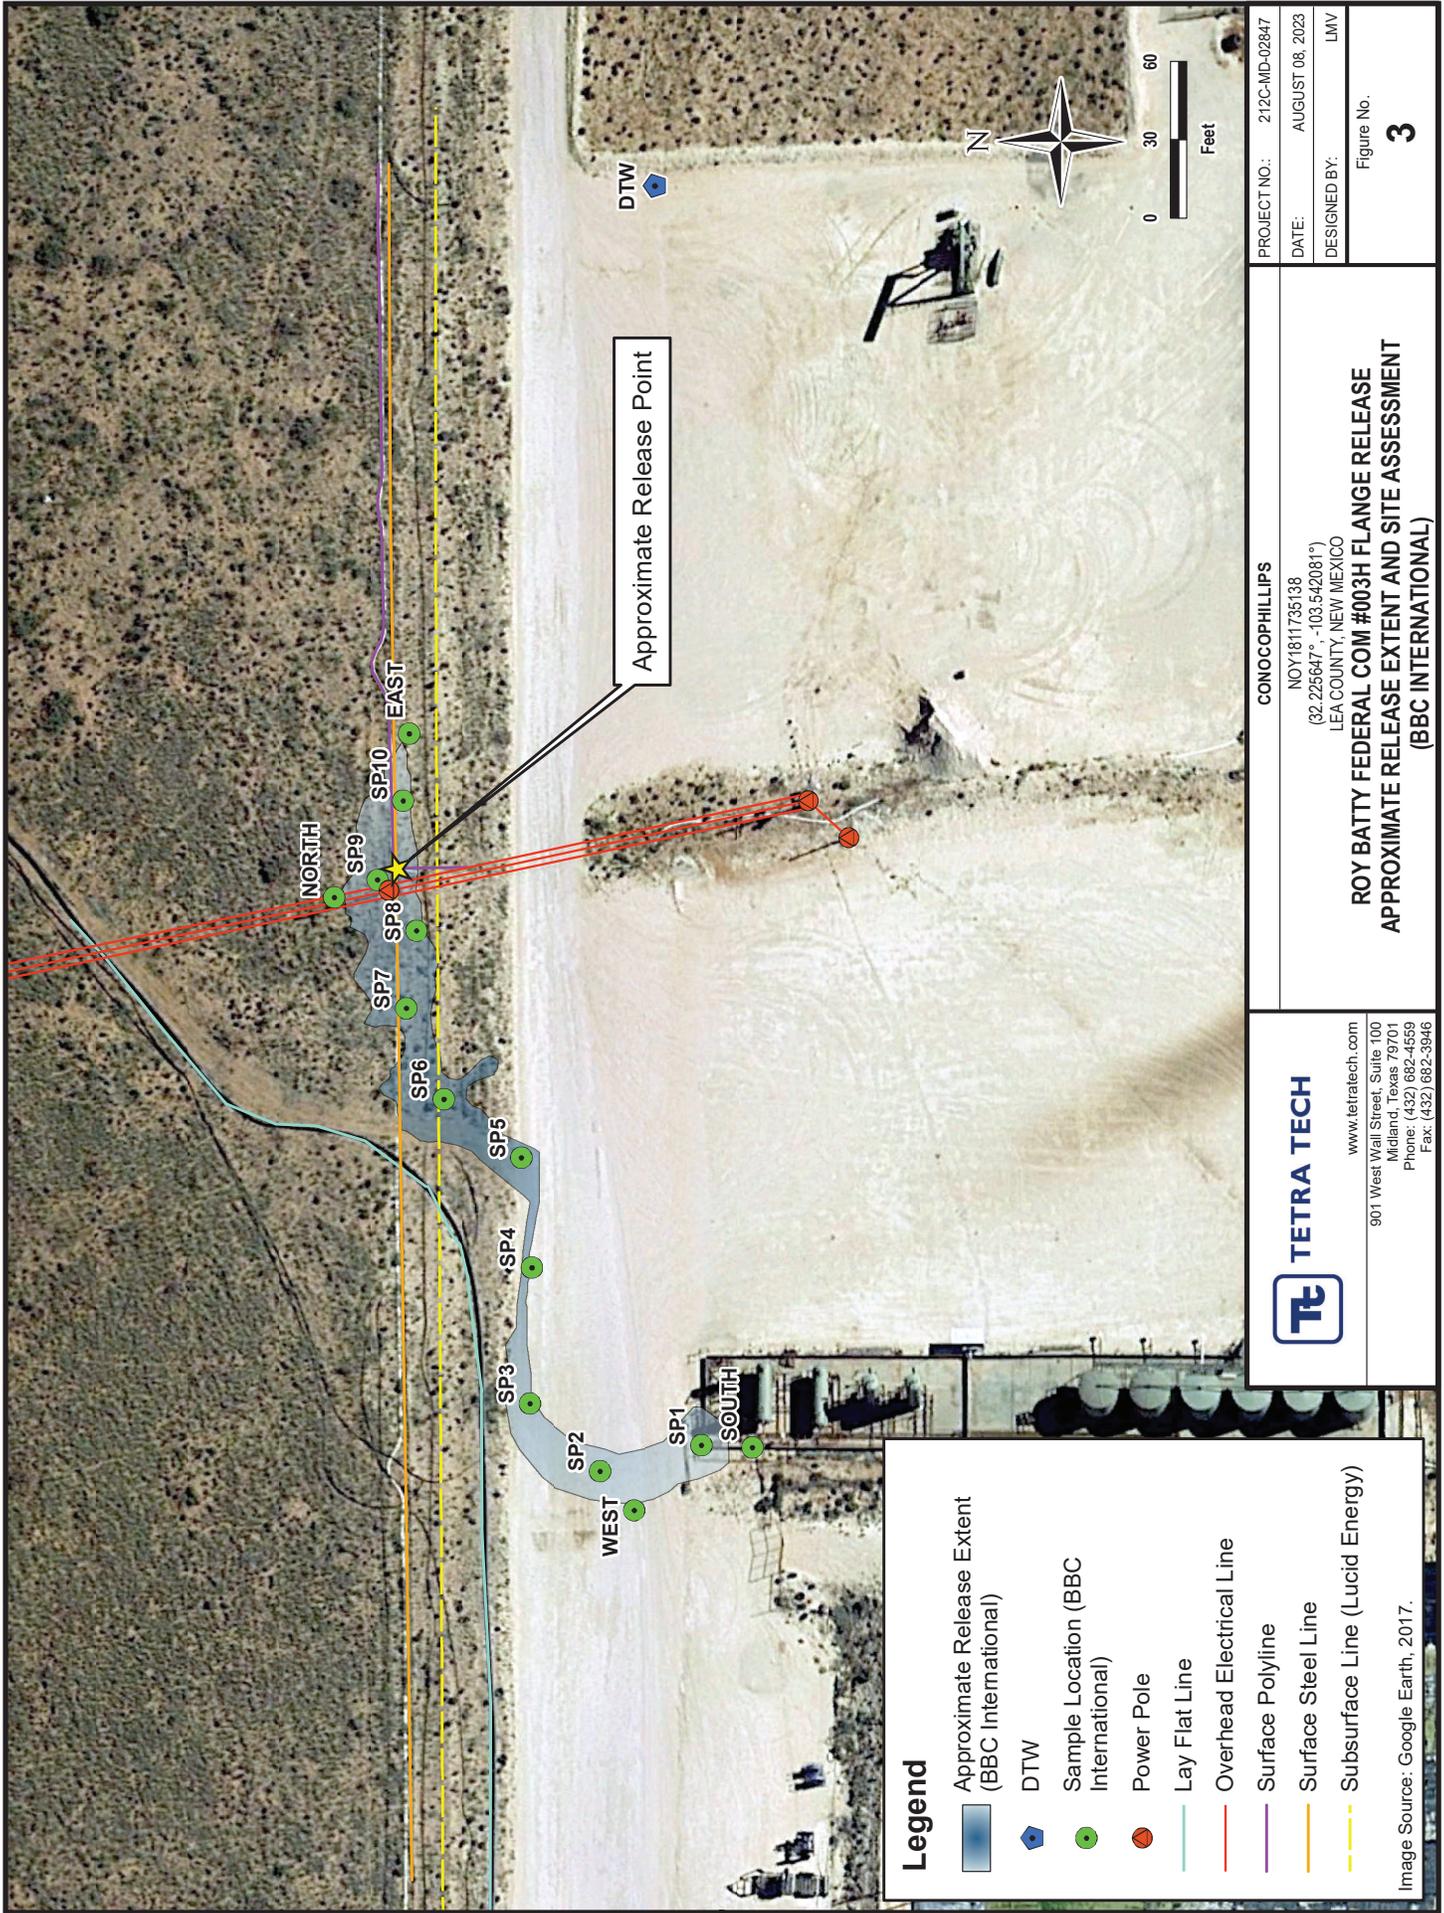
PROJECT NO.: 212C-MD-02847
 DATE: AUGUST 08, 2023
 DESIGNED BY: LMV
 Figure No. **3**

CONOCOPHILLIPS
 NOY1811735138
 (32.225647°, -103.542081°)
 LEA COUNTY, NEW MEXICO
**ROY BATTY FEDERAL COM #003H FLANGE RELEASE
 APPROXIMATE RELEASE EXTENT AND SITE ASSESSMENT
 (BBC INTERNATIONAL)**

According to information provided by COPC, BBC International, Incorporated (BBC) was initially contracted to map the extent and sample the release footprint and the surrounding area. Based upon the mapped initial extent provided by BBC, the release footprint was approximately 6,050 square feet of lease pad, lease road and adjacent pastureland.

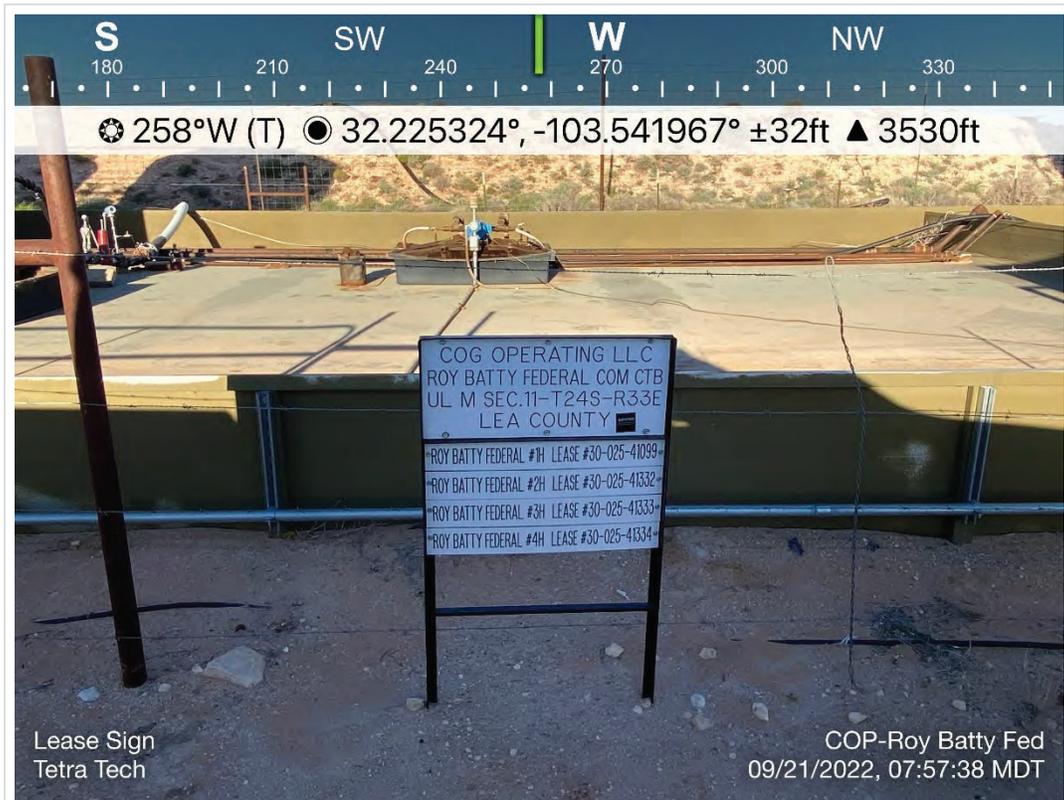
TETRA TECH, INC. PROJECT NO. 212C-MD-02847	DESCRIPTION	Site signage and location information; Roy Batty Federal Com CTB.	1
	SITE NAME	ConocoPhillips Roy Batty Fed Com #003H	9/21/2022

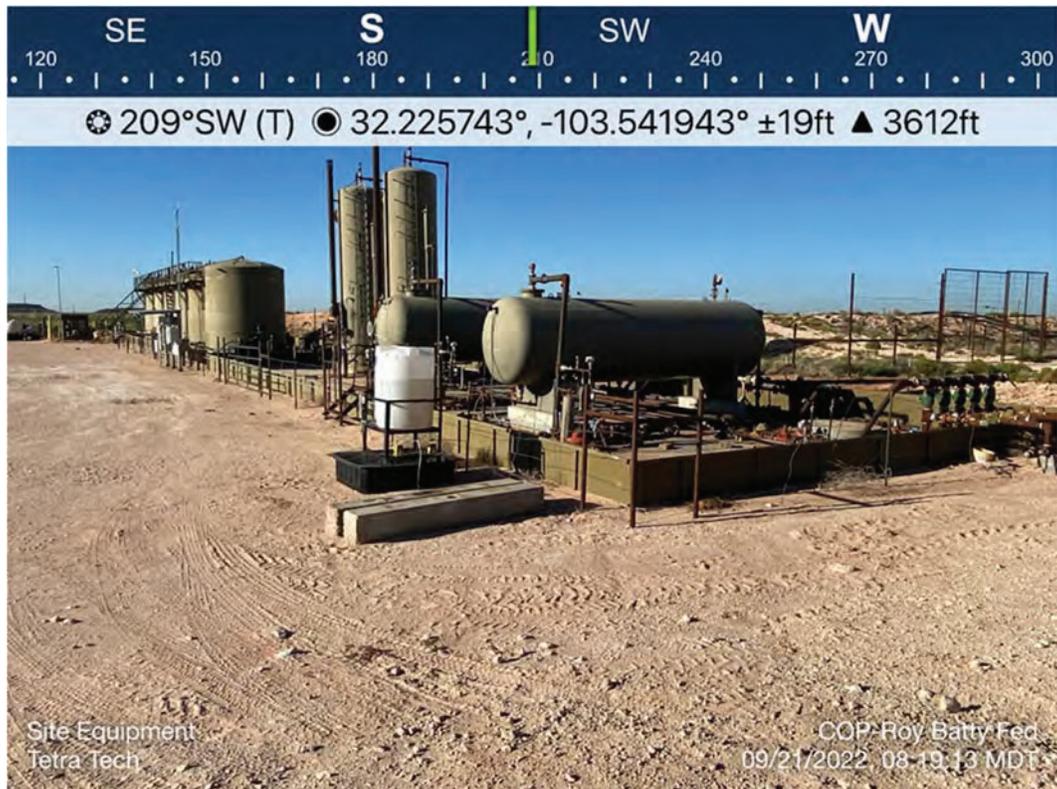
TETRA TECH, INC. PROJECT NO. 212C-MD-02847	DESCRIPTION	View south-southwest. Separators at the southern extent of the reported release footprint.	2
	SITE NAME	ConocoPhillips Roy Batty Fed Com #003H	9/21/2022

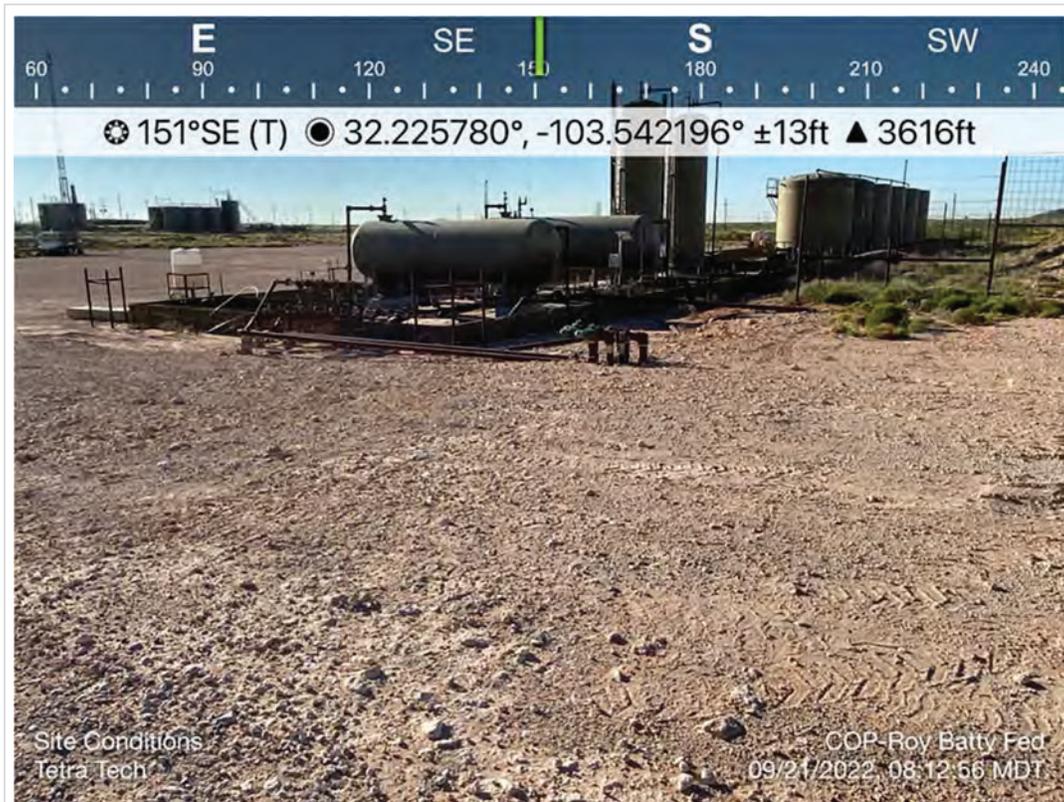
TETRA TECH, INC. PROJECT NO. 212C-MD-02847	DESCRIPTION	View southeast. View from the lease road towards the lease pad.	3
	SITE NAME	ConocoPhillips Roy Batty Fed Com #003H	9/21/2022

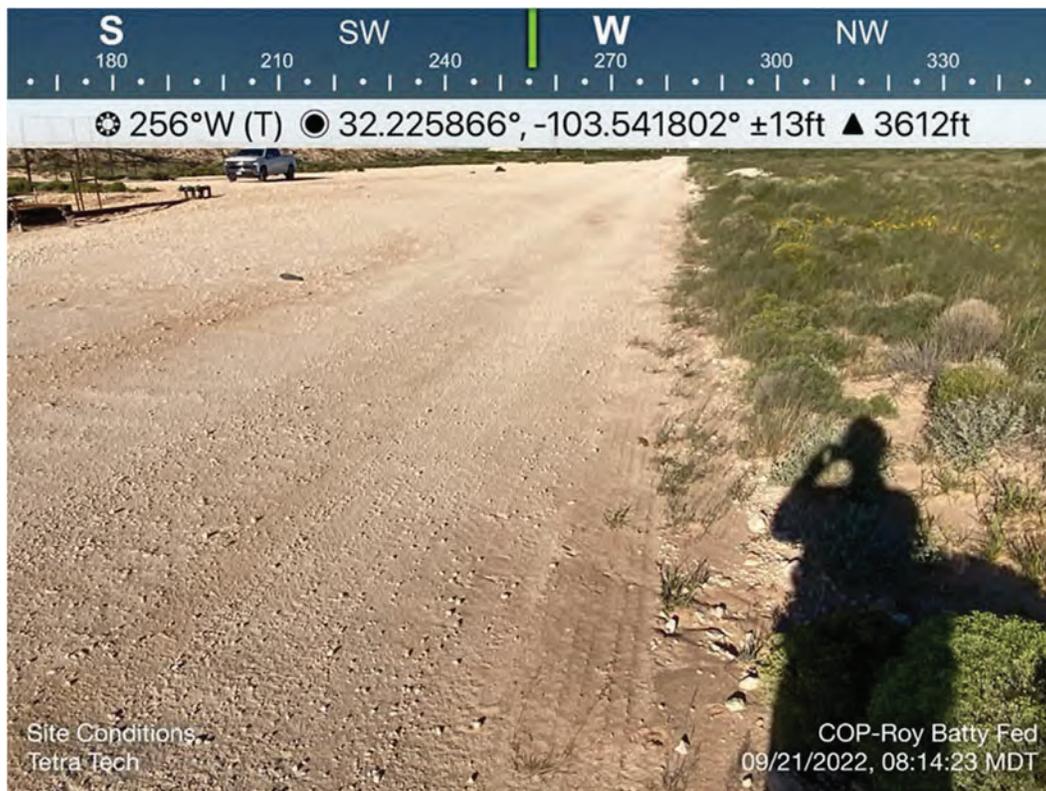
TETRA TECH, INC. PROJECT NO. 212C-MD-02847	DESCRIPTION	View west. View from lease road, looking towards the west. Assumed flow path, no visible evidence of impact.	4
	SITE NAME	ConocoPhillips Roy Batty Fed Com #003H	9/21/2022

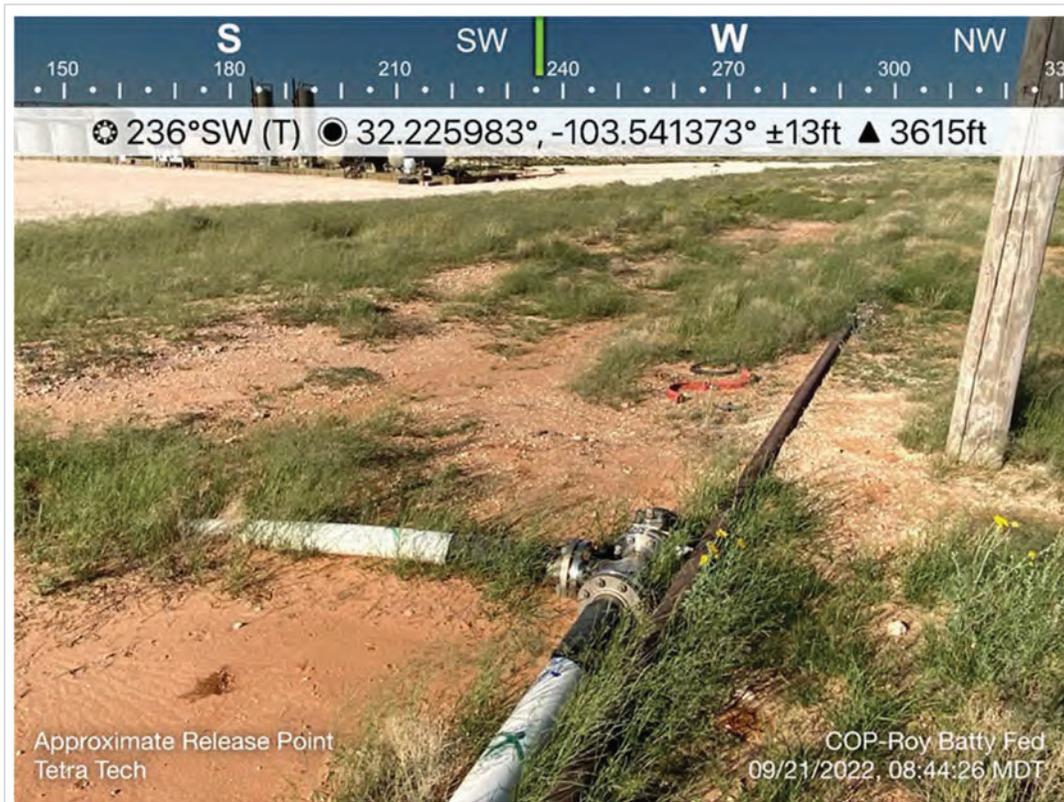
TETRA TECH, INC. PROJECT NO. 212C-MD-02847	DESCRIPTION	View southwest. Approximate release point in the pasture north of the pad, sparse vegetation present.	5
	SITE NAME	ConocoPhillips Roy Batty Fed Com #003H	9/21/2022

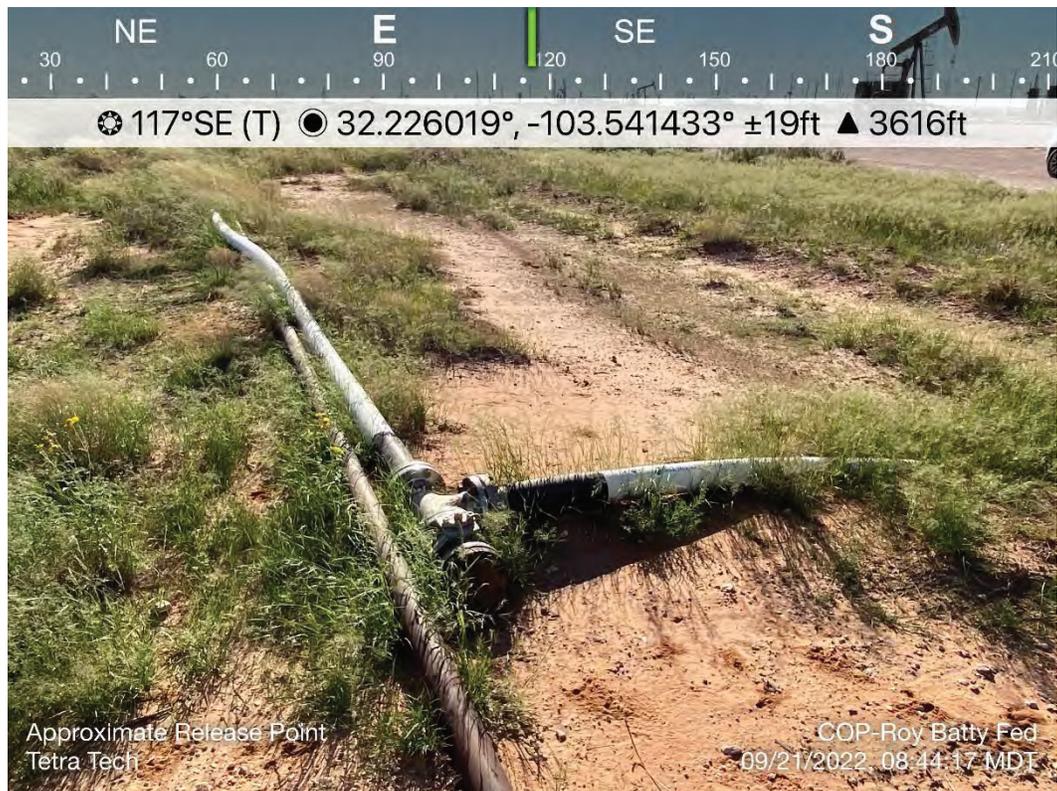
TETRA TECH, INC. PROJECT NO. 212C-MD-02847	DESCRIPTION	View southwest. Sparse vegetation east of the approximate release point.	6
	SITE NAME	ConocoPhillips Roy Batty Fed Com #003H	9/21/2022

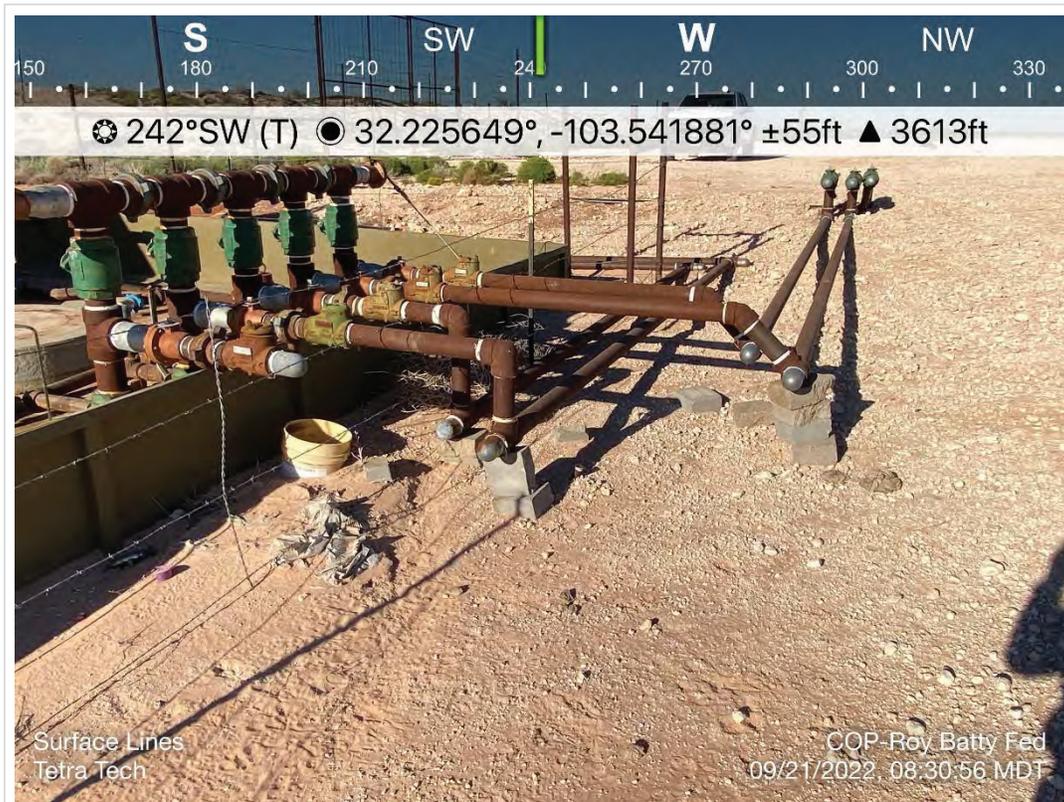
TETRA TECH, INC. PROJECT NO. 212C-MD-02847	DESCRIPTION	View southwest. No visible evidence of impact.	7
	SITE NAME	ConocoPhillips Roy Batty Fed Com #003H	9/21/2022

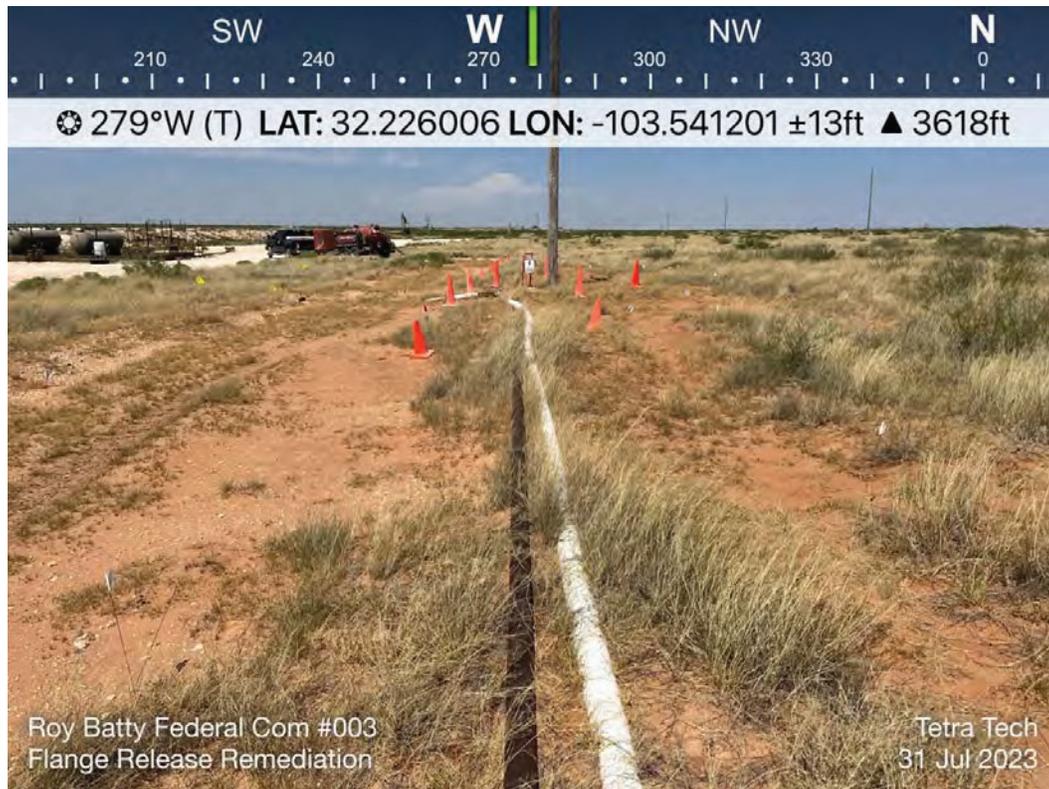
TETRA TECH, INC. PROJECT NO. 212C-MD-02847	DESCRIPTION	View west. Proposed remediation area prior to beginning excavations. The area along surface lines was noted as being vegetated.	8
	SITE NAME	Roy Batty Federal Com #003H Flange Release	7/31/2023

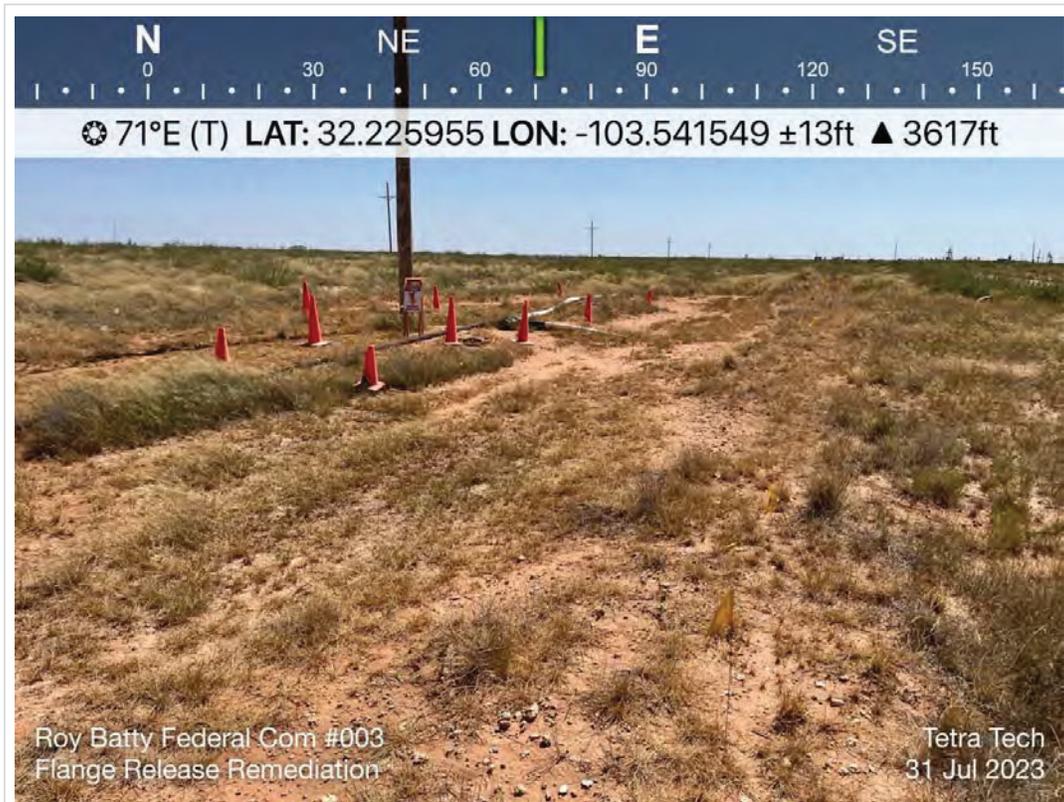
TETRA TECH, INC. PROJECT NO. 212C-MD-02847	DESCRIPTION	View east-northeast. Proposed remediation area prior to beginning excavations. The area along surface lines was noted as being vegetated.	9
	SITE NAME	Roy Batty Federal Com #003H Flange Release	7/31/2023

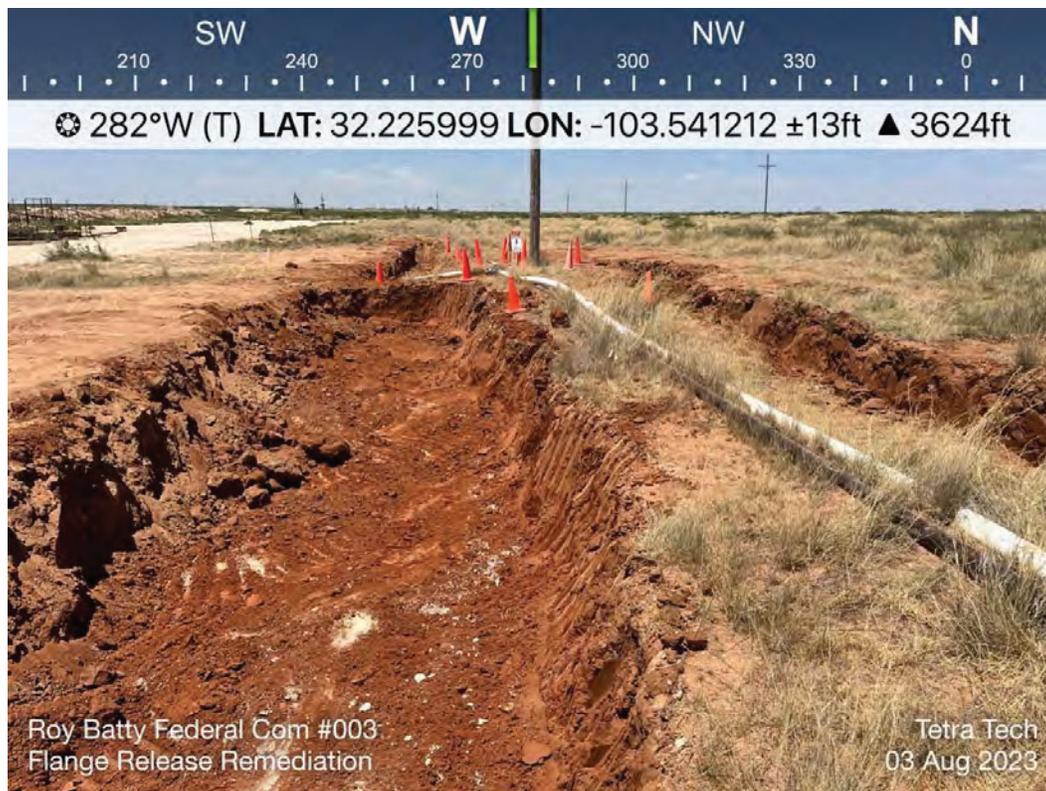
TETRA TECH, INC. PROJECT NO. 212C-MD-02847	DESCRIPTION	View west. Eastern portion of the 4-foot excavated area.	10
	SITE NAME	Roy Batty Federal Com #003H Flange Release	8/3/2023

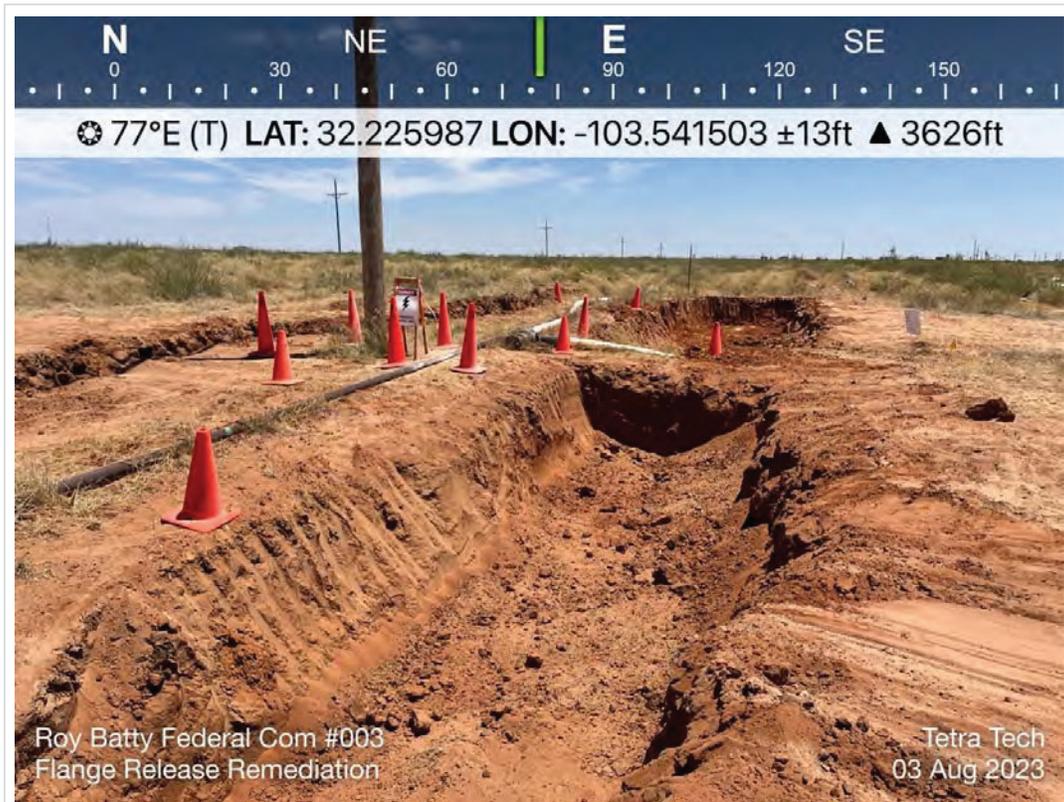
TETRA TECH, INC. PROJECT NO. 212C-MD-02847	DESCRIPTION	View east. Central portion of the 4-foot excavated area. Power pole exclusion zone.	11
	SITE NAME	Roy Batty Federal Com #003H Flange Release	8/3/2023

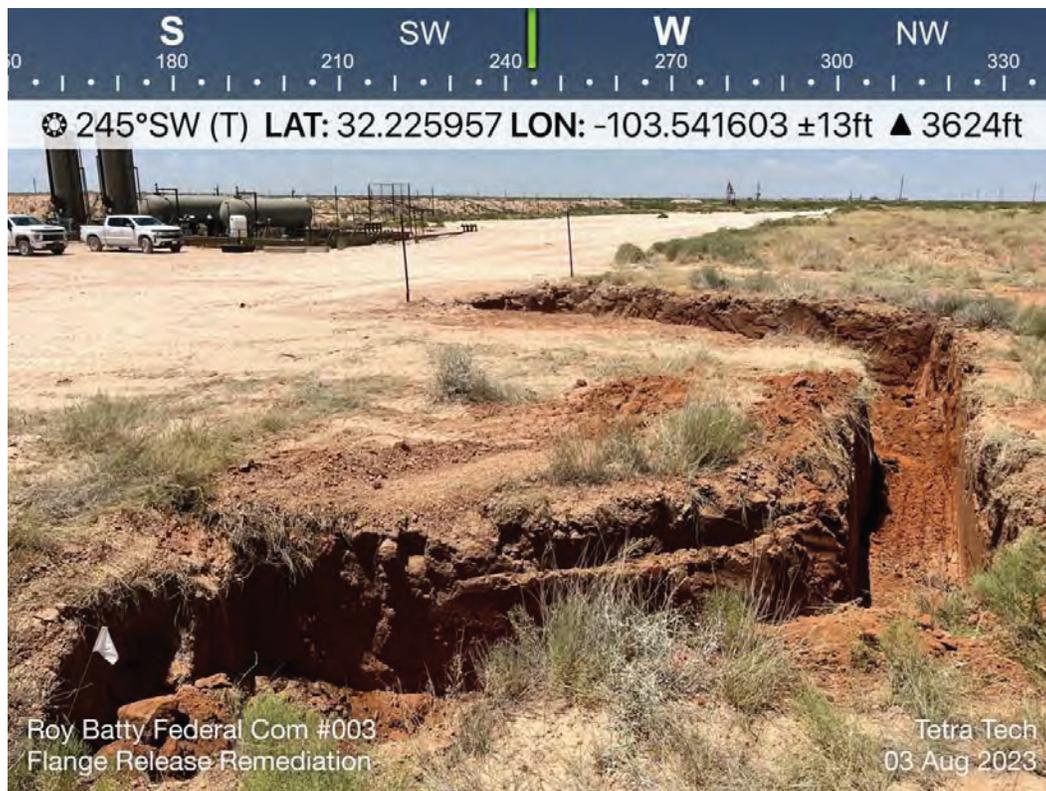
TETRA TECH, INC. PROJECT NO. 212C-MD-02847	DESCRIPTION	View west-southwest. Southwestern portion of the 4-foot excavated area.	12
	SITE NAME	Roy Batty Federal Com #003H Flange Release	8/3/2023

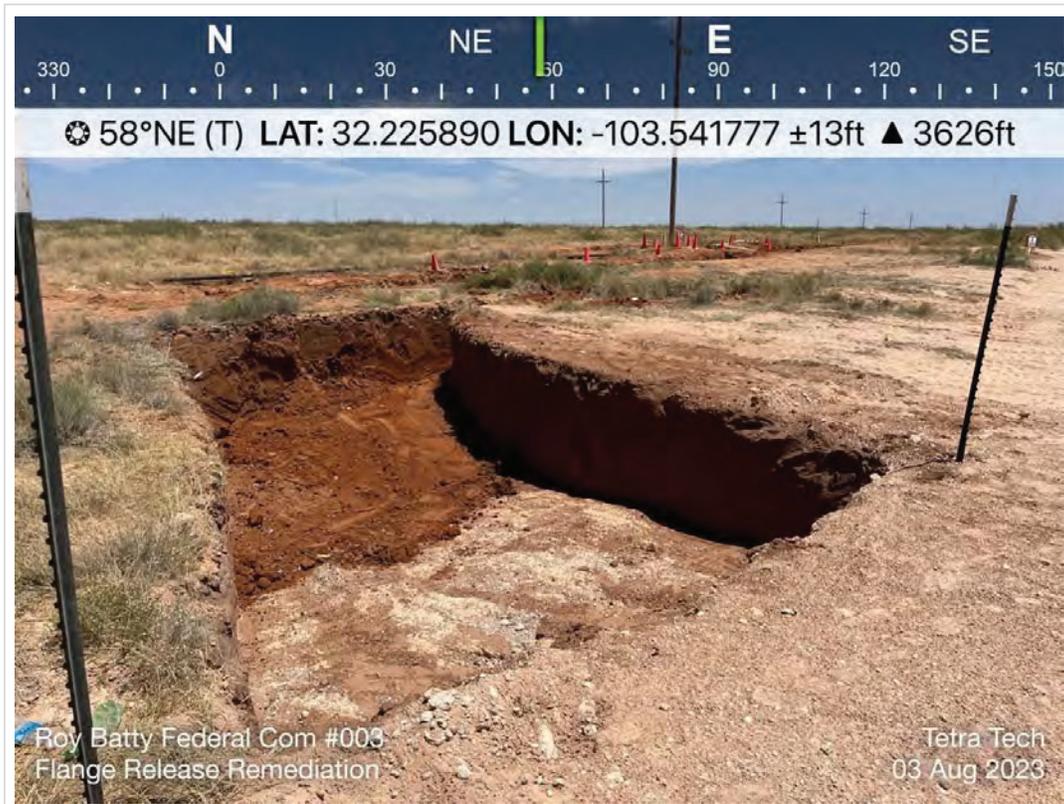
TETRA TECH, INC. PROJECT NO. 212C-MD-02847	DESCRIPTION	View northeast. Southwestern portion of the 4-foot excavated area.	13
	SITE NAME	Roy Batty Federal Com #003H Flange Release	8/3/2023

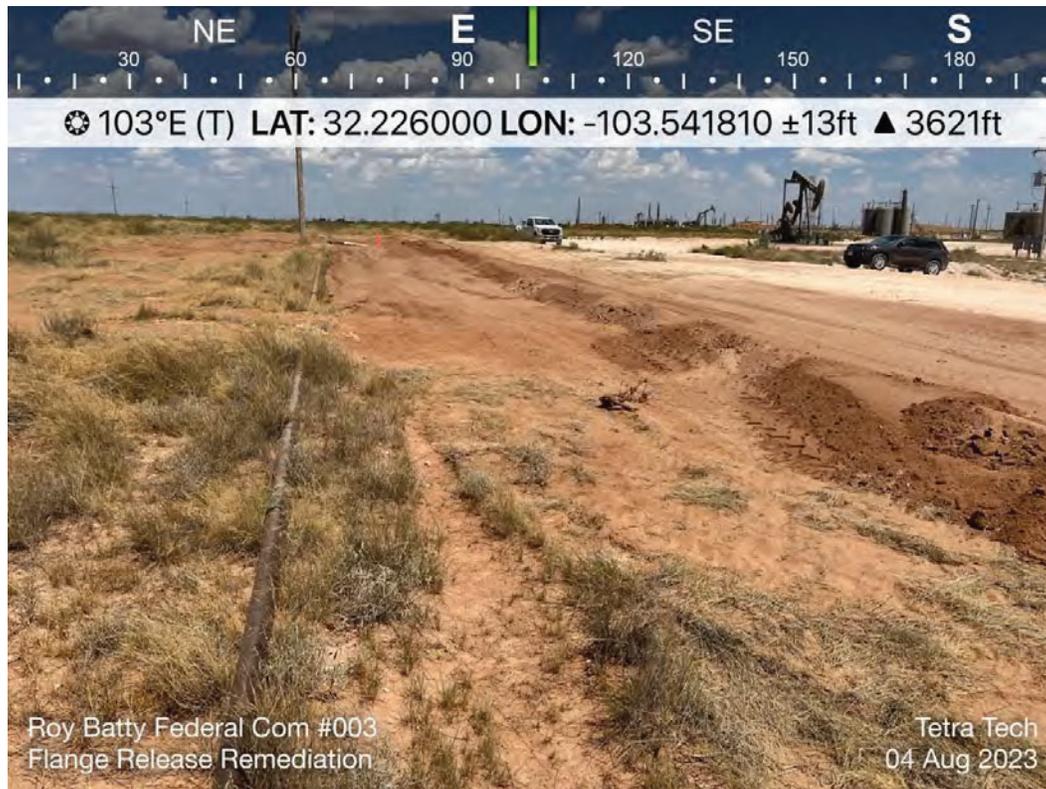
TETRA TECH, INC. PROJECT NO. 212C-MD-02847	DESCRIPTION	View east. Backfilled and seeded excavation area.	14
	SITE NAME	Roy Batty Federal Com #003H Flange Release	8/4/2023

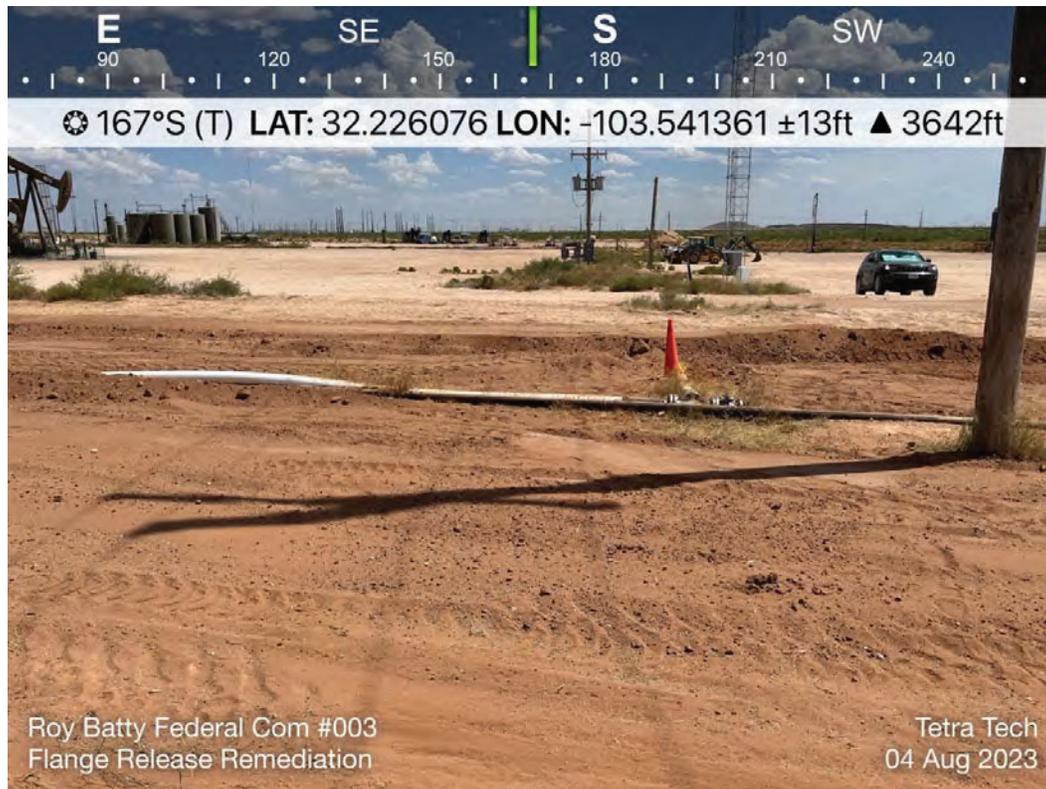
TETRA TECH, INC. PROJECT NO. 212C-MD-02847	DESCRIPTION	View south. Backfilled and seeded excavation area.	16
	SITE NAME	Roy Batty Federal Com #003H Flange Release	8/4/2023
