**SITE CHARACTERIZATION, ASSESSMENT, REMEDIATION, AND  
CLOSURE REPORT**

**SHUDDE 27 CTB – LOAD LINE AREA  
32.722668, -104.360797  
UNIT D, SECTION 26, T18S-R26E  
EDDY COUNTY, NEW MEXICO  
NMOCD INCIDENT ID # nAPP2302538491 & nAPP2302541480**

**SILVERBACK OPERATING  
ARTESIA DIVISION  
108 S 4TH STREET  
ARTESIA, NEW MEXICO 88210**

**RANGER ENVIRONMENTAL SERVICES, LLC  
P.O. BOX 201179  
AUSTIN, TEXAS 78720**

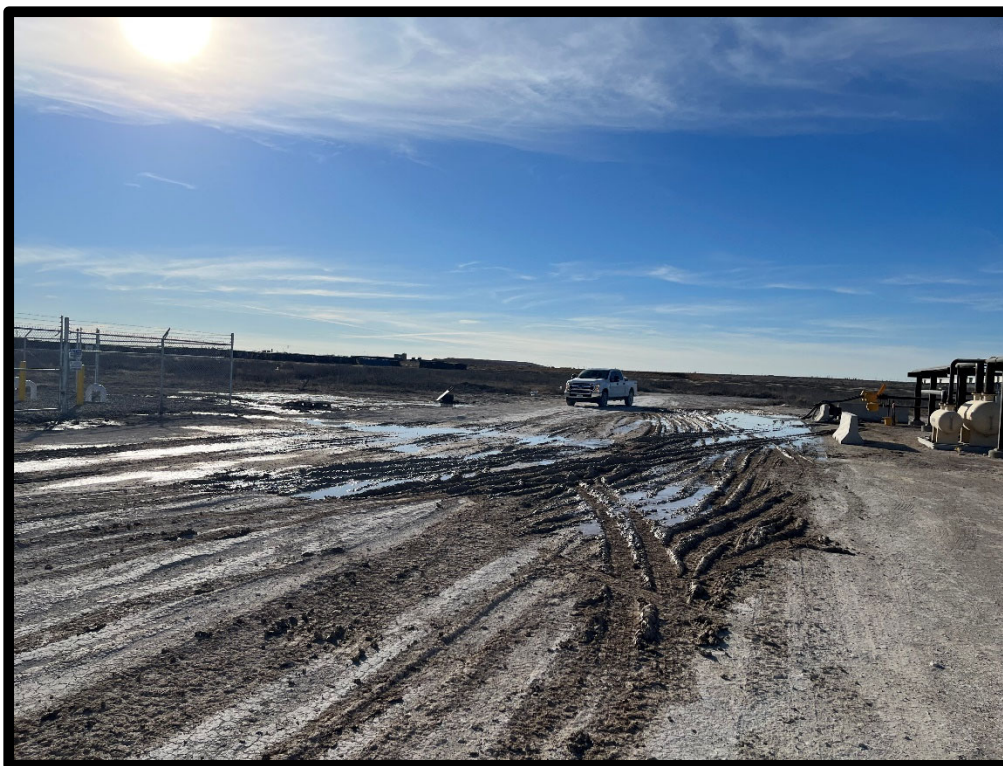
*(Approximate GPS Coordinates: 32.722879, -104.360521)*

**PHOTOGRAPH NO. 1 – A view of the January 13, 2023 release upon discovery. The view is towards the southwest.**

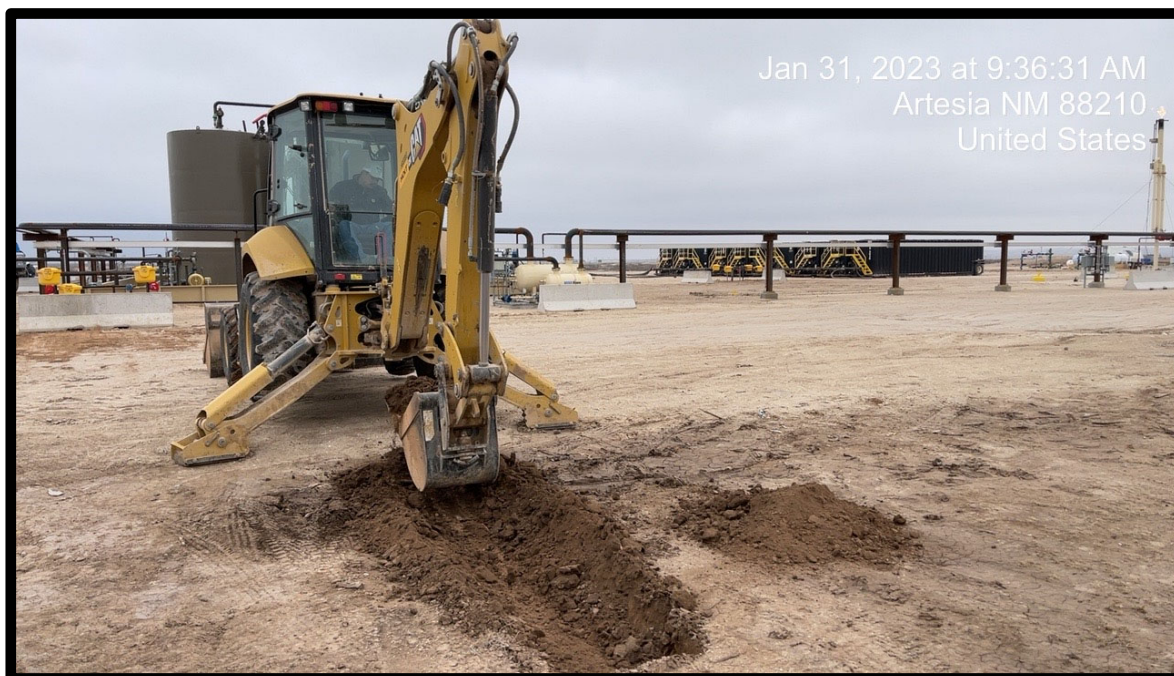
*(Approximate GPS Coordinates: 32.722772, -104.360836)*

**PHOTOGRAPH NO. 2 – A view of the site during the site assessment activities completed on January 31, 2023. The view is towards the north.**

During the January 31, 2023 assessment, a total of six test excavations (TH-1 through TH-6) were completed. The test excavations were completed to a maximum depth of approximately four feet bgs. During the test hole installation process, field screening of the encountered soils were analyzed by Ranger personnel at the surface and at approximate one-foot intervals using an organic vapor monitor (OVM) and a field chloride titration kit to assist in evaluating soil conditions and/or levels of impacts in the area.

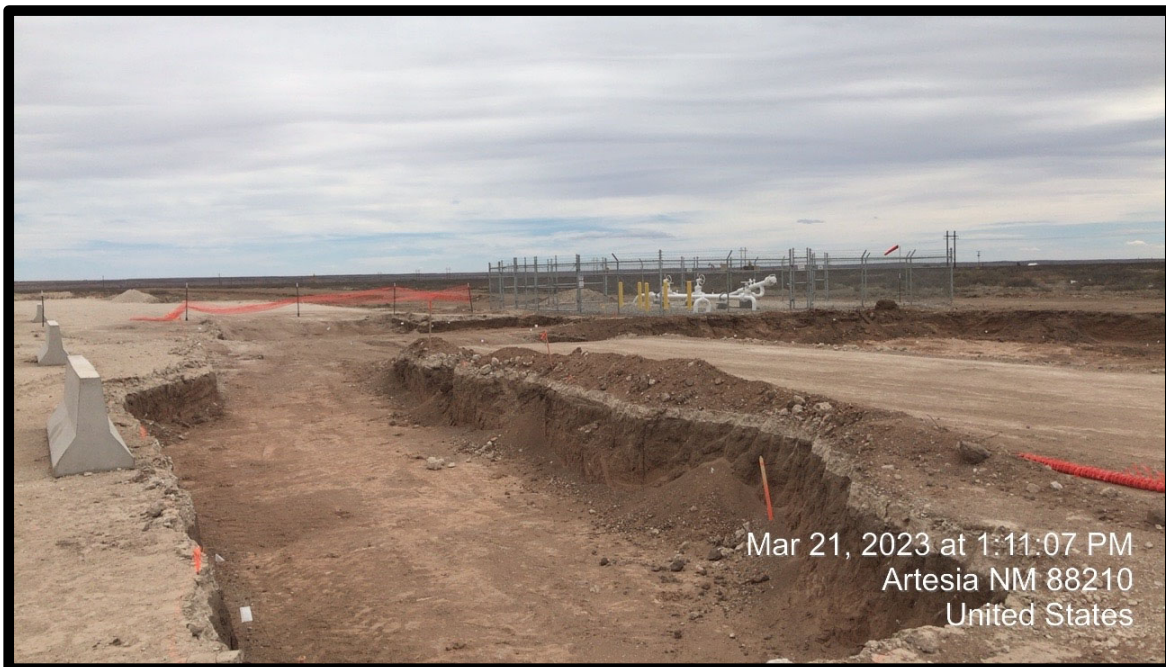
*(Approximate GPS Coordinates: 32.722942, -104.361016)*

**PHOTOGRAPH NO. 3 – A view of the excavation area upon completion of the remedial operations at the site. The view is towards the southeast.**

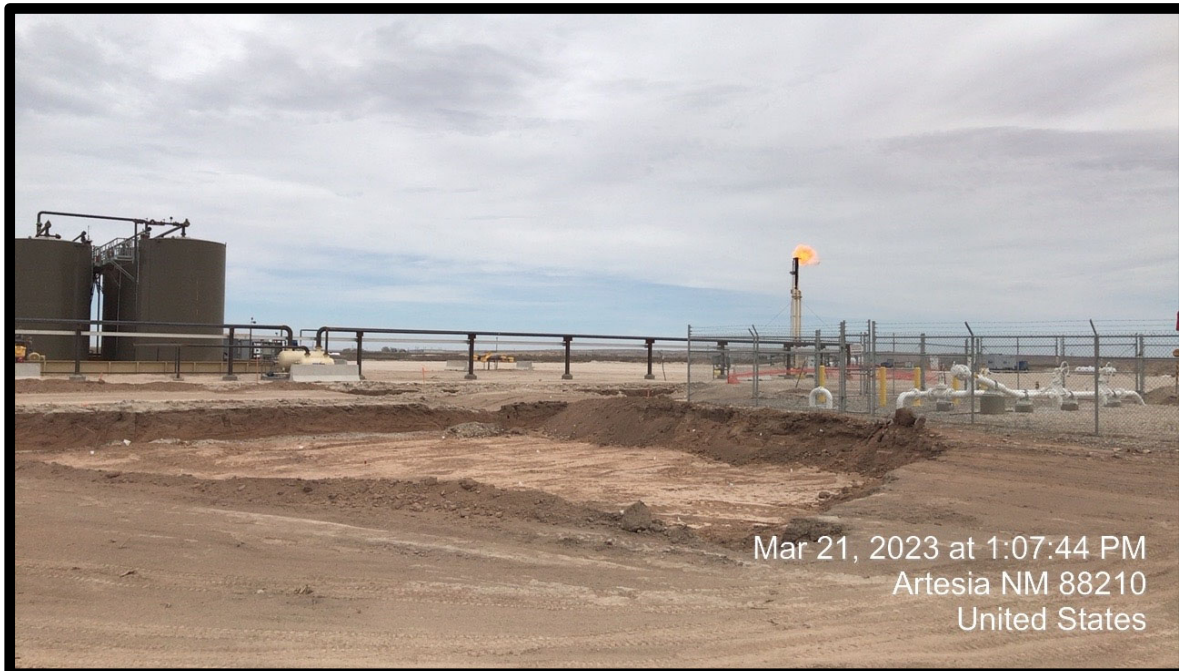
*(Approximate GPS Coordinates: 32.722606, -104.360916)*

**PHOTOGRAPH NO. 4 – An additional view of the excavation area upon completion of the remedial operations at the site. The view is towards the northeast.**
