Release Notification and Corrective Action

Site Name: Ross Draw Unit #012	Site Type: Oil Production Facility
Date Release Discovered: 03/05/2014	API# (if applicable): 30-015-24793

Ross Draw Unit #012

nHMP1407325518 & nAPP2315142829

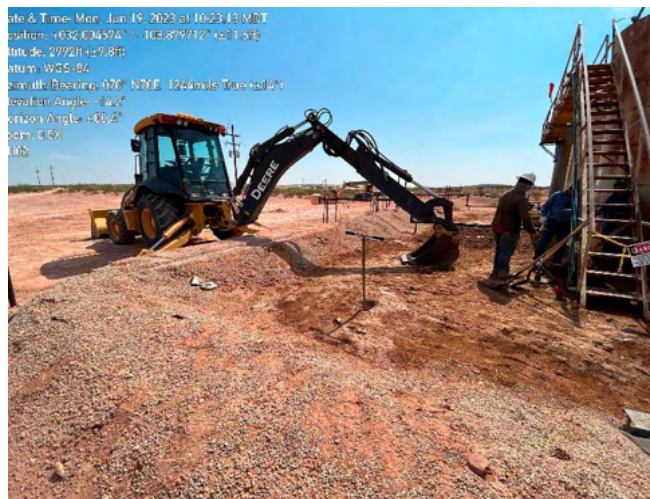
Photograph 1

Description: Eastern view of delineation activities near PH02.

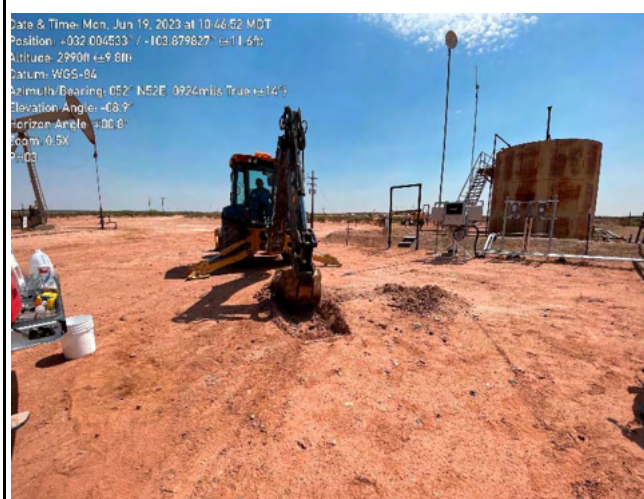
Photograph 2

Description: Northeastern view of delineation activities near PH03.

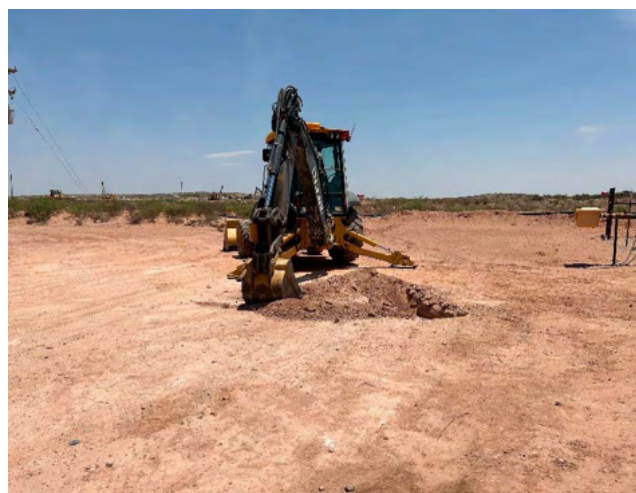
Photograph 3

Description: Eastern view of delineation activities near PH06.

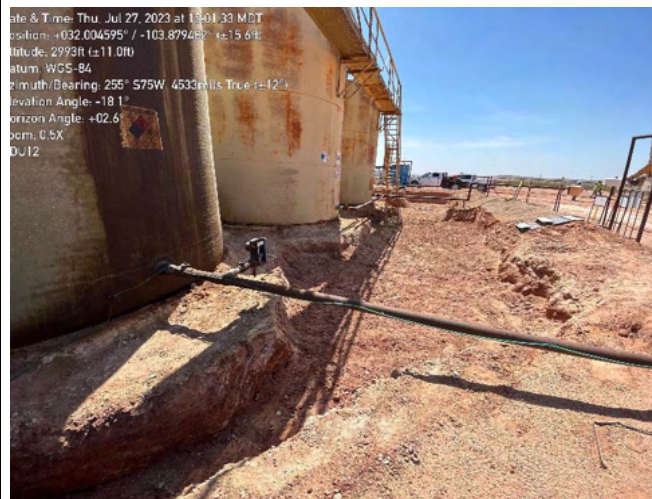
Photograph 5
Date: 07/27/2023

Description: Western view of completed excavation extent.

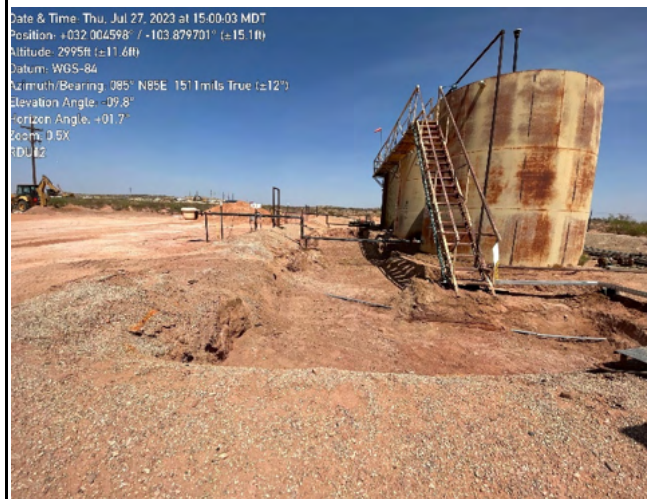
Photograph 6
Date: 07/27/2023

Description: Eastern view of completed excavation extent.

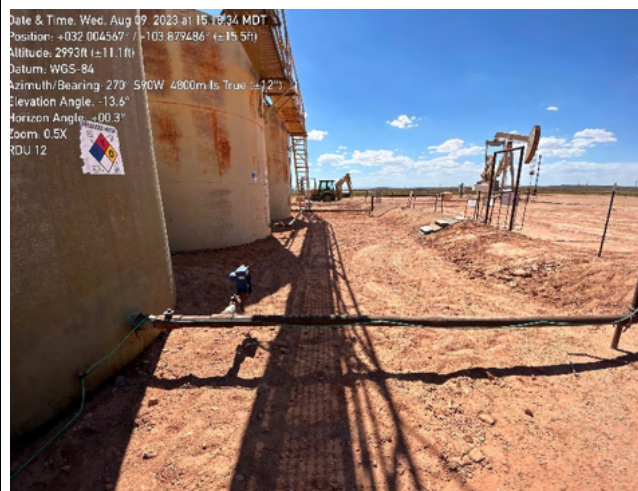
Photograph 7
Date: 08/09/2023

Description: Western view of completed backfill.

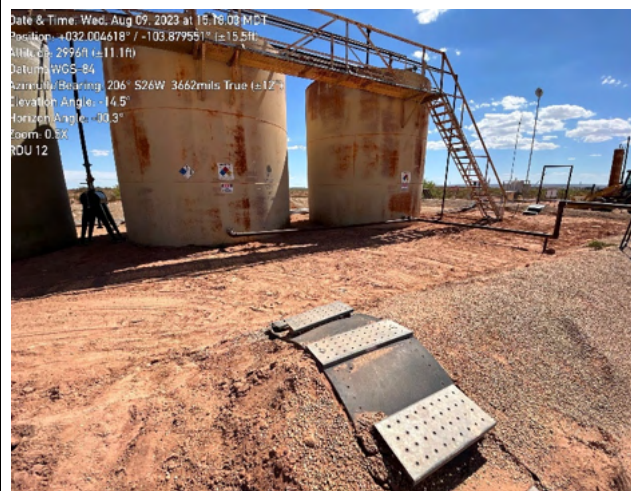
Photograph 8
Date: 08/09/2023

Description: Southwestern view of completed backfill.

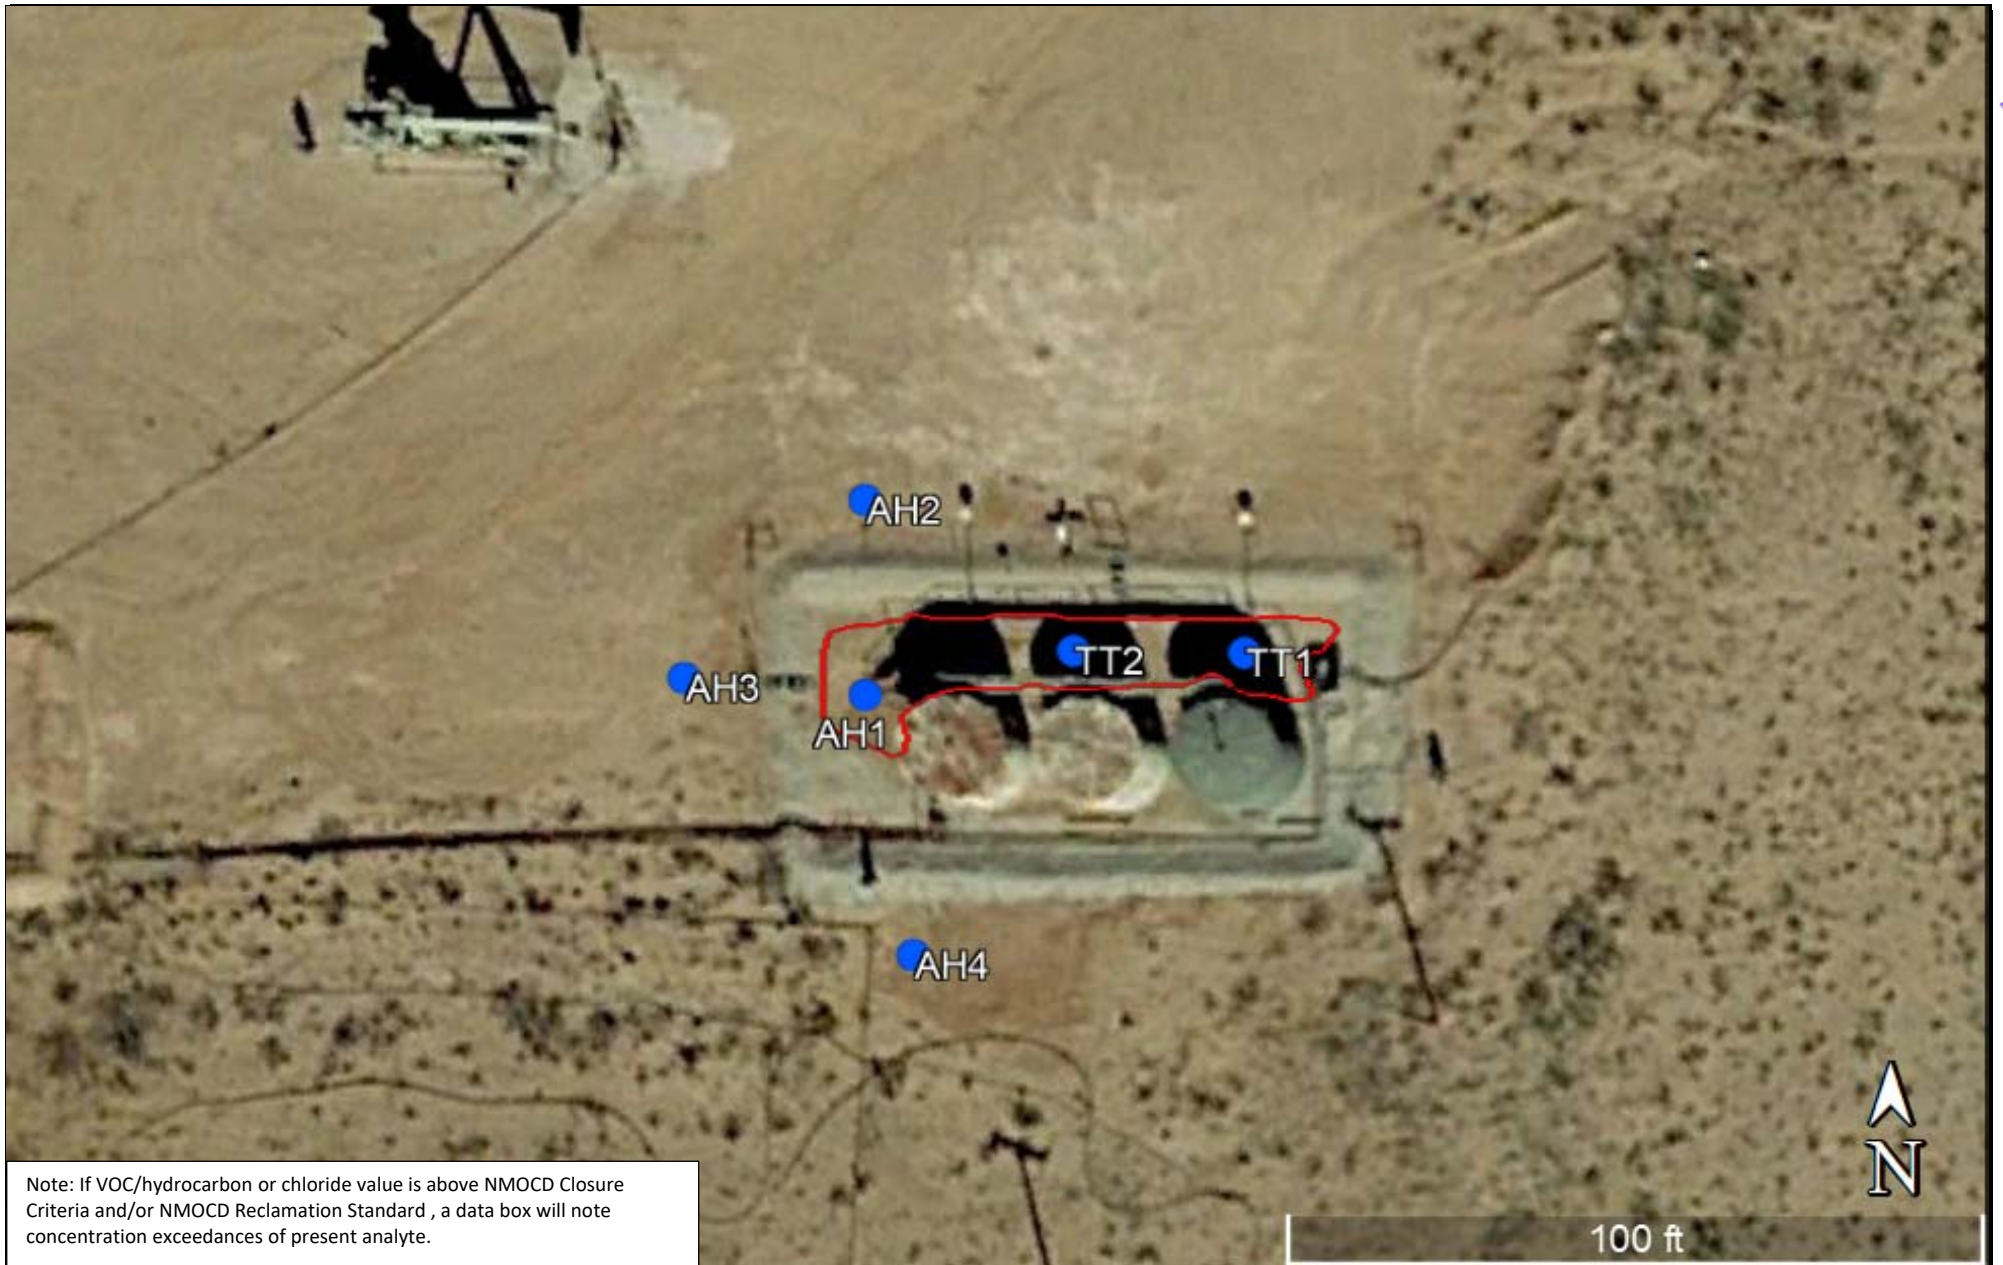
Site and Sample Location Map

Legend:	
●	Delineation Point
—	Release outline

Figure 3
 Site and Sample Location
 RDU 12
 2RP-2211
 WPX Energy, Inc.
 GPS: 31.004760, -103.879775

On **January 15, 2020**, Etech personnel conducted initial site assessments for **two (2)** releases, **2RP-2211** and **2RP-4095**, that occurred at the RDU 12 Site in Eddy County, NM. The assessments consisted of generating a footprint via GPS receiver of the aforementioned releases and photo documentation of the current Site conditions. Based on visual observation, approximately **eight hundred and nineteen (819)** square feet of surface area was impacted from the release assigned **2RP-2211**; approximately **five thousand and fifty-three (5,053)** square feet of surface area was impacted from the release assigned **2RP-4095**. Between **January 22, 2020** and **February 25, 2020**, a series of test trenches and/or hand-augered soil bores were advanced within the release footprints in an effort to define the vertical and horizontal extent of impacted soil. Field soil samples were collected and field-screened for the presence of Volatile Organic Compounds utilizing a Photoionization Detector (PID) and concentrations of chloride utilizing a Hach Quantab® chloride test kit. A "Site & Sample Location Map" is provided as Figure 3 (**2RP-2211**) and Figure 3A (**2RP-4095**). Field data and soil profile logs, if applicable, are provided as Appendix B.
