June 16, 2023

**Re: Release Characterization and Remediation Work Plan  
ConocoPhillips-Heritage Concho  
Talco 9-26-35 Federal 003H Flowline Release  
Unit Letter G, Section 09, Township 26 South, Range 35 East  
Lea County, New Mexico  
DOR: 3/28/2023  
Incident ID# NAPP2308946629**

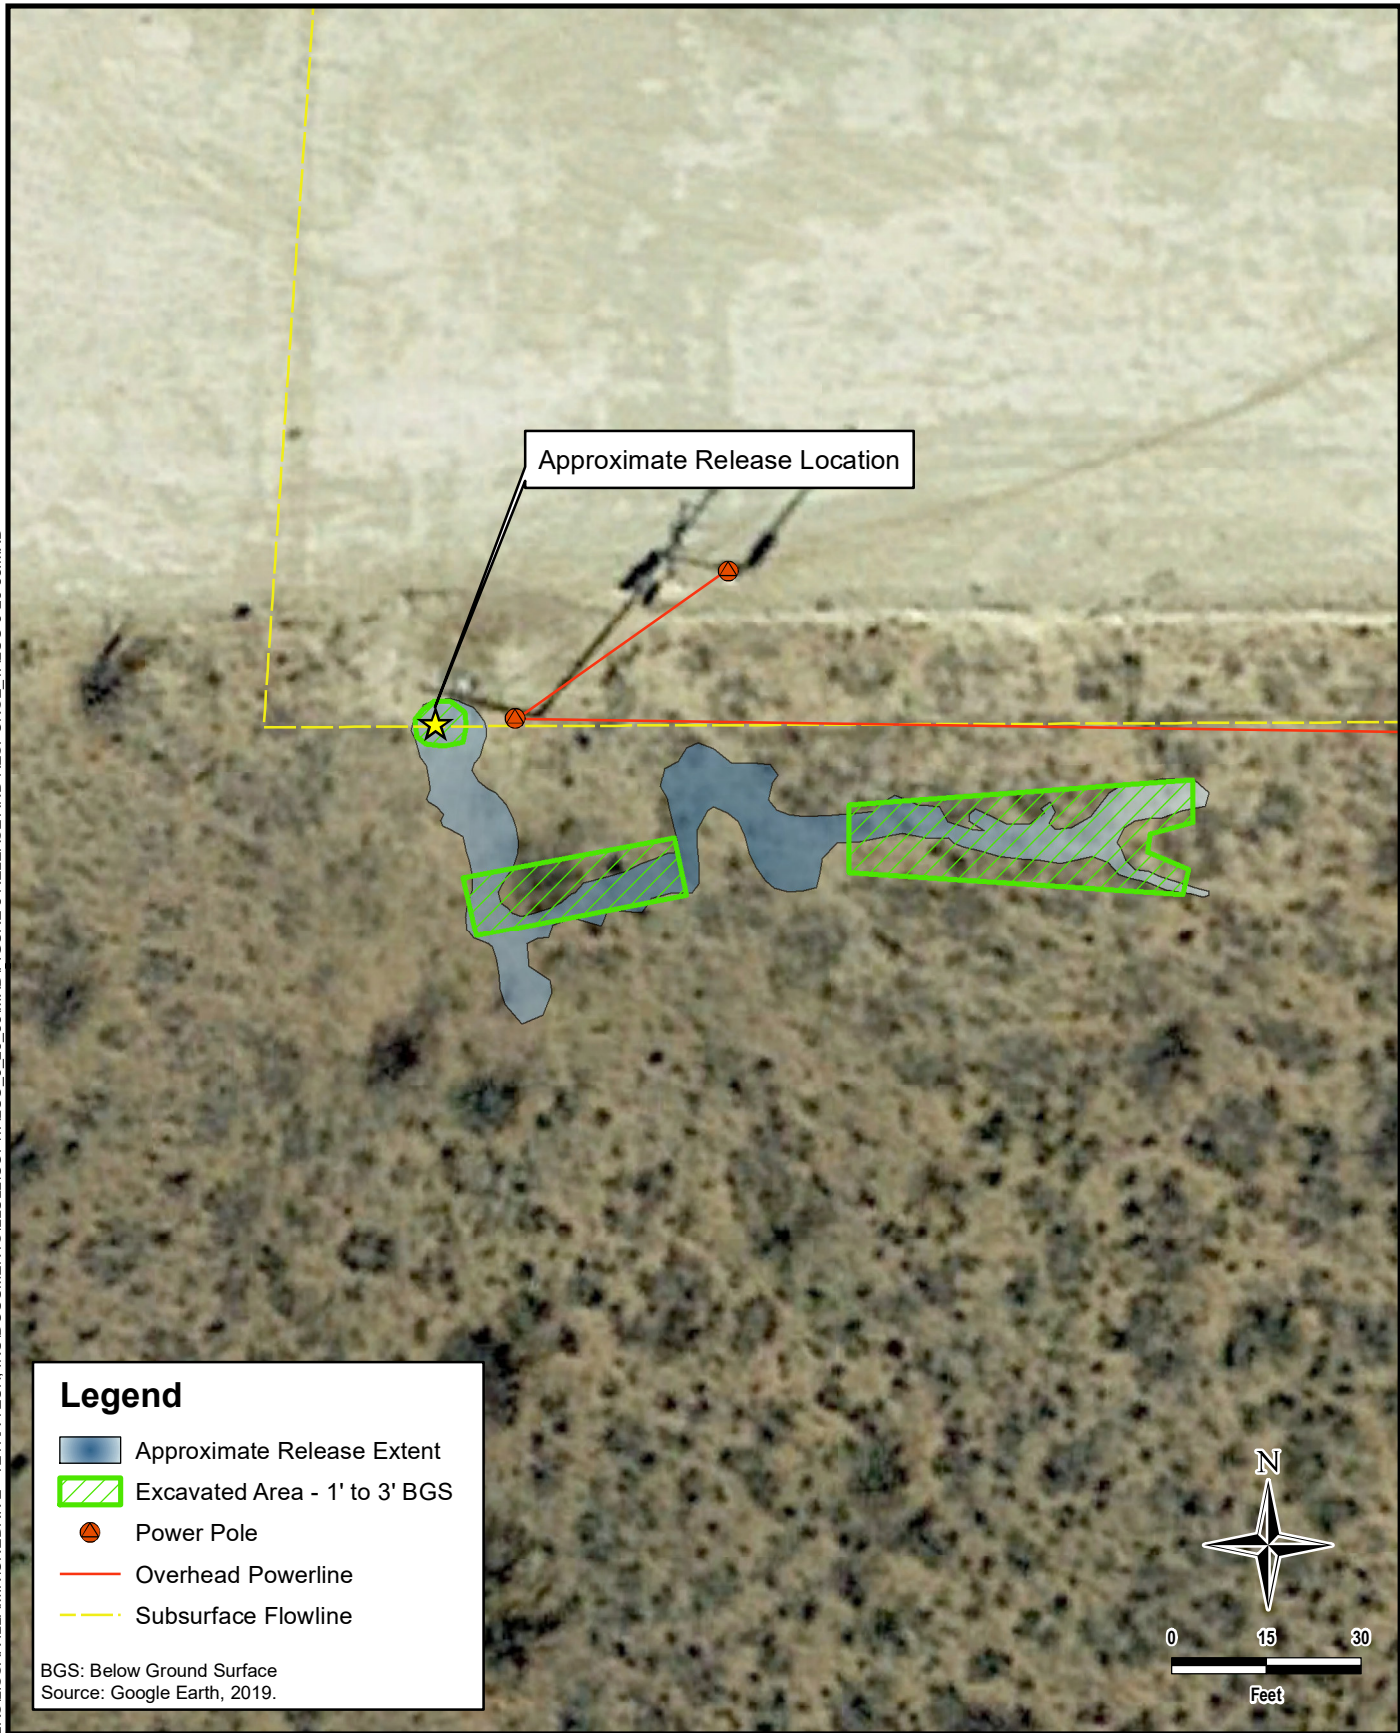
**3**

Initial response remedial actions were performed at the release site on April 6, 2023. Visibly stained areas were partially excavated to depths at 1 to 3 feet below ground surface (bgs) to remove impacted materials. Approximately 60 cubic yards of contaminated soil were removed and sent to R360 Halfway Facility in

Hobbs, New Mexico for disposal. The initial response areas are indicated in Figure 3. Photographic documentation of the initial response action is found in Appendix C. Waste manifests from the initial response are included in Appendix D.

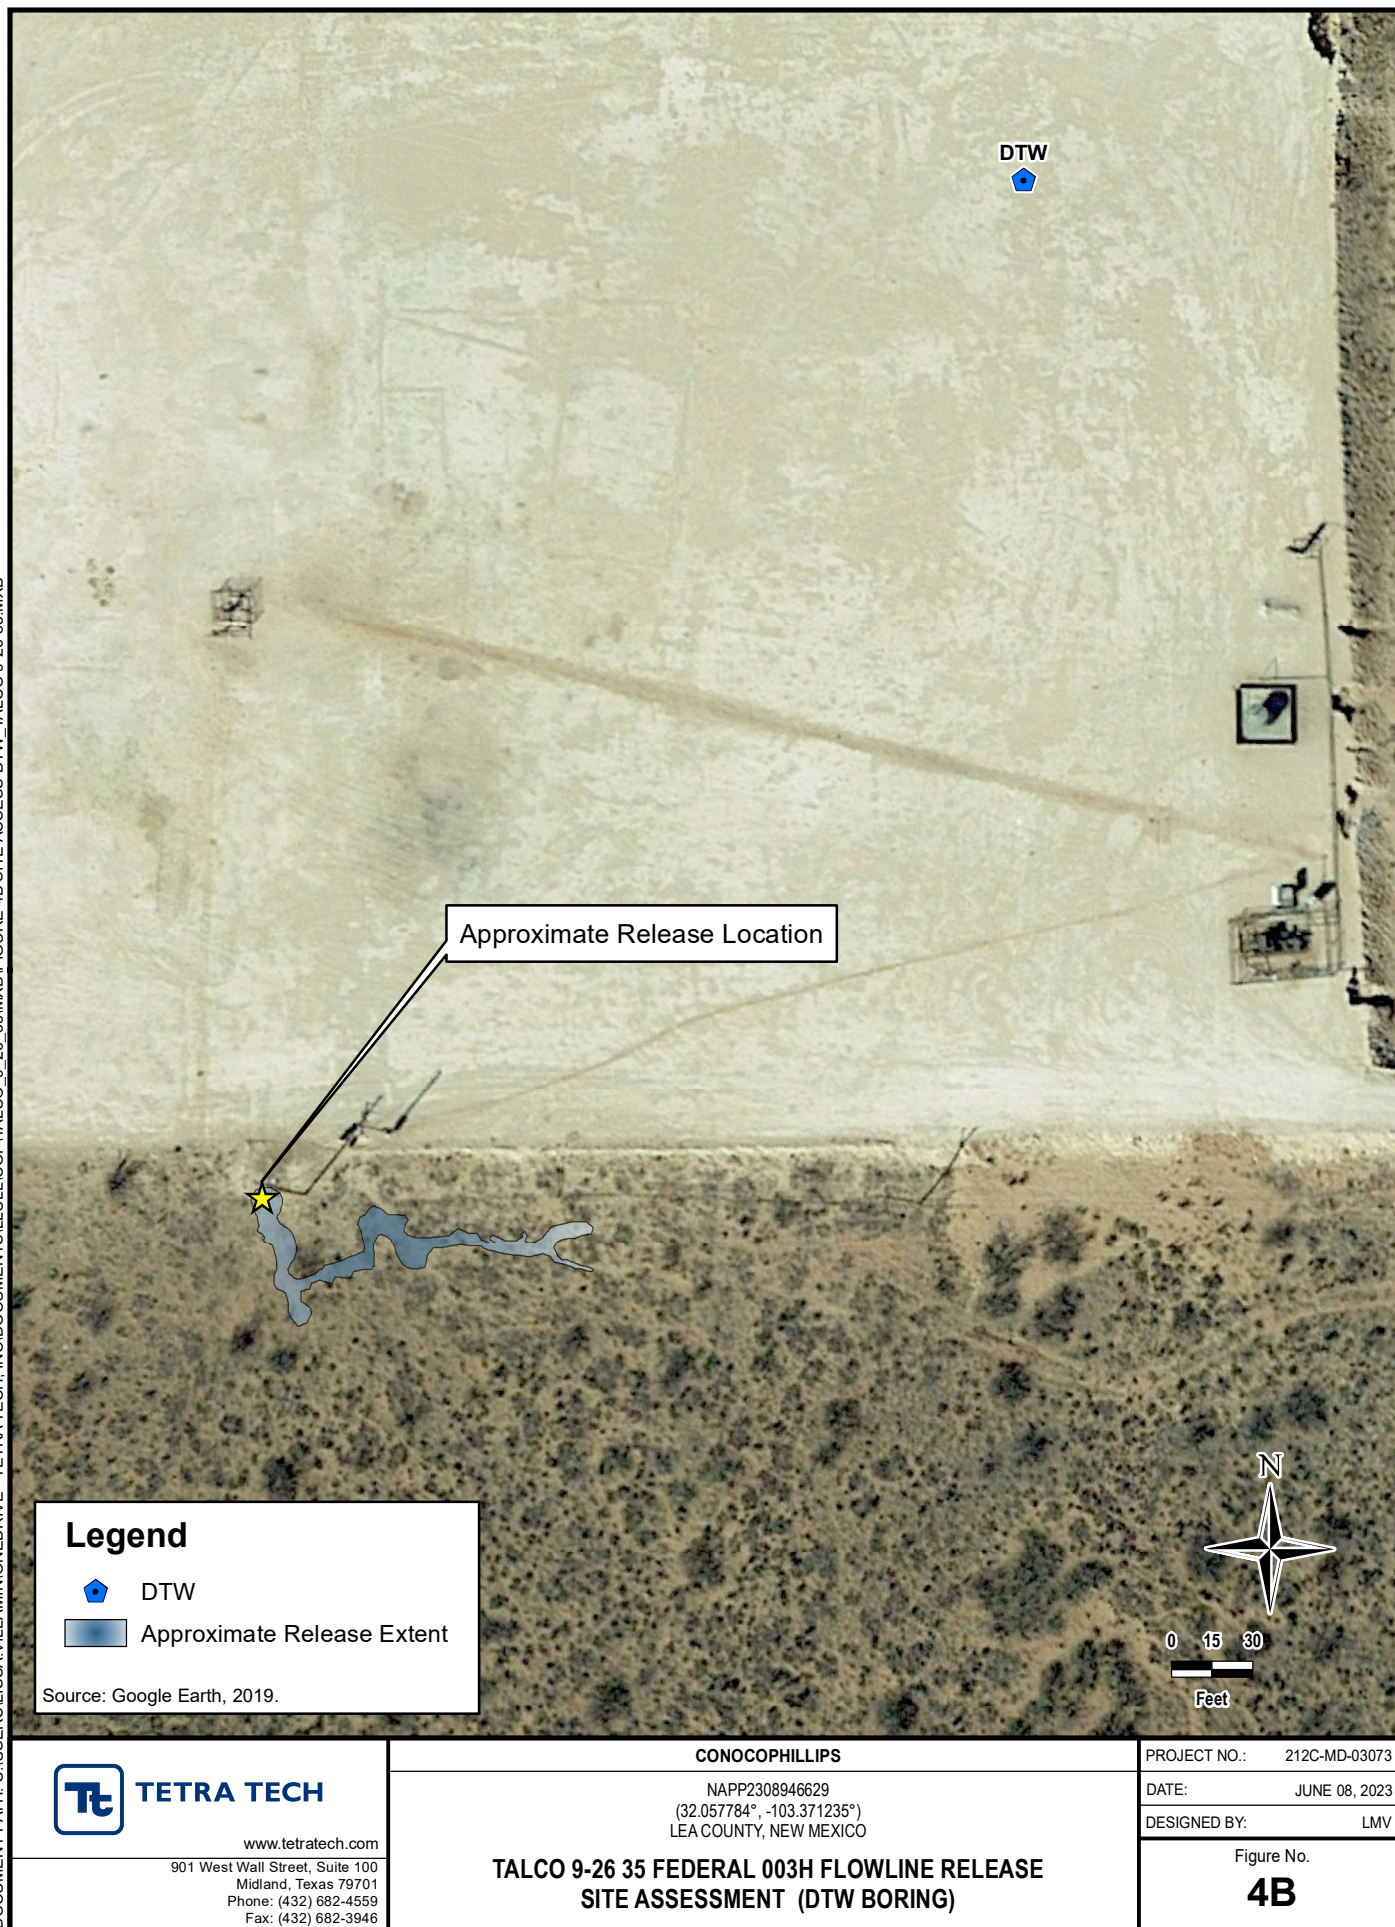
DOCUMENT PATH: C:\USERS\LISSA.VILLAMONEDRIVE - TETRA TECH, INC\DOCUMENTS\TALCO 9-26 35\TALCO 9-26 35\MXD\FIGURE 4B SITE ASSESS DTW TALCO 9-26 35.MXD

As the available water level information was from a well further than ½ mile away from the Site, COP elected to drill a boring for groundwater verification. On May 24, 2023, a licensed drilling subcontractor was onsite to drill a depth-to-water (DTW) borehole to 55 feet bgs. The borehole was located on the developed pad approximately 460-feet northwest. The borehole was dry upon completion, and soils were dry from surface to total depth. The depth to groundwater in the area was thus verified as greater than 55 feet bgs. The borehole was plugged with 3/8" bentonite chips. The borehole coordinates are 32.058777°, -103.370256°, and the boring location is indicated on Figure 4B. The site characterization data, along with the boring log, is included in Appendix E.

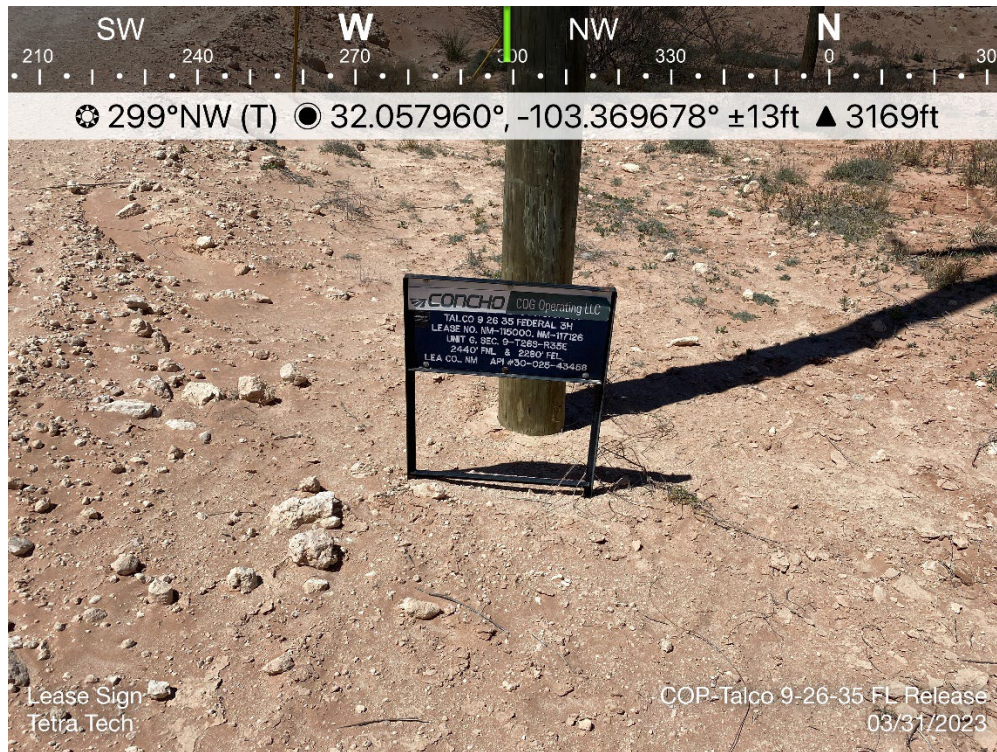
TETRA TECH, INC. PROJECT NO. 212C-MD-03073	DESCRIPTION	Site signage. Talco 9 26 35 Federal 3H and location information.	1
	SITE NAME	Talco 9 26 35 Federal #003H Flowline Release	3/31/2023

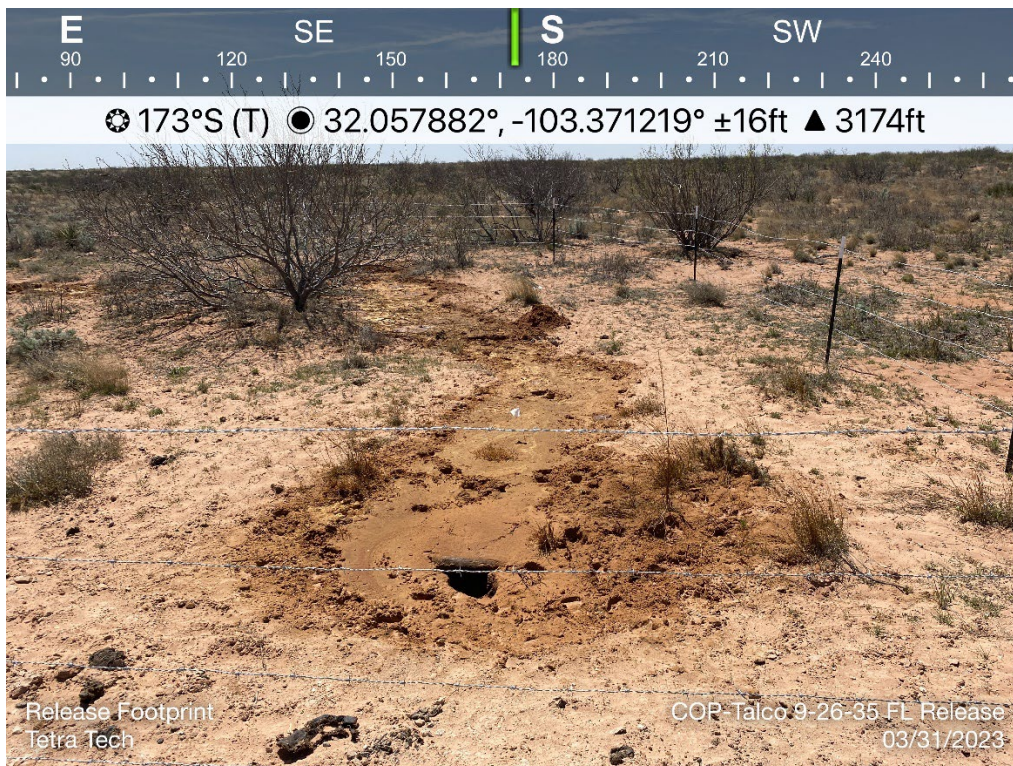
TETRA TECH, INC. PROJECT NO. 212C-MD-03073	DESCRIPTION	View south of release point and footprint.	2
	SITE NAME	Talco 9 26 35 Federal #003H Flowline Release	3/31/2023

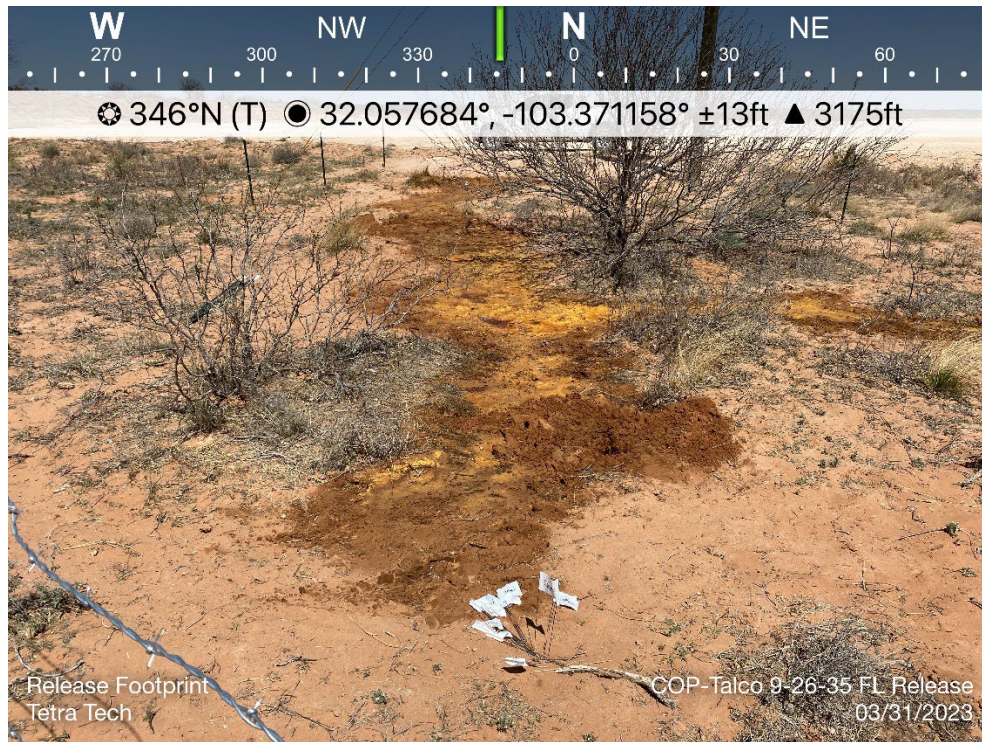
TETRA TECH, INC. PROJECT NO. 212C-MD-03073	DESCRIPTION	View north. Release footprint, surface staining.	3
	SITE NAME	Talco 9 26 35 Federal #003H Flowline Release	3/31/2023

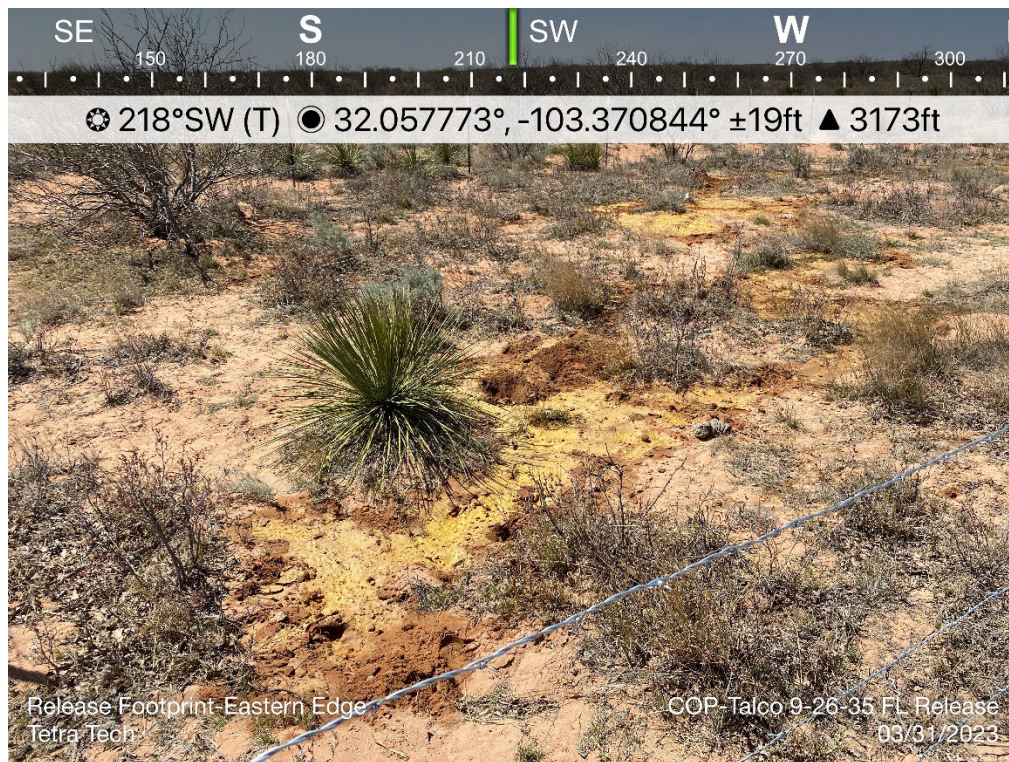
TETRA TECH, INC. PROJECT NO. 212C-MD-03073	DESCRIPTION	View southwest. Eastern portion of release area, surface staining.	4
	SITE NAME	Talco 9 26 35 Federal #003H Flowline Release	3/31/2023

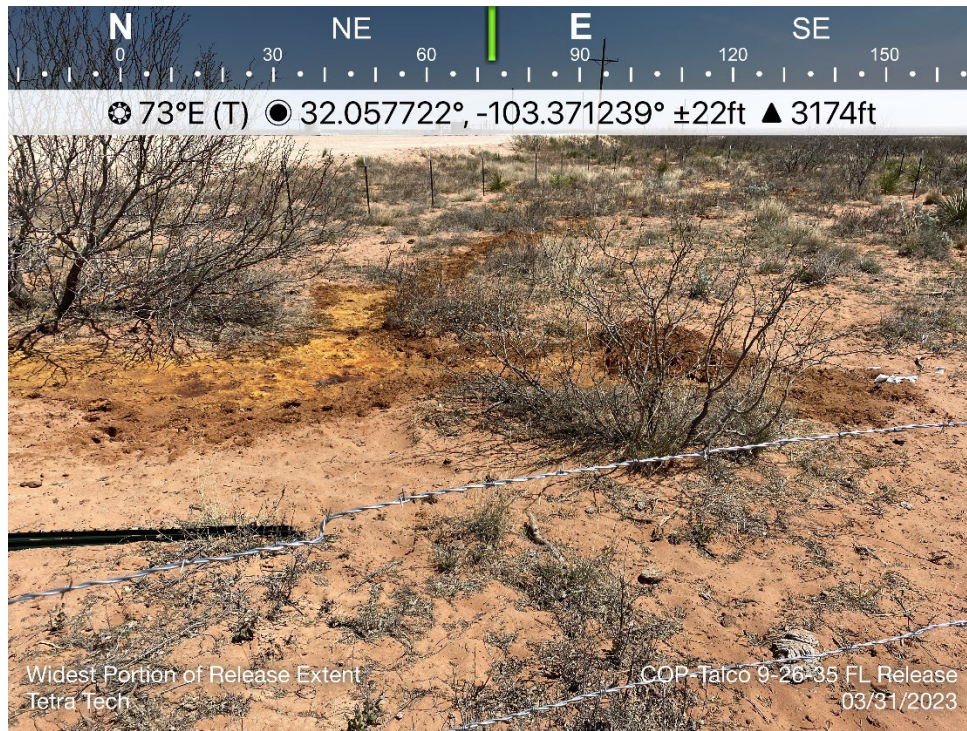
TETRA TECH, INC. PROJECT NO. 212C-MD-03073	DESCRIPTION	View east. Release footprint, surface staining.	5
	SITE NAME	Talco 9 26 35 Federal #003H Flowline Release	3/31/2023

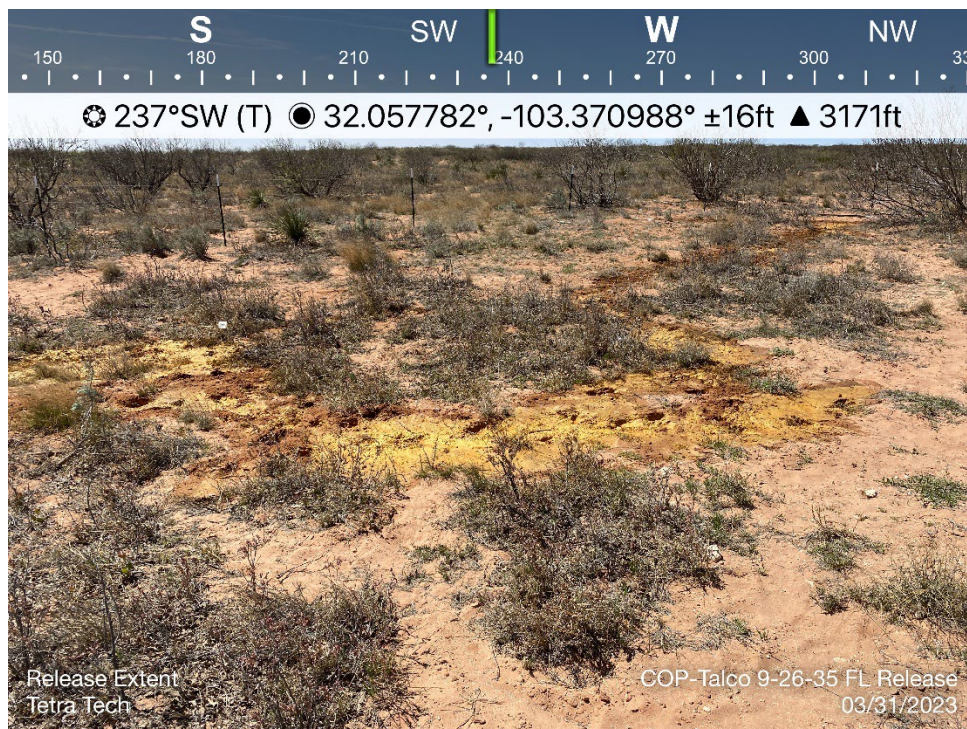
TETRA TECH, INC. PROJECT NO. 212C-MD-03073	DESCRIPTION	View southwest. Release footprint, surface staining.	6
	SITE NAME	Talco 9 26 35 Federal #003H Flowline Release	3/31/2023

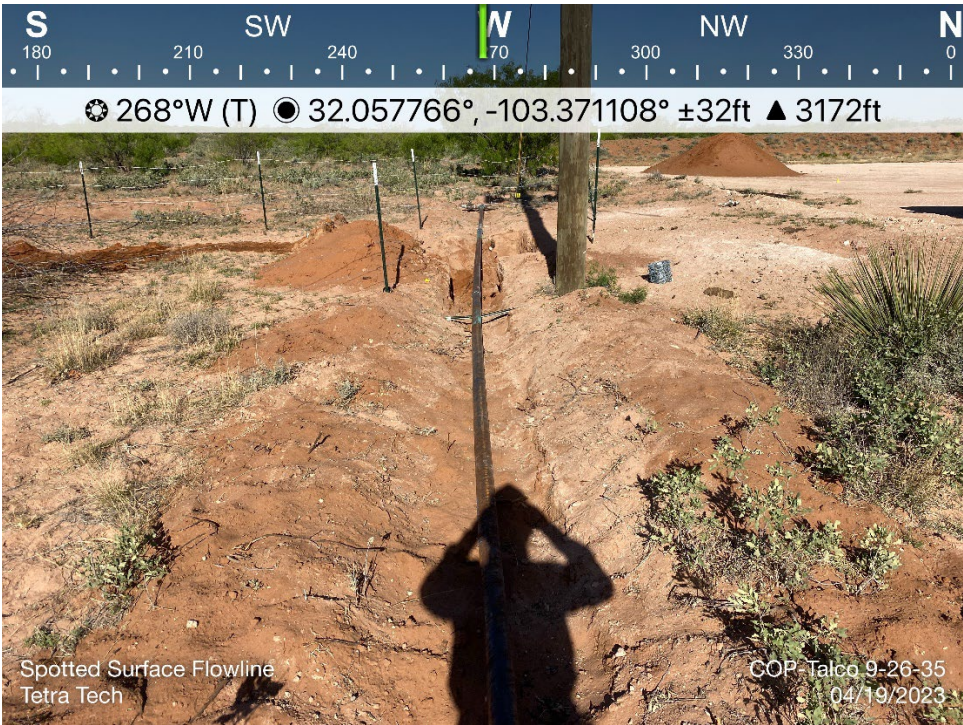
TETRA TECH, INC. PROJECT NO. 212C-MD-03073	DESCRIPTION	View west. Initial Response excavation, exposed subsurface steel line.	7
	SITE NAME	Talco 9 26 35 Federal #003H Flowline Release	4/19/2023

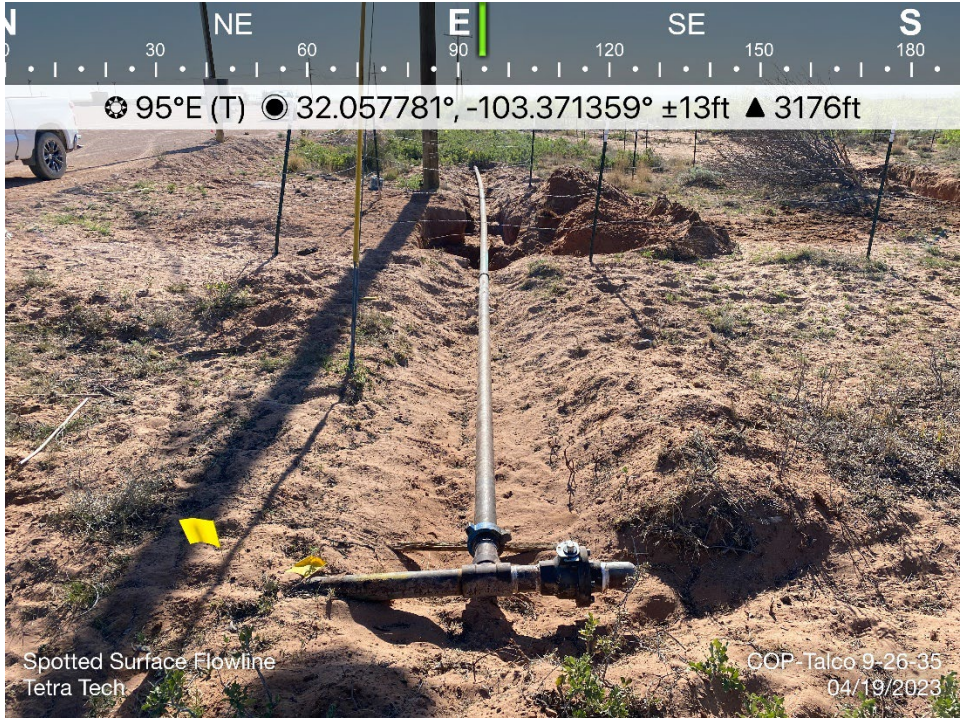
TETRA TECH, INC. PROJECT NO. 212C-MD-03073	DESCRIPTION	View east. Initial Response excavation, exposed subsurface steel line.	8
	SITE NAME	Talco 9 26 35 Federal #003H Flowline Release	4/19/2023

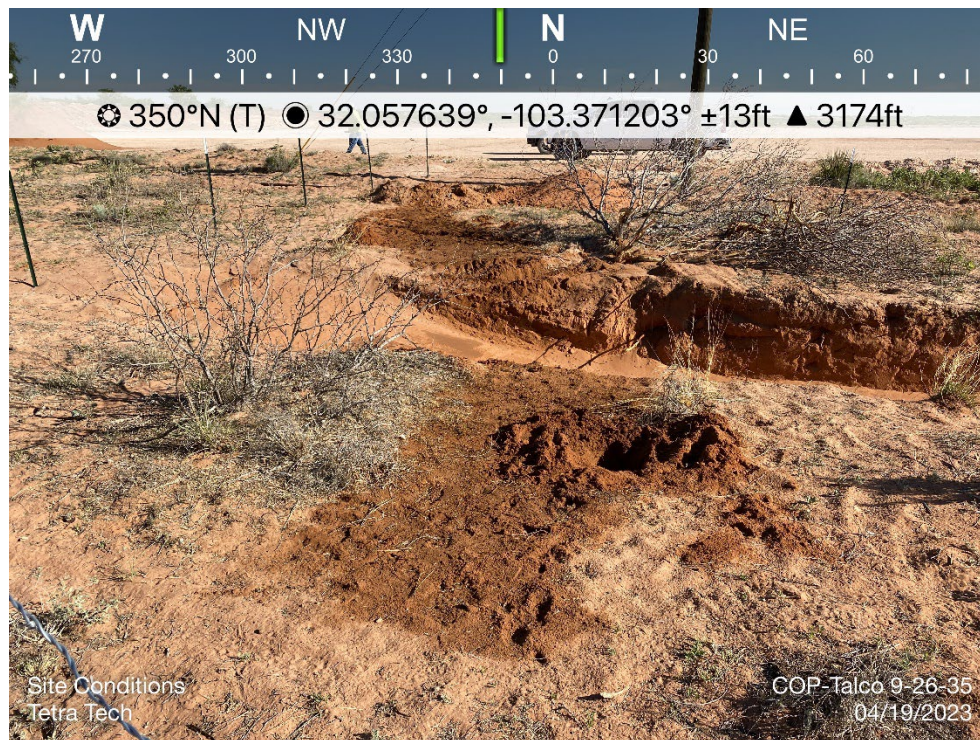
TETRA TECH, INC. PROJECT NO. 212C-MD-03073	DESCRIPTION	View north. Initial Response excavation, surface staining.	9
	SITE NAME	Talco 9 26 35 Federal #003H Flowline Release	4/19/2023

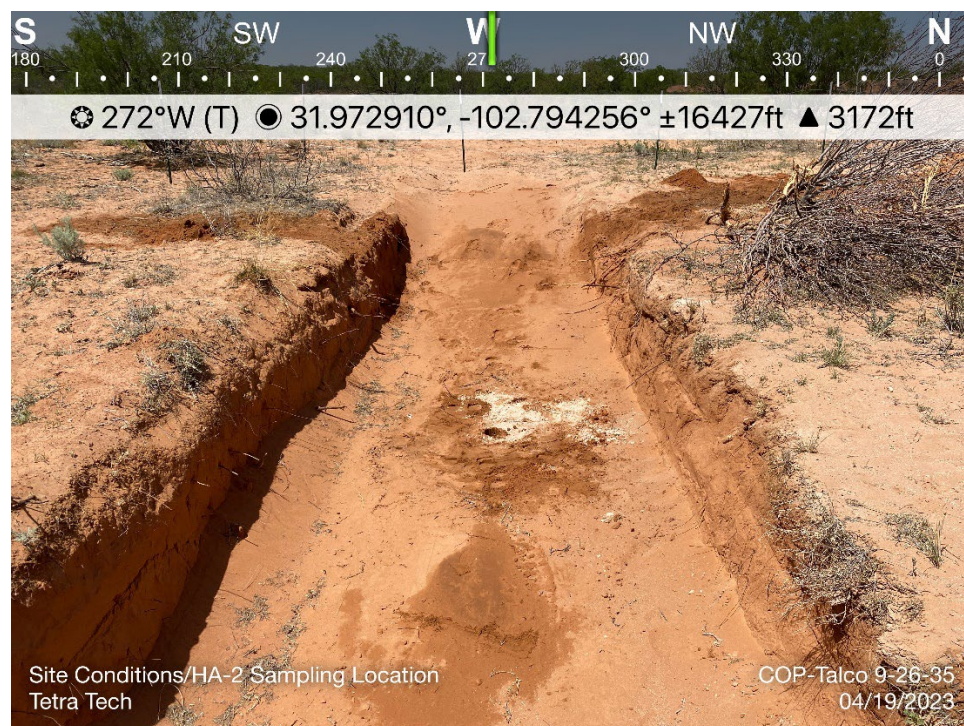
TETRA TECH, INC. PROJECT NO. 212C-MD-03073	DESCRIPTION	View west. Initial Response excavation, residual staining.	11
	SITE NAME	Talco 9 26 35 Federal #003H Flowline Release	4/19/2023
