Extex Operating – Penroc 10 State No. 1

Oil Spill Clean Up

Penroc 10 State No. 1 – Remediation & Delineation Report

On 5/1/2023, Extex Operating reported a minor 5 bbl oil spill at the Penroc 10 State No.1 production site (Incident # nAPP2312129778). Extex representatives arrived at the spill site and determined 5 bbls of oil were released due to separator equipment failure and recovered approximately 5 bbls of oil.

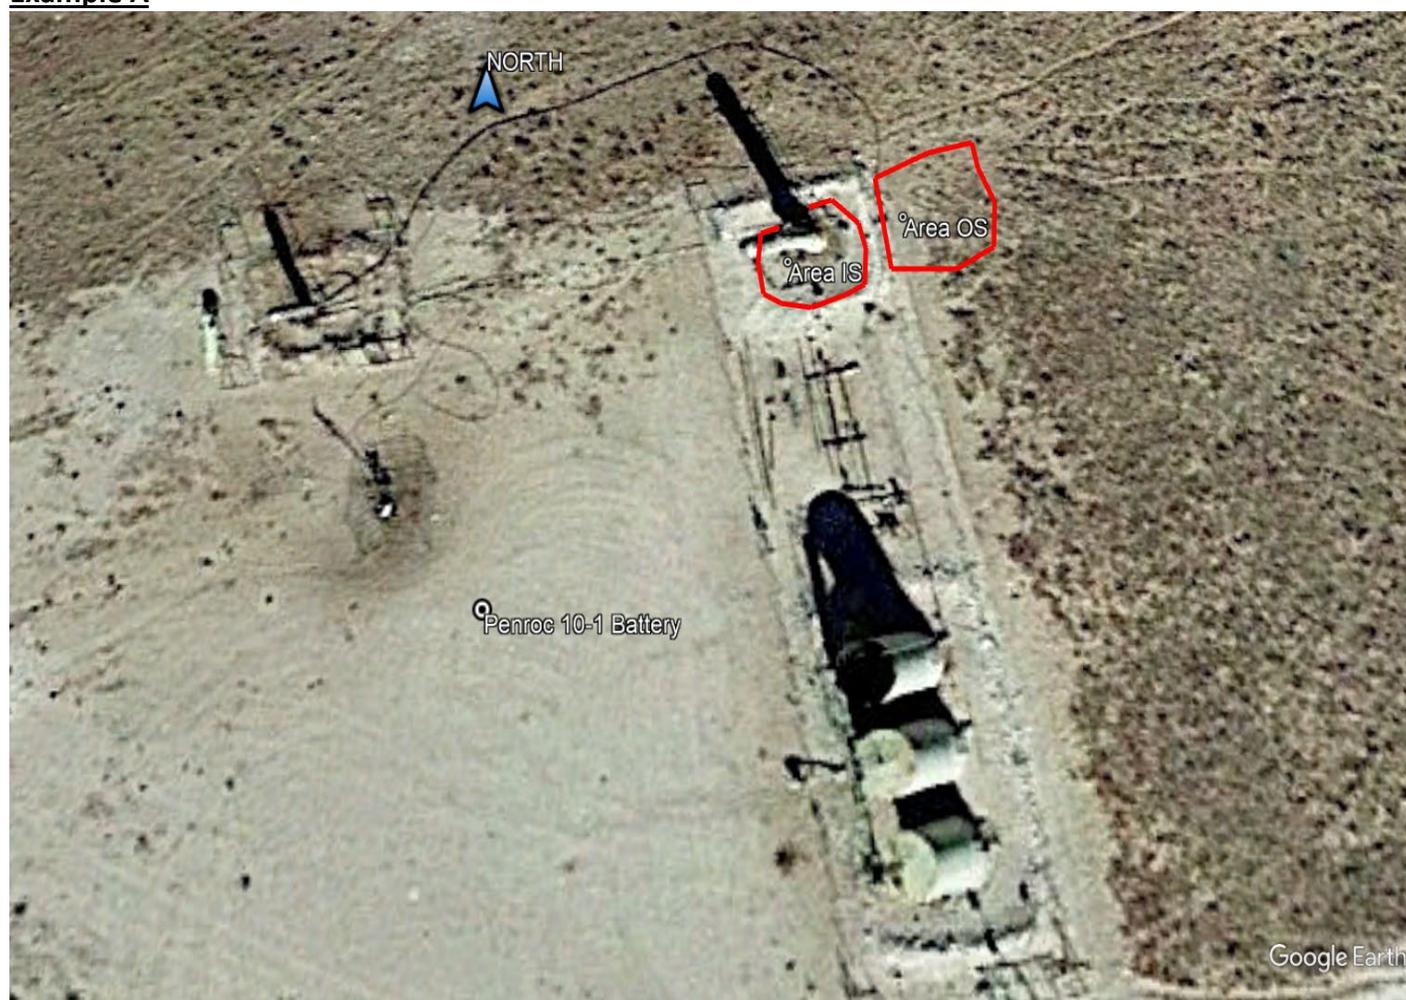
Example A

Provided below is a satellite image of the Penroc 10-1 battery located in Lea County New Mexico. The spill areas have been highlighted and labeled as Area (IS) for inside containment and Area (OS) for outside containment. (See Example A)

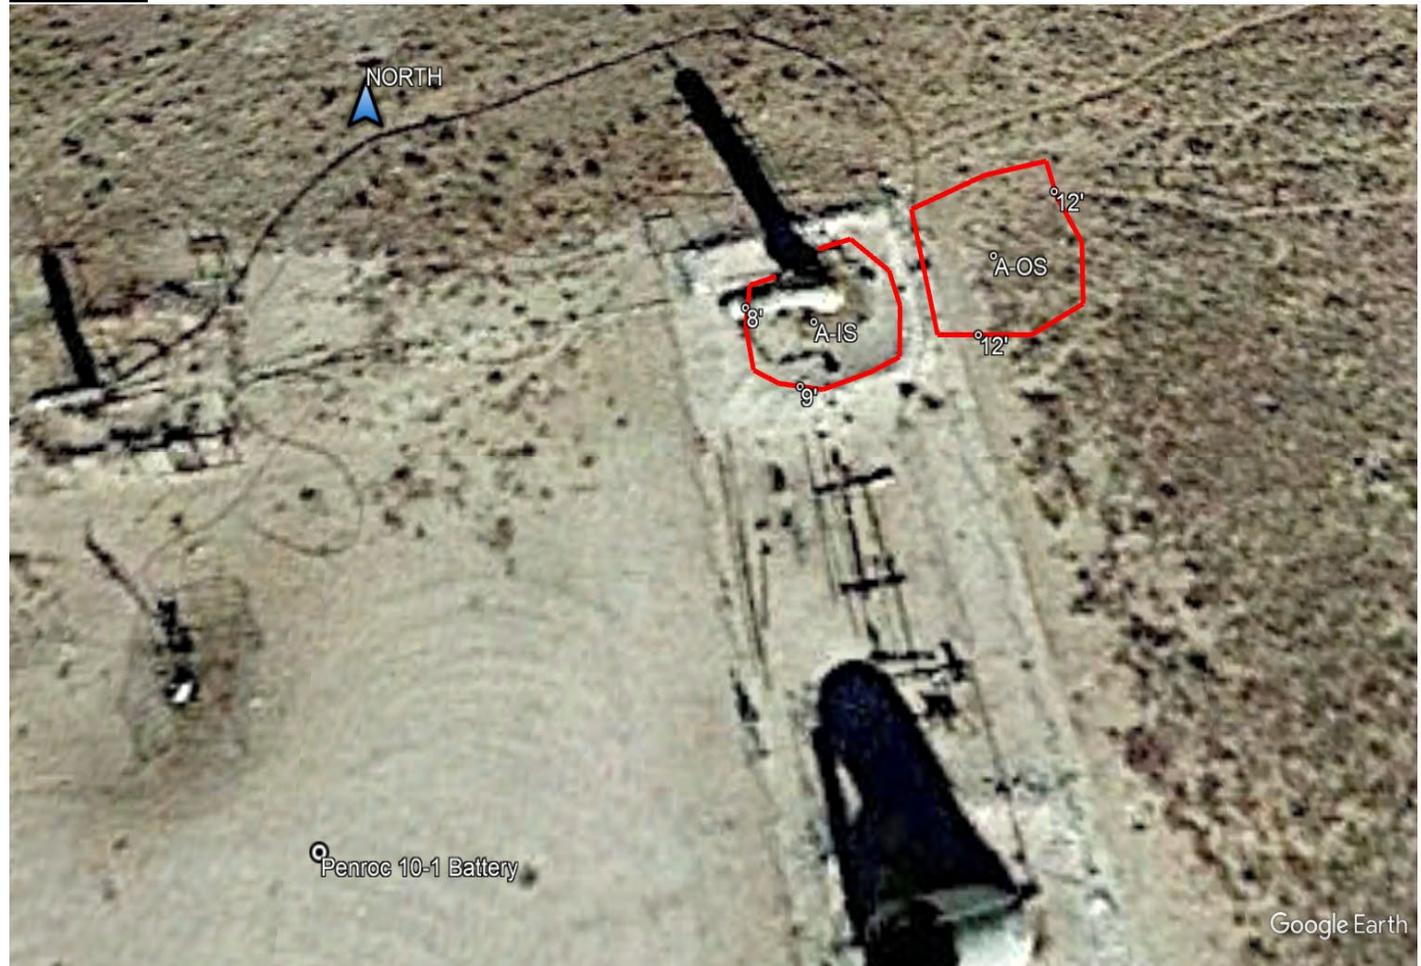
Example B

Area – “OS”: 12-foot by 12-foot area of light oil and produced water staining to the east of the vessel, outside containment. (See Example B) All flow line spills have been repaired and there’s no free-standing oil or produced water within the delineated areas.

AREA – OS: All surface oil leakage and staining was excavated and removed from the area outside containment. Initial testing of soil (Sample ID's: P-10-1-OC-1 & P-10-1-OC-2) by Cardinal Laboratories concluded that further excavation was required and additional soil was removed to a depth of 6-12 inches and hauled to disposal. Secondary testing determined that all soil containing TPH and chlorides exceeding State of New Mexico OCD thresholds had been excavated and removed from this area.

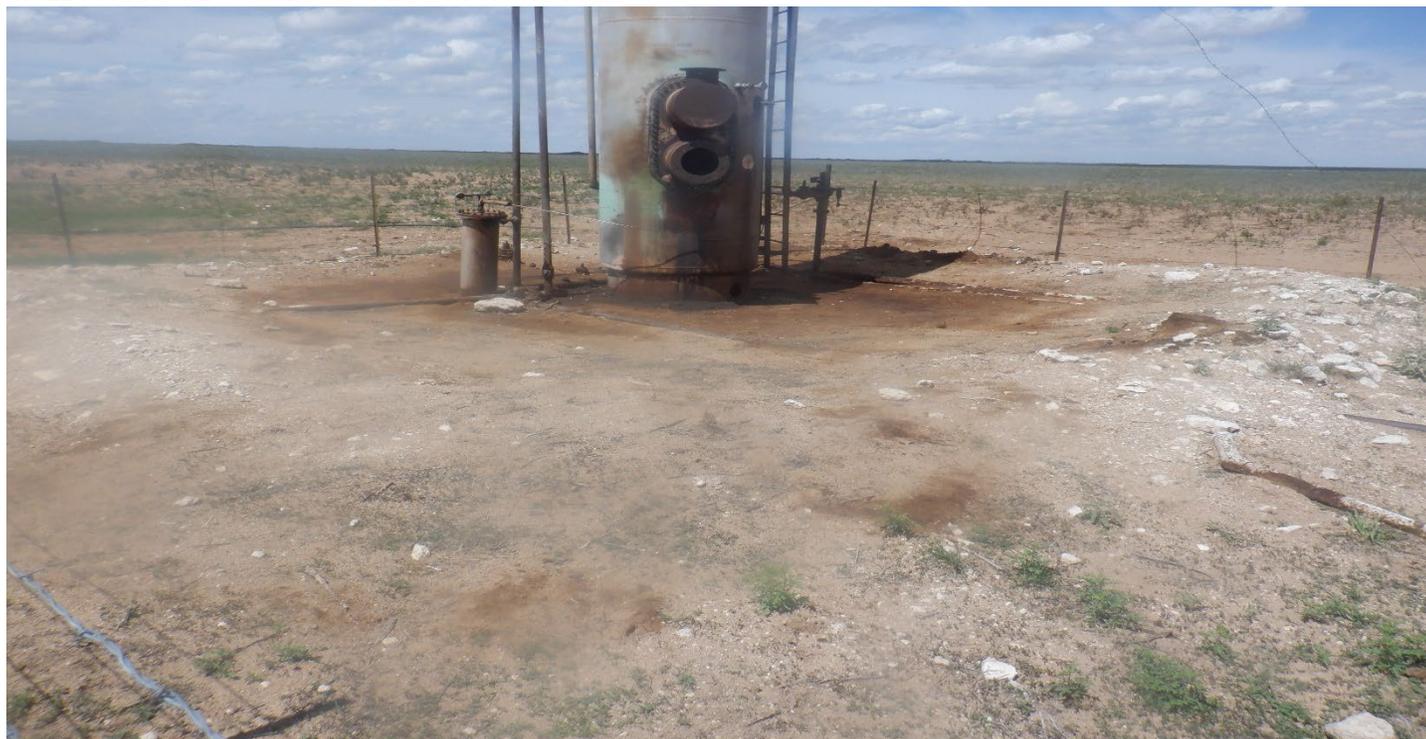
SPILL PHOTO #1 – AREA “IS”: Before Remediation:

Area – “IS”: 9-foot by 8-foot area of light oil leakage around the vessel within containment.

AREA – IS: All surface oil leakage and staining was excavated and removed from containment. All soil containing TPH and chlorides exceeding State of New Mexico OCD thresholds was excavated and removed from around the vessel within containment. Certified soil samples were collected and delivered to Cardinal Laboratories in Hobbs, New Mexico. All contaminated soil excavated and removed was hauled to Gandy Marley Disposal.

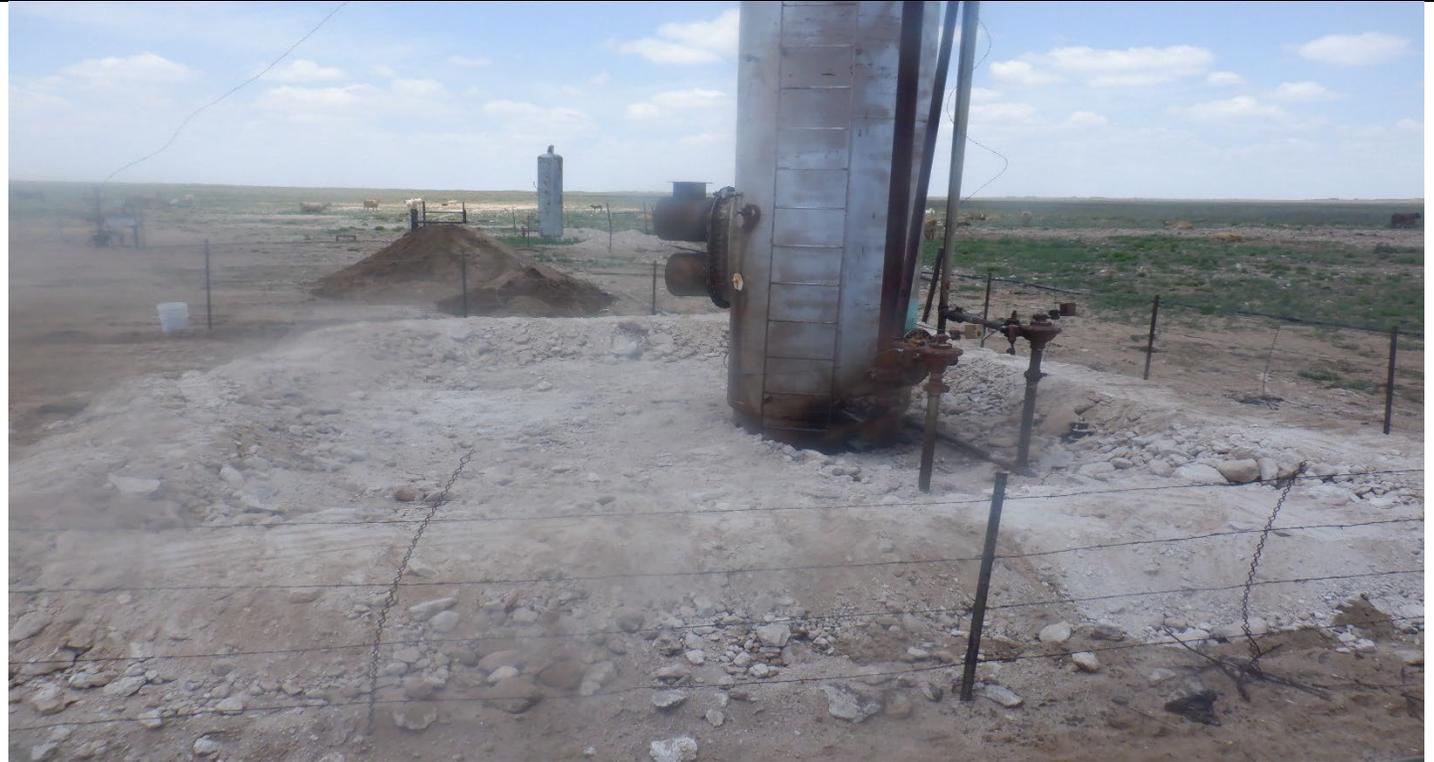
BACKFILL PHOTO #1; AREA – “IS”:

AREA – IS: 10-yards of fresh caliche was delivered and used for backfill and the construction of berms within and around the excavated area.

The excavated area was backfilled and leveled with new containment berms constructed for spill protection. The area outside containment was backfilled and leveled to represent the natural surroundings; all caliche and native soil was used for backfill. All fences were placed back around containment, and all remaining caliche delivered to the battery was used for berm construction around the vessel.

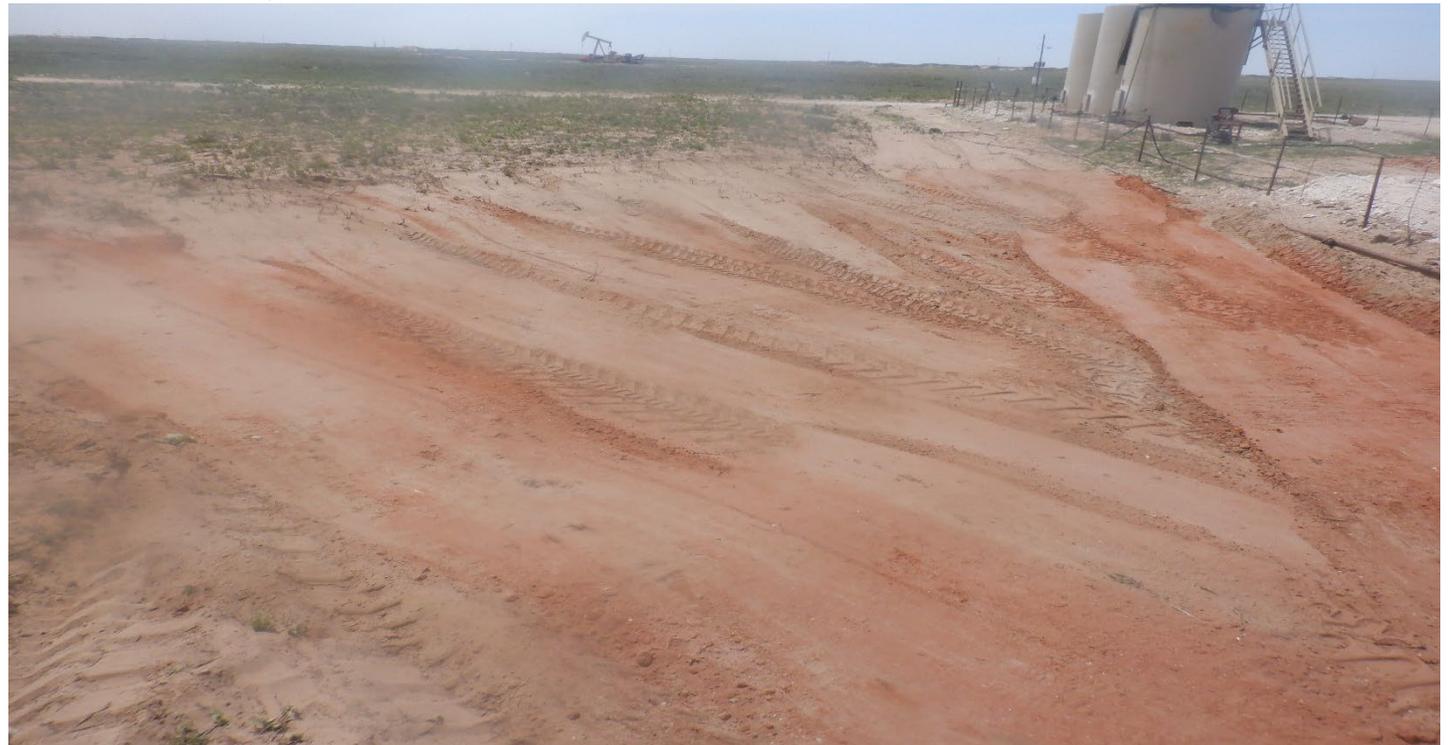
BACKFILL PHOTO #2; AREA – “OS”:

AREA – OS: 10-yards of native soil/sand was delivered and used for backfill within the area east of the vessel.
