Incident ID	nAB1914252088
District RP	2RP-5435
Facility ID	
Application ID

August 19, 2019

Devon Energy Corporation retained Vertex Resource Services Inc. (Vertex) to conduct a Spill Assessment for a produced water and crude oil release caused by a mechanical malfunction on Apache 25 Federal #003, API 30-015-32719, Incident 2RP-5435 (hereafter referred to as "site"). This letter provides a description of the Spill Assessment and includes a request for Spill Closure. The spill area is located at N 32.3684883, W -103.8266678.

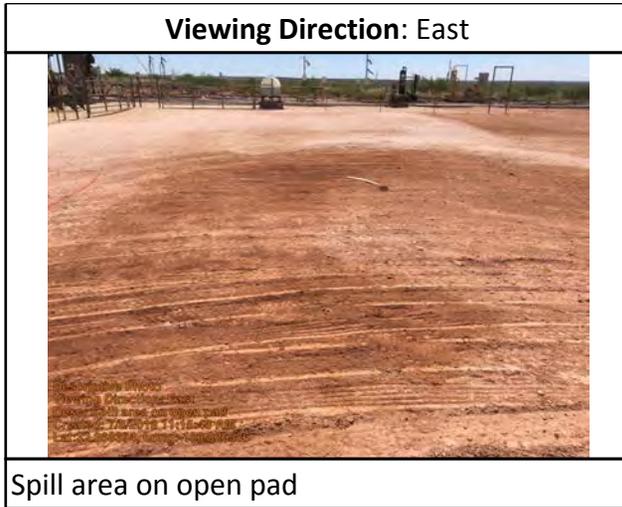
Spill area on open pad

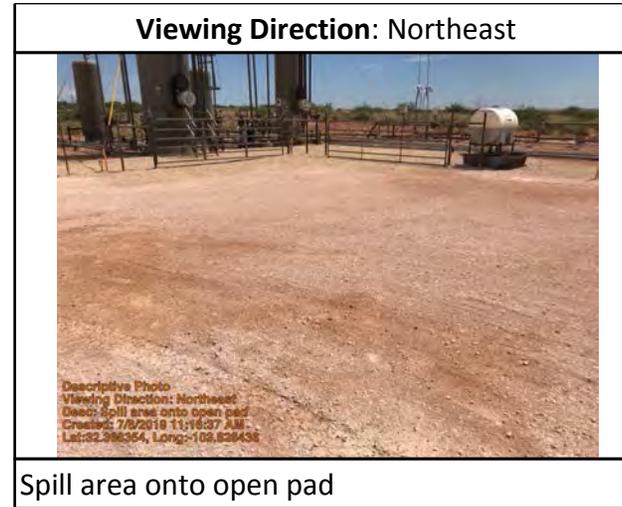
Spill area onto open pad

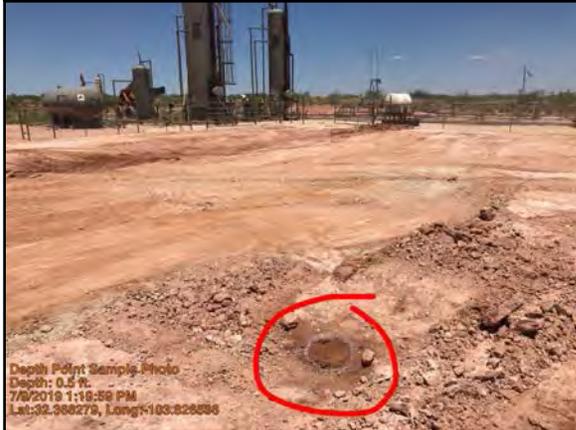
Sample Point ID: TP19-01

Depth: 0.5 ft.

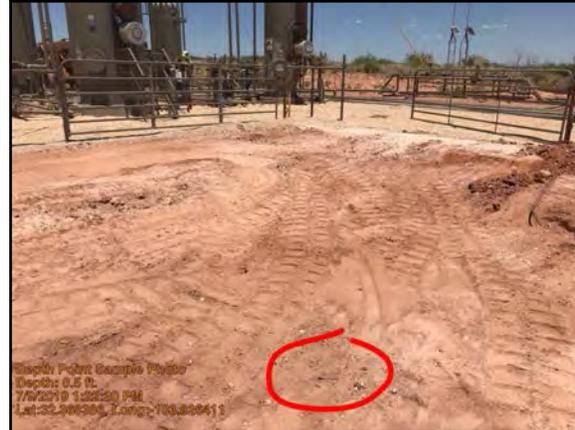
Sample Point ID: TP19-02

Depth: 0.5 ft.

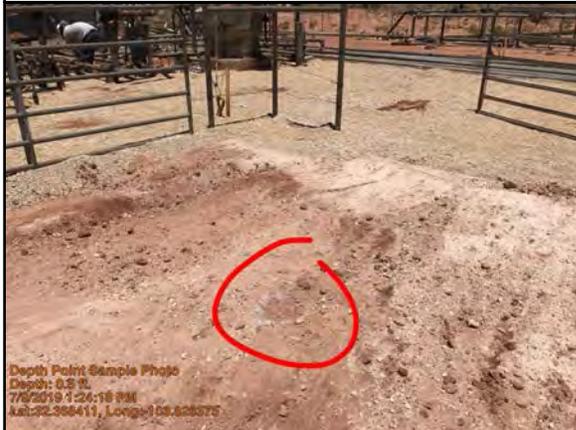
Sample Point ID: TP19-03

Depth: 0.5 ft.

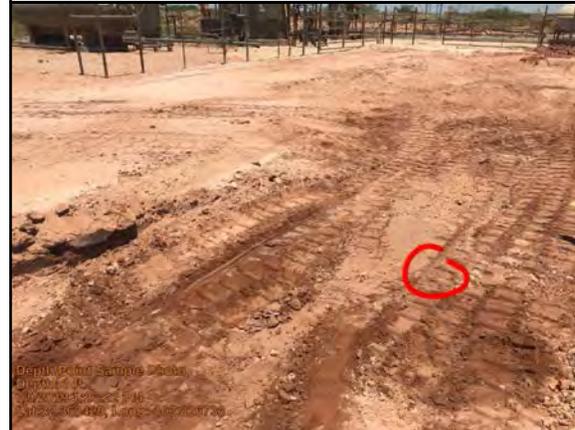
Sample Point ID: TP19-04

Depth: 1 ft.

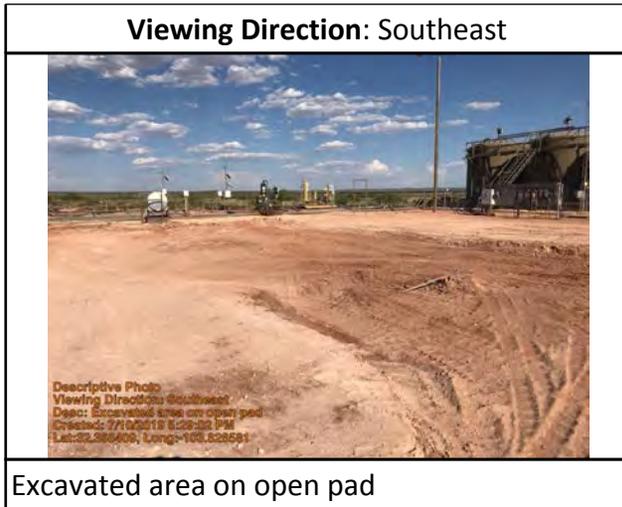
Excavated area on open pad

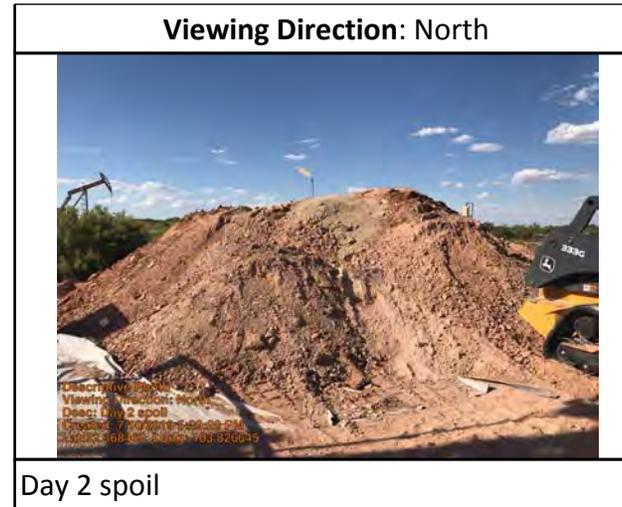
Day 2 spoil

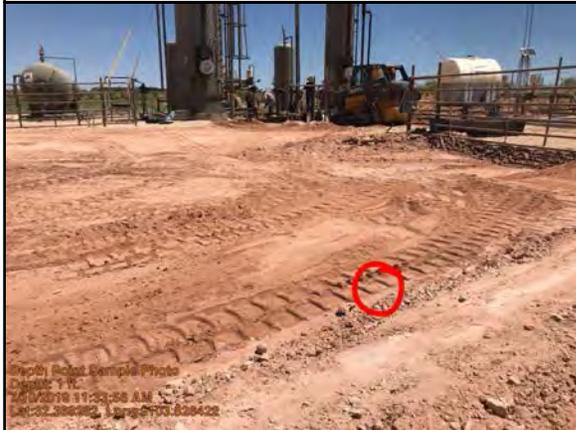
Sample Point ID: TP19-08

Depth: 1 ft.

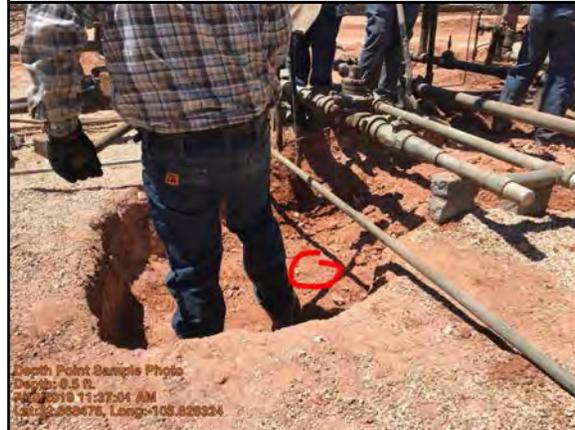
Sample Point ID: TP19-11

Depth: 0.5 ft.

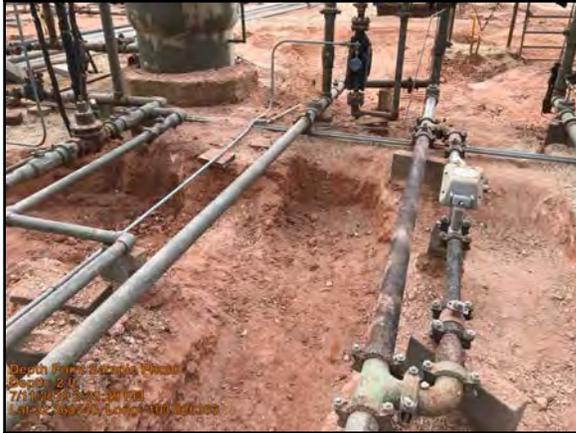
Sample Point ID: TP19-15

Depth: 2 ft.

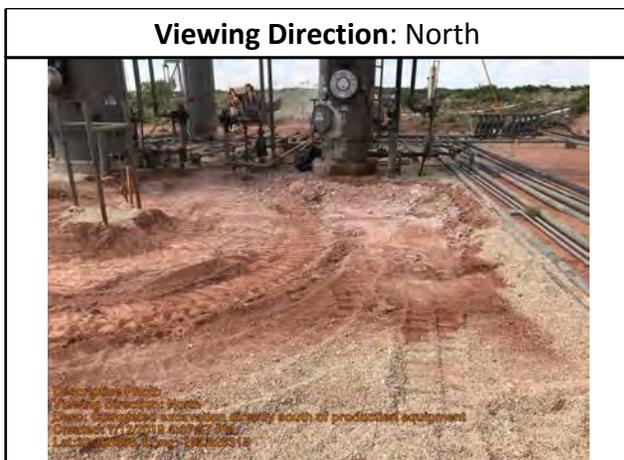
Completed excavation directly south of production equipment

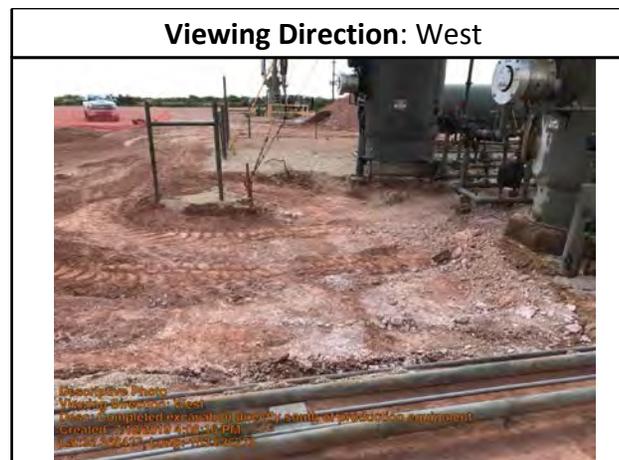
Completed excavation directly south of production equipment

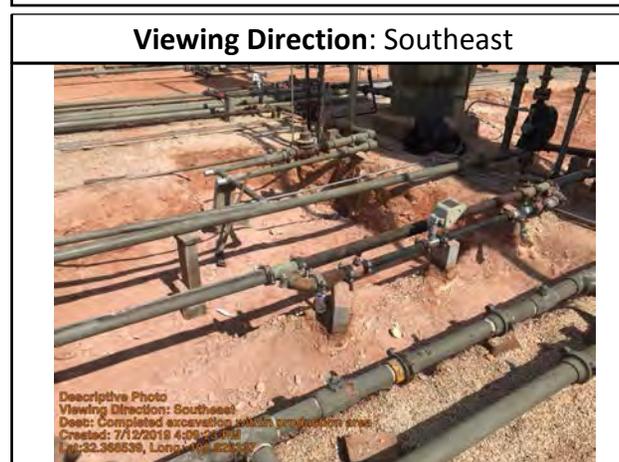
Completed excavation within production area

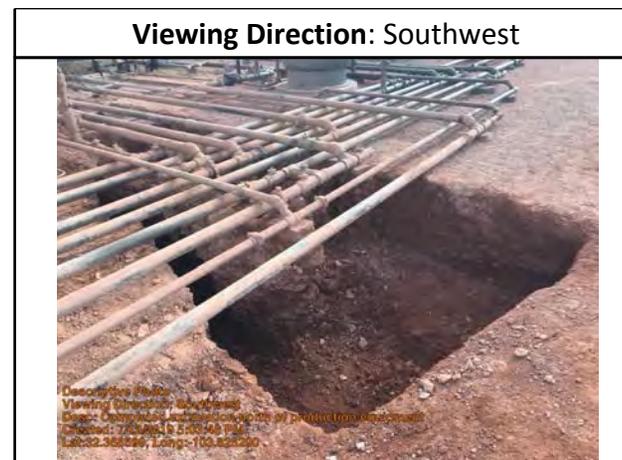
Completed excavation north of production equipment

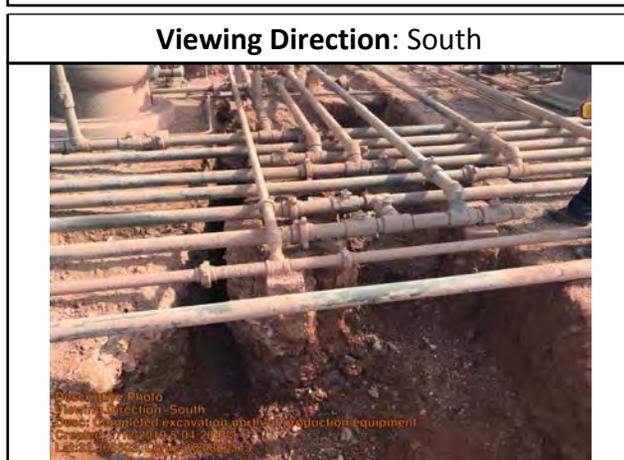
Completed excavation north of production equipment
