**Re: Release Characterization and Remediation Report
Maverick Permian, LLC
SEMU Permian Upper Battery Release
Unit Letter K, Section 19, Township 20 South, Range 38 East
Lea County, New Mexico
Incident ID# nAPP2207049431**

Site Remediation Closure Report
SEMU Permian Upper Battery
nAPP2207049431

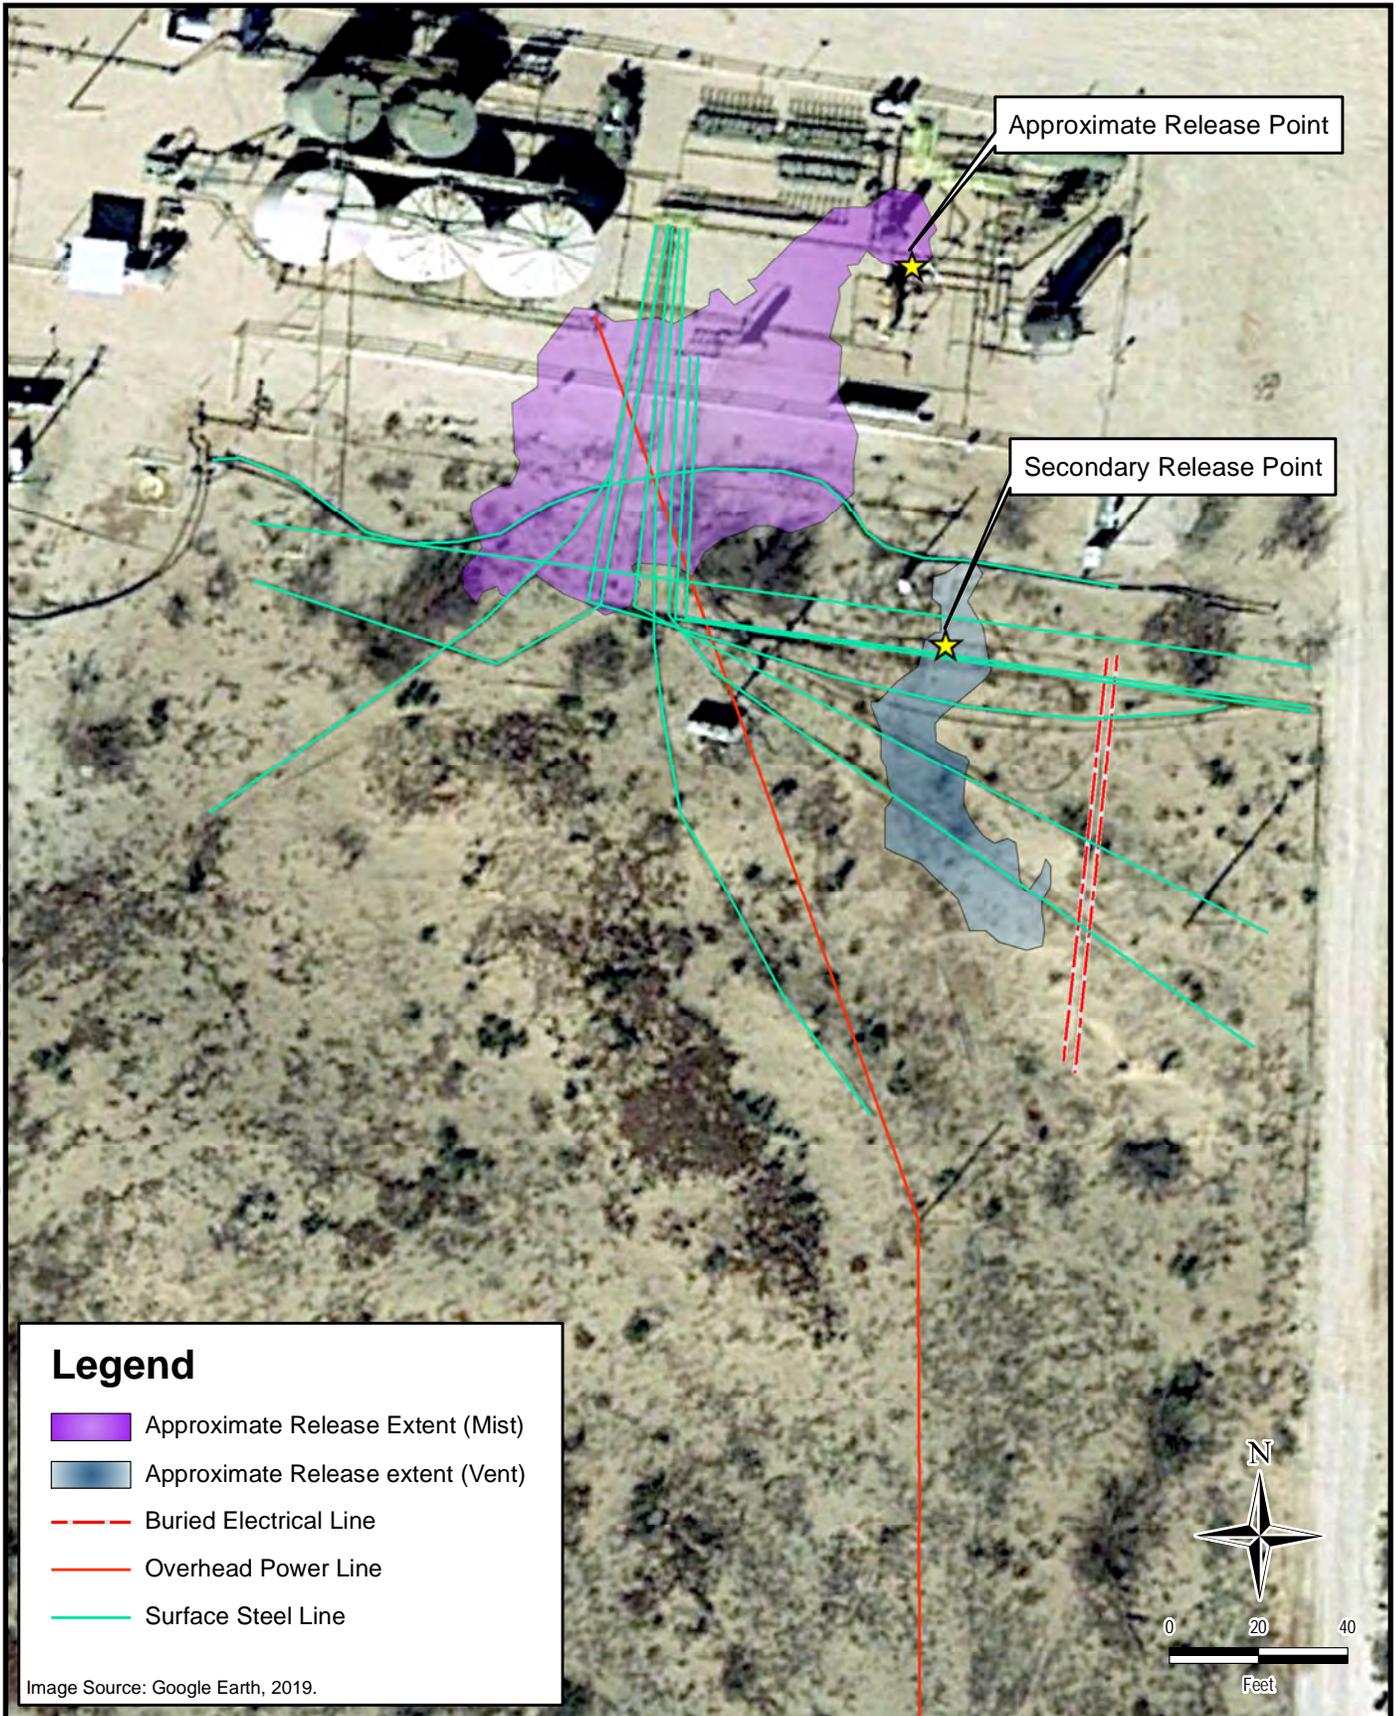
Figure No.
3

- Approximate Release Extent (Mist)
- Approximate Release extent (Vent)
- Buried Electrical Line
- Overhead Power Line
- Surface Steel Line

Initial response remedial actions were performed at the release site between April 7 and 11, 2022. Visually stained areas of the pastureland were scraped to remove impacted materials to approximately 1-foot bgs, resulting in approximately 46 cubic yards of contaminated soil being removed and transported to the R360 Halfway Facility in Hobbs, New Mexico for disposal. The initial response area is indicated in **Figure 3**.

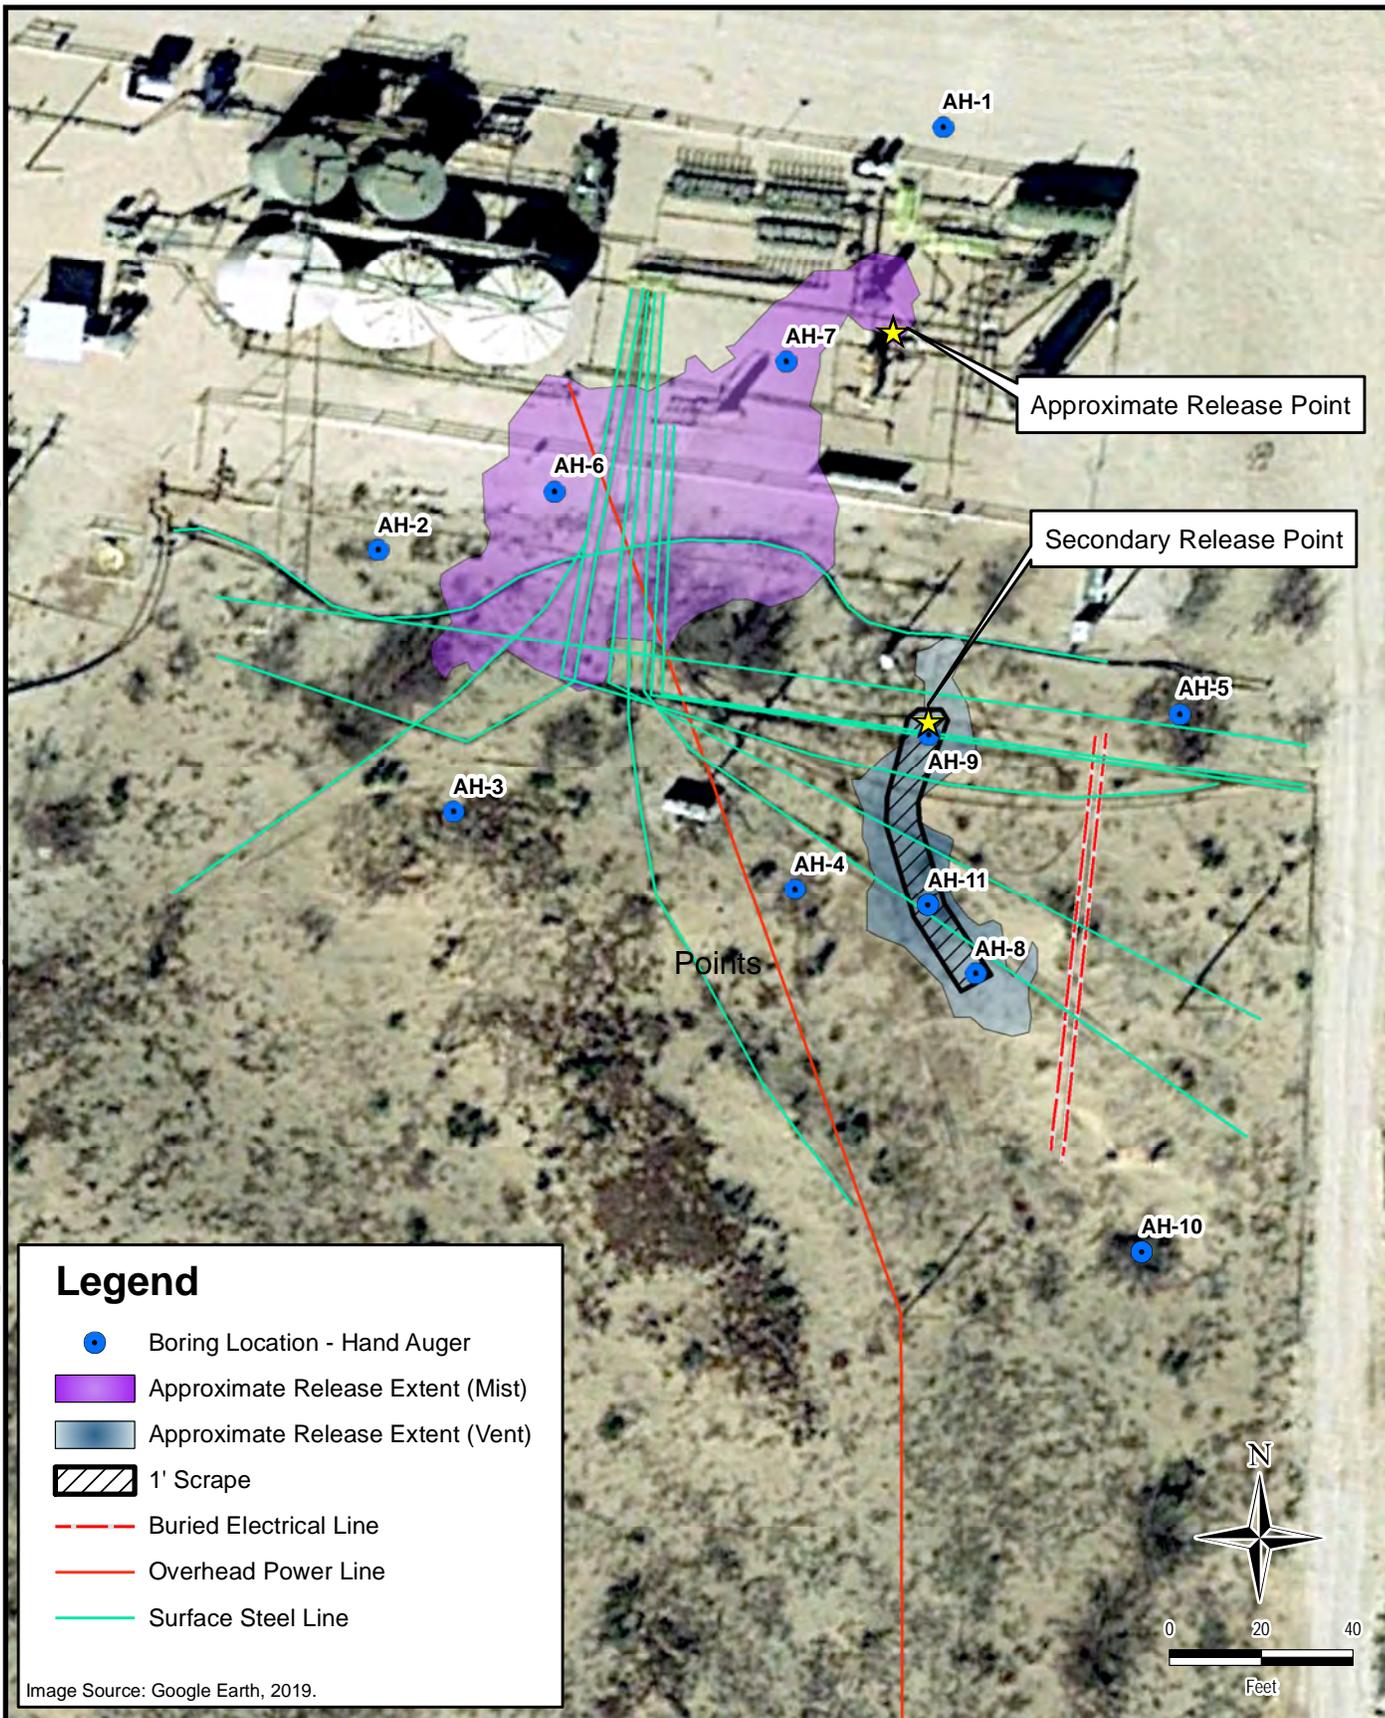
Figure No.
4

- Boring Location - Hand Auger
- Approximate Release Extent (Mist)
- Approximate Release Extent (Vent)
- 1' Scrape
- Buried Electrical Line
- Overhead Power Line
- Surface Steel Line

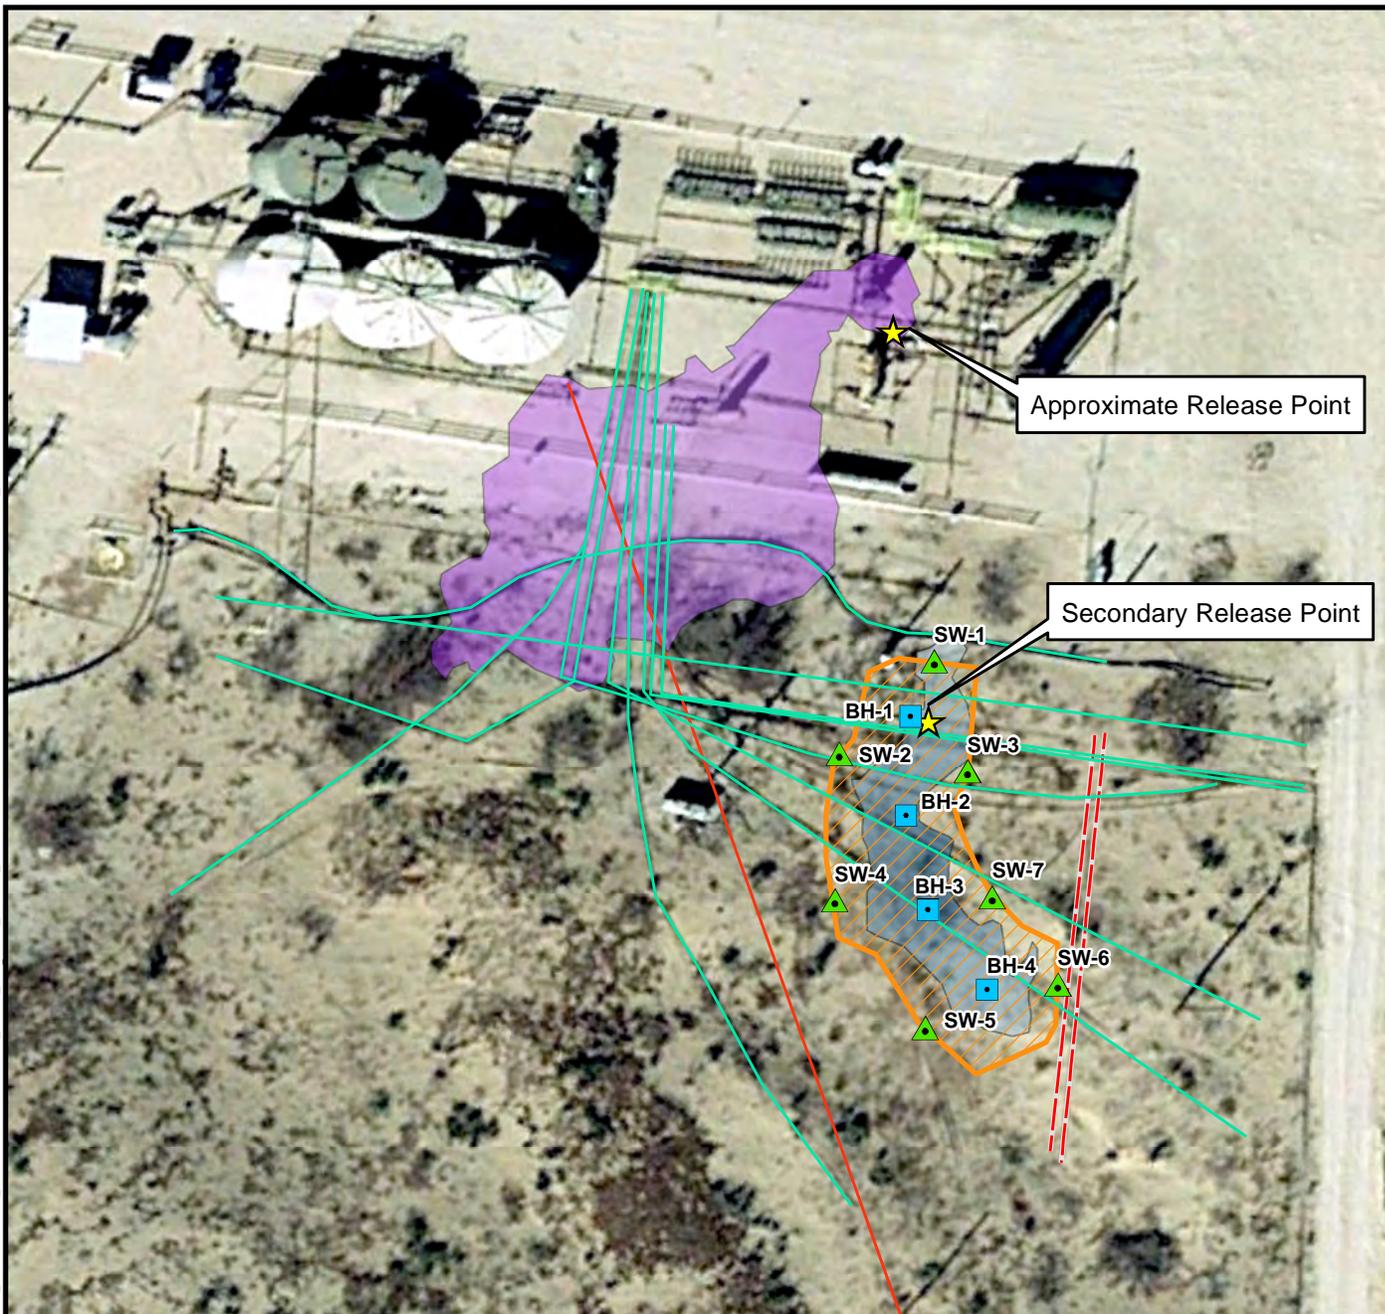
- Bottom Hole Confirmation Sample Location
- ▲ Sidewall Confirmation Sample Location
- Approximate Release Extent (Mist)
- Approximate Release Extent (Vent)
- Excavation Extent - 4' bgs
- Buried Electrical Line
- Overhead Power Line
- Surface Steel Line
