**Subject: Closure Letter Report  
ConocoPhillips  
1RP-4254  
Red Hills West State 16 W2 CTB Release  
Unit Letter A, Section 16, Township 26 South, Range 32 East  
Lea County, New Mexico**

## Red Hills West State 16 W2 CTB (RP-4254) Corrective Action Plan

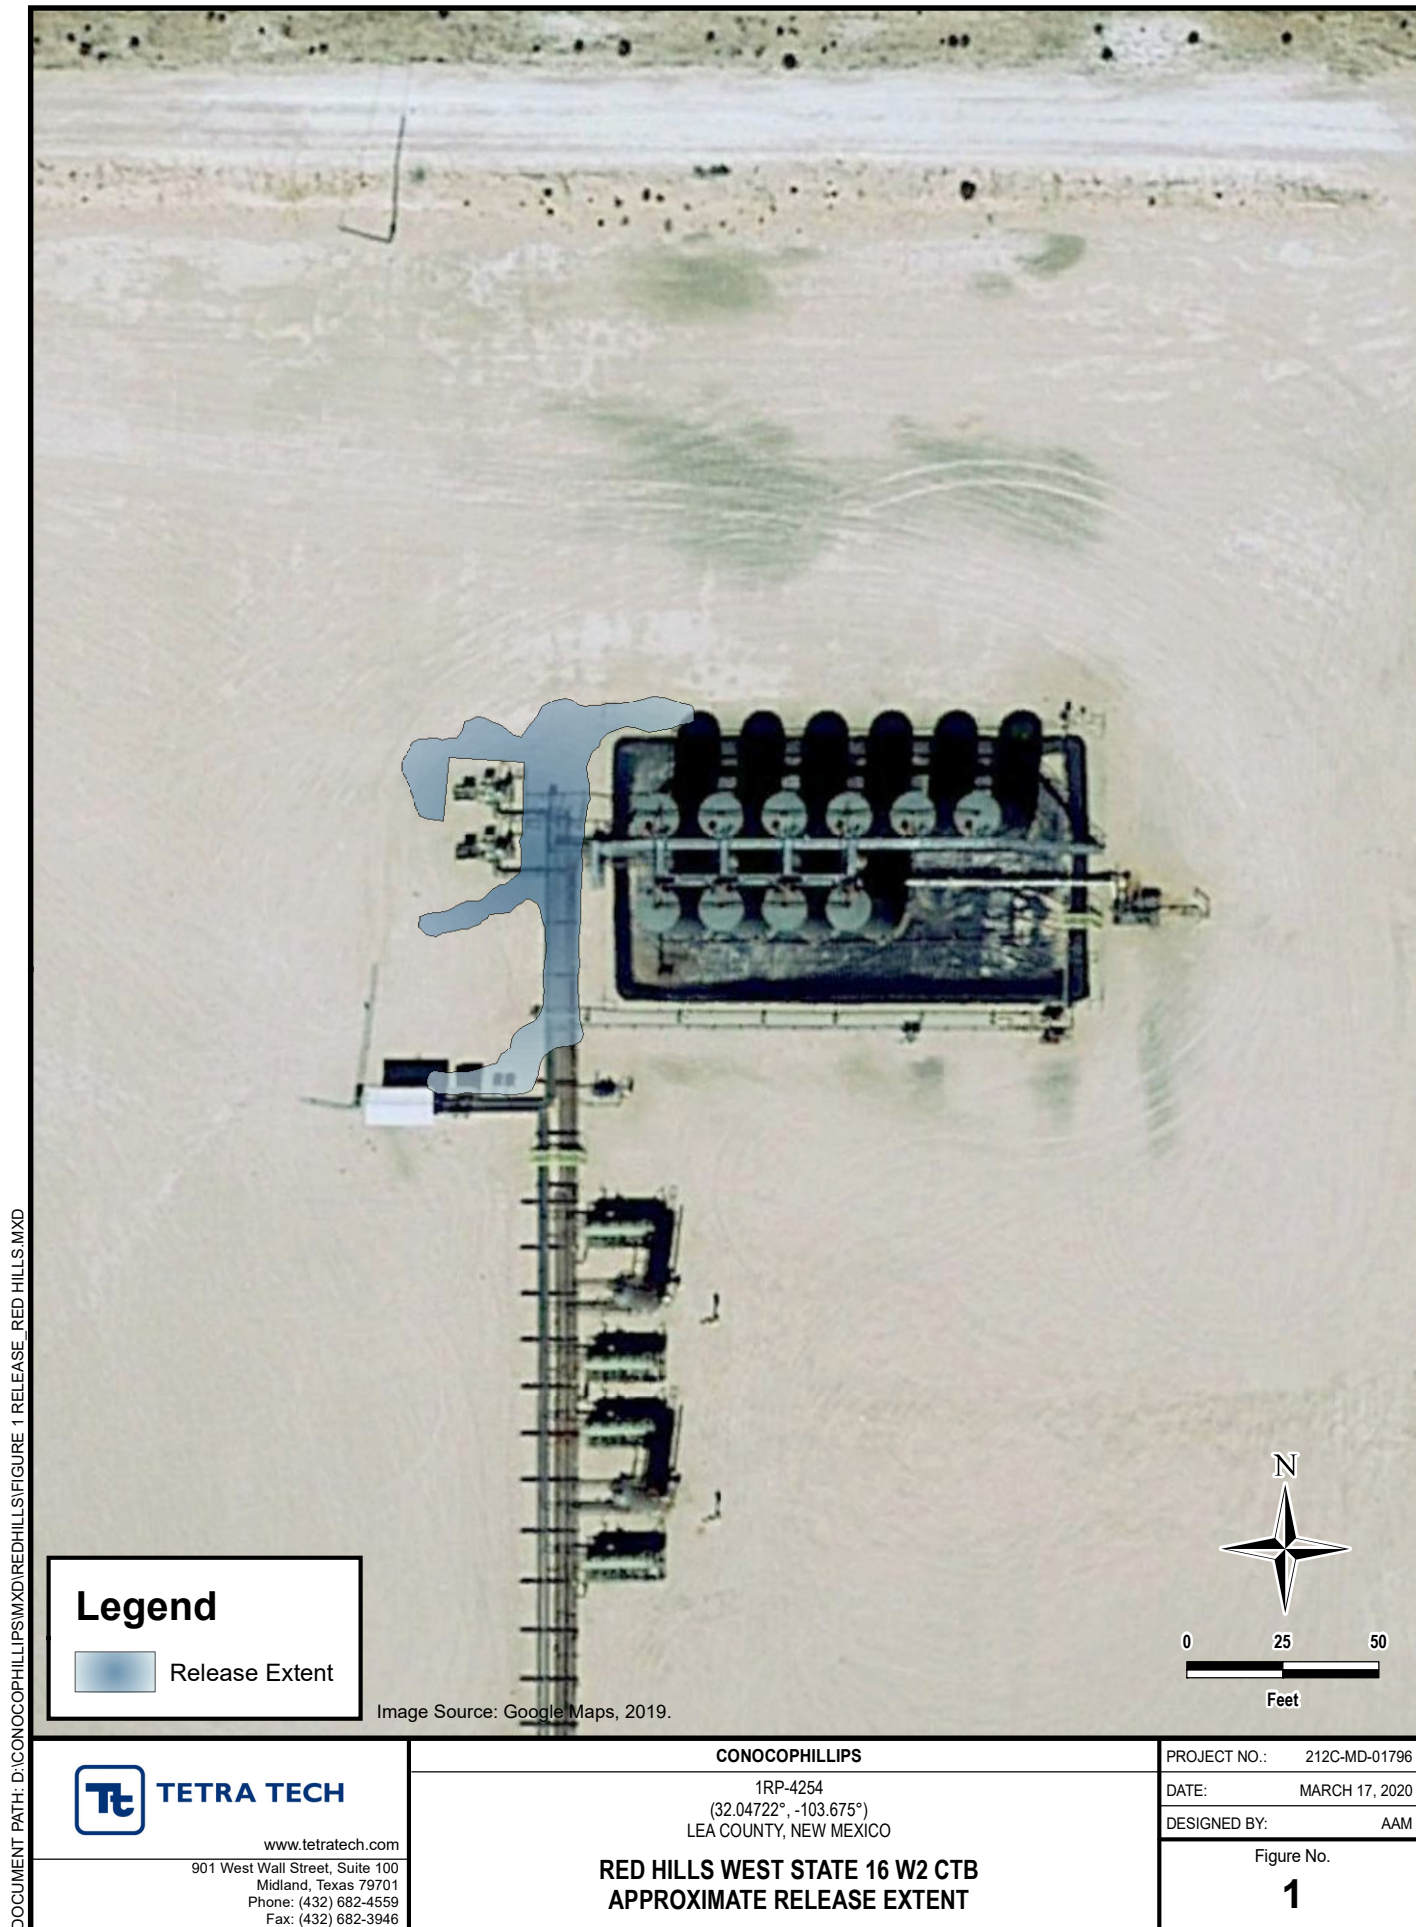
On behalf of ConocoPhillips, Tetra Tech, Inc. (Tetra Tech) submits the following Closure Report in response to a release that occurred at the ConocoPhillips' Red Hills West State 16 W2 Central Tank Battery (CTB). The C-141 states the site is in Unit Letter D, Section 16, Township 26 South, Range 32 East, in Lea County. However, based on the coordinates provided, the site is actually in Unit Letter A, Section 16, Township 26 South, Range 32 East in Lea County, New Mexico (Site). The approximate release Site coordinates are 32.047883°, -103.675105° and the Site is approximately 29.6 miles southeast of Lovington in southern Lea County, New Mexico (Figure 1).

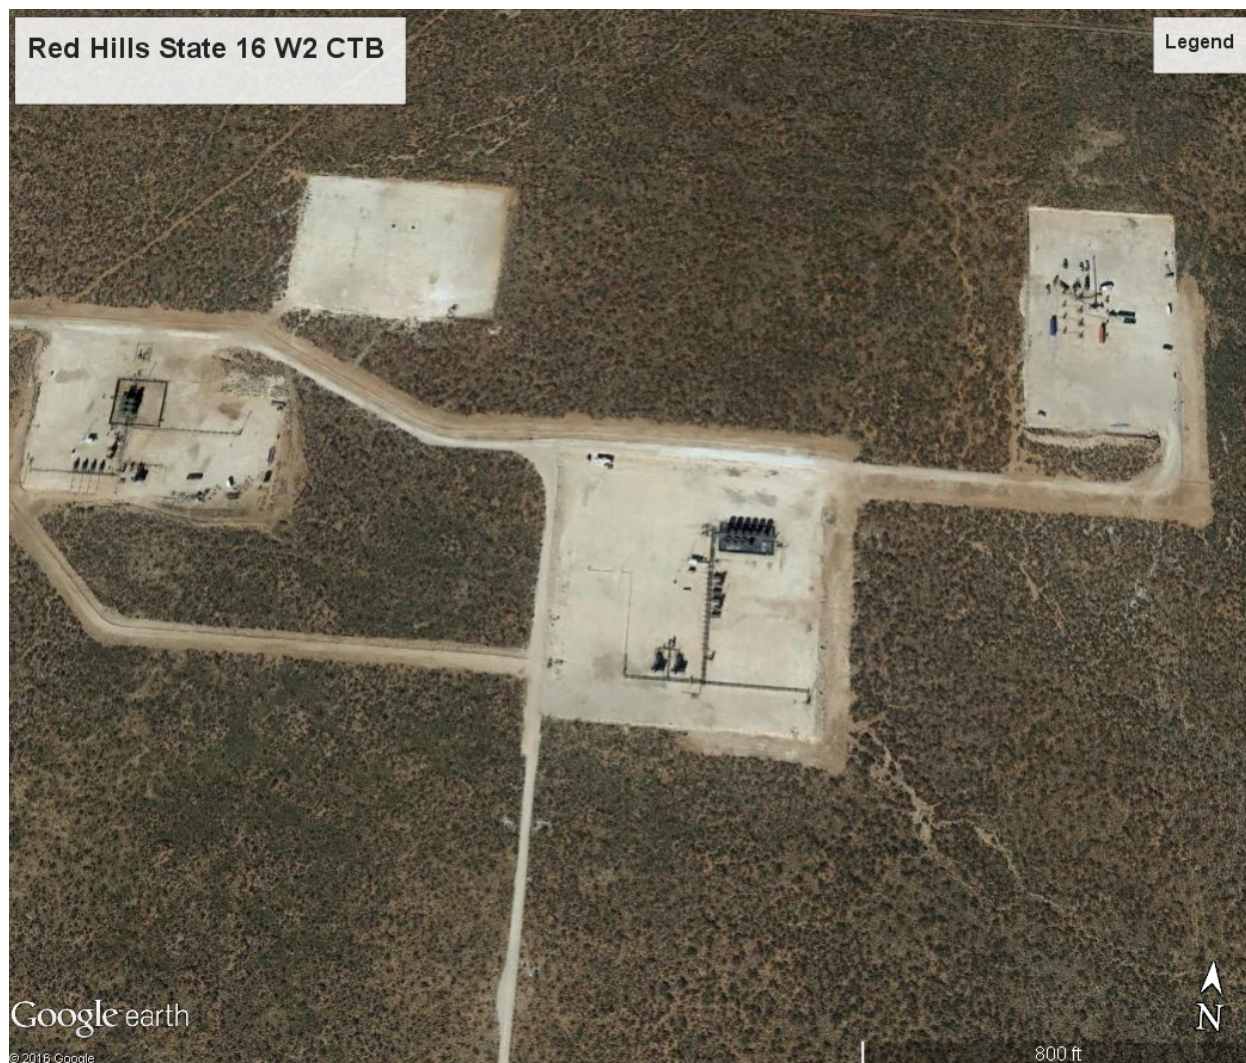
# Figure 1 – Site Map

COP personnel were on site to visually assess the release on April 15, 2016. The release was mapped and photographed (Appendix B). Based on the assessment, the release will be excavated down 6 inches bgs. Once the excavation is completed, a composite field screening sample from the bottom of the excavation will be taken and field tested for chlorides and organic vapors. If the field screening indicates that the composite will not achieve chloride, Gasoline Range Organics (GRO), Diesel Range Organics (DRO) and BTEX readings below regulatory standards, the excavation will be deepened until confirmation sampling (from three discrete samples collected from the excavation bottom) indicates that all constituents are below regulatory standards. The confirmation samples will be taken to a commercial laboratory to confirm that chloride, GRO, DRO and BTEX readings are below regulatory standards.

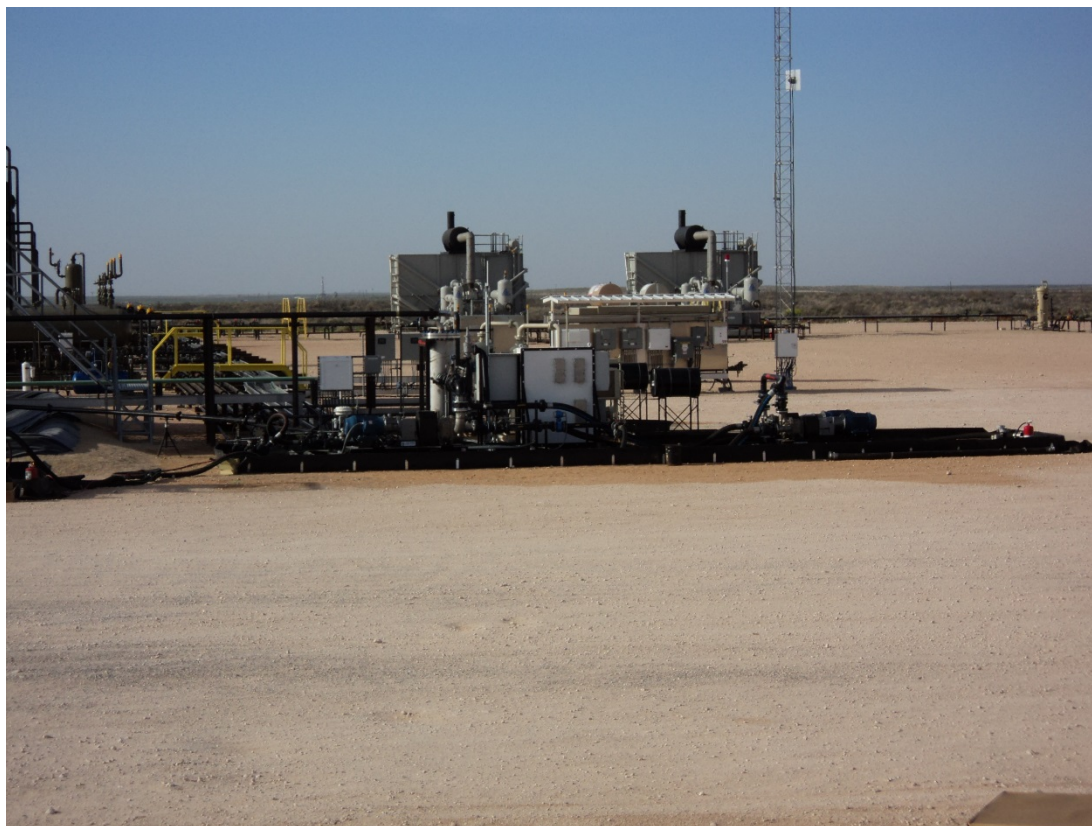
View looking towards the south of the de-oiler skid (4/15/2016)

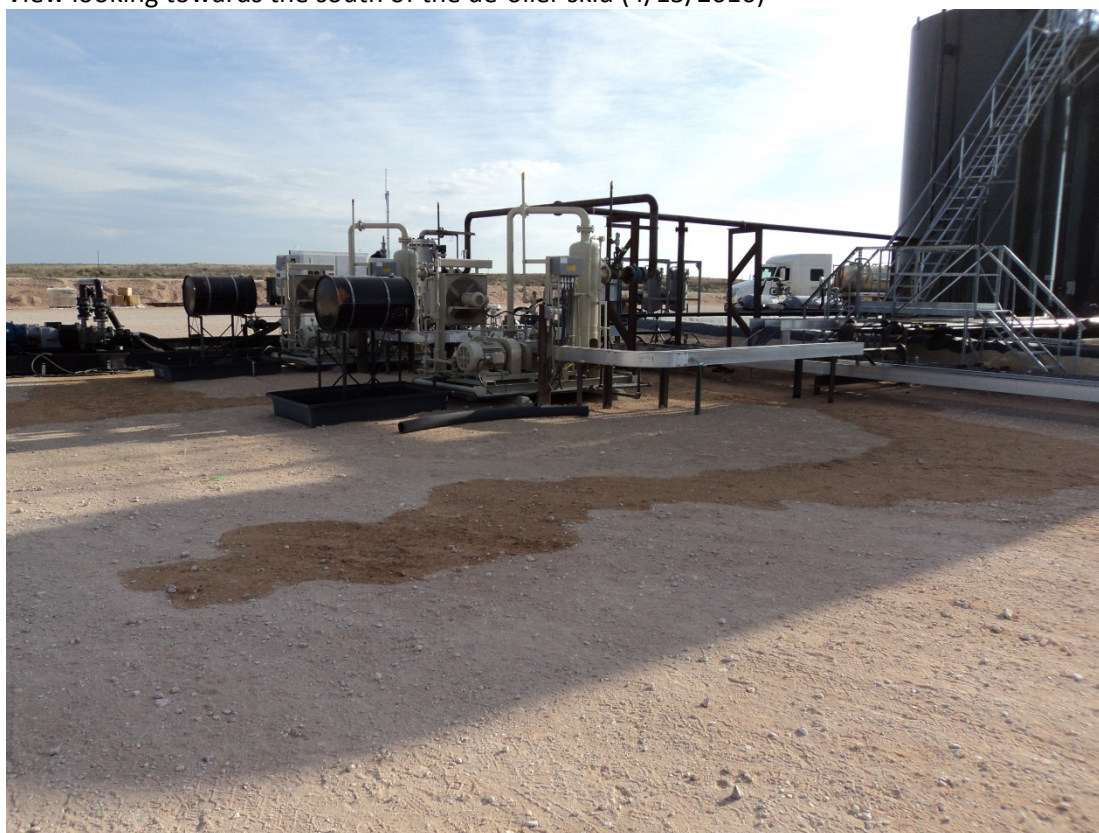
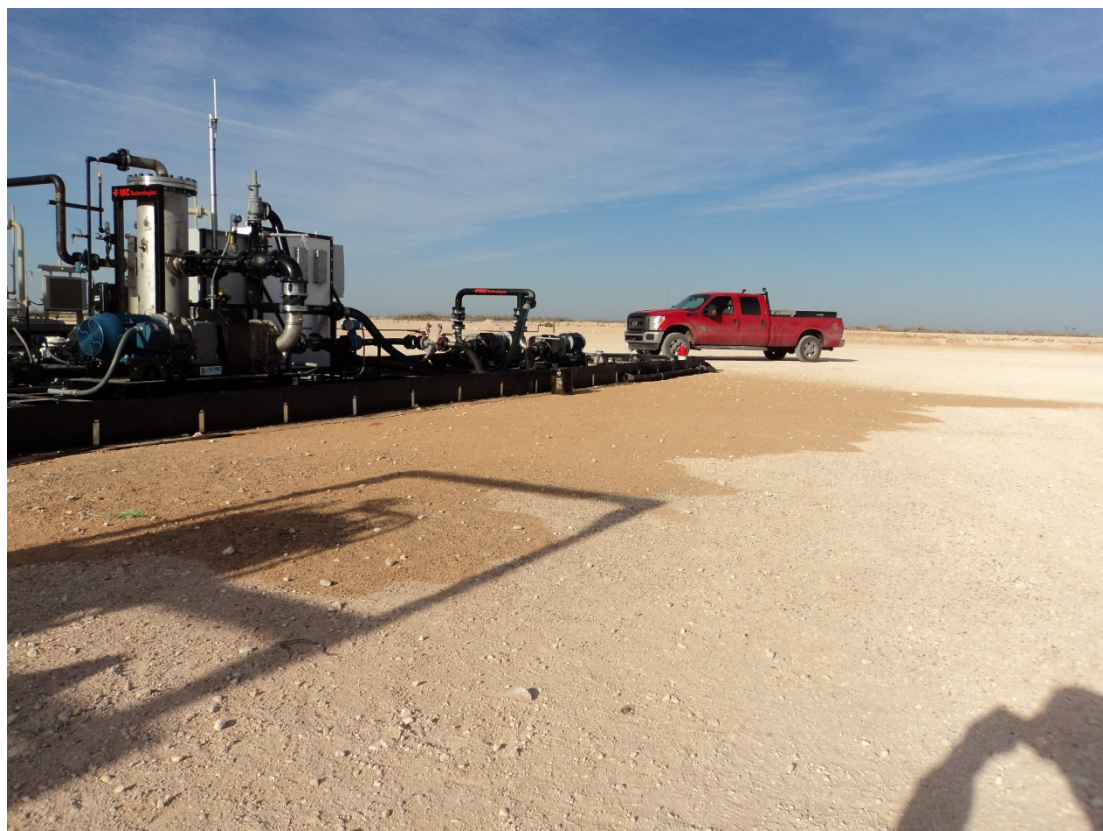
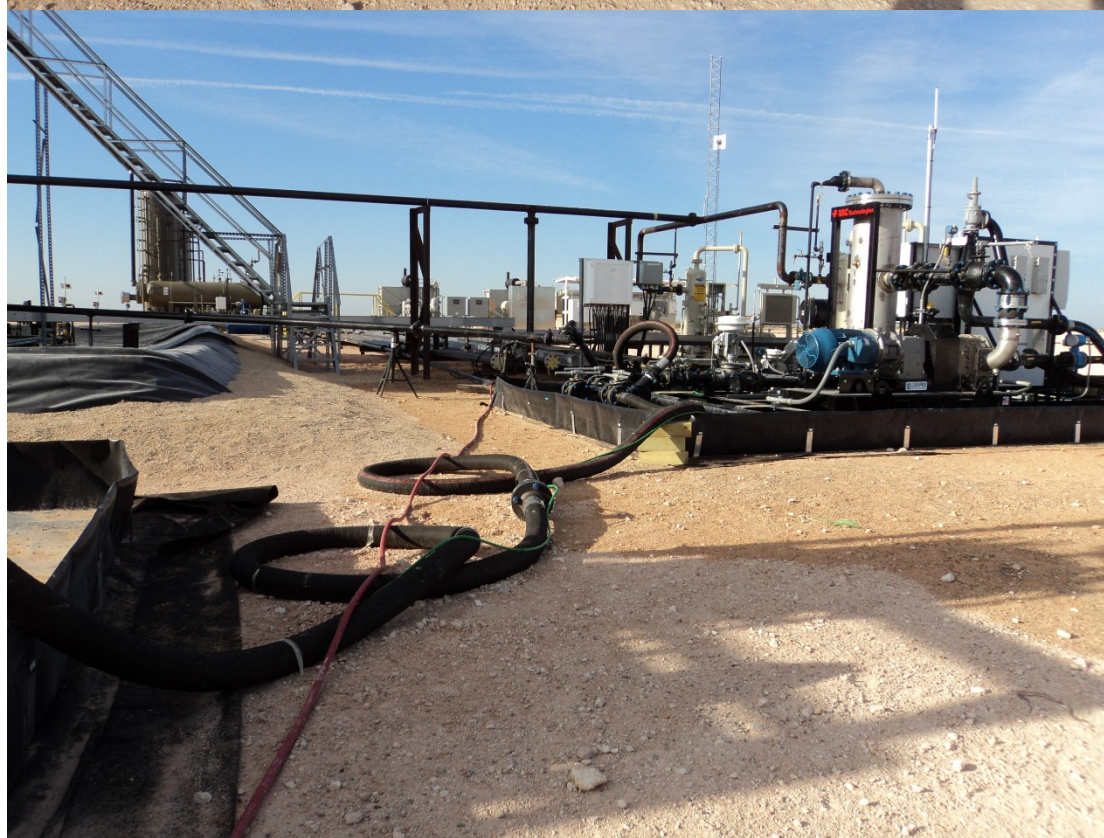
# **Appendix B – Photo Documentation**

On Thursday April 14, 2016 at 0345, a release of produced water occurred due to a ruptured hose associated with de-oiler operations, resulting in the release of 25 BBLs of produced water (approximately 20 BBLs of produced water spilled to lined containment (with all recovered) and 5 BBLs of produced water spilled to ground). Immediate action was to shut down the pumps, recover produced water in containment, replace the hose, and return equipment back to service. NMOCD was notified of the release on April 14, 2016, and an initial C-141 was submitted (Appendix A).

All excavated soils will be taken to a NMOCD approved facility for disposal. Clean soil will be imported to the site to serve as backfill and contoured to the surrounding location. A sample of the backfill soil will be taken to a commercial laboratory to confirm that the chloride reading is below regulatory standards.
