Re: Site Assessment and Closure Report
Coral PWU 28-4 Battery
API No. N/A
GPS: Latitude 32.625351, Longitude -104.0745087
UL "P", Sec.28, T19S, R29E
Eddy County, NM
NMOCD Ref. No. NAPP2217839045

Pima Environmental Services, LLC (Pima) has been contracted by Devon Energy Production Company (Devon) to perform a spill assessment and has prepared this Closure Report for a produced water release that occurred at the Coral PWU 28-4 Battery (Coral). The initial C-141 was submitted on April 21, 2023 (Appendix C). This incident was assigned Incident ID NAPP2217839045, by the New Mexico Oil Conservation Division (NMOCD).

**SITE PHOTOGRAPHS
DEVON ENERGY
CORAL PWU 28 4 BATTERY**

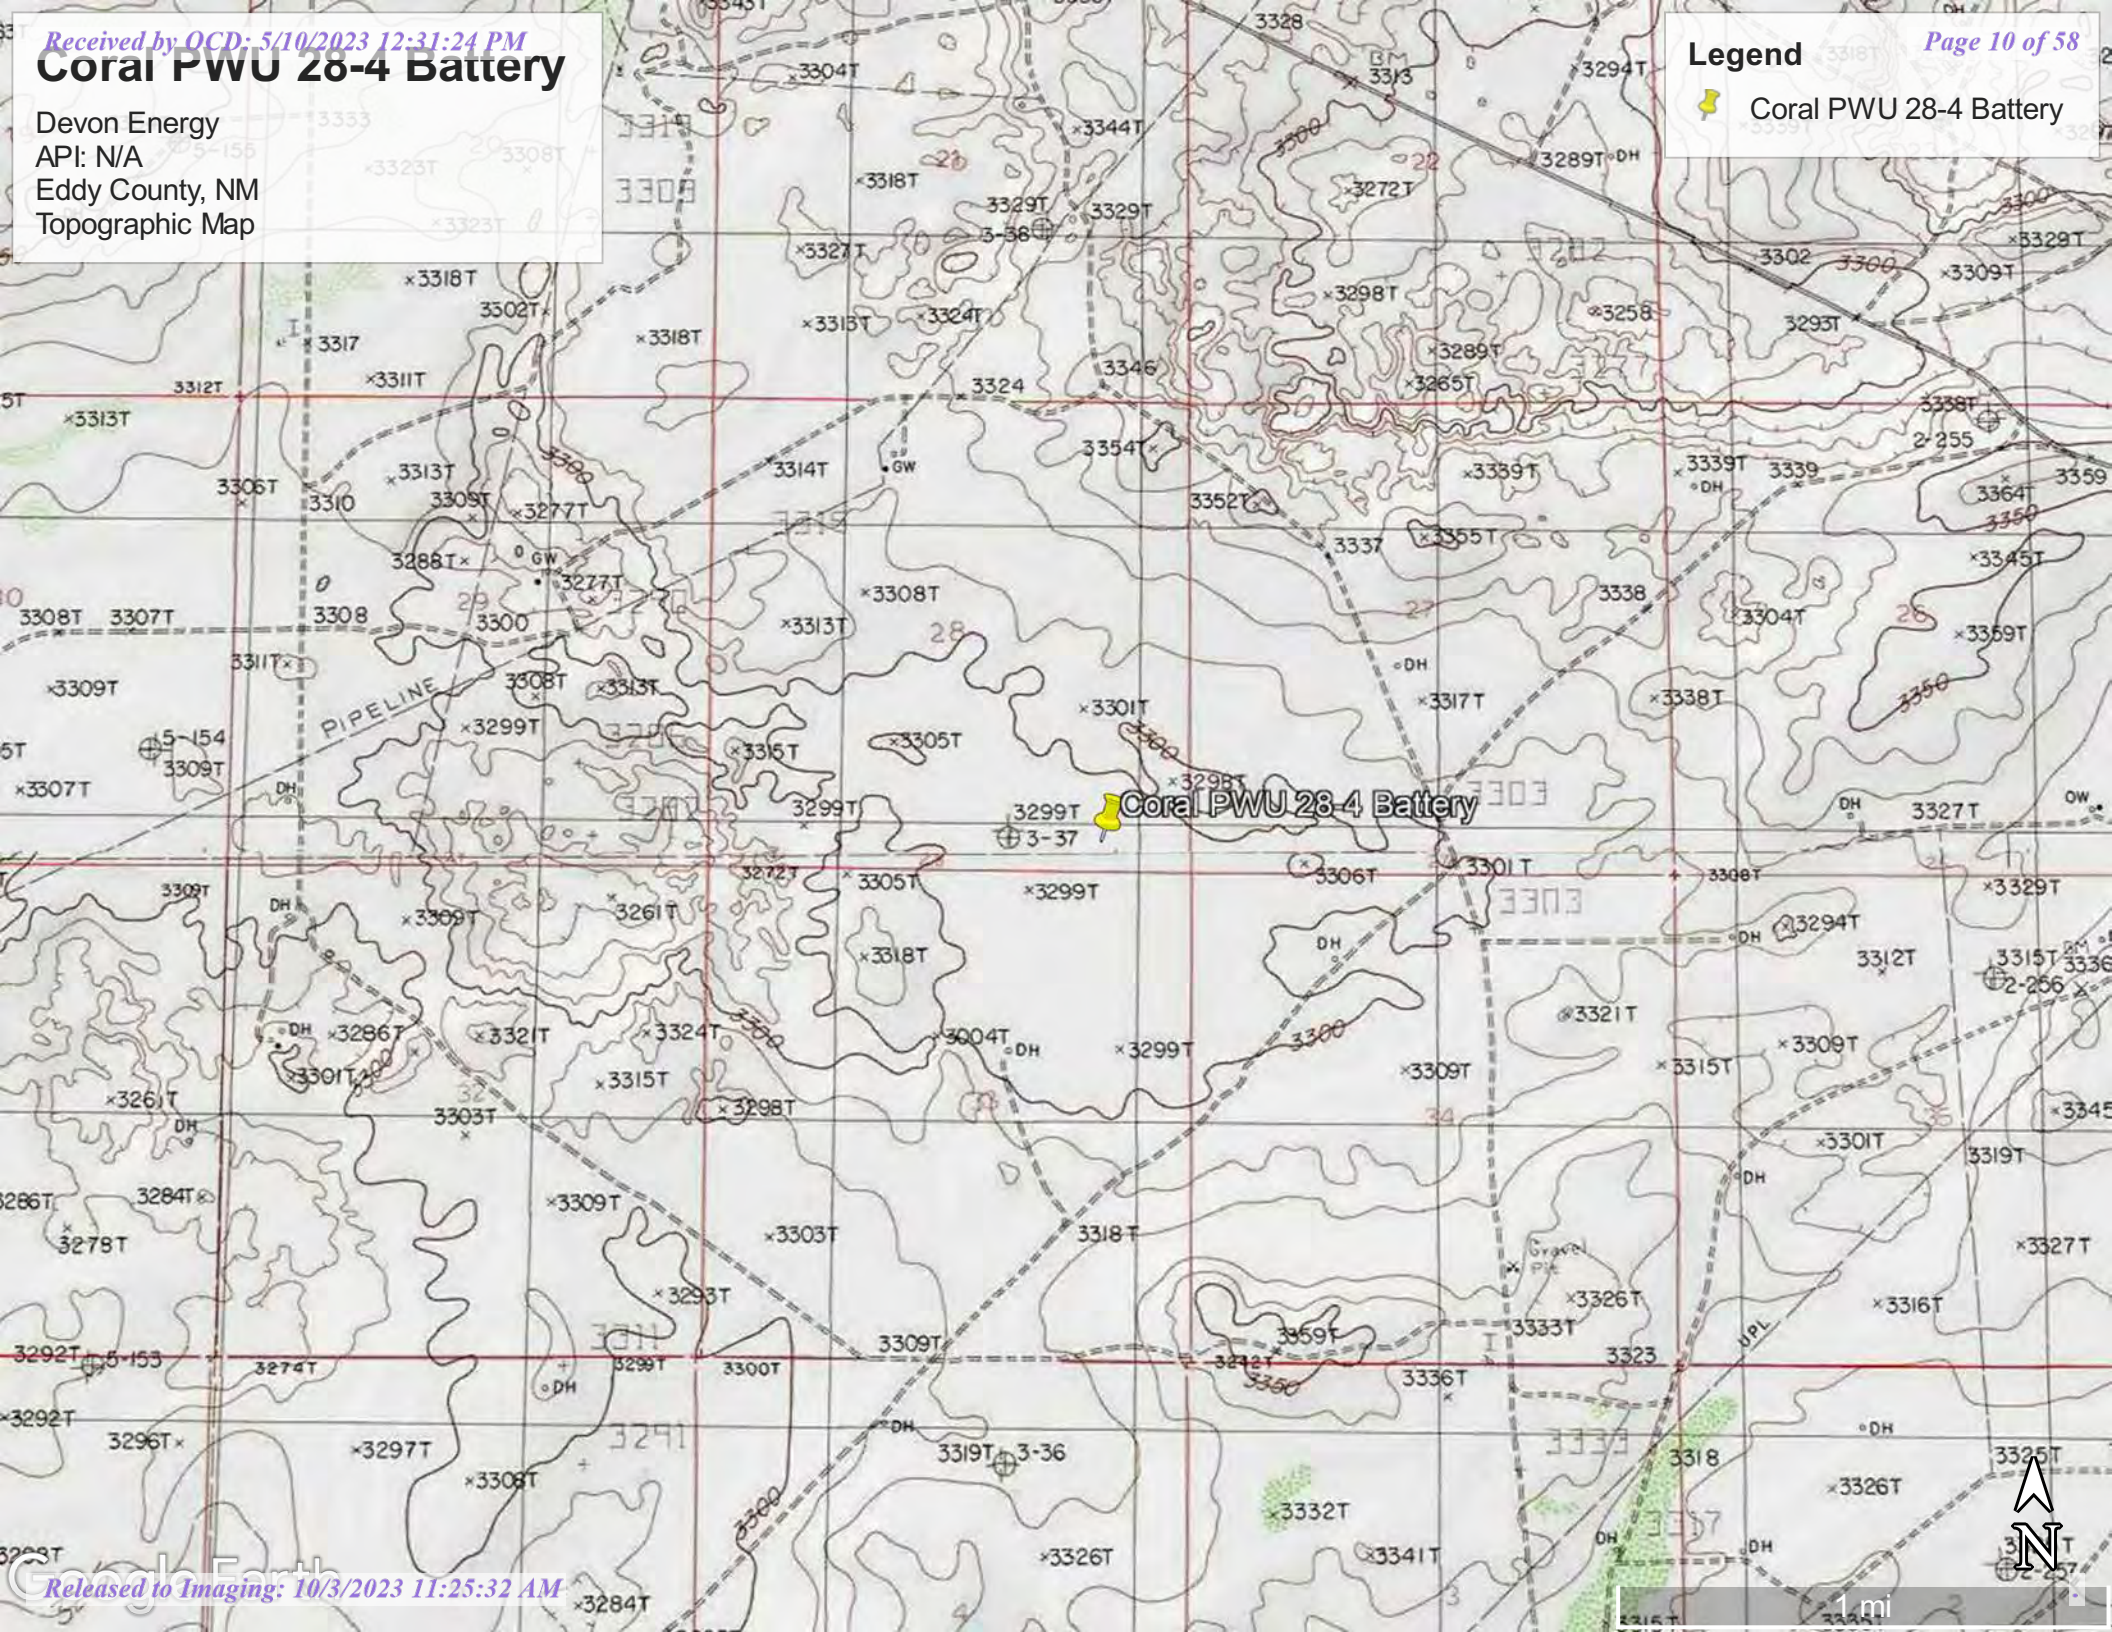
Devon Energy
API: N/A
Eddy County, NM
Topographic Map

Reference Figure 2 for a Topographic map.

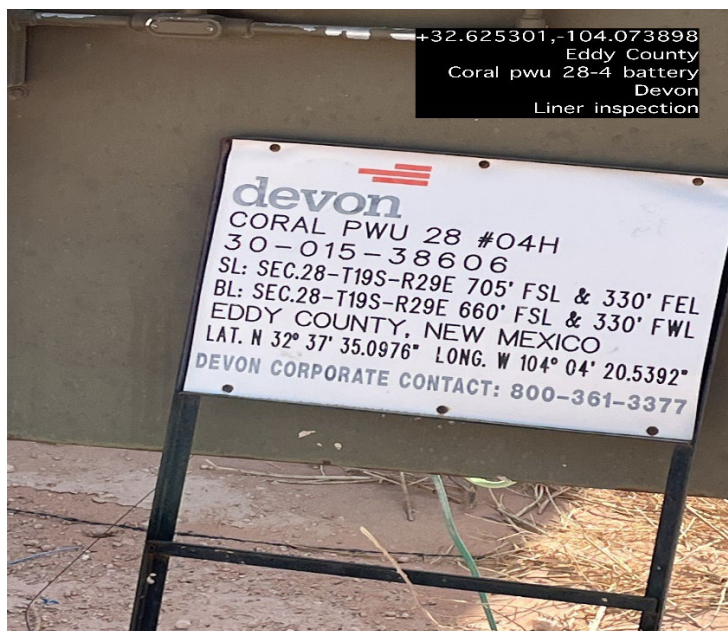
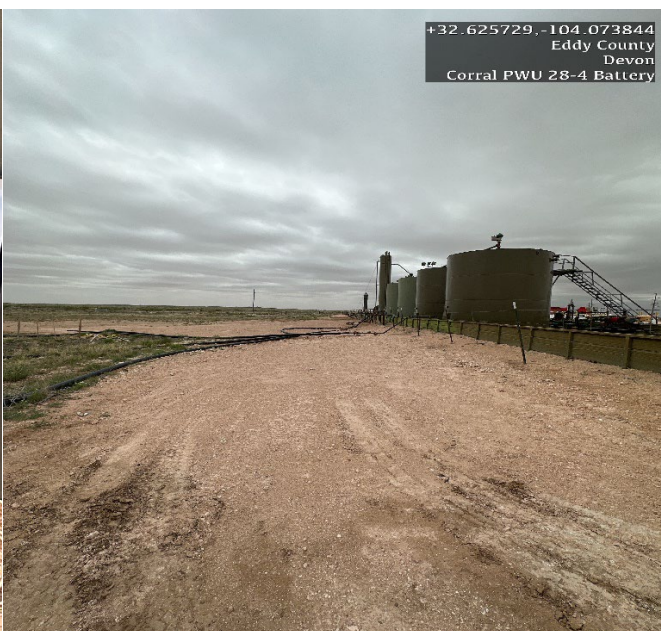
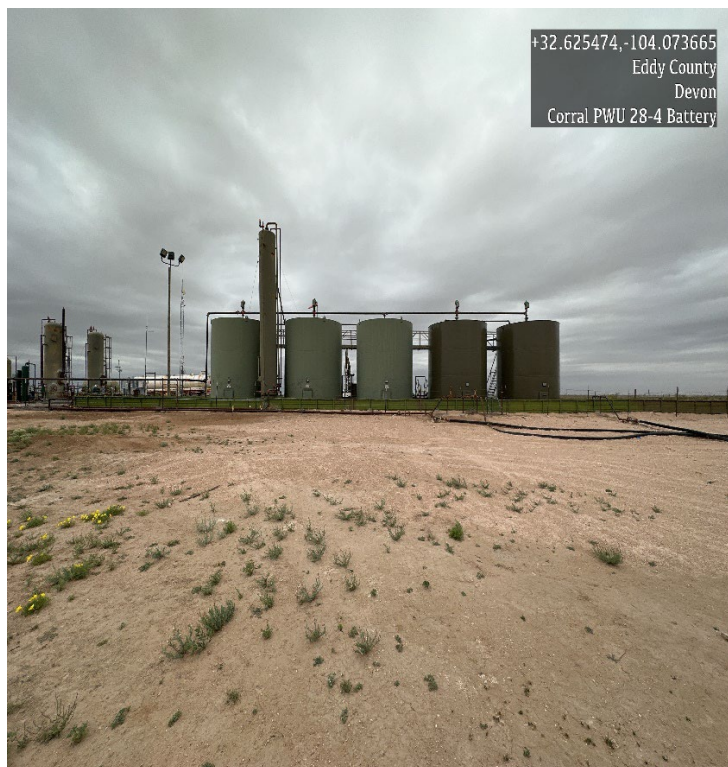
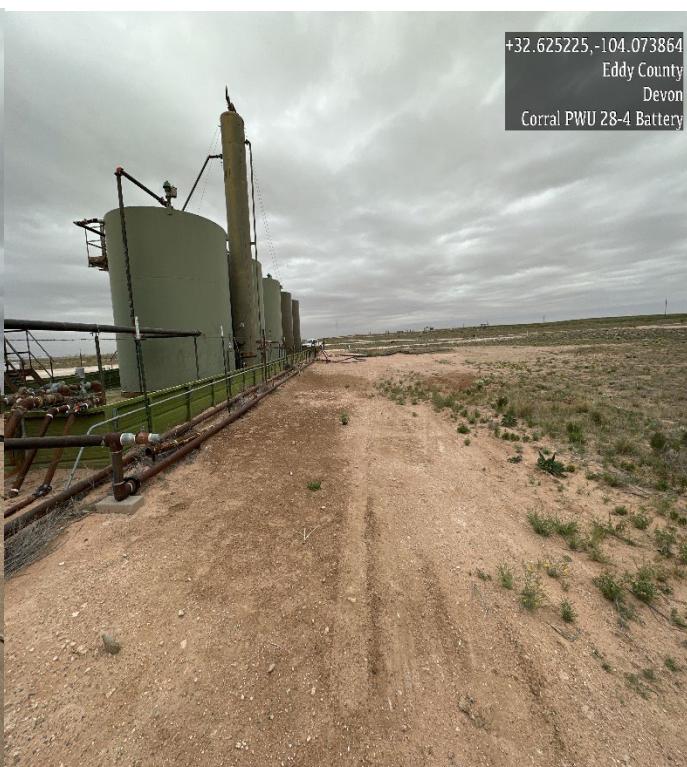
Site Assessment

NAPP2217839045 On June 26, 2022, Lease Operator arrived at location and discovered water spraying from a water transfer line, a check valve had washed out, causing fluid to be released. The released fluids were calculated to be approximately .34 of a barrel (bbls) of produced water, no fluids were able to be recovered.

The sample results were below NMOCD Closure Criteria 19.15.29 NMAC. Based on these findings, Devon Construction Department mobilized personnel and equipment to conduct a scrape to remove surface staining. No further remediation activities are required at this time. The contaminated surface soil was hauled to an approved, lined disposal facility.
