**Re: Closure Request
Mesa Dolphin CTB
Incident Number nAPP2313555368
Lea County, New Mexico**

Ensolum, LLC (Ensolum), on behalf of BTA Oil Producers, LLC (BTA), has prepared this *Closure Request* to document assessment, delineation, and soil sampling activities performed at the Mesa Dolphin CTB (Site). The purpose of the Site assessment, delineation, and soil sampling activities was to assess for the presence or absence of impacts to soil following a release of produced water within the lined containment and overspray onto the well pad at the Site. Based on field observations, delineation activities, and soil sample laboratory analytical results, BTA is submitting this *Closure Request*, describing Site assessment and delineation activities that have occurred and requesting no further action and closure for Incident Number nAPP2313555368.

BTA Oil Producers, LLC
Closure Request
Mesa Dolphin CTB

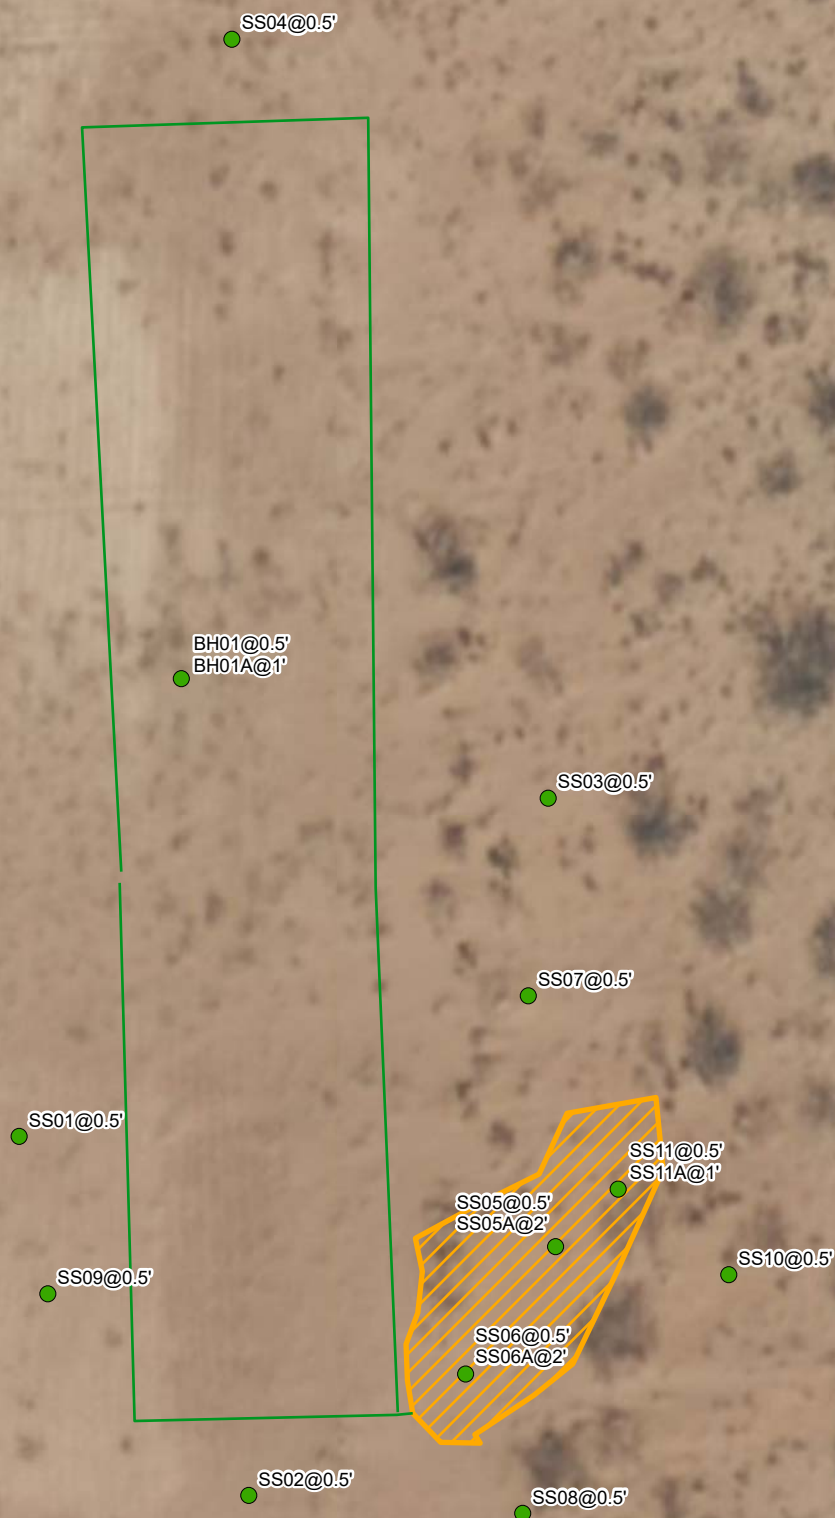
FIGURE
2

Laboratory analytical results for delineation soil samples BH01 and BH01A, collected at depths of 0.5 feet and 1-foot bgs, respectively, indicated all COC concentrations were compliant with the Closure Criteria and successfully defined the vertical extent of the release within the lined containment. Laboratory analytical results for boreholes SS05, SS06, and SS11, collected within the overspray extent at depths ranging from 0.5 feet to 2 feet bgs, indicated all COC concentrations were compliant with the Closure Criteria. Laboratory analytical results for delineation soil samples SS01 through SS04 and SS07 through SS10, collected at 0.5 feet bgs around the lined containment and overspray extent, indicated all COC concentrations were compliant with the most stringent Table I Closure Criteria and successfully defined the lateral extent of the release. Laboratory analytical results are summarized in Table 1 and the complete laboratory analytical reports are included as Appendix D.

Delineation Soil Sample Locations

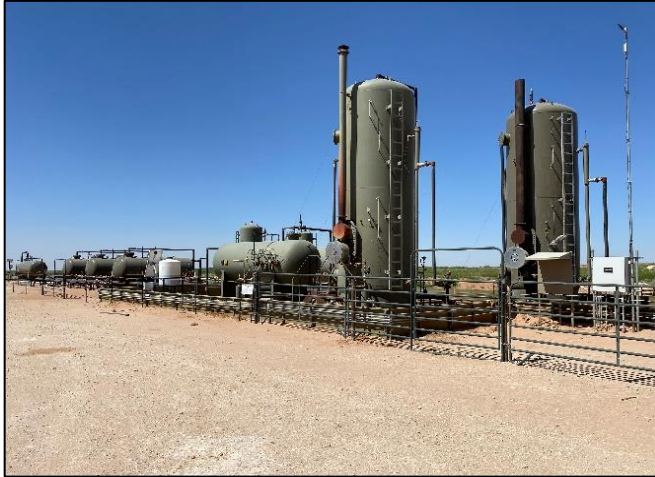
Photograph: 1 Date: 5/12/2023
Description: Initial assessment activities
View: Northeast

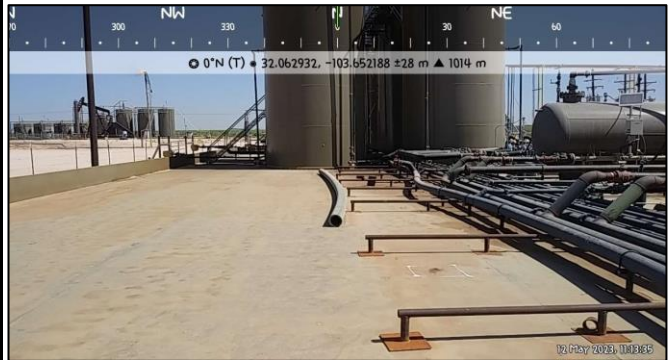
Photograph: 2 Date: 5/12/2023
Description: Liner inspection activities
View: Northeast

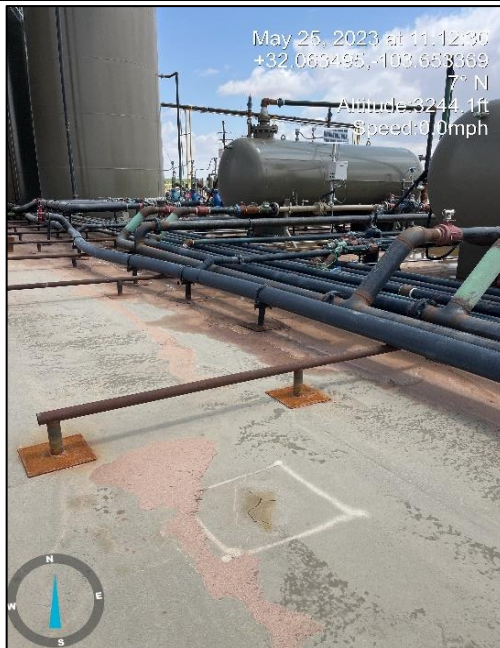
Photograph: 3 Date: 5/25/2023
Description: Liner delineation activities
View: North

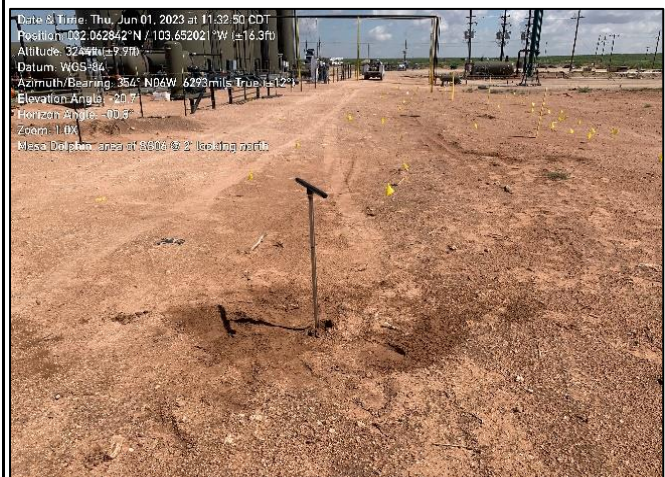
Photograph: 4 Date: 6/1/2023
Description: Overspray extent delineation activities
View: North
