Remediation Summary and Closure Request

**BTA Oil Producers, LLC
Grama 8817 JV-P Tank Battery
Lea County, New Mexico
Unit Letter "M", Section 16, Township 22 South, Range 34 East
Latitude 32.386066 North, Longitude 103.481032 West
NMOCD Incident # nAPP2316732214**

July 2023

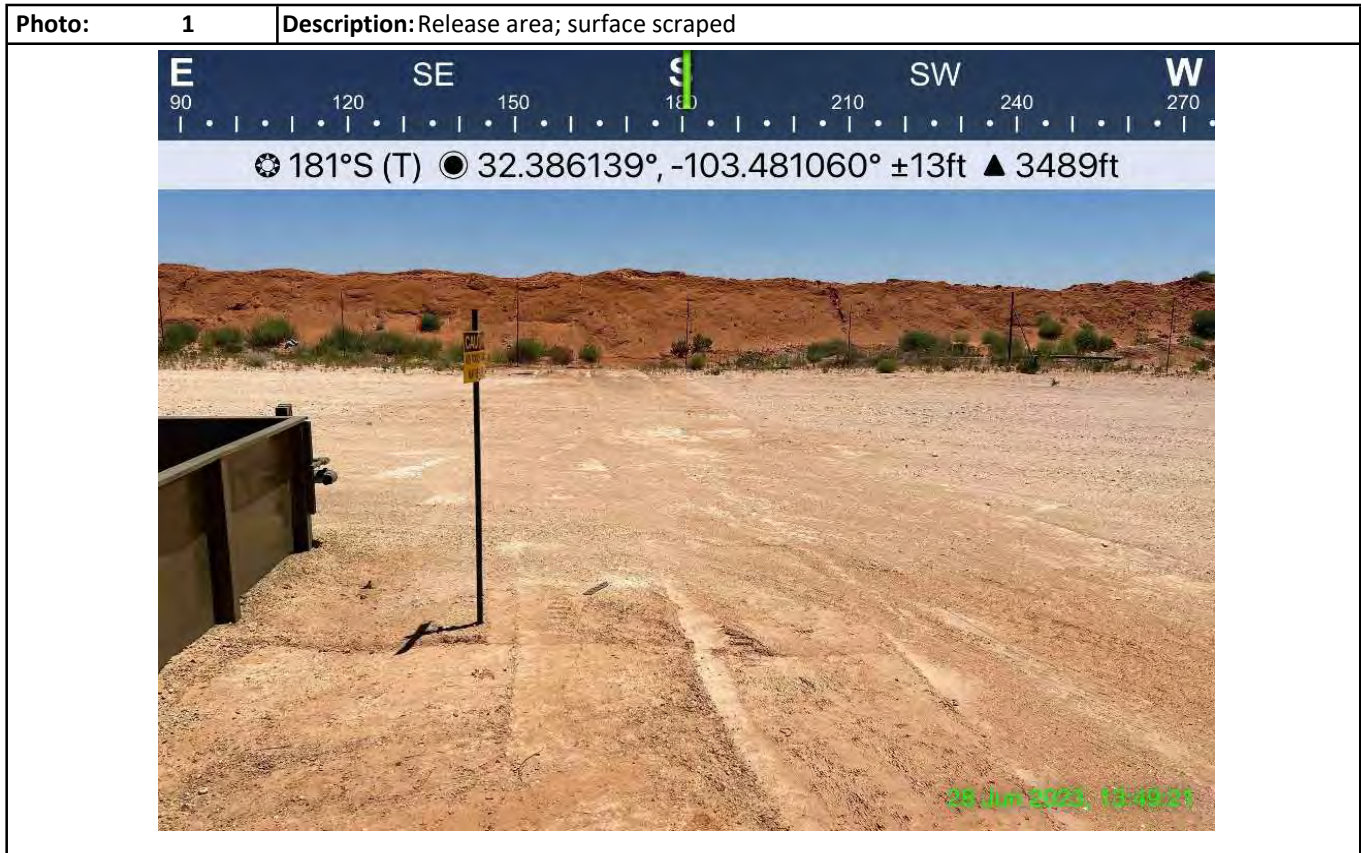
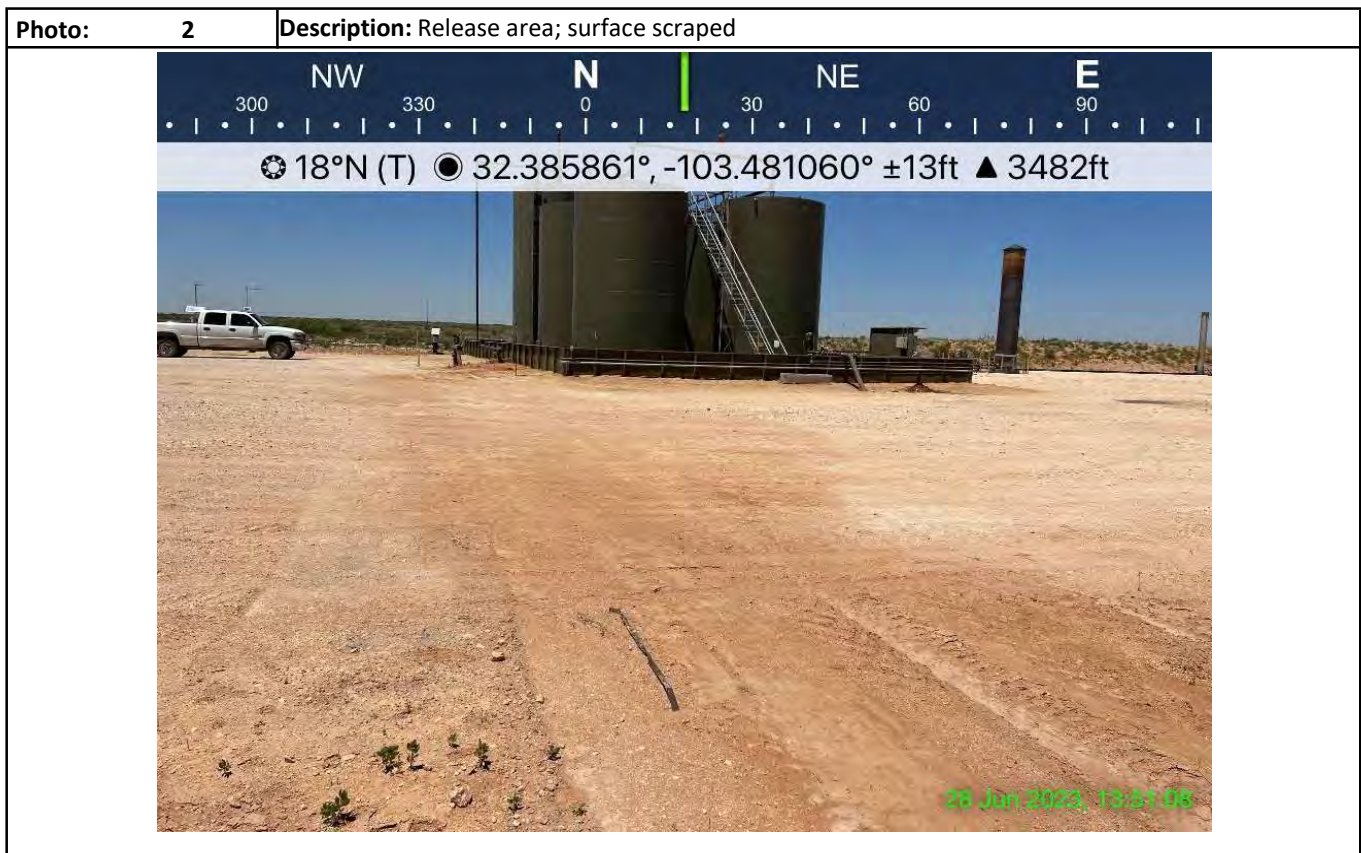
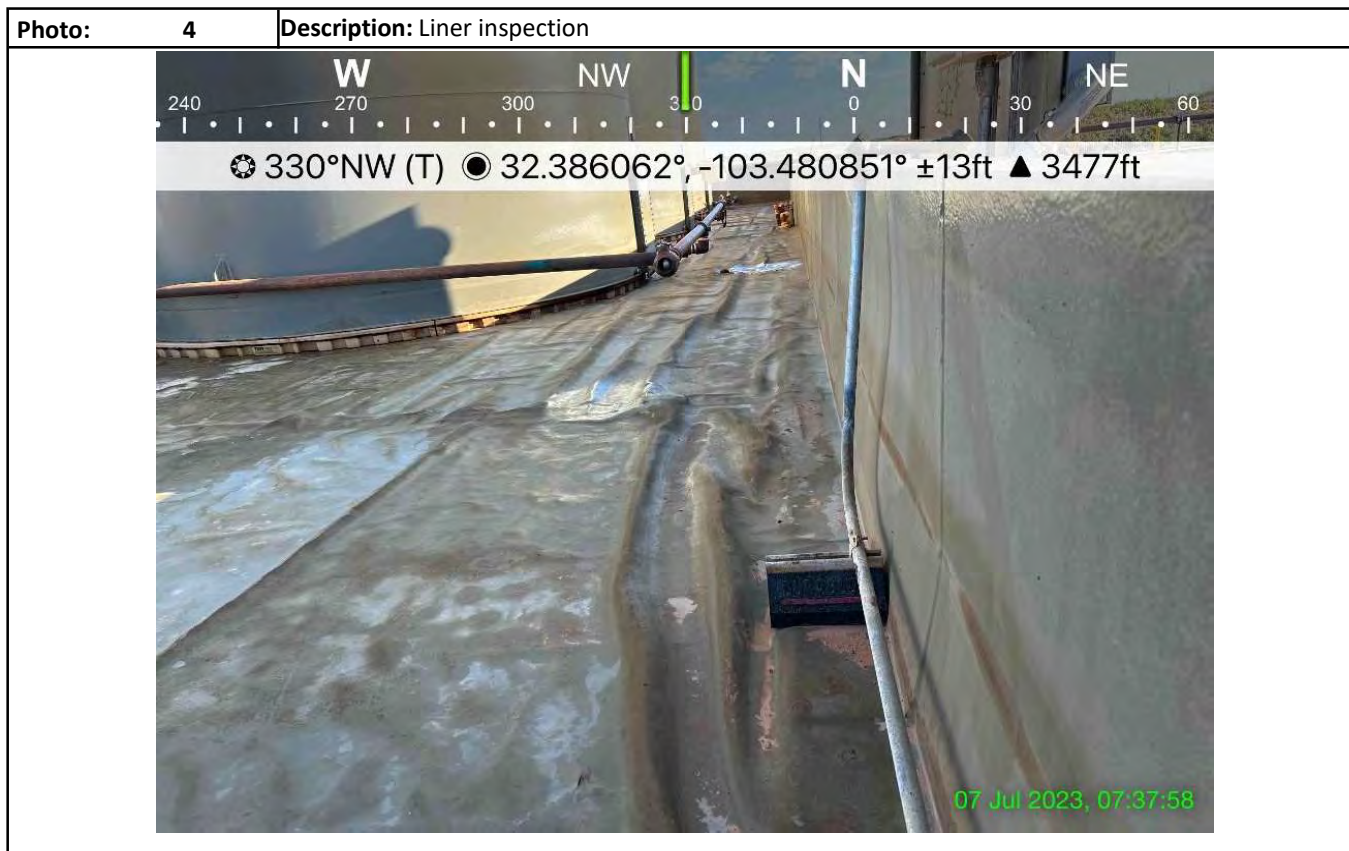
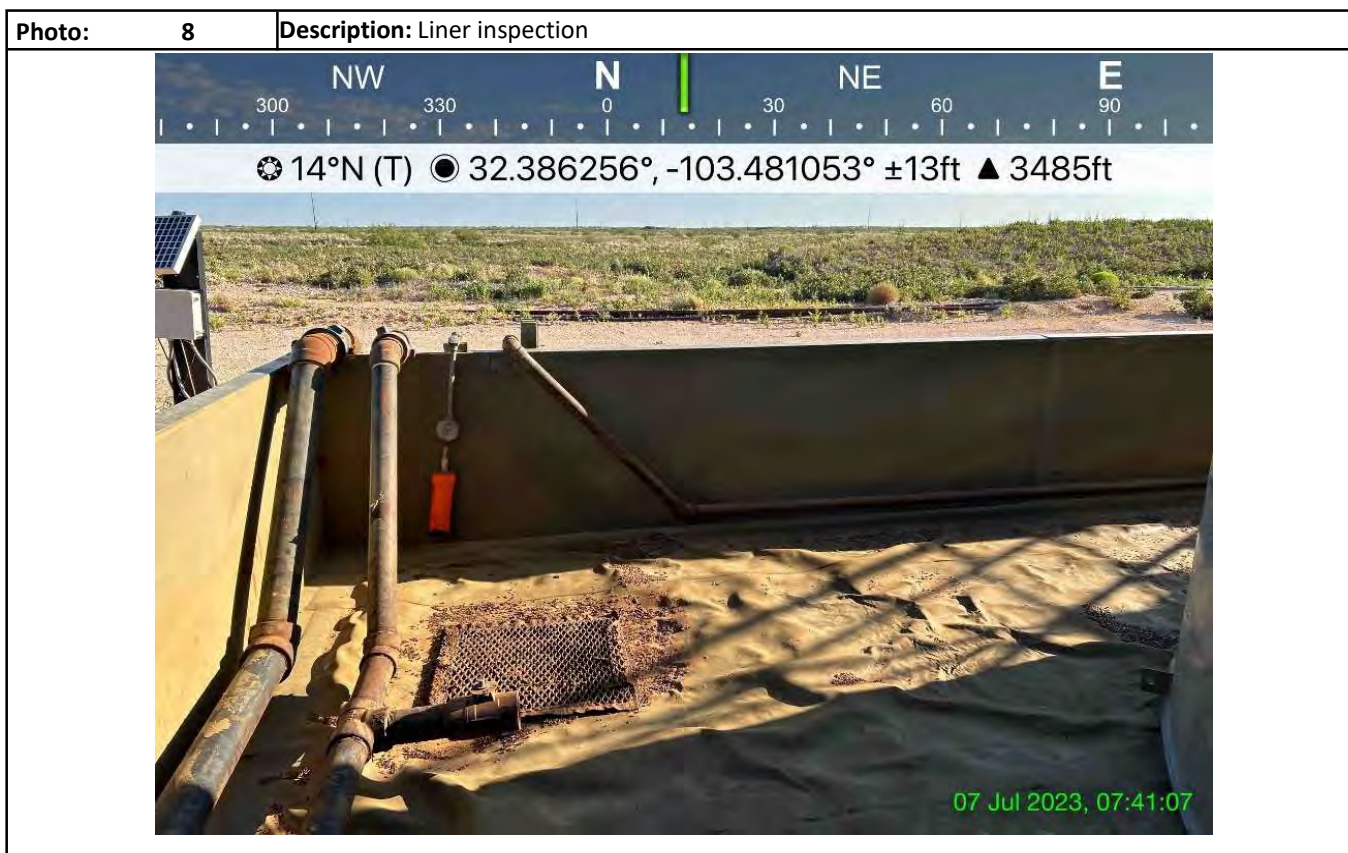
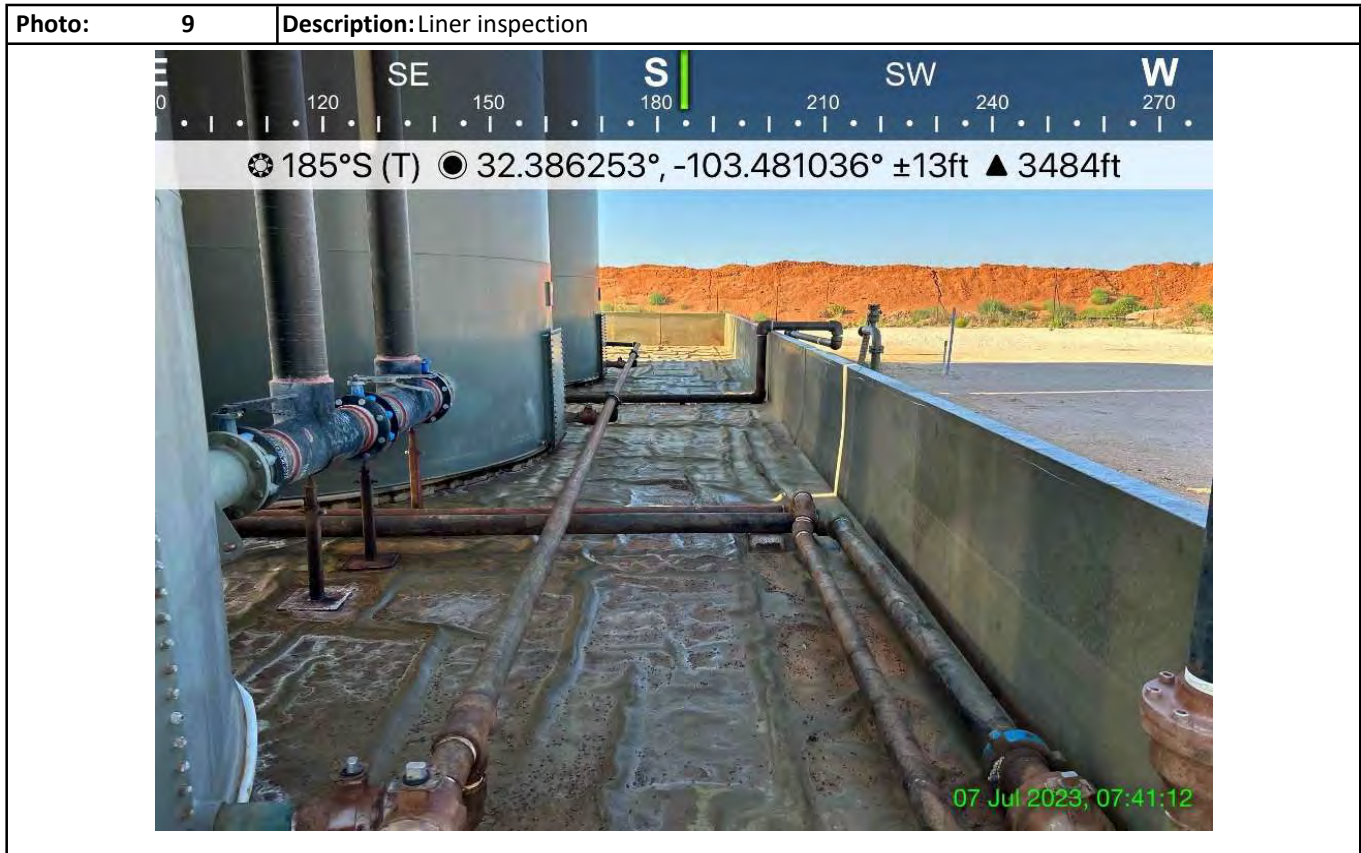
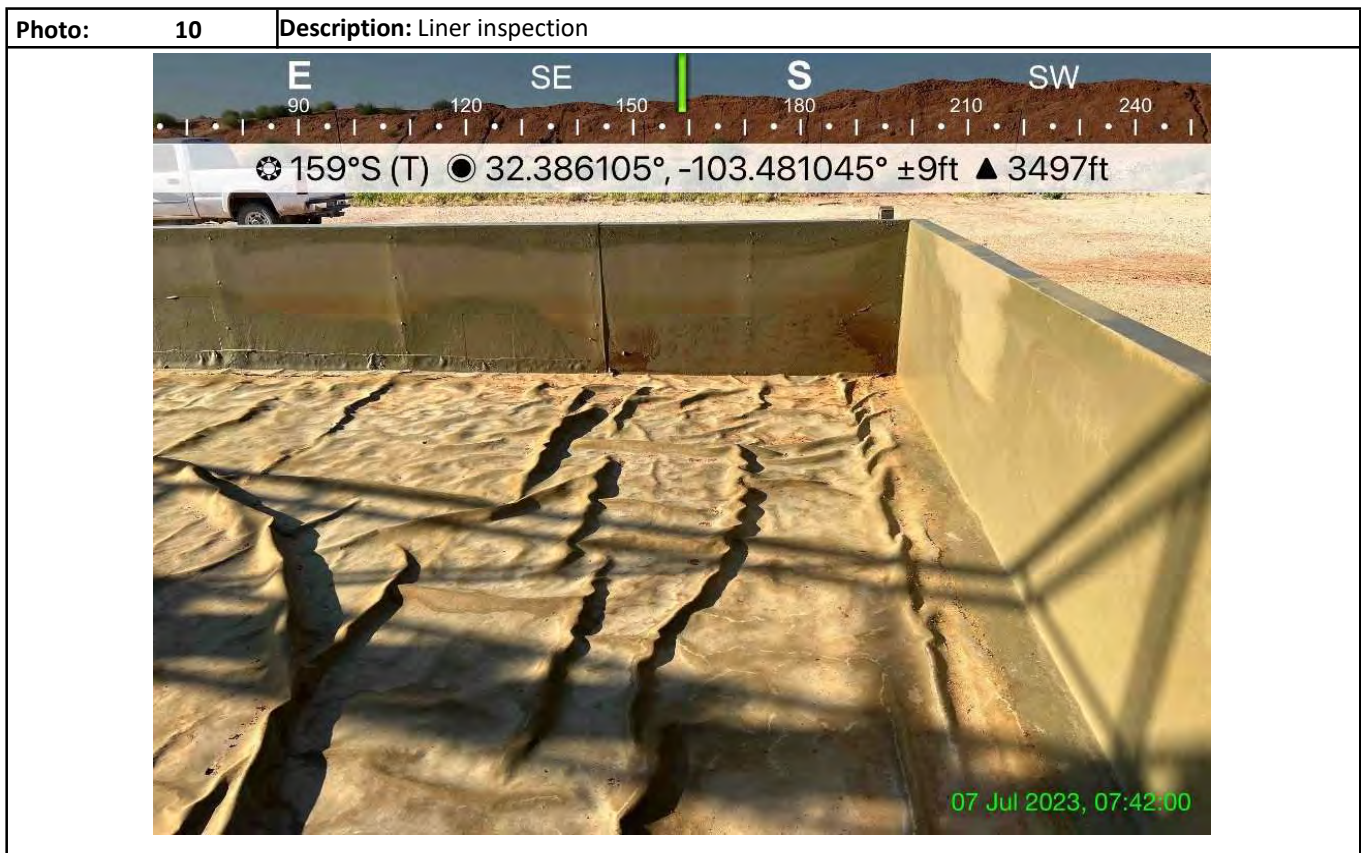
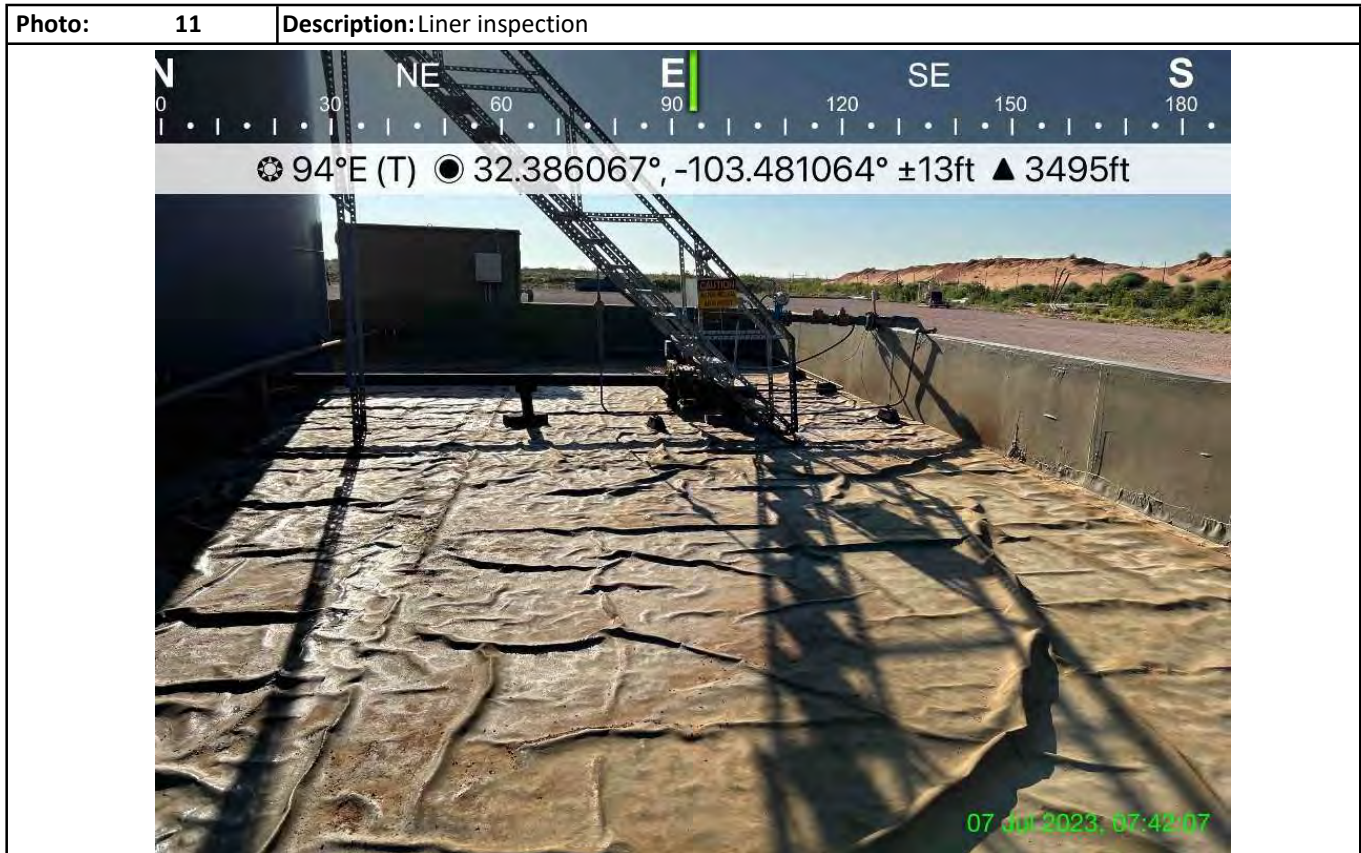
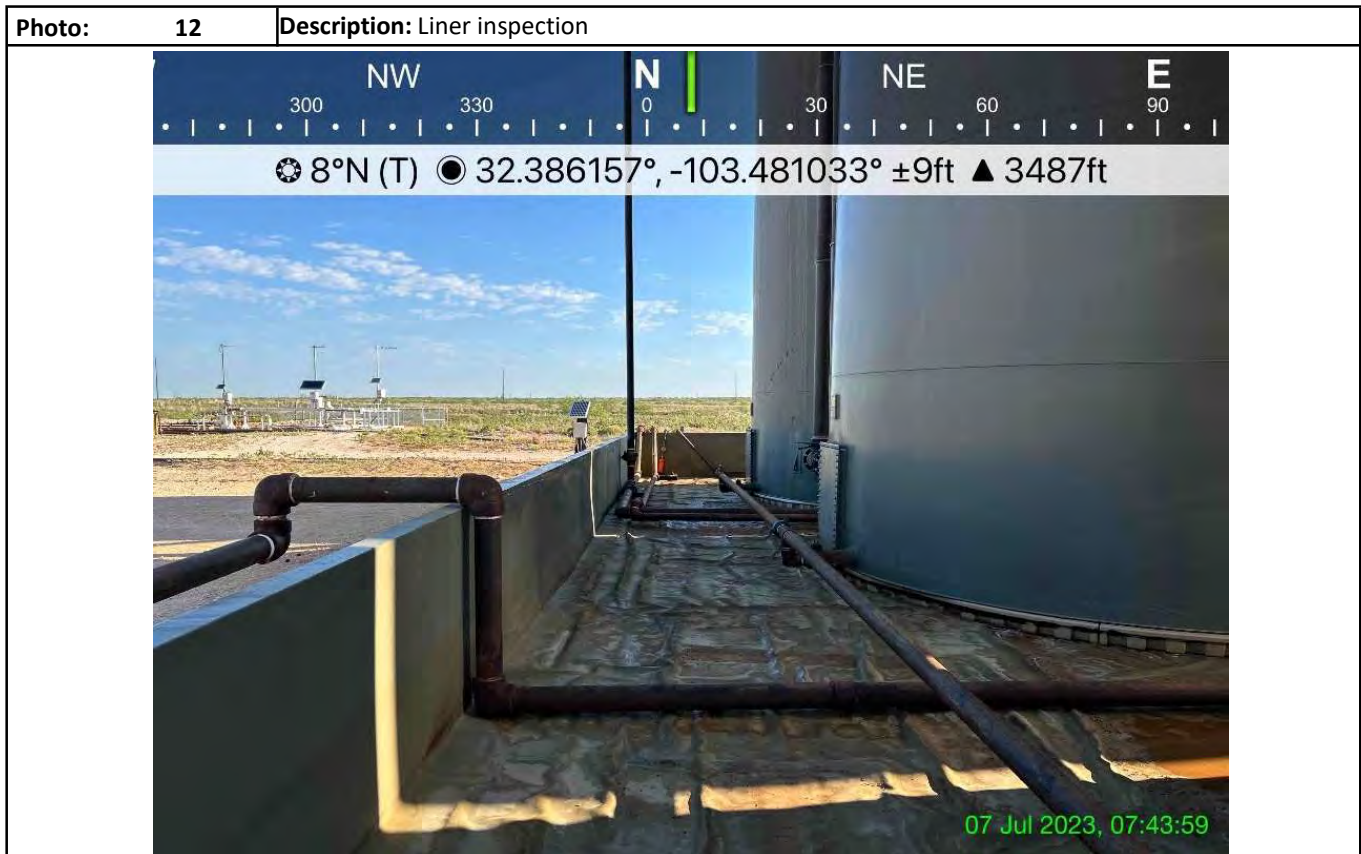
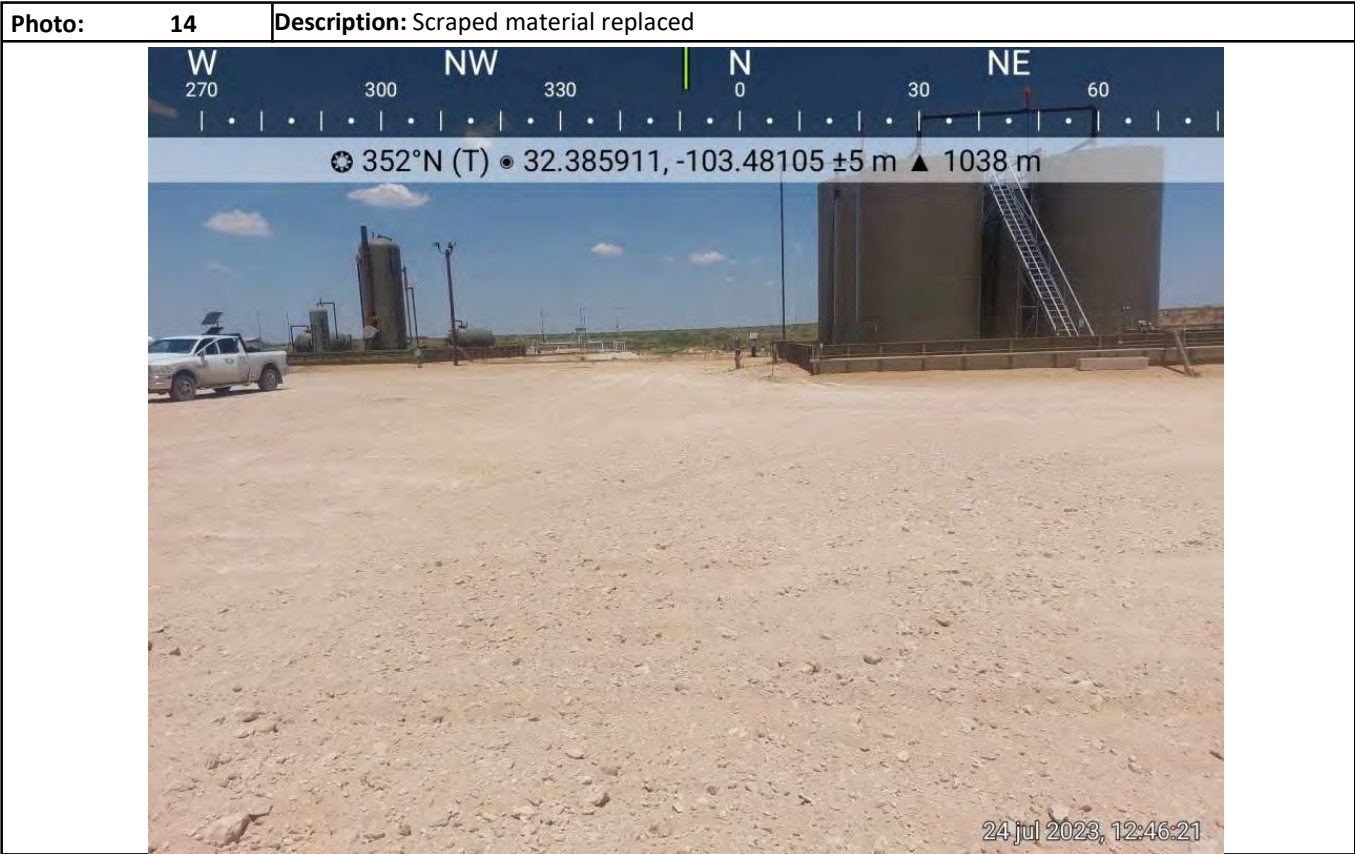
Attachment III Site Photographs

On July 7, 2023, Hungry Horse personnel arrived on location to inspect the liner. The liner and metal containment were thoroughly inspected from edge to edge, as well as around the tanks and process equipment installed on the liner itself. The liner was found to be in place, intact, with no visible breaks, or tears. There was no evidence of the release leaking through the metal containment area. Photographs are provided as Attachment III and a completed Liner Inspection Form as Attachment V.
