**Re: Closure Request
Mesa #002H Water Transfer Line
Incident Number NRM1927430793
Lea County, New Mexico**

Ensolium, LLC (Ensolium), on behalf of BTA Oil Producers, LLC (BTA), has prepared this *Closure Request* to document assessment, delineation, and soil sampling activities performed at the Mesa #002H Water Transfer Line (Site). The purpose of the Site assessment, delineation, and soil sampling activities was to assess for the presence or absence of impacts to soil resulting from a historical produced water release at the Site. Based on field observations, field screening activities, and soil sample laboratory analytical results, BTA is submitting this *Closure Request*, describing Site assessment and delineation activities that have occurred and requesting closure for Incident Number NRM1927430793.

BTA Oil Producers, LLC
Closure Request
Mesa #002H Water Transfer Line

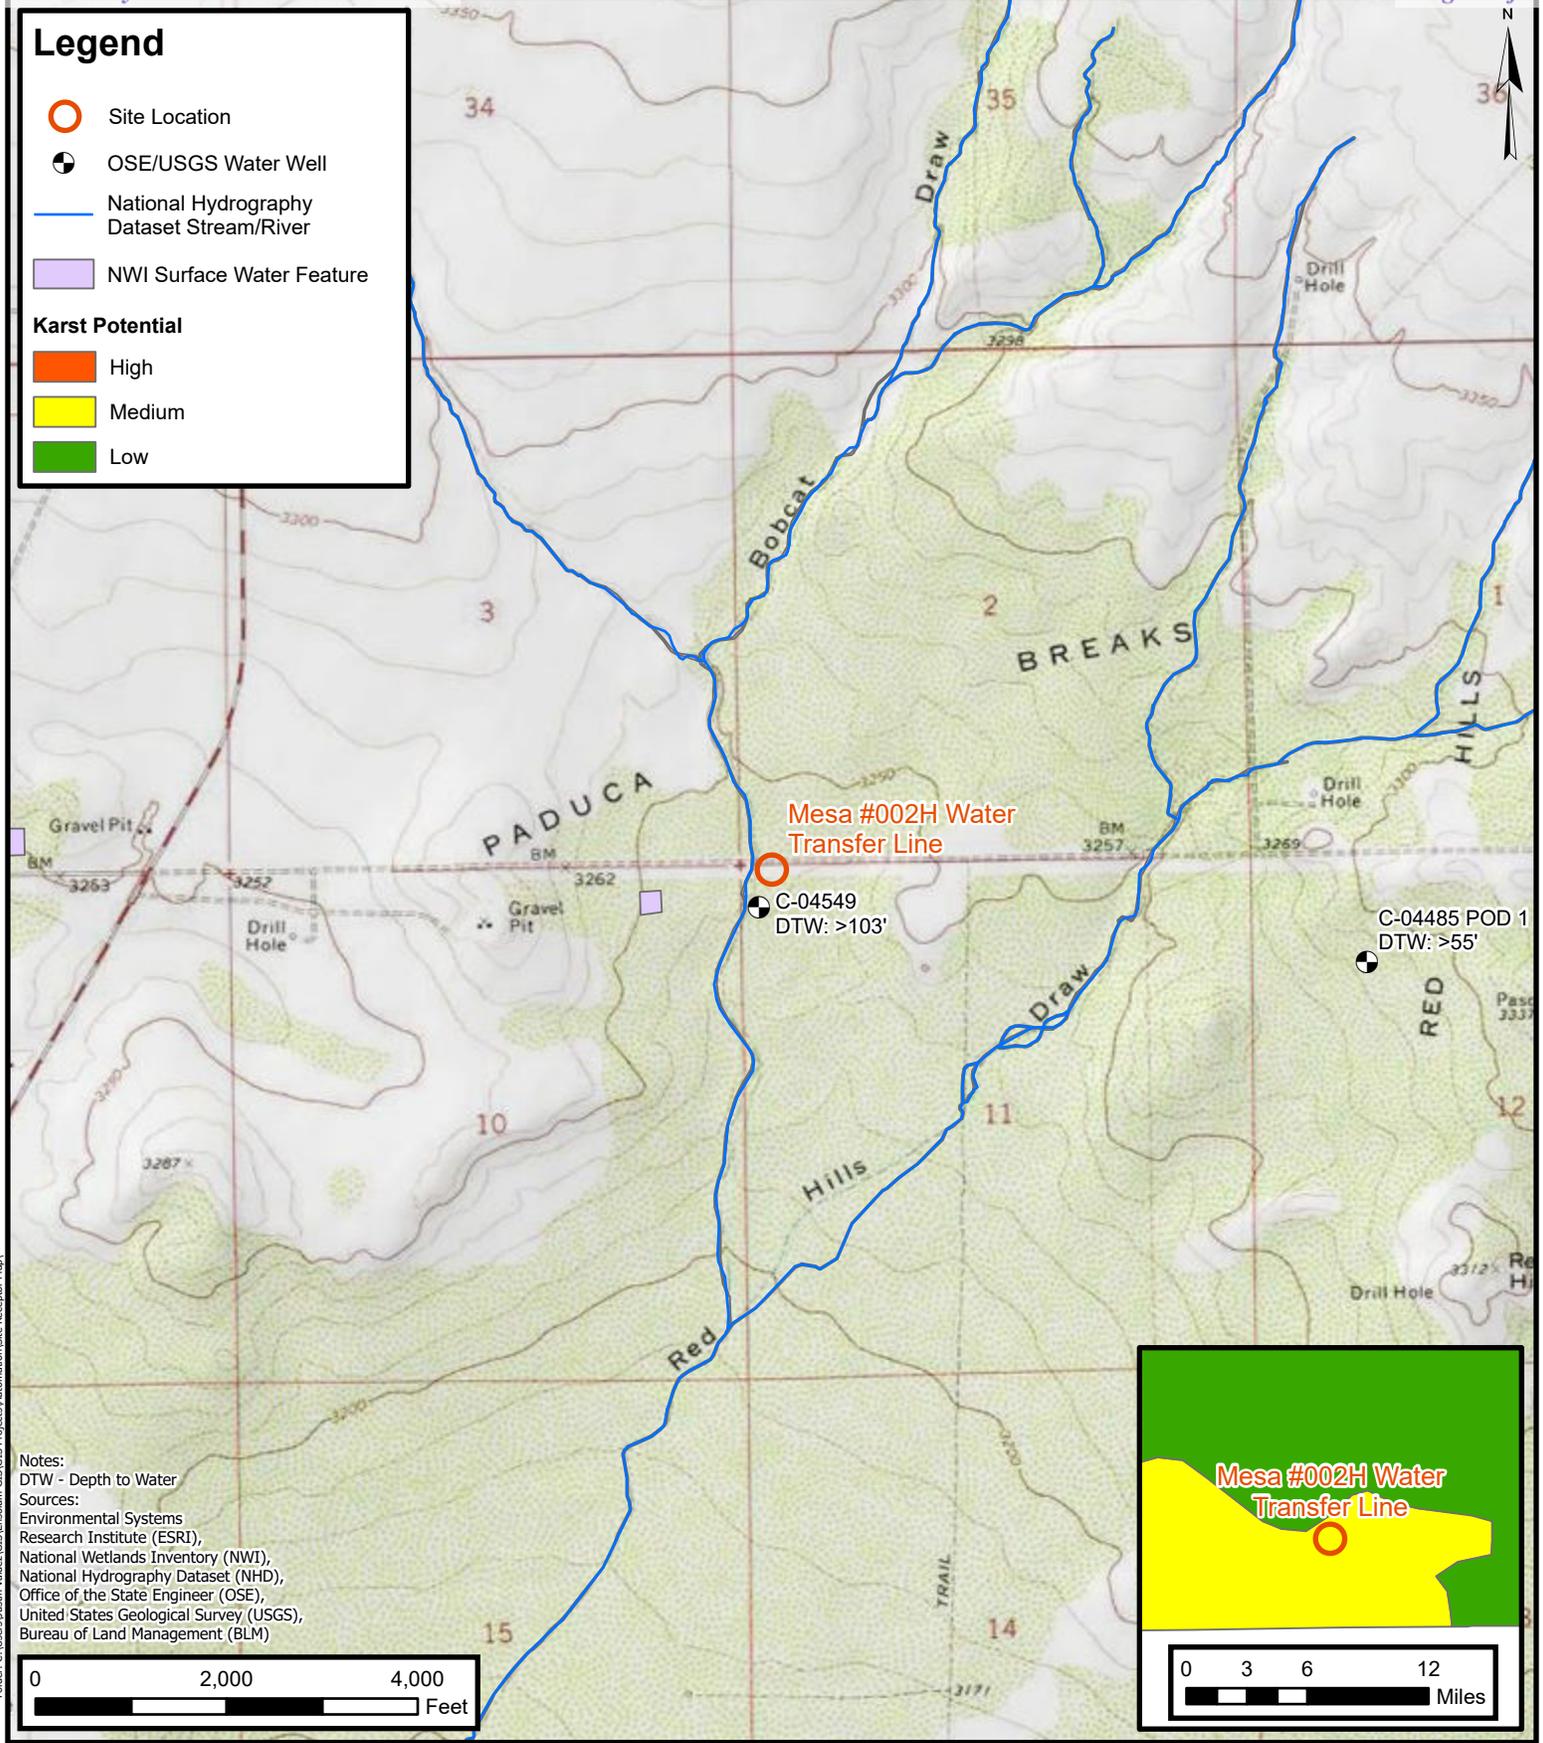
FIGURE
 1

feet bgs, and no groundwater was encountered. All wells used for depth to groundwater determination are presented on Figure 1. The associated well records are included in Appendix A.

The closest continuously flowing or significant watercourse to the Site is a riverine, located approximately 195 feet west of the Site. The Site is greater than 200 feet from a lakebed, sinkhole, or playa lake and greater than 300 feet from an occupied residence, school, hospital, institution, church, or wetland. The Site is greater than 1,000 feet to a freshwater well or spring and is not within a 100-year floodplain or overlying a subsurface mine. The Site is not underlain by unstable geology (medium potential karst designation area). Site receptors are identified on Figure 1.

Site Receptor Map
 BTA Oil Producers, LLC
 Mesa #002H Water Transfer Line
 Incident Number: NRM1927430793
 Unit D, Sec 11, T26S, R32E
 Lea County, New Mexico

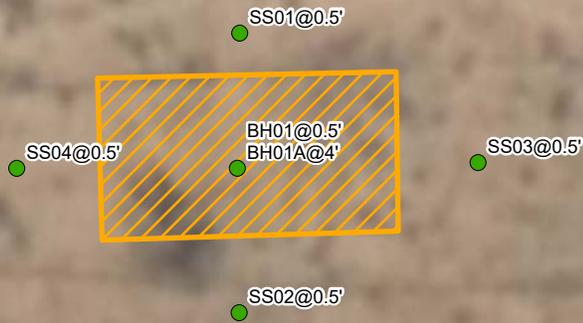
2

- Delineation Soil Sample in Compliance with Closure Criteria
- Release Extent

Notes:
 Sample ID @ Depth Below Ground Surface.

Delineation Soil Sample Locations

On June 1, 2023, Ensolum personnel were at the Site to complete delineation activities to assess for the absence or presence of impacted soil within the inferred release area. Four assessment soil samples (SS01 through SS04) were collected around the inferred release area at a depth of approximately 0.5 feet bgs. One borehole (BH01) was advanced via hand auger within the inferred release area. The delineation borehole was advanced to a depth of 4 feet bgs. Discrete delineation soil samples were collected from the borehole at depths of 0.5 feet and 4 feet bgs. The soil samples were field screened for volatile organic compounds (VOCs) utilizing a calibrated photoionization detector (PID) and chloride using Hach® chloride QuanTab® test strips. Field screening results and observations were logged on lithologic/soil sampling logs, which are included in Appendix B. The soil sample locations were mapped utilizing a handheld Global Positioning System (GPS) unit and are depicted on Figure 2. Photographic documentation was completed during the Site visit and a photographic log is included as Appendix C.

Laboratory analytical results for soil samples SS01 through SS04, BH01, and BH01A indicated all COC concentrations were compliant with the Site Closure Criteria. Laboratory analytical results are summarized in Table 1 and the complete analytical reports are included as Appendix D.
