| Site Name: James 29 Federal | Site Type: Battery |

Cause of Release: Equipment Failure

Liner Integrity Certification

CIMAREX ENERGY
JAMES 29 FEDERAL CTB
LEA, NM

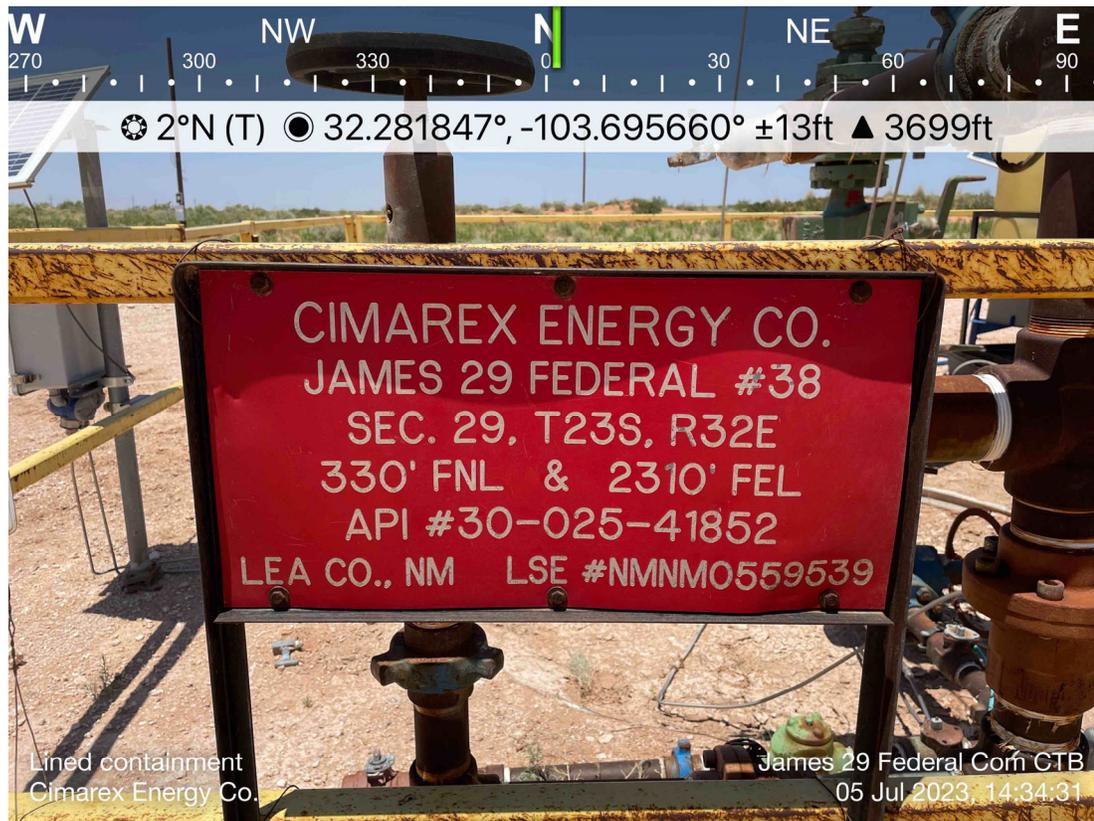
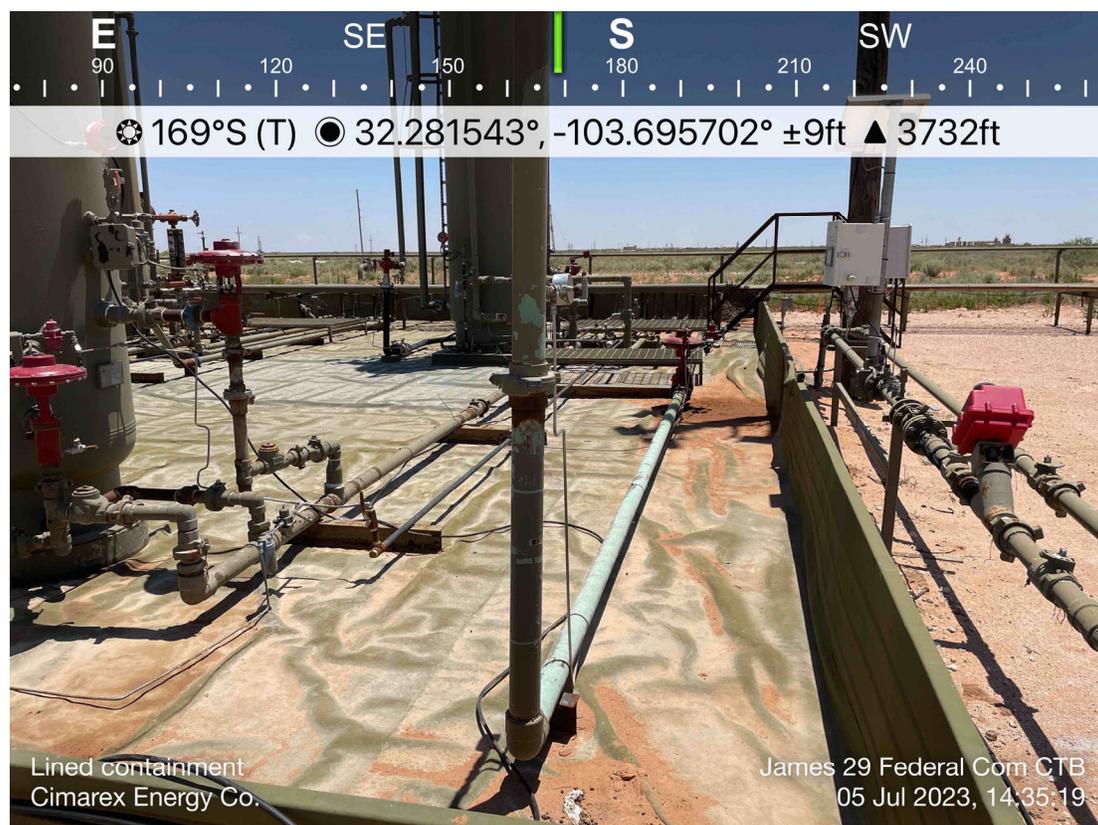
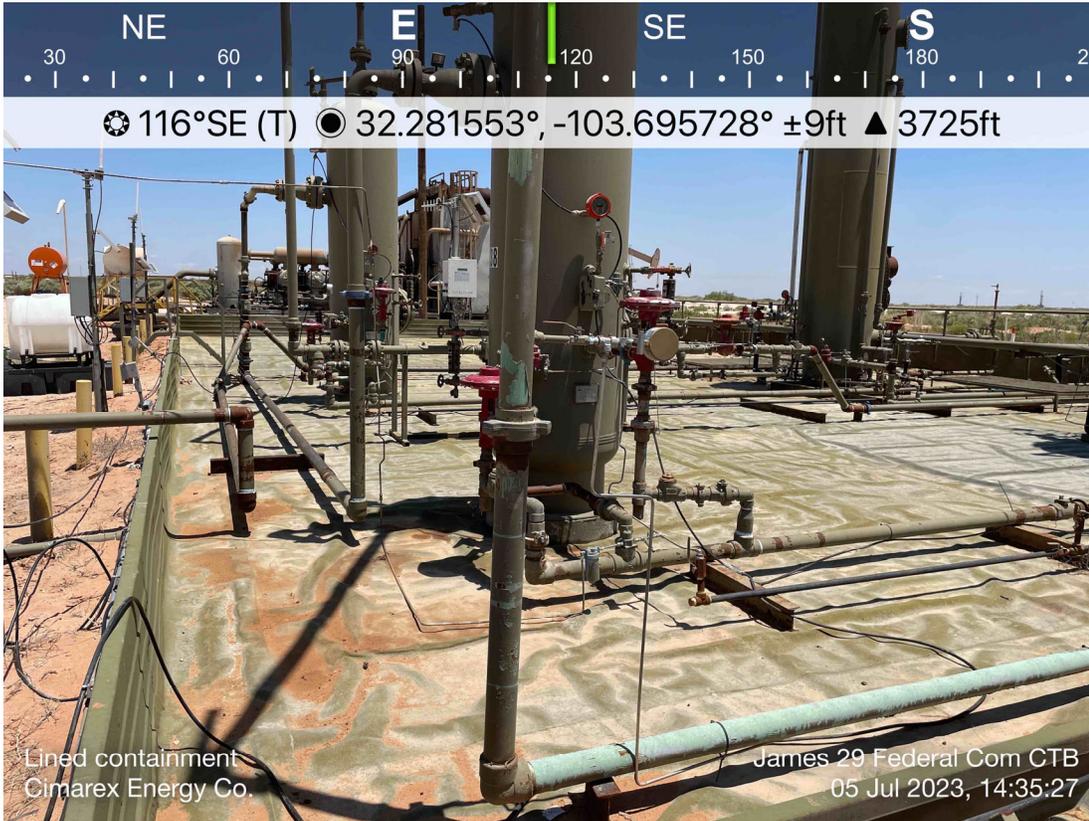
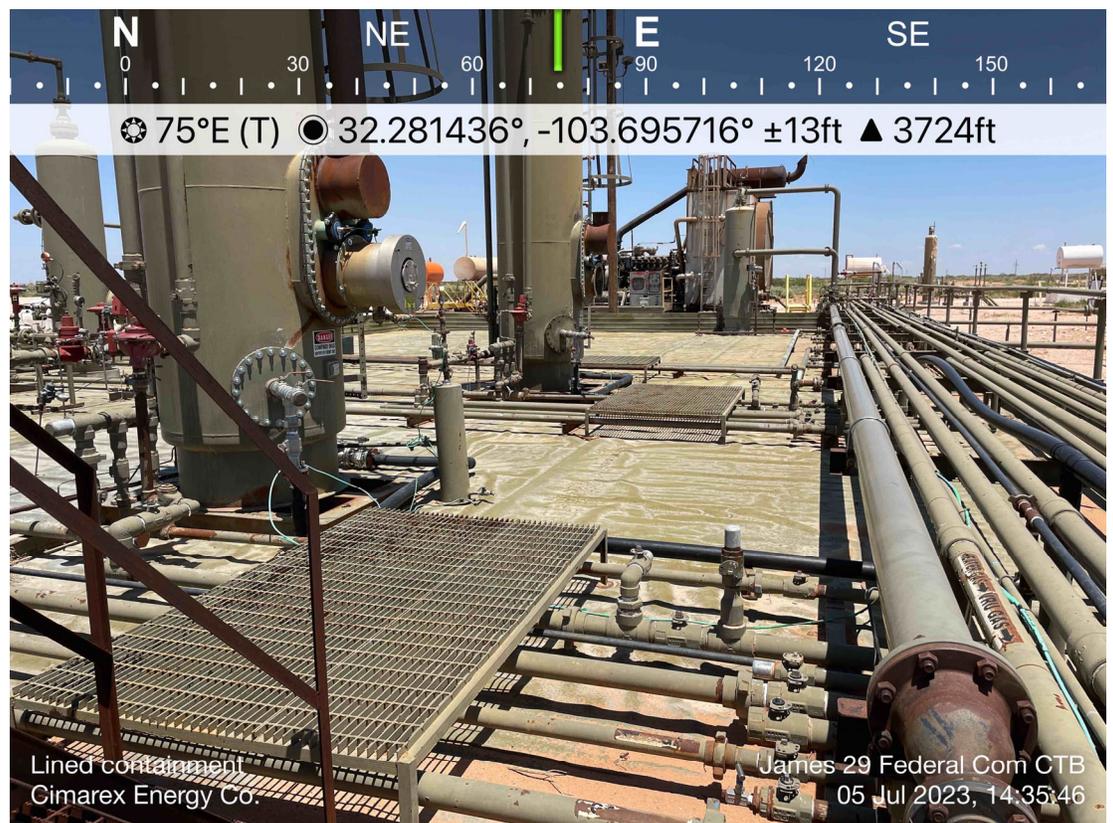
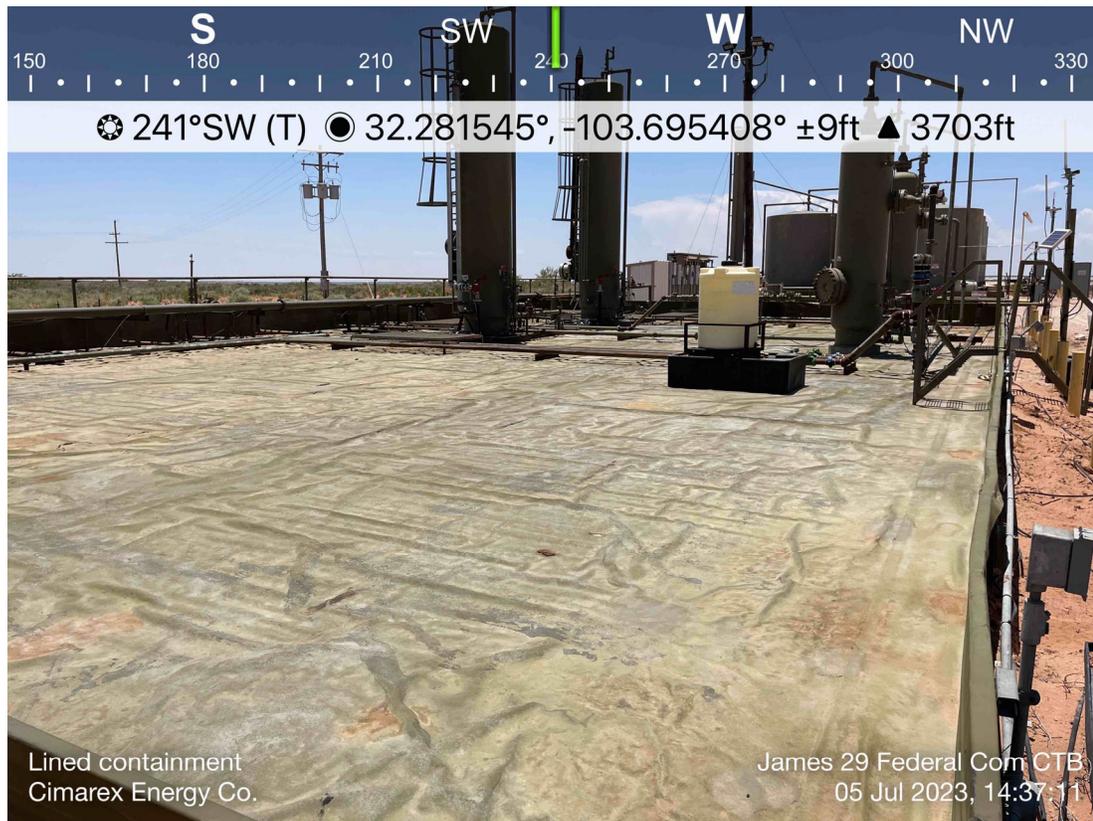
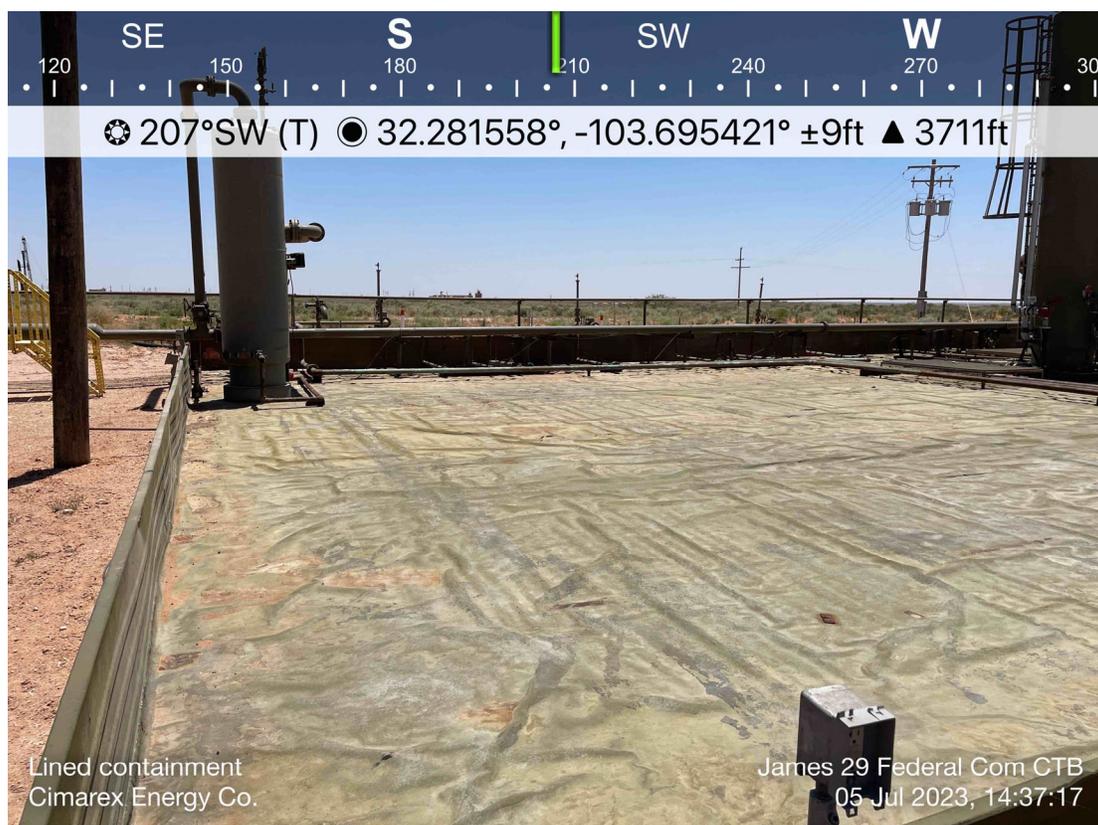
- Responsible Party has visually inspected the liner.
- Liner remains intact and was able to contain the leak in question.
- At least two business days' notice was given to the appropriate division district office before conducting the liner inspection.
- Photographs illustrating liner integrity are included.

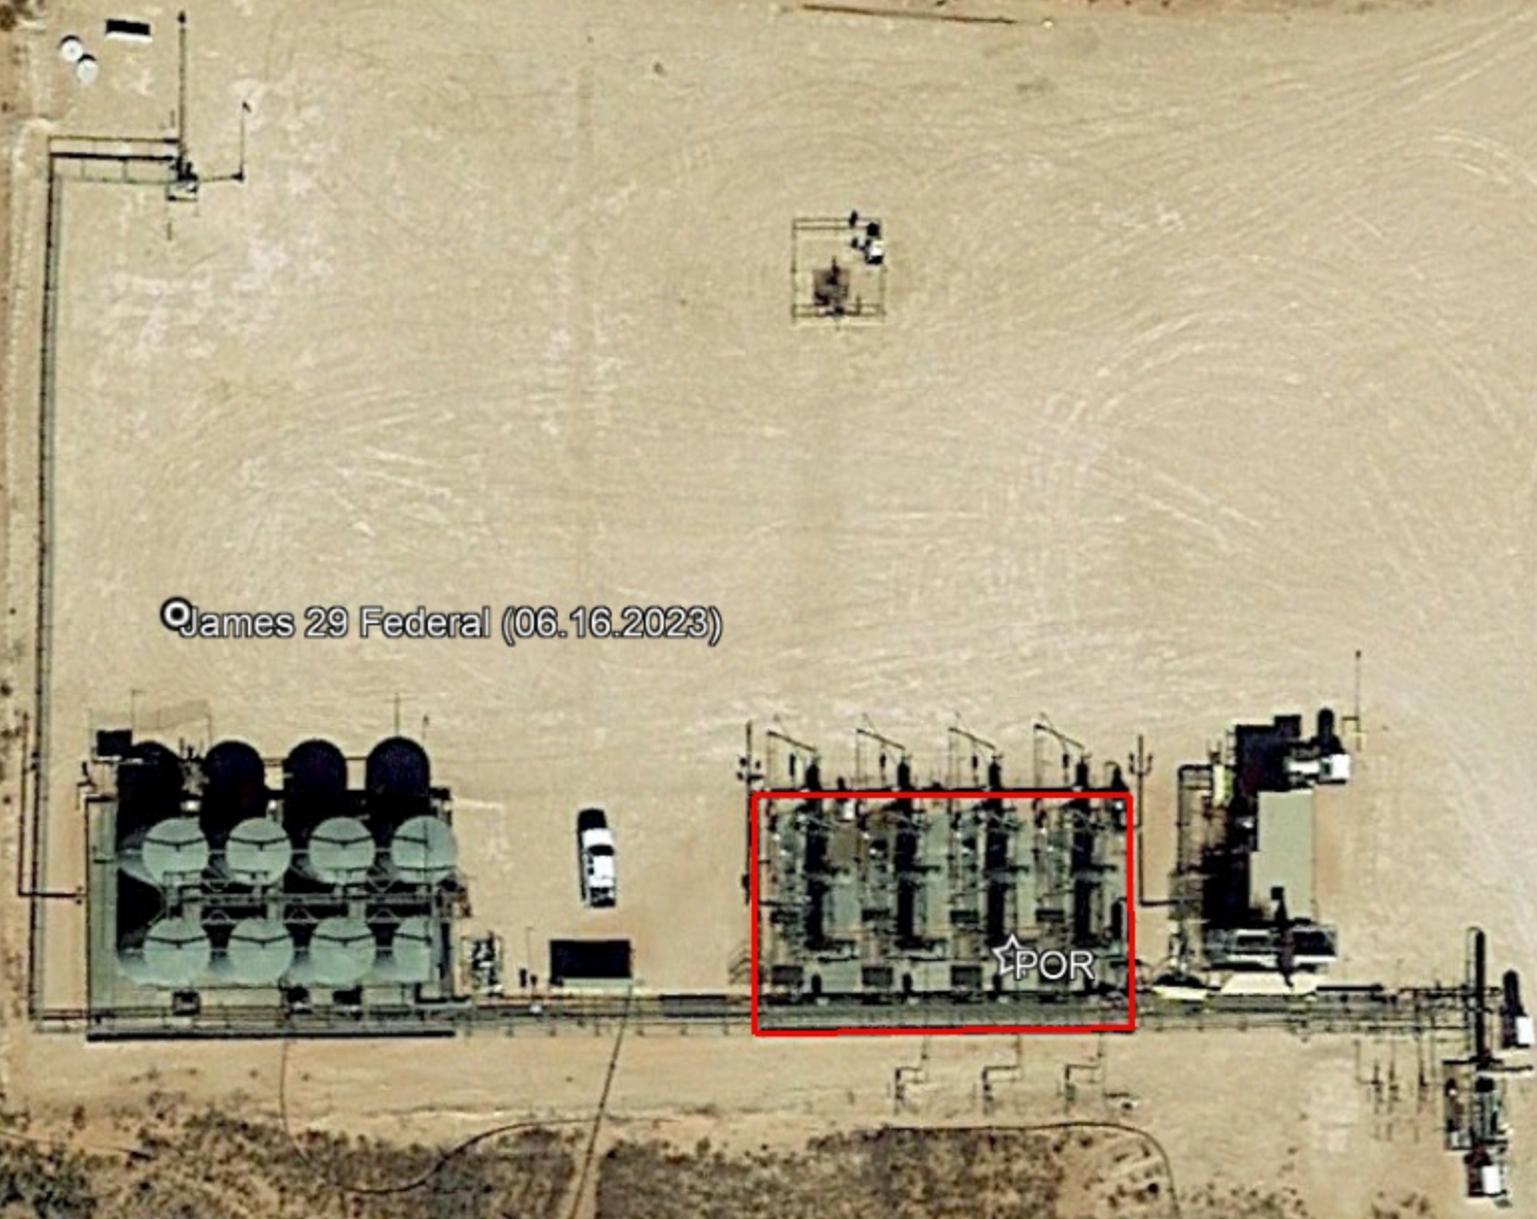
Site Map

- James 29 Federal (06.16.2023)
- ▭ Lined Containment Area
- ★ Point of Release

★POR

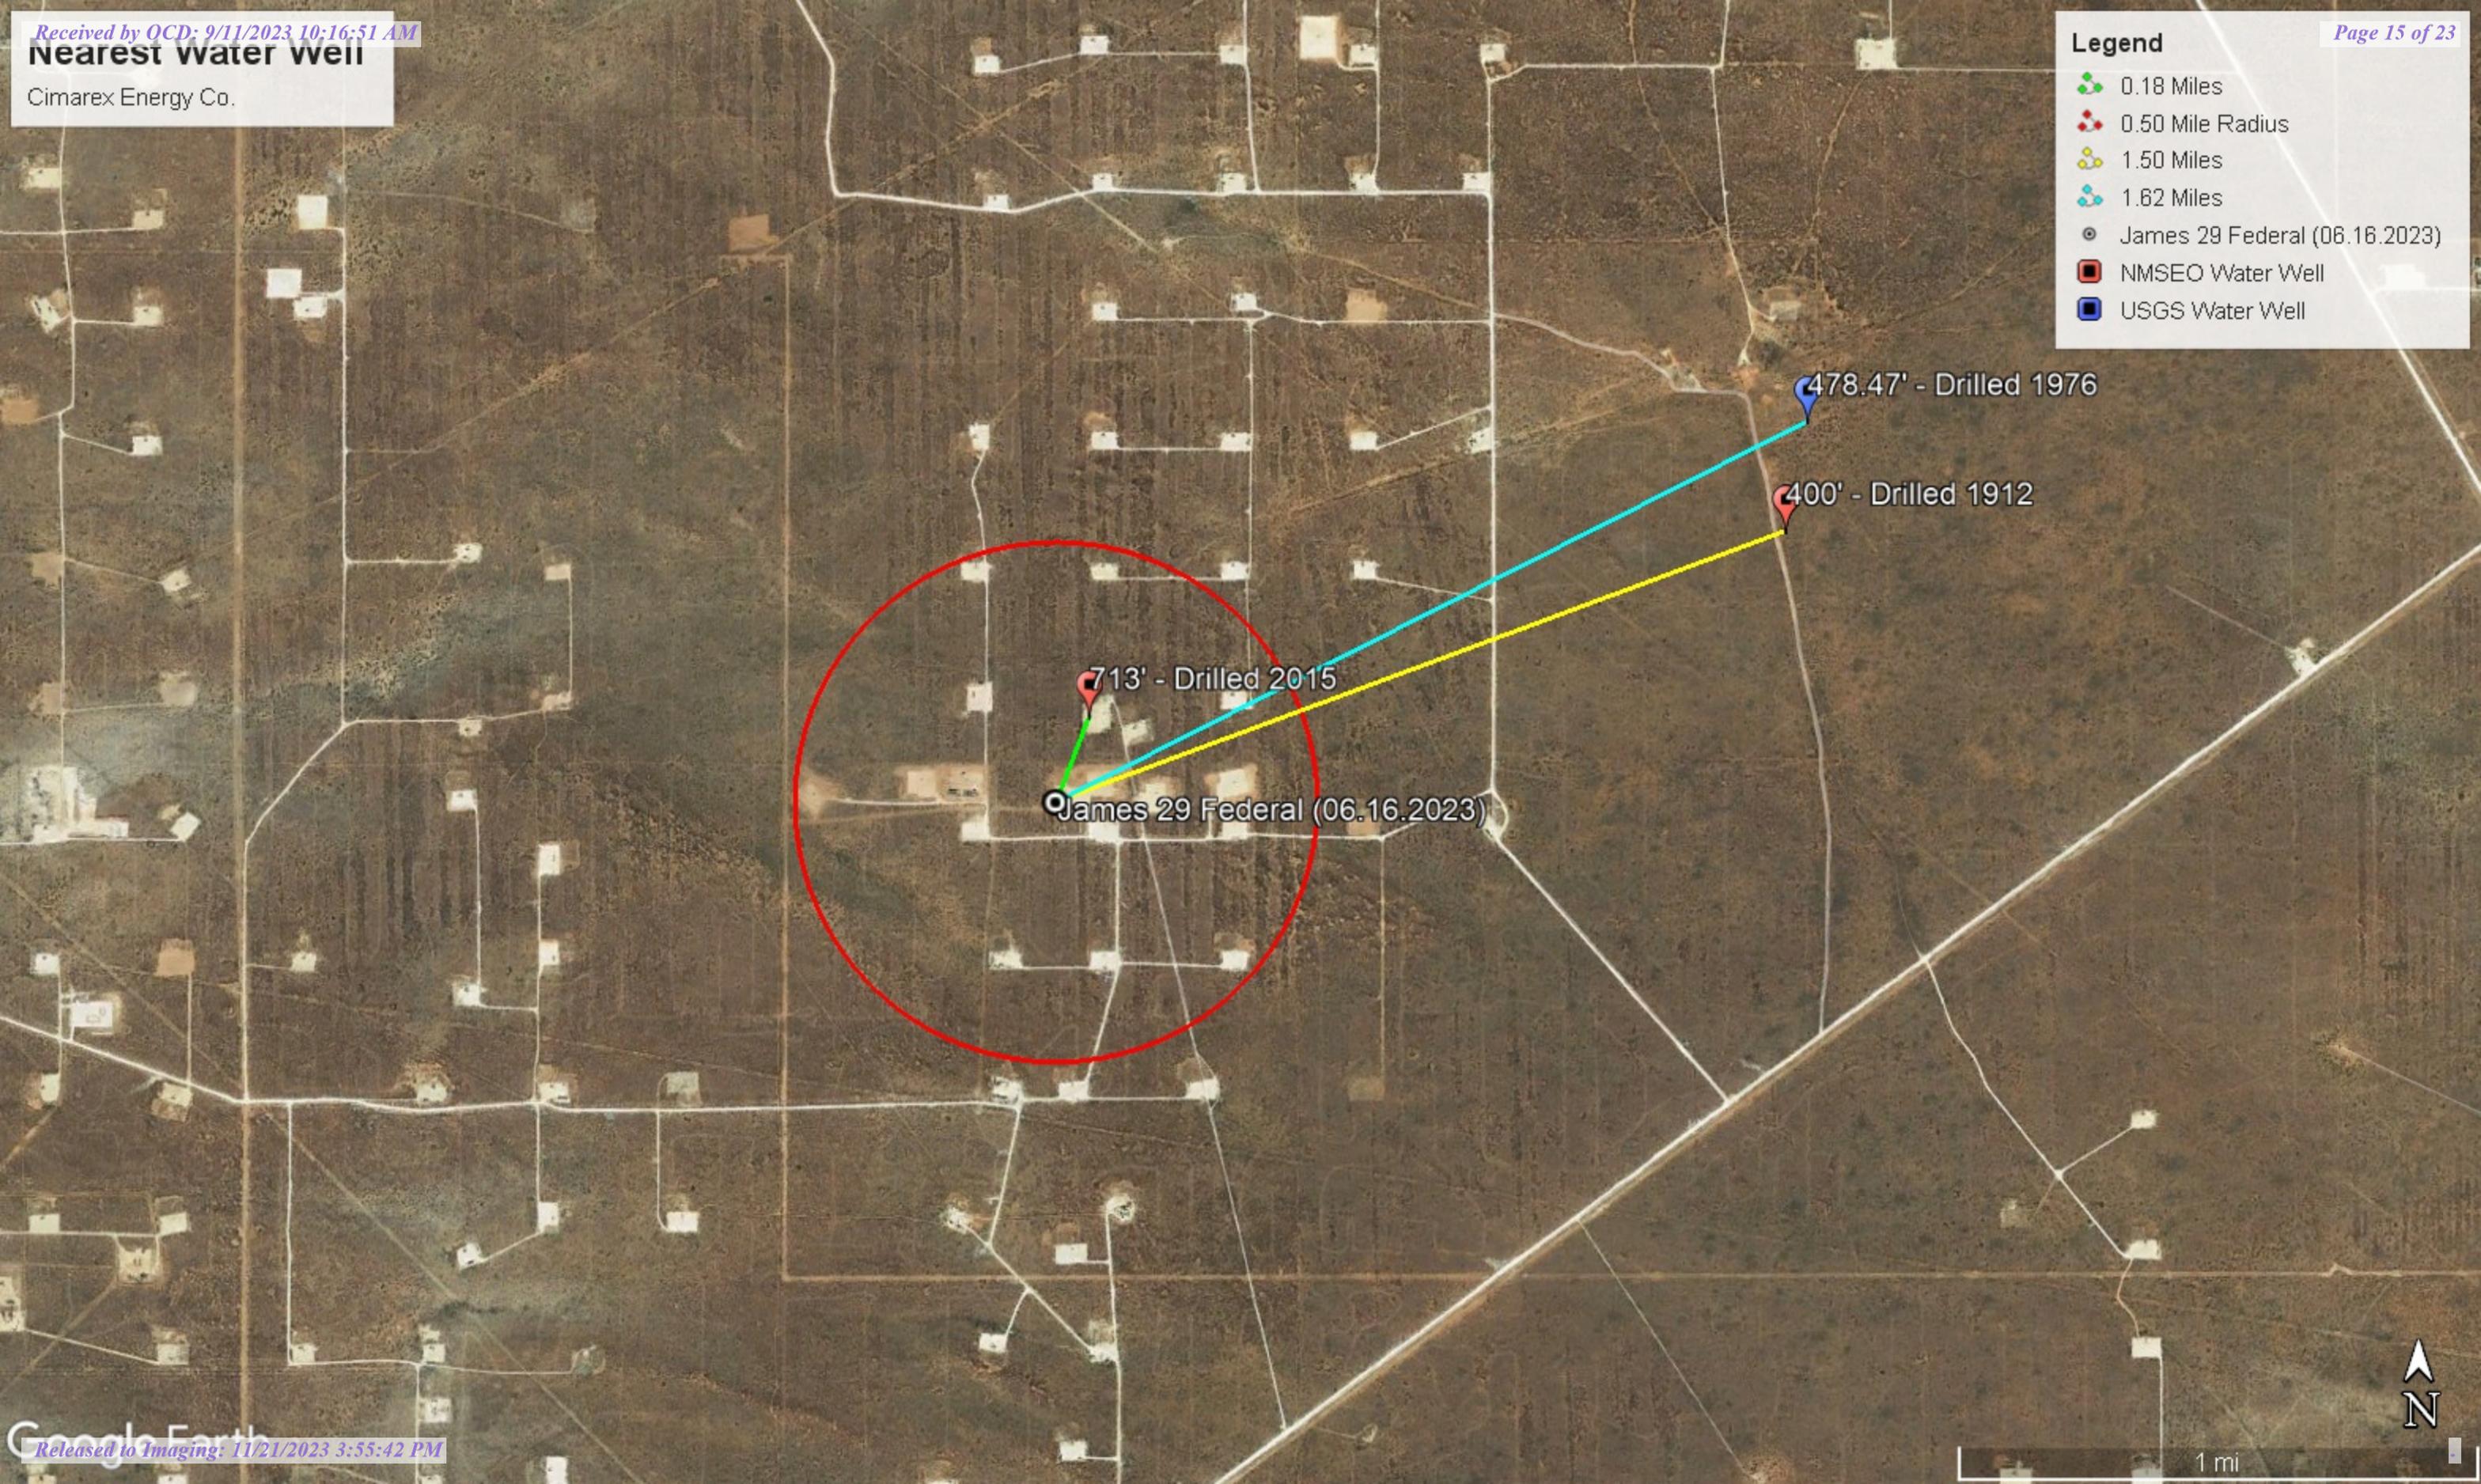
Nearest Water Well

- 0.18 Miles
- 0.50 Mile Radius
- 1.50 Miles
- 1.62 Miles
- James 29 Federal (06.16.2023)
- NMSEO Water Well
- USGS Water Well
