**Re: Site Assessment, Remediation, and Closure Report
 Fat Tire Federal Tank Battery
 API No. N/A
 GPS: Latitude 32.85360 Longitude -104.02030 UL
 "A", Sec. 12, T17S, R29E
 Eddy County, NM
 NMOCD Ref. No. NAPP2300332370**

Paragon Environmental, LLC (Paragon) has been contracted by Spur Energy Partners (Spur) to perform a spill assessment and write the closure report for the release site known as the Fat Tire Federal Tank Battery (Fat Tire). Contractor BB&I performed the remediation since they were the responsible party that caused the release. Details of the release are summarized below:

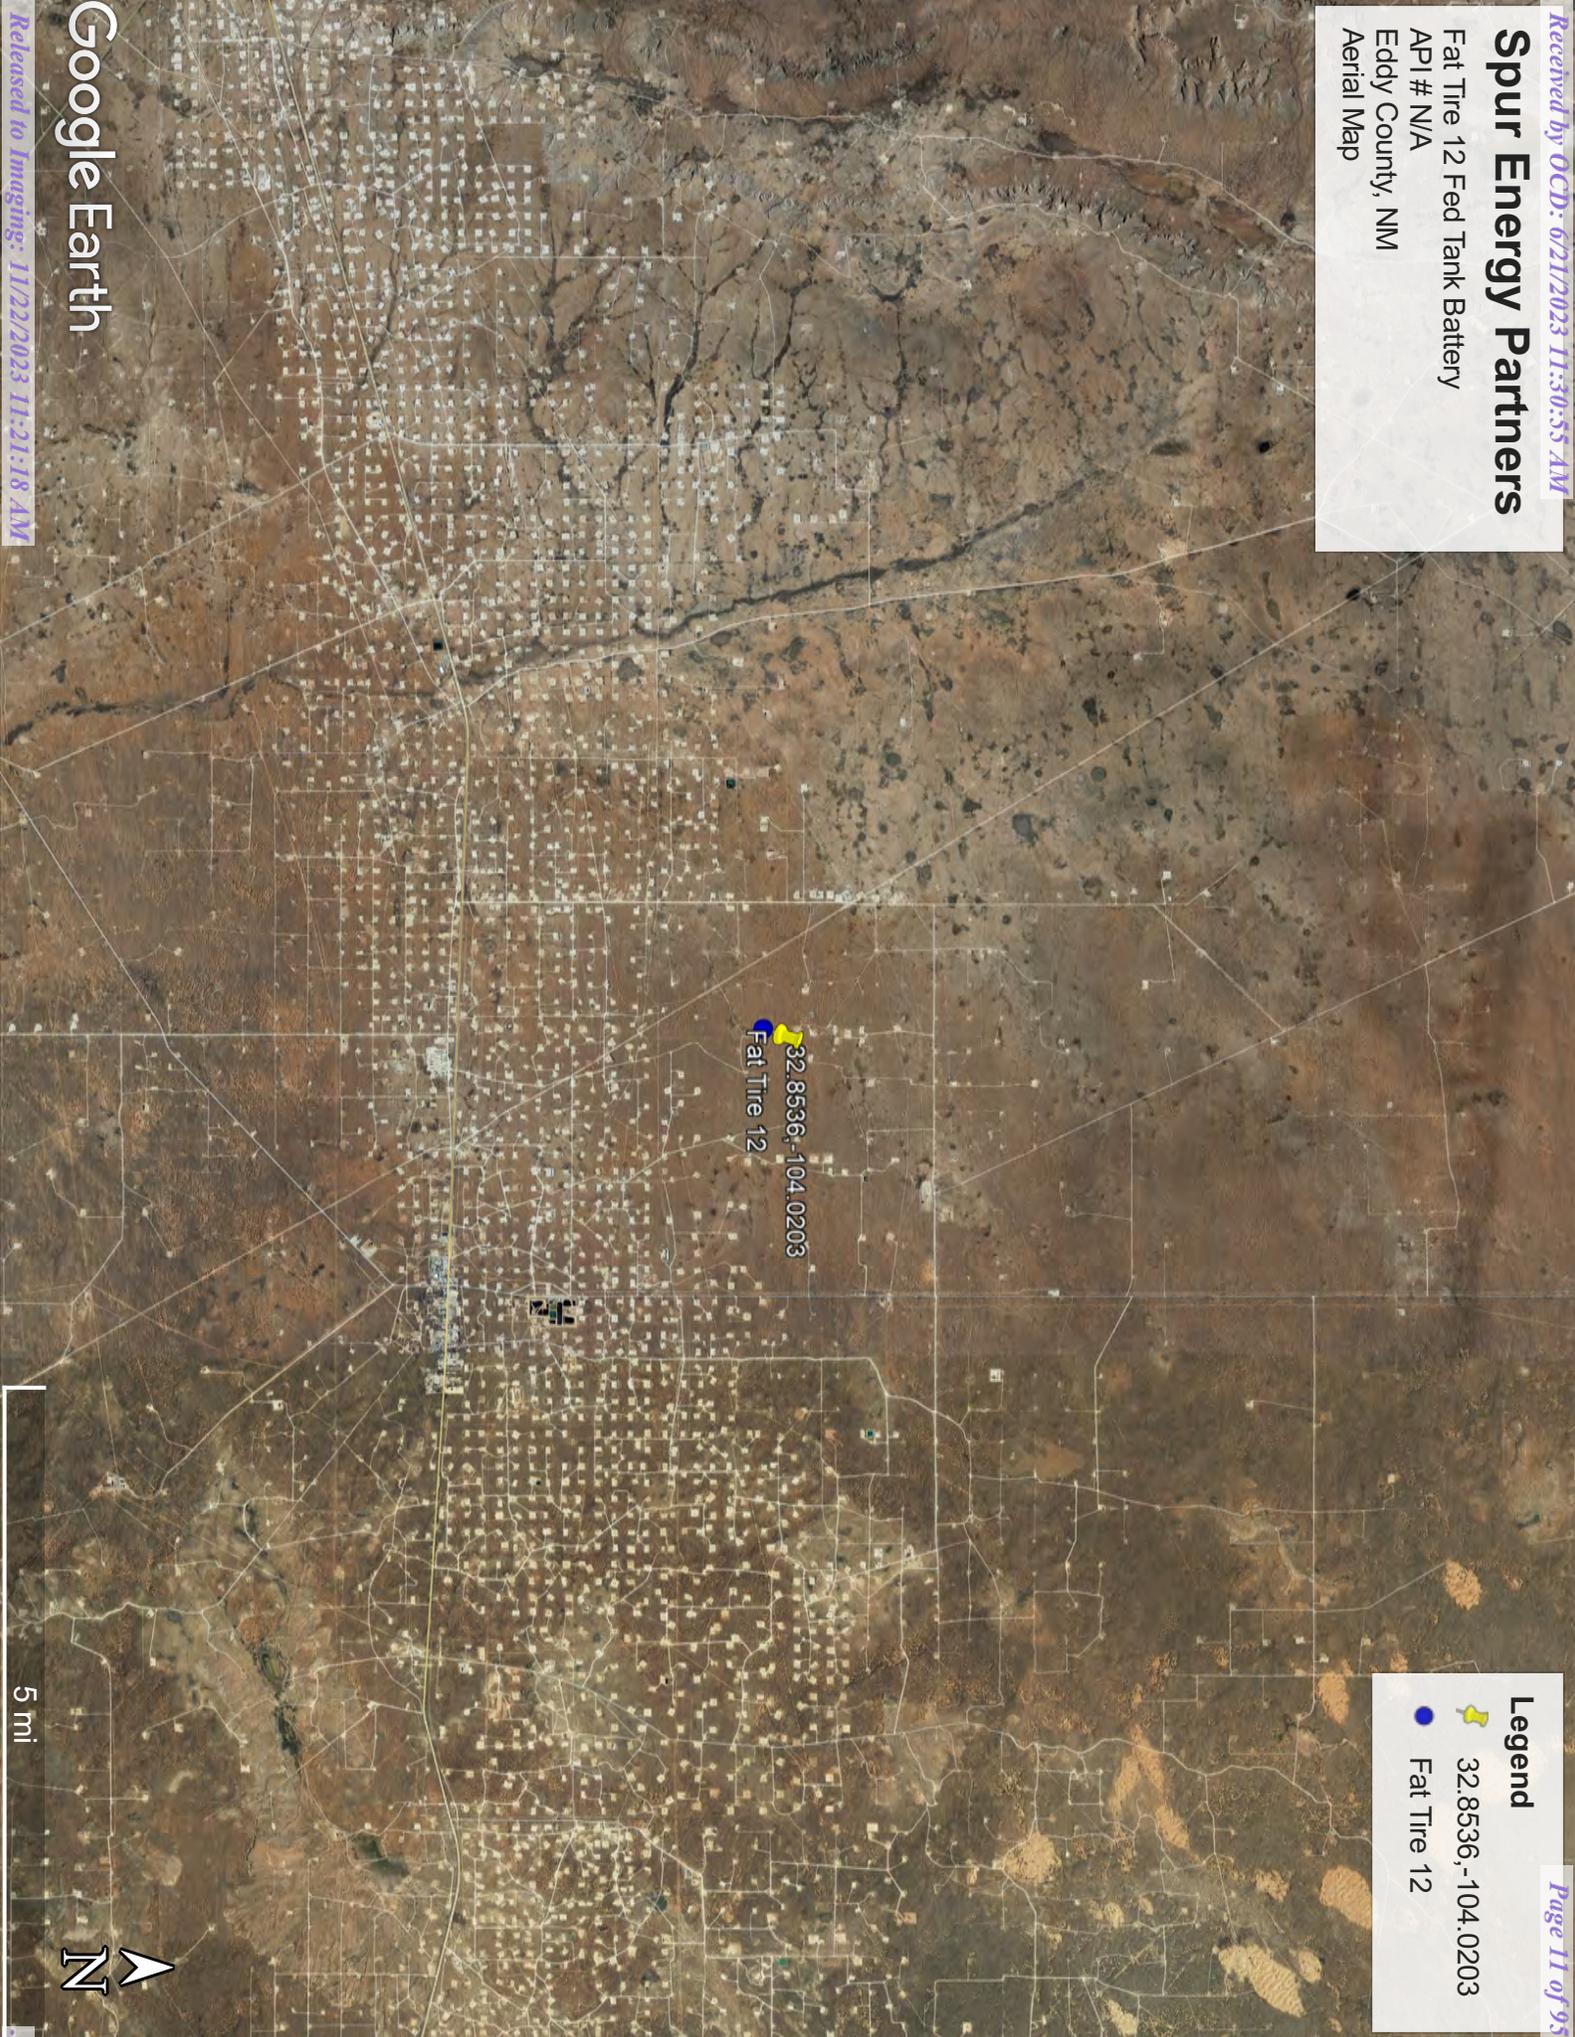
Fat Tire 12

Legend

- 1-Foot Excavation
- 2-Feet Excavation
- 5-Feet Excavation
- Sample Areas
