Release Notification

| Site Name Lone Watie CTB | Site Type Central Tank Battery |

Cause of Release Corrosion caused a pin hole on a 6" Victaulic 90 on the water tank inlet line to release fluids into impermeable lined containment. All fluids were recovered. A 48-hour advance liner inspection notice was sent to NMOCD District 2. Liner was visually inspected and determined to be operating as designed. XTO requests closure of this incident.

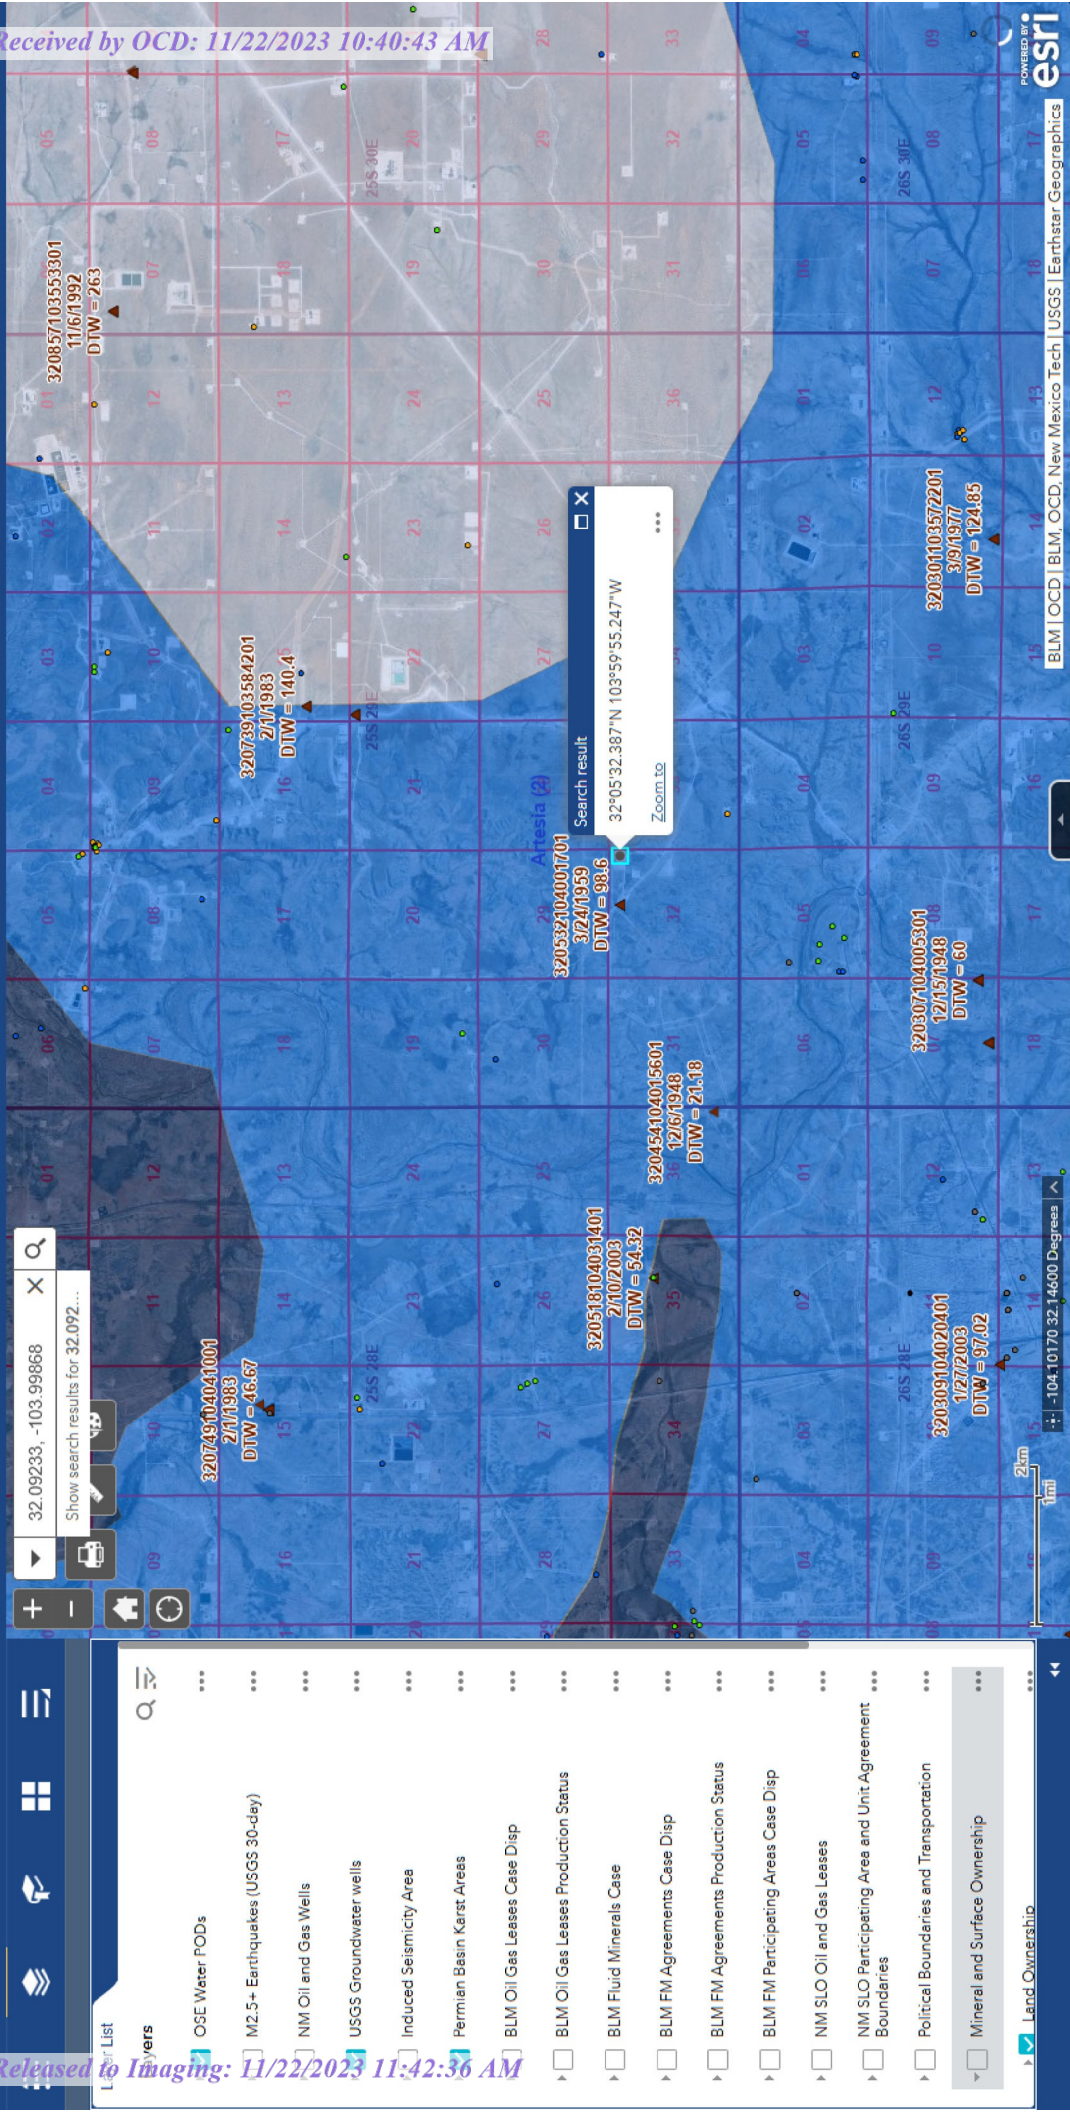
USGS 320532104001701 25S.29E.32.21111

Eddy County, New Mexico
Latitude 32°05'32", Longitude 104°00'17" NAD27
Land-surface elevation 2,988 feet above NAVD88
The depth of the well is 128 feet below land surface.
This well is completed in the Other aquifers (N9999OTHER) national aquifer.
This well is completed in the Rustler Formation (312RSLR) local aquifer.
