RE: Release Investigation, and Closure Report
Skelly 18" Steel Line
Unit A, Section 13, Township 17 South, Range 30 East
32.838535°, -103.920052°
Eddy County, New Mexico
Terracon Project No. KH237026

Frontier Field Services, LLC
Skelly 18" Steel Line
32.838535°, -103.920052°
NMOCD Reference # nAPP2304036127
Terracon Project # KH237026

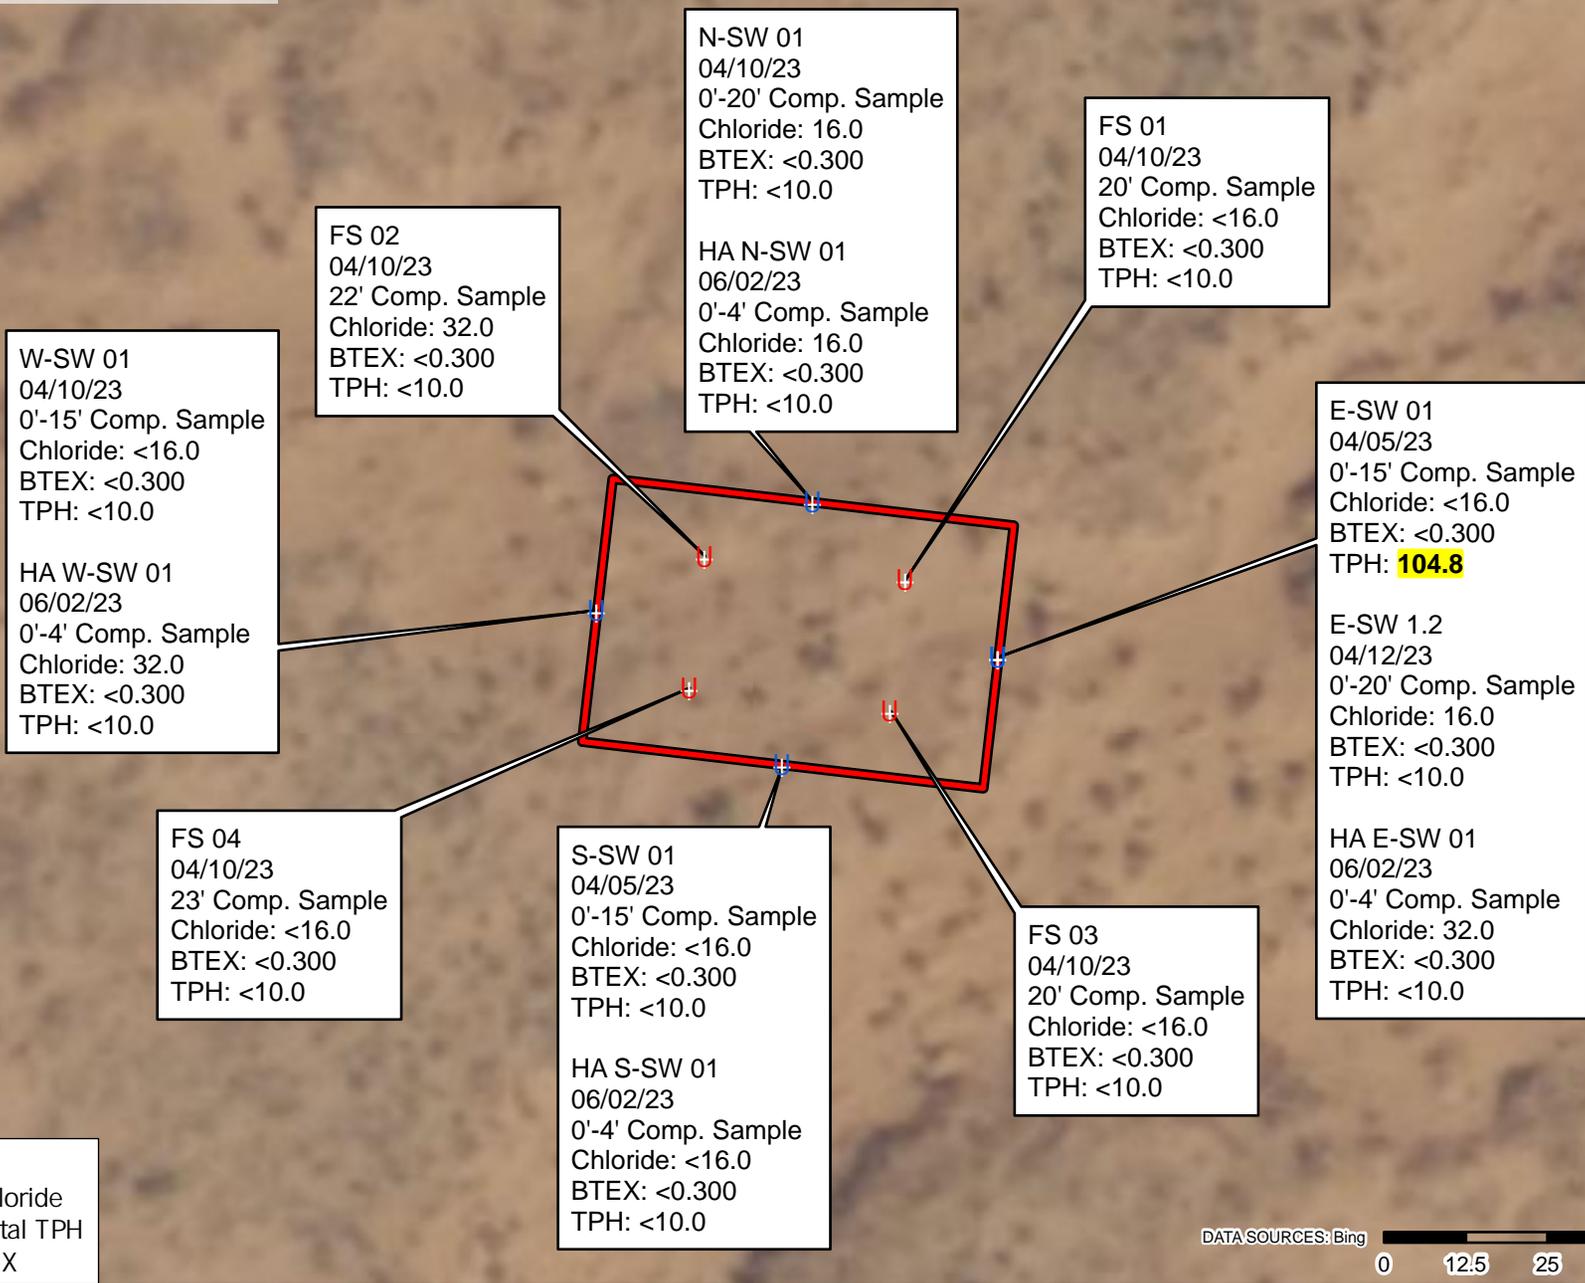
3

A total of 8 composite soil side wall samples (SW) and four floor samples (FS) (N-SW 01, S-SW 01, E-SW 01, W-SW 01, FS01, FS 02, FS 03, and FS 04) were collected from the excavation over 200 sq. ft., placed in the laboratory-provided sample containers, preserved with ice, and transported under chain of custody to Cardinal Laboratories in Hobbs, New Mexico for analysis of BTEX, TPH, and chlorides.

NMOCDA RAL =
 600 mg/kg for chloride
 100 mg/kg for Total TPH
 50 mg/kg for BTEX

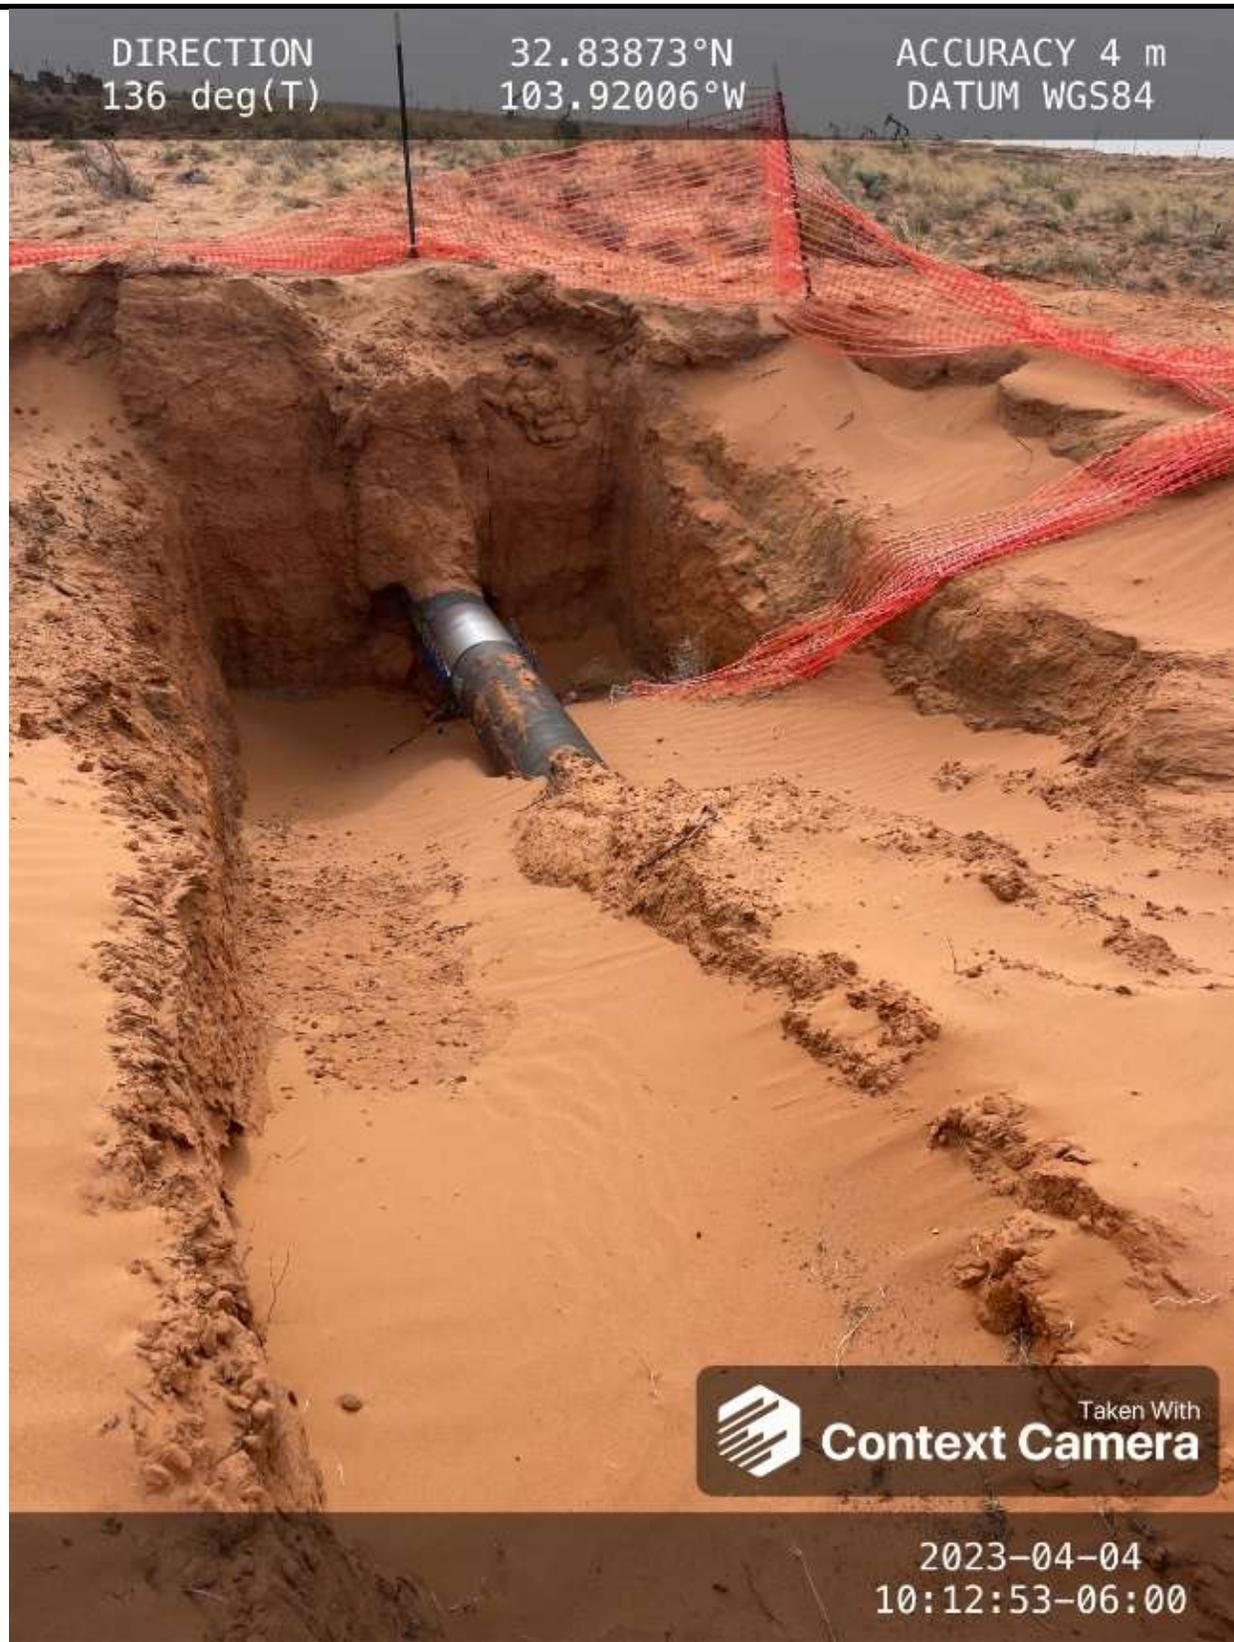
PHOTO 1: View of area prior to excavation

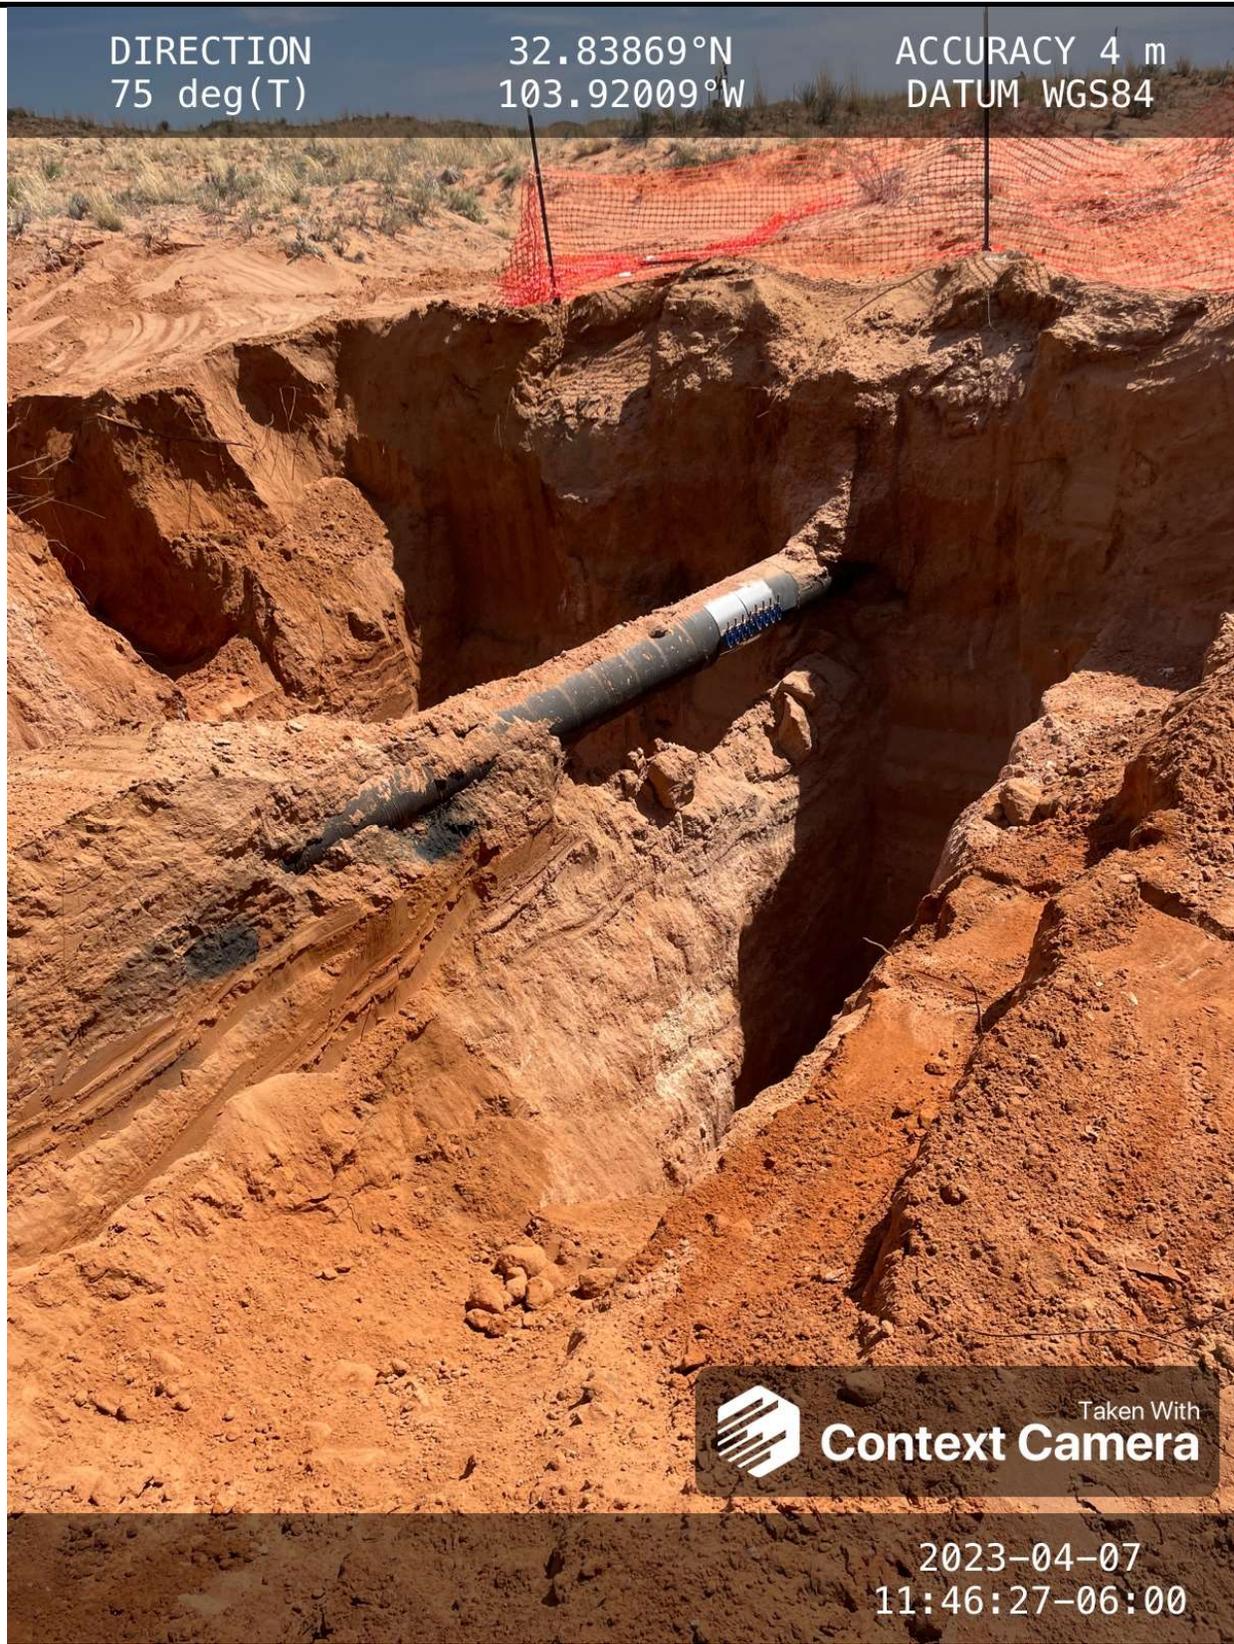
PHOTO 2: View of area, excavation in progress

On April 05, 2023, and April 10, 2023, Terracon mobilized to the site to meet Gandy Corporation (Gandy) personnel, who were to perform soil remediation activities. Areas exhibiting visual impact were excavated to a depth of approximately 20 to 23 feet bgs.

Approximately 1,160 cubic yards of soil were excavated and stockpiled atop a polyethylene liner pending waste characterization and disposal under an approved Form C-138. Excavation efforts ceased based on the results of removing visual impacts. Excavated materials were disposed of at Lea Land Landfill.

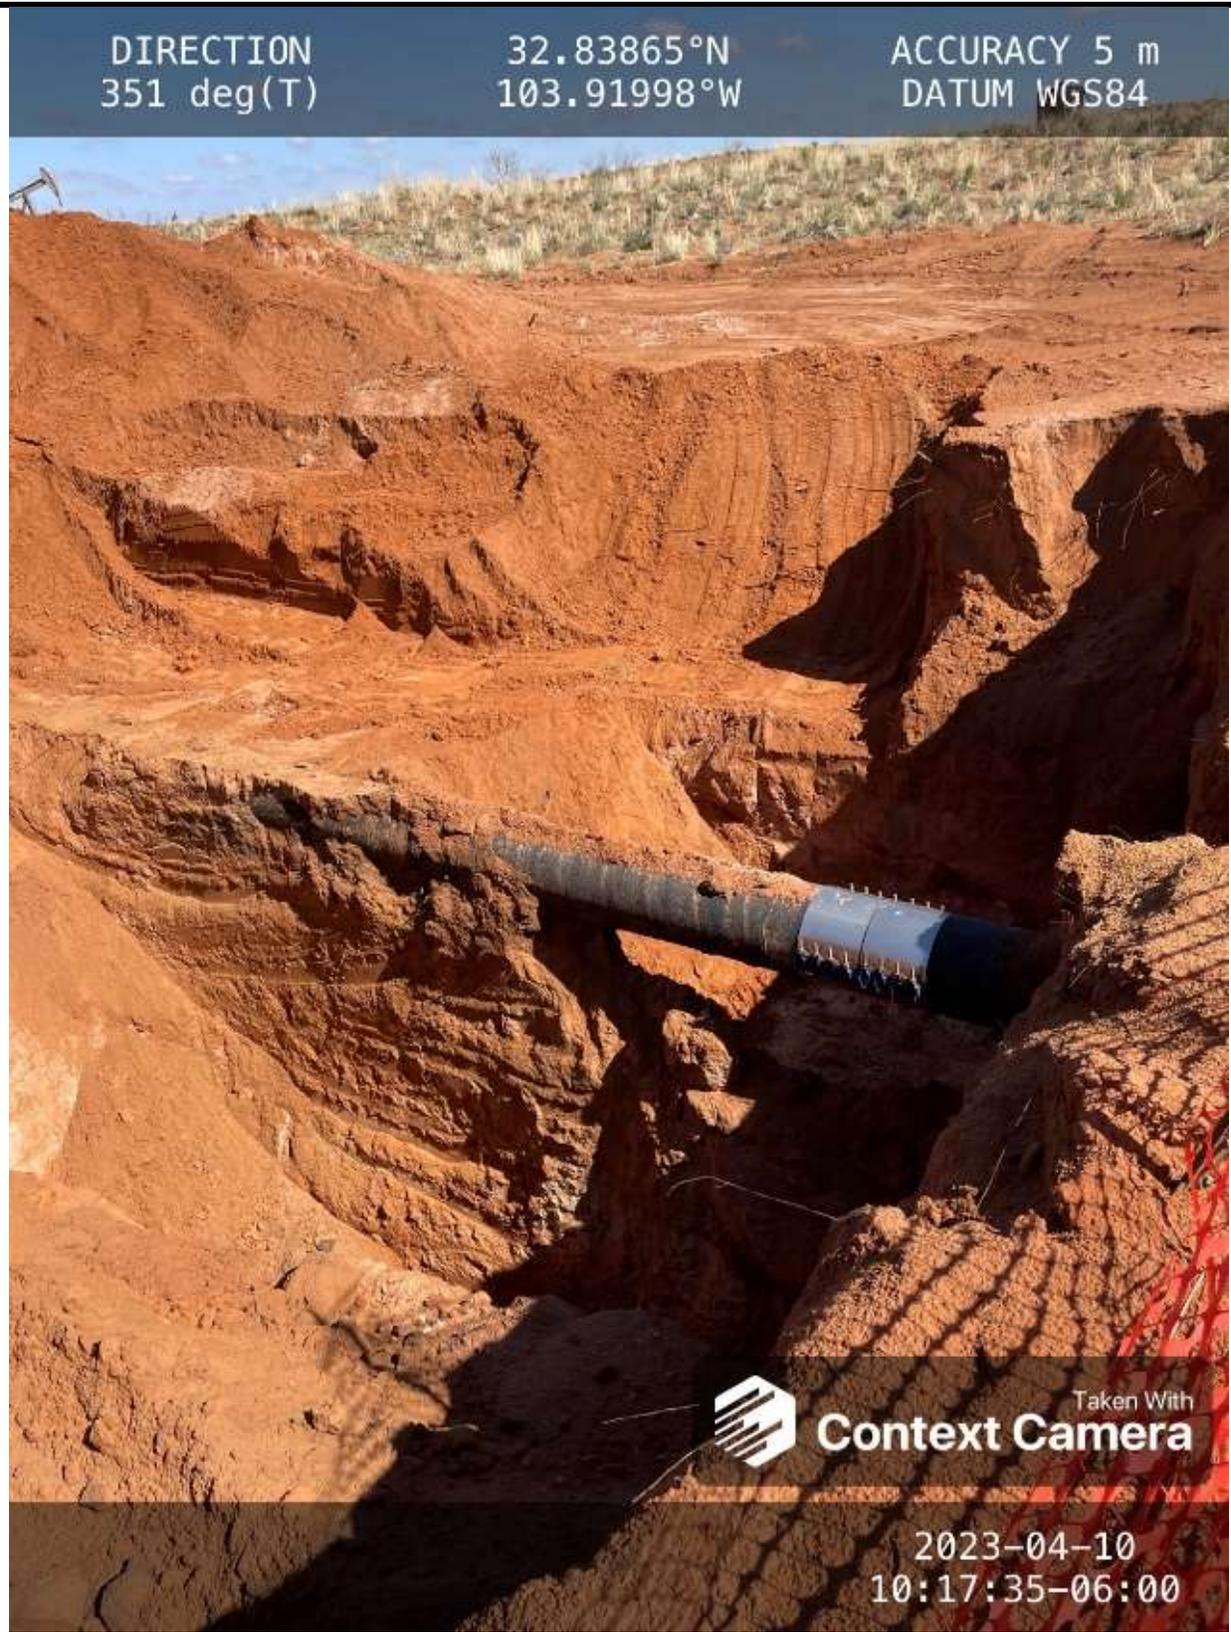
PHOTO 3: View of area after excavation
