## Remediation Summary and Closure Request

**BTA Oil Producers, LLC**

**North Ridge East**

**NMOCD Incident # nAPP2320646612**

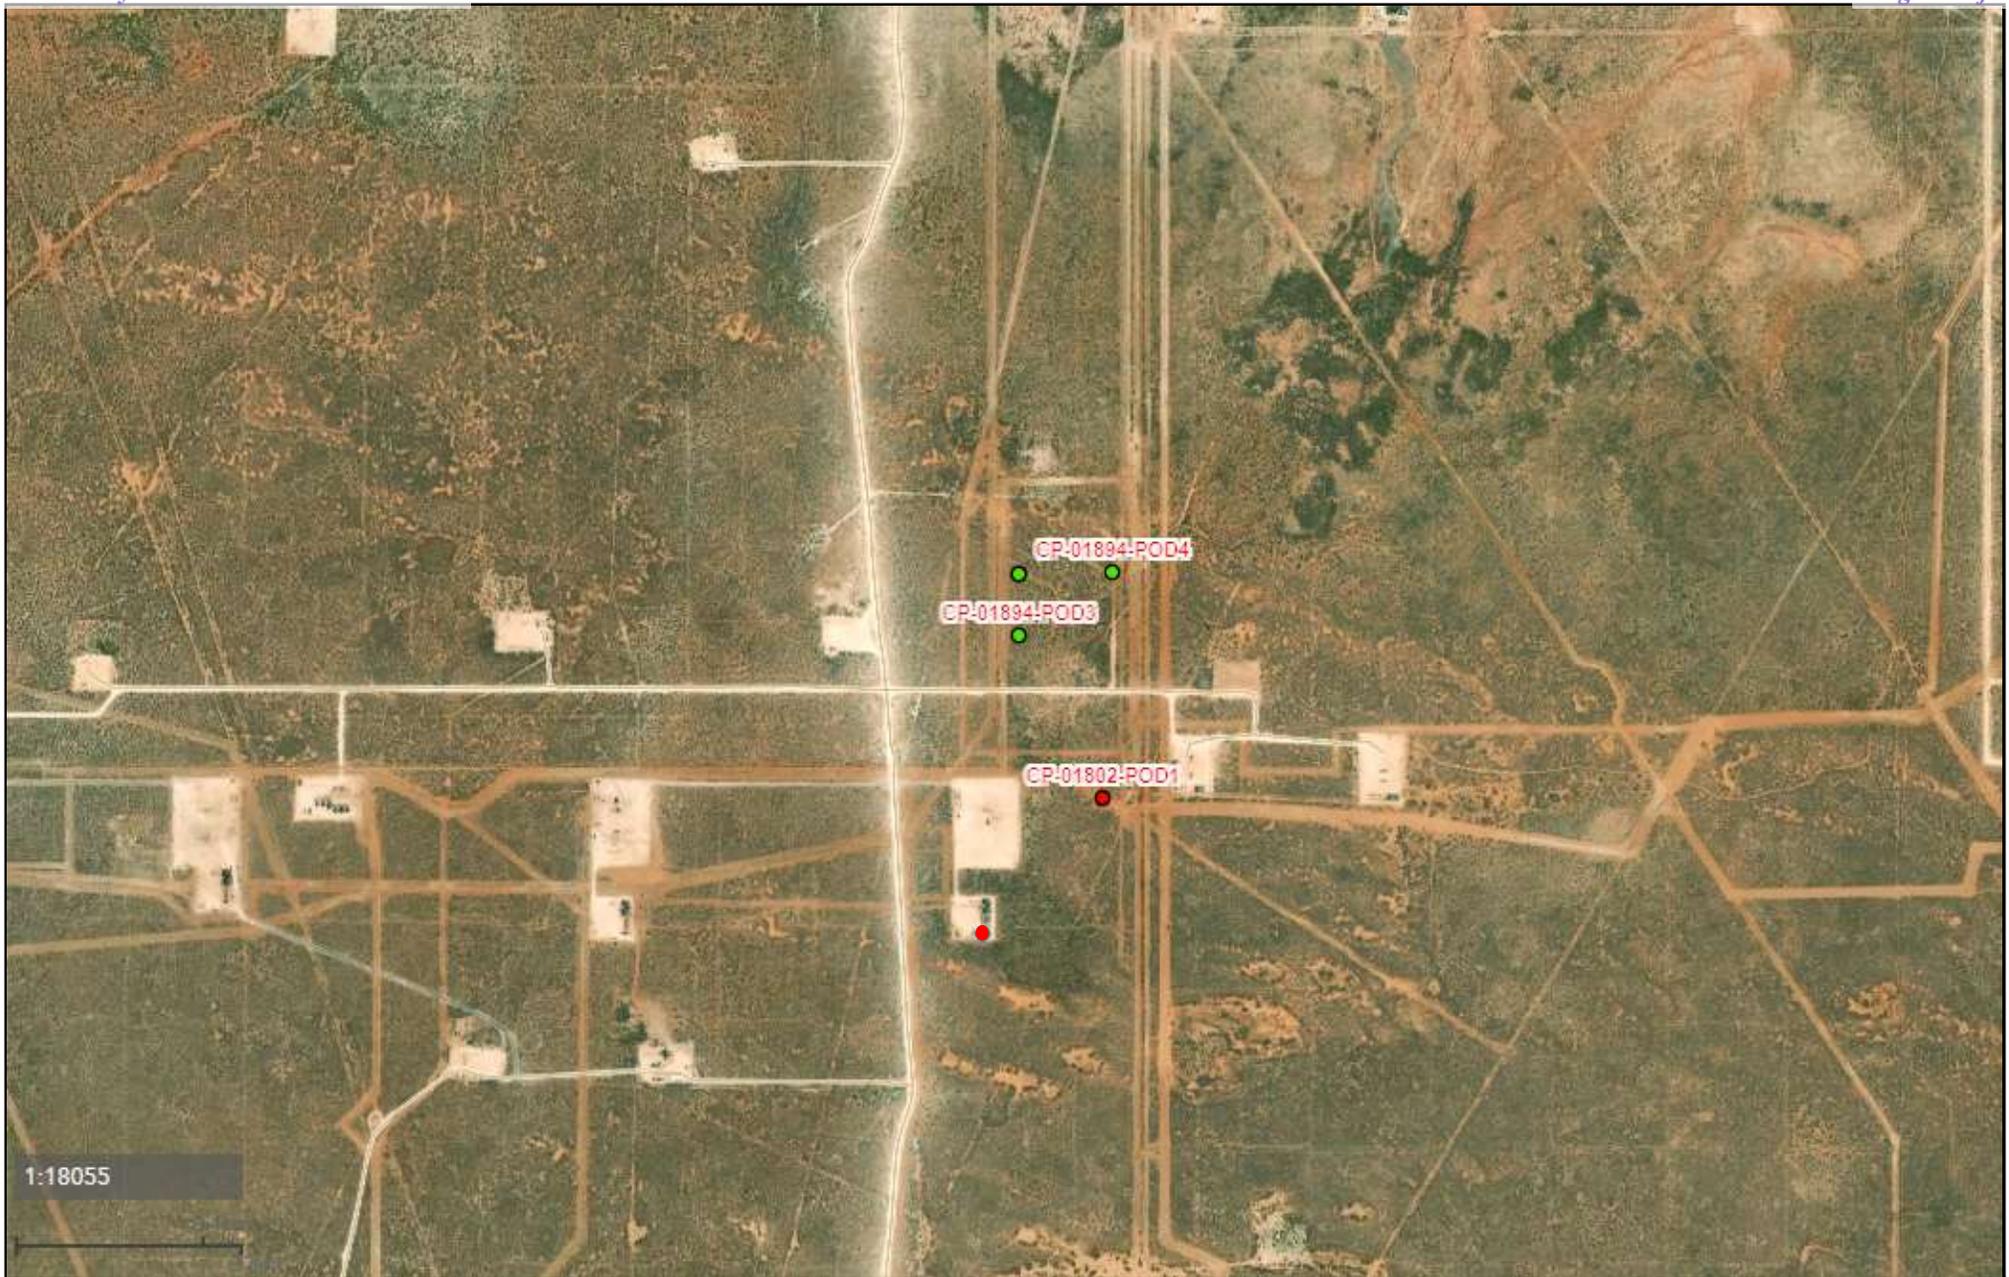
**Figure 2**  
OSE POD Locations Map  
BTA Oil Producers, LLC  
North Ridge East - Fire  
GPS: 32.352562, -103.436069  
Lea County

A search of the New Mexico Office of the State Engineer (NMOSE) and United States Geological Survey (USGS) groundwater databases was completed in an effort to determine the horizontal distance to known water sources within a half mile radius of the Release Site. Approximate depth to groundwater was determined using maintained and published water well data. Karst mapping indicates the site is not located in a Karst designated area. Karst and Wetland Maps are provided as Attachment I. Depth to groundwater information is provided as Attachment III and results are depicted on Figures 2 & 3.

One well was located within a half mile of the release area. Well CP 01802 POD1 was drilled on November 7-9, 2019 to a depth of approximately 200 feet bgs. However, as no water was present, the well was plugged. Therefore, depth to water is reasonably estimated to be greater than 100 feet bgs. Utilizing this information, the NMOCD Closure Criteria for the Site is depicted in the table below.

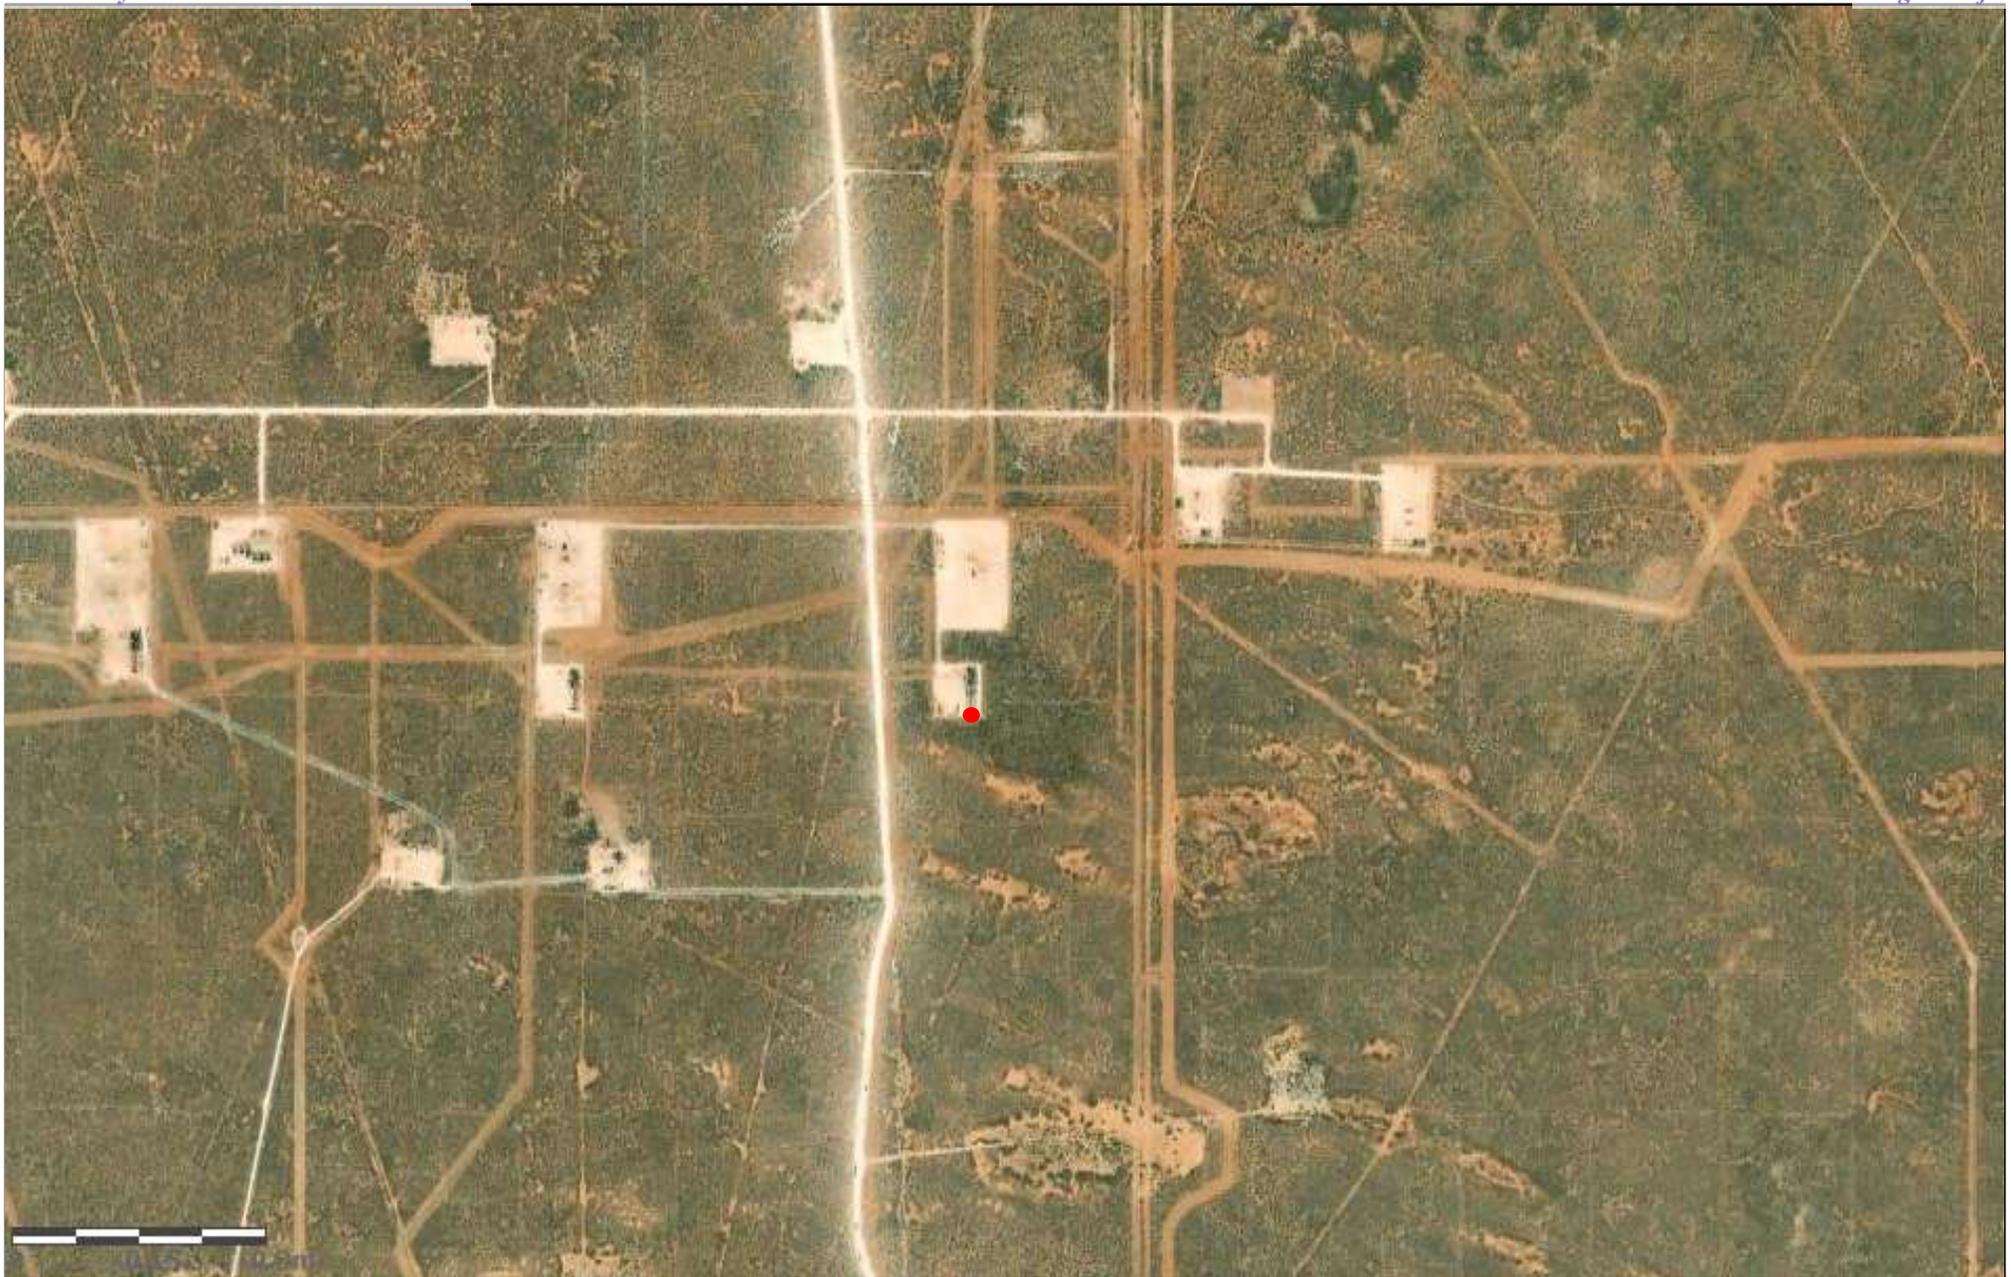
**Figure 3**

USGS Well Locations Map  
BTA Oil Producers, LLC  
North Ridge East - Fire  
GPS: 32.352562, -103.436069  
Lea County

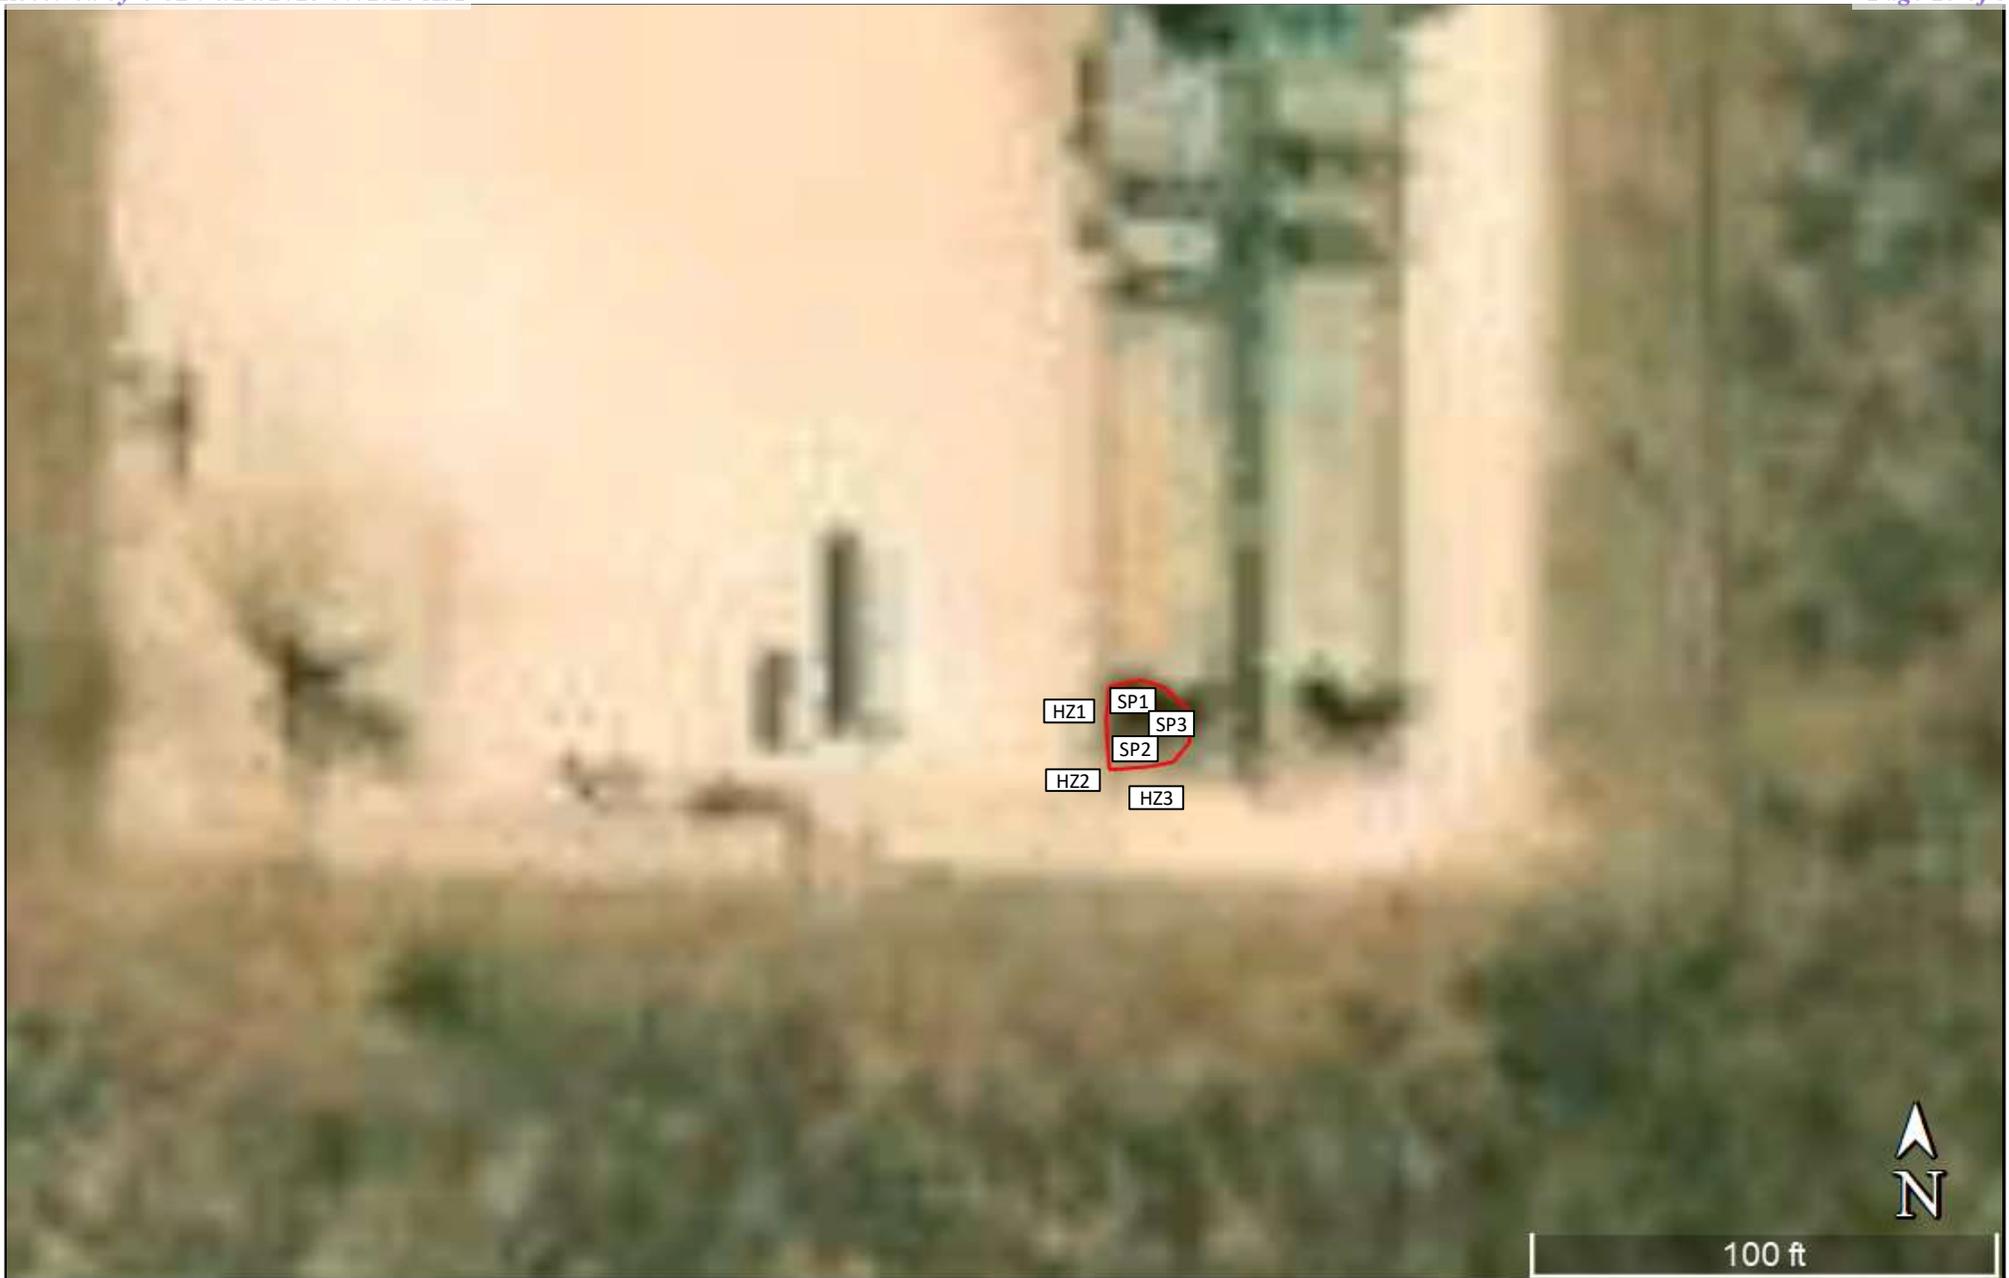
**Figure 4**

Based on field observations and field test data noted above and provided in Attachment IV, twelve representative soil samples were selected for laboratory analysis. Delineation soil samples SP1 through SP3, HZ1 through HZ3, were submitted to the laboratory for analysis of BTEX, TPH, and chloride. Laboratory analytical results indicated contaminant concentrations were below the NMOCD Closure Criteria in each of the submitted samples.

Delineation Sample Map  
BTA Oil Producers, LLC  
North Ridge East - Fire  
GPS: 32.352238, -103.435856  
Lea County

A Delineation Sample Map is provided as Figure 4. A Summary of Soil Sample Laboratory Analytical Results is provided as Table 1 and Laboratory Analytical Reports are provided as Attachment V.

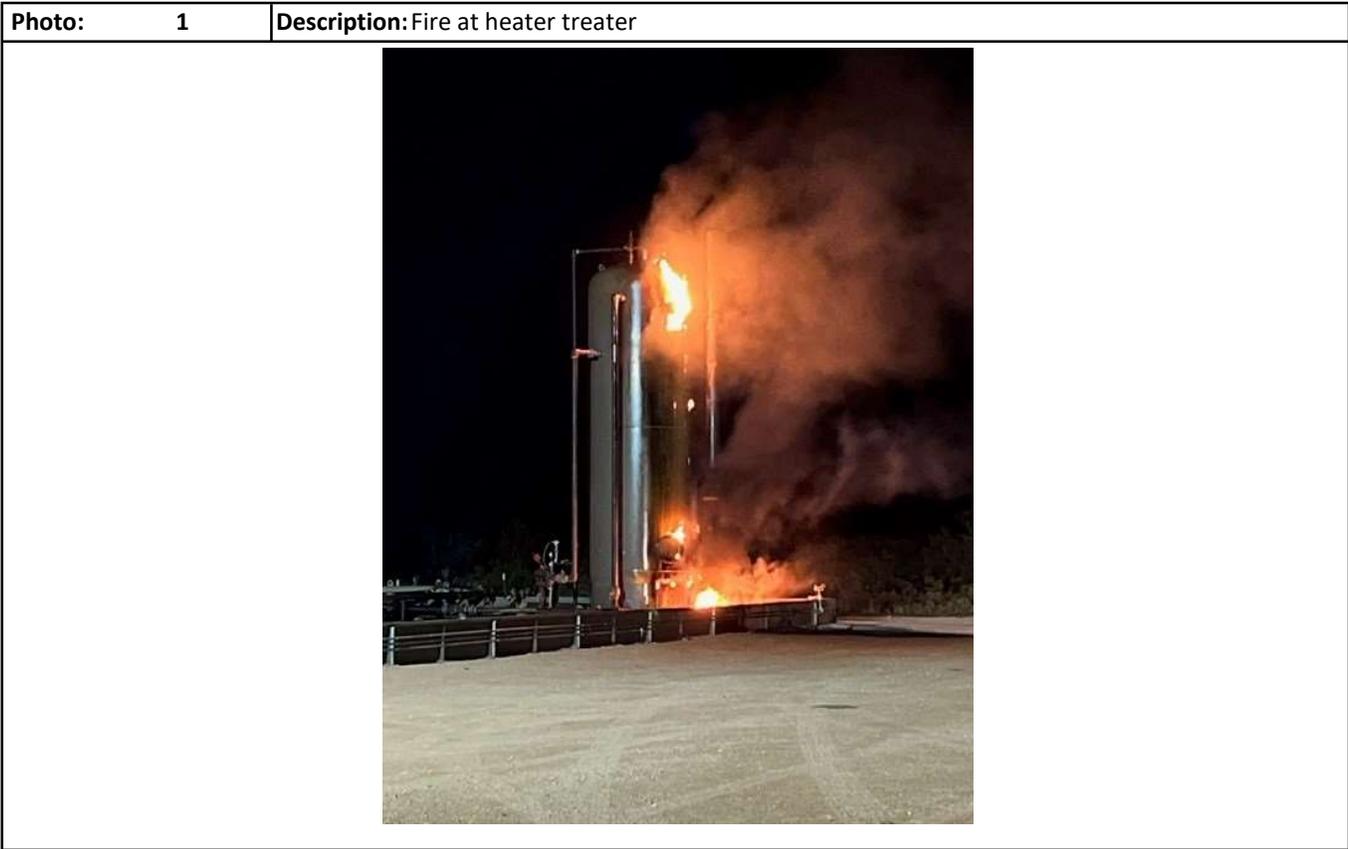
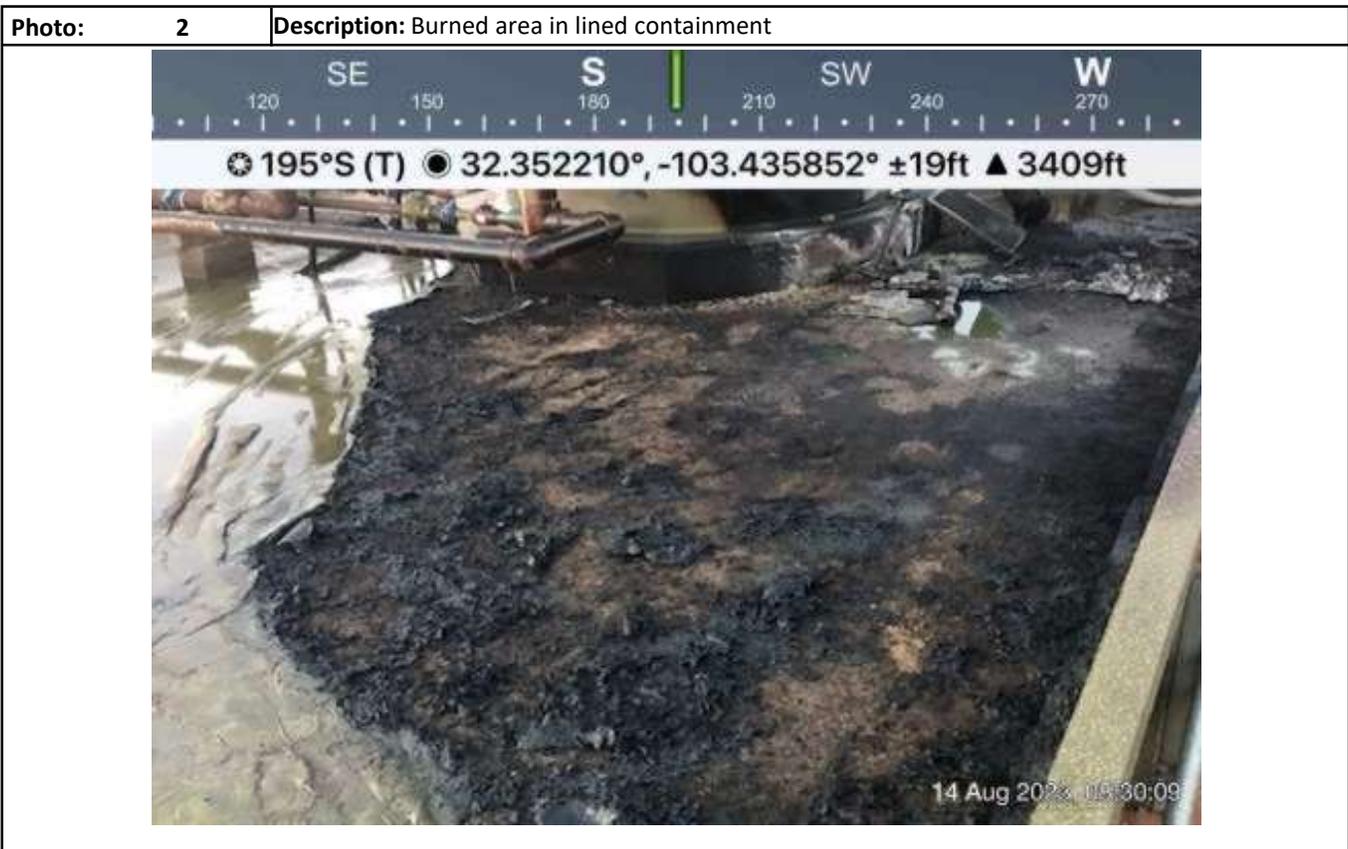
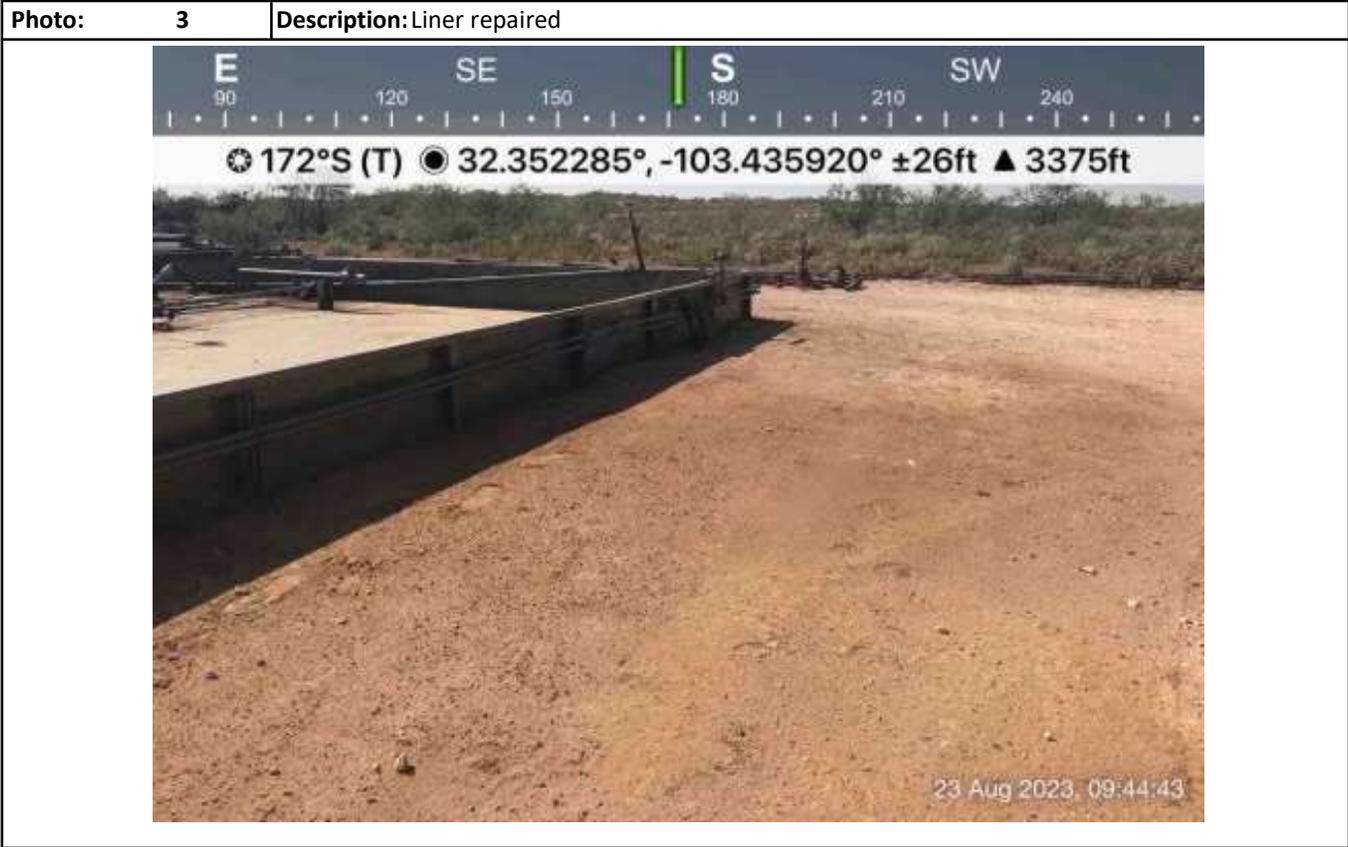
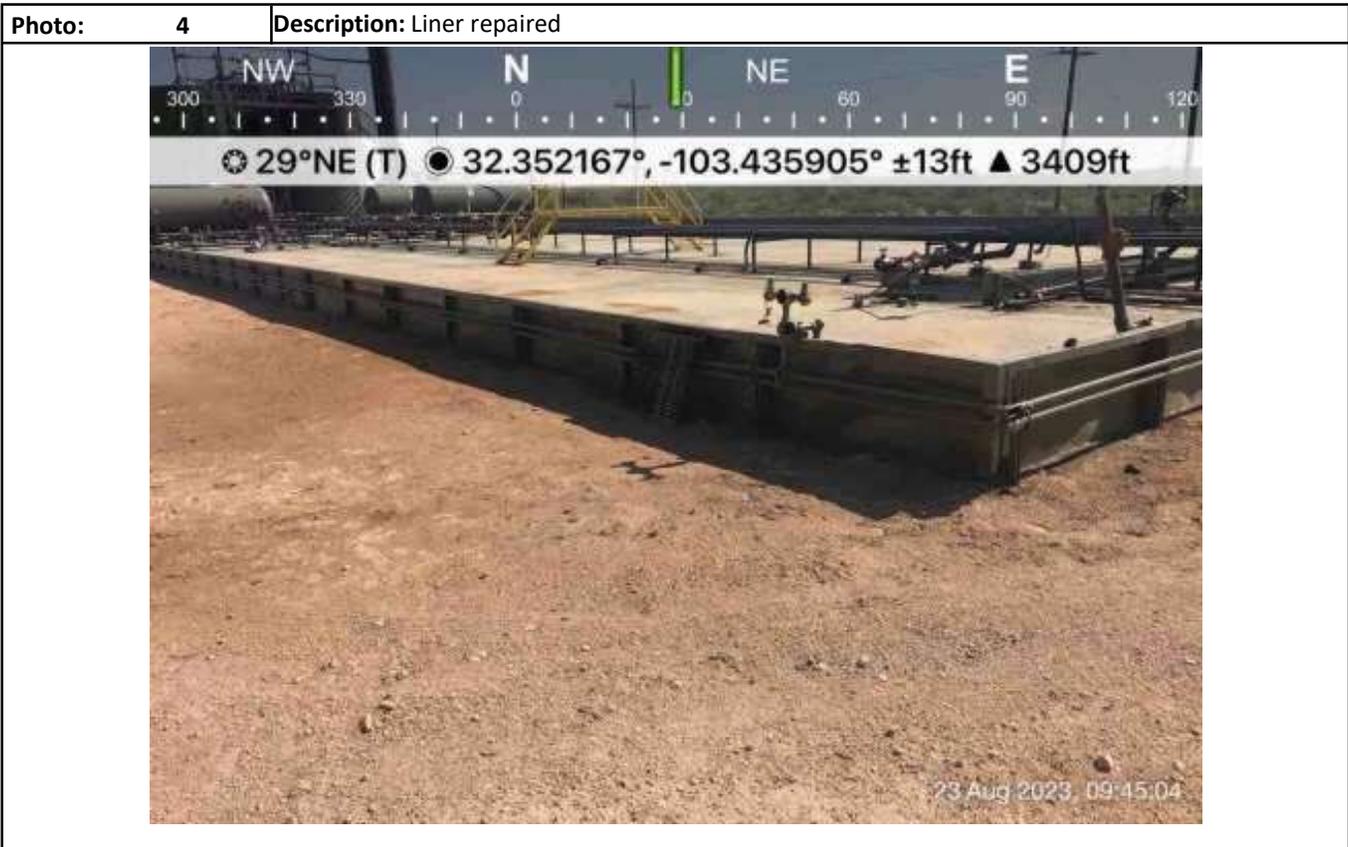
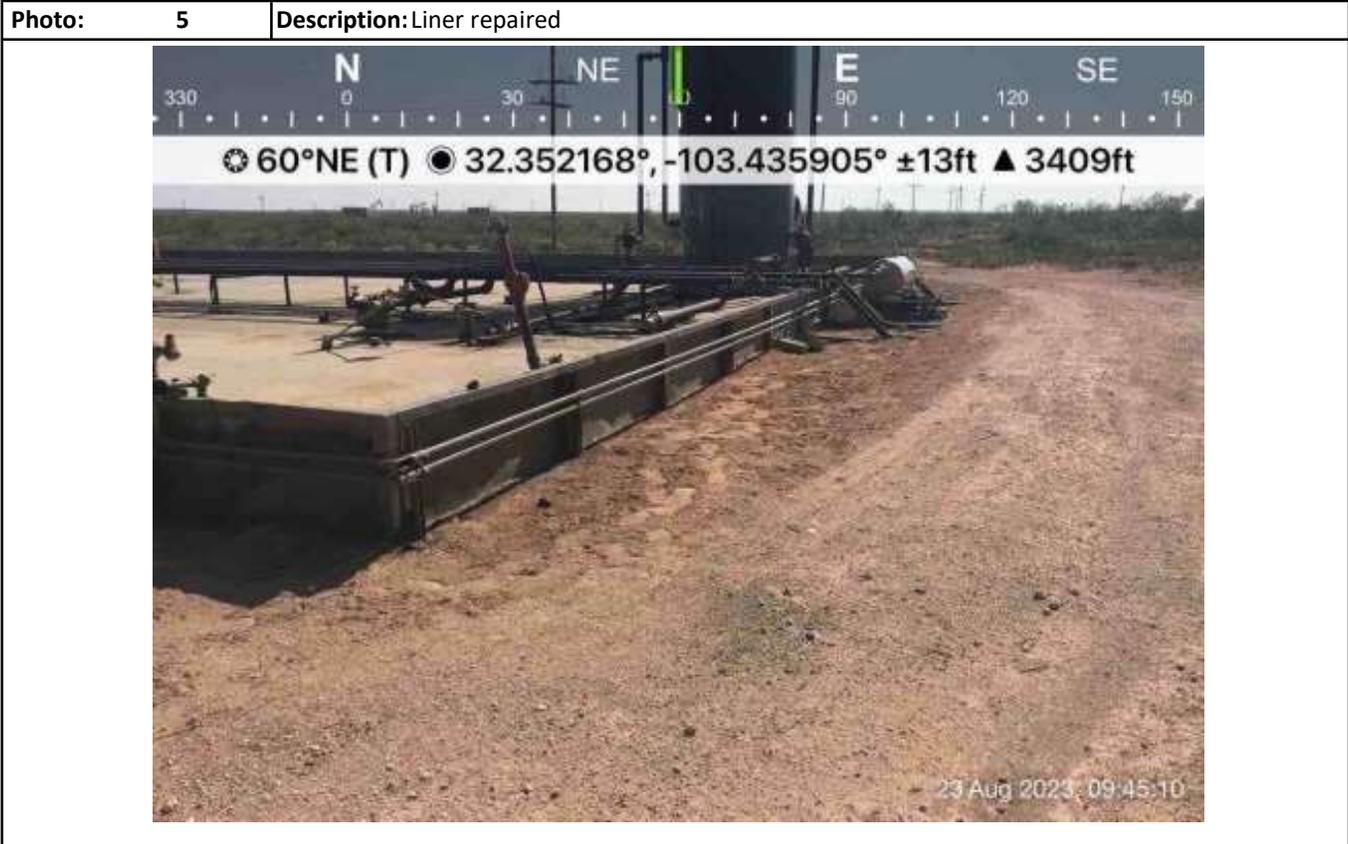
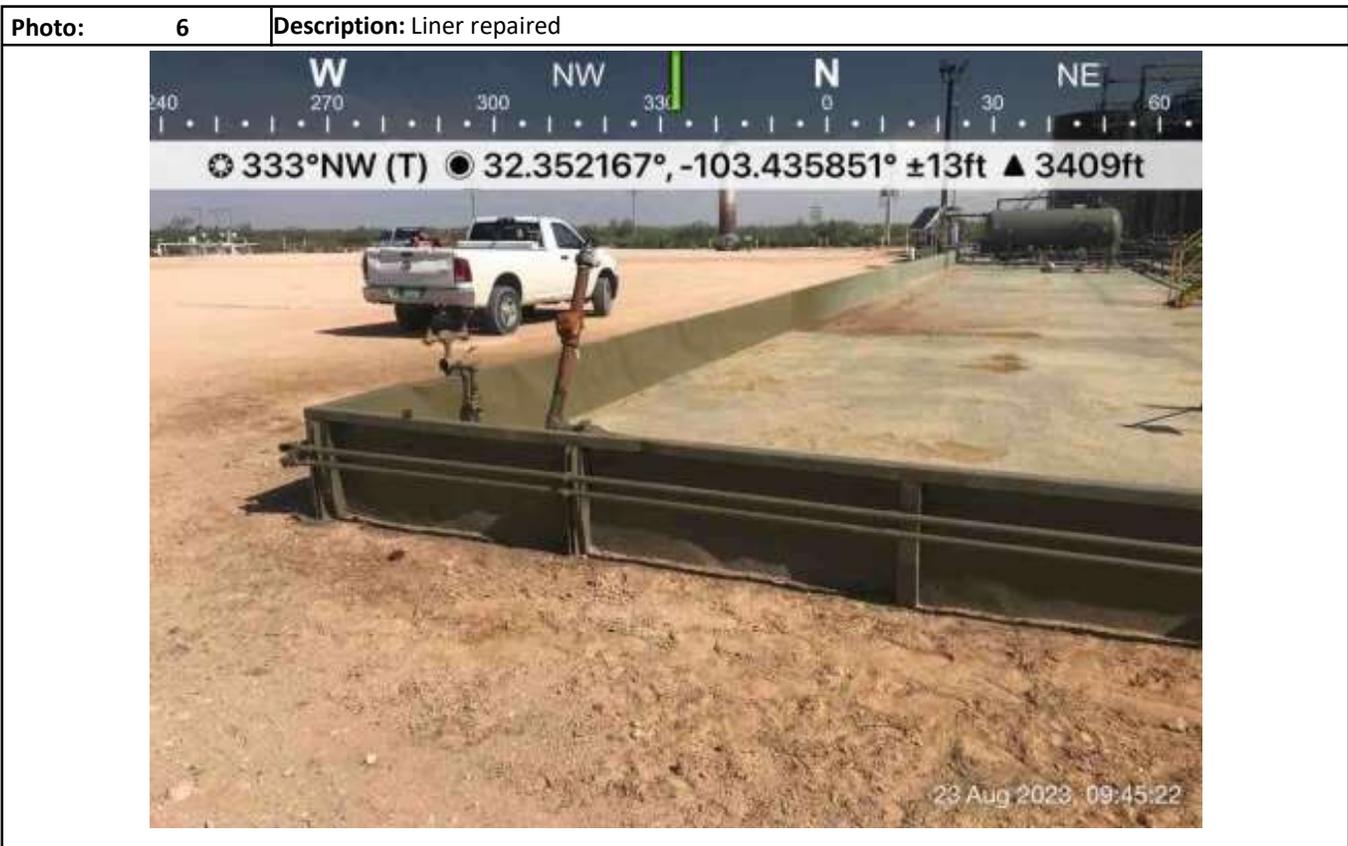
## **Attachment II Site Photographs**

On August 14, 2023, Hungry Horse conducted an initial site assessment consisting of photographing, mapping, and sampling the burned area within containment. During sampling, hand augered test bores were advanced throughout the burned area in an effort to determine the vertical extent of contamination. These sample locations are identified by SP designation. In addition, hand augered sample bores were advanced along the outside edges of the containment area in an effort to determine the horizontal extent of contamination. These sample locations are identified by HZ designation. During the advancement of the hand augered sample bores, soil samples were collected and field screened for the presence of chloride concentrations utilizing a Hanna instruments® DiST® 4 EC tester and/or a Hach Quantab® chloride test kit.

As no fluid was lost during the fire, and laboratory analytical results indicated contaminant concentrations were below the strictest NMOCD Closure Criteria in each of the submitted samples, no excavation activities were required and the liner was subsequently repaired.

Based upon laboratory analytical results from confirmation soil samples, the liner was repaired. As the affected area is located within lined containment on an active tank battery pad, no seeding will be required.
