Closure Report
Bradley 14-11 Federal Com 1H
Incident ID: NRM2025344424
Eddy County, New Mexico
Unit M Sec 14 T24S R26E
32.210488°, -104.270929°

Re: Closure Report
Bradley 14-11 Federal Com 1H
Incident ID: NRM2025344424
Cimarex Energy Co.
Site Location: Unit M, S14, T24S, R26E
(Lat 32.210488°, Long -104.270929°)
Eddy County, New Mexico

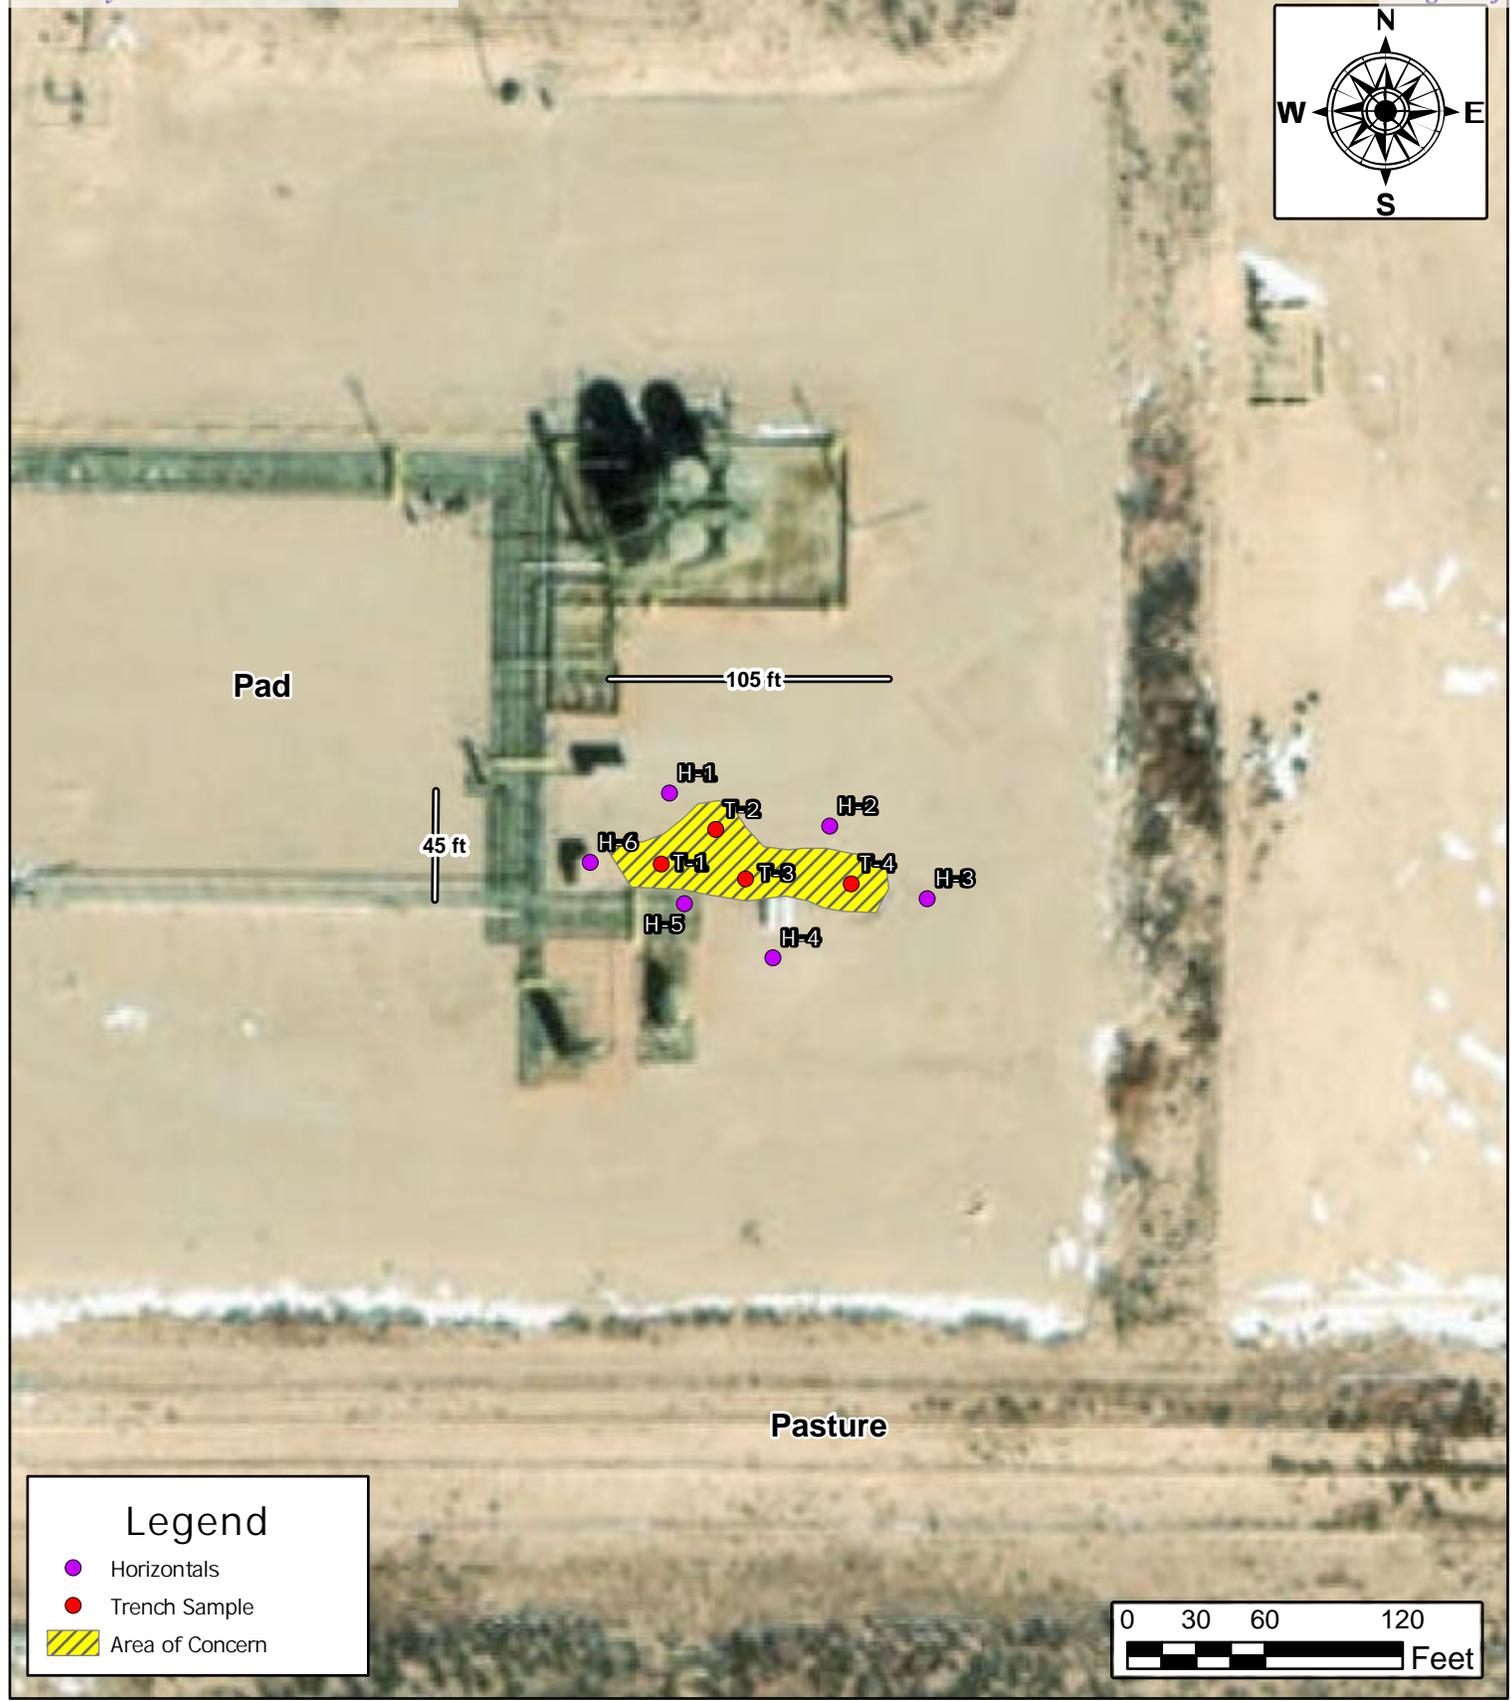
Based on the initial C-141 obtained from the New Mexico Oil Conservation Division (NMOCD), the leak was discovered on September 1, 2020, caused by internal corrosion of a 10" trunk line between the separator and water tank. It resulted in approximately ten (10) barrels of produced water, and one (1) barrel of produced water was recovered. The impacted area is located on the pad. Refer to Figure 3 for a spill overview. The initial C-141 form is attached in Appendix C.

- Horizontal
- Trench Sample
- Area of Concern

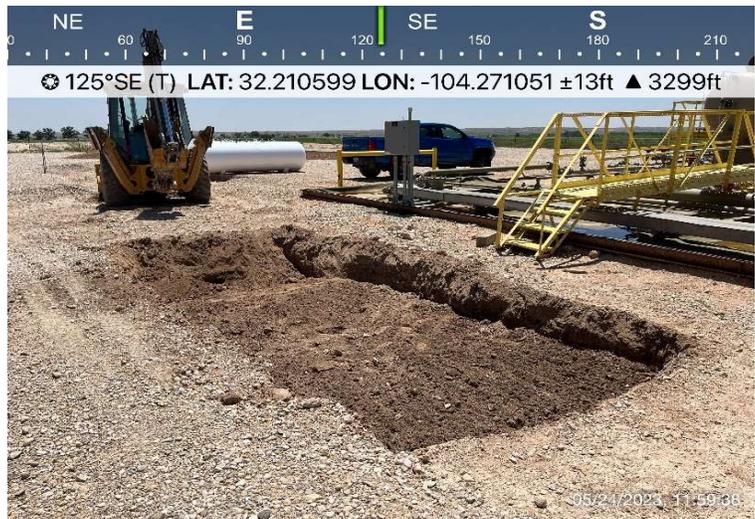
View Southeast, area of CS-1 and CS-2.

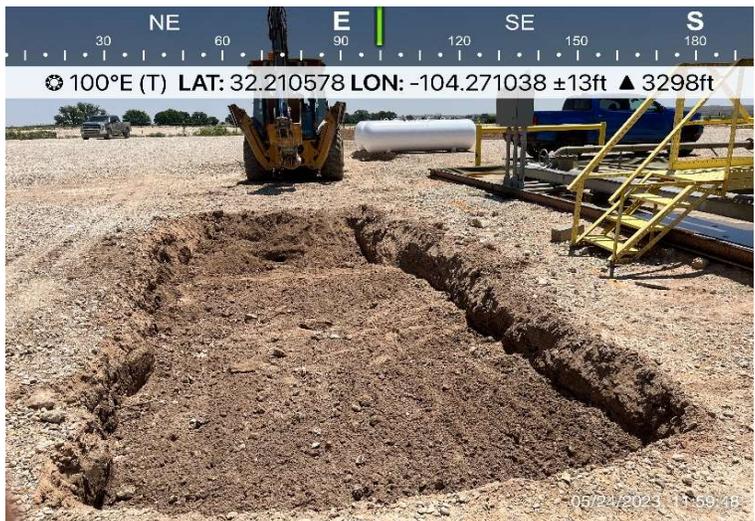
Photograph No. 2

View East, area of CS-1 and CS-2.

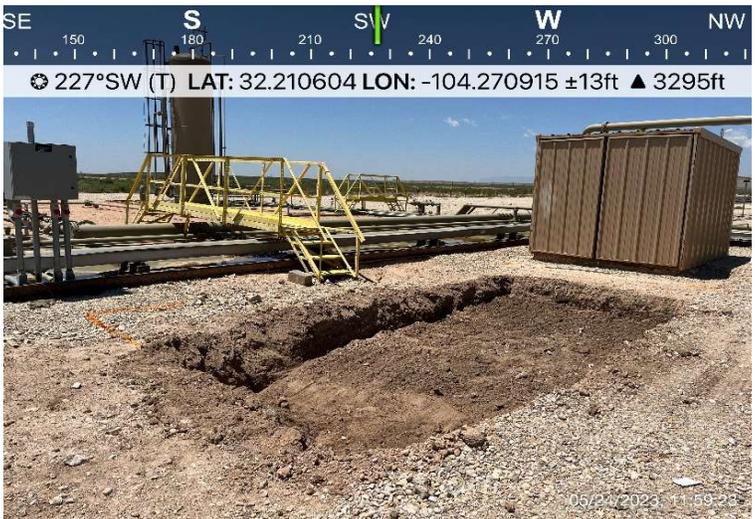
Photograph No. 3

View Southwest, area of CS-1 and CS-2.
