## Closure Report

Leak 9  
Unit O, Section 31, T19S, R37E  
Lea County, New Mexico  
GPS Coordinates 32.60986, -103.28888  
**Incident #** nAPP2304851705

Targa Resources  
P.O. Box 547  
Bridgeport, Texas 76426

**October 23, 2023**

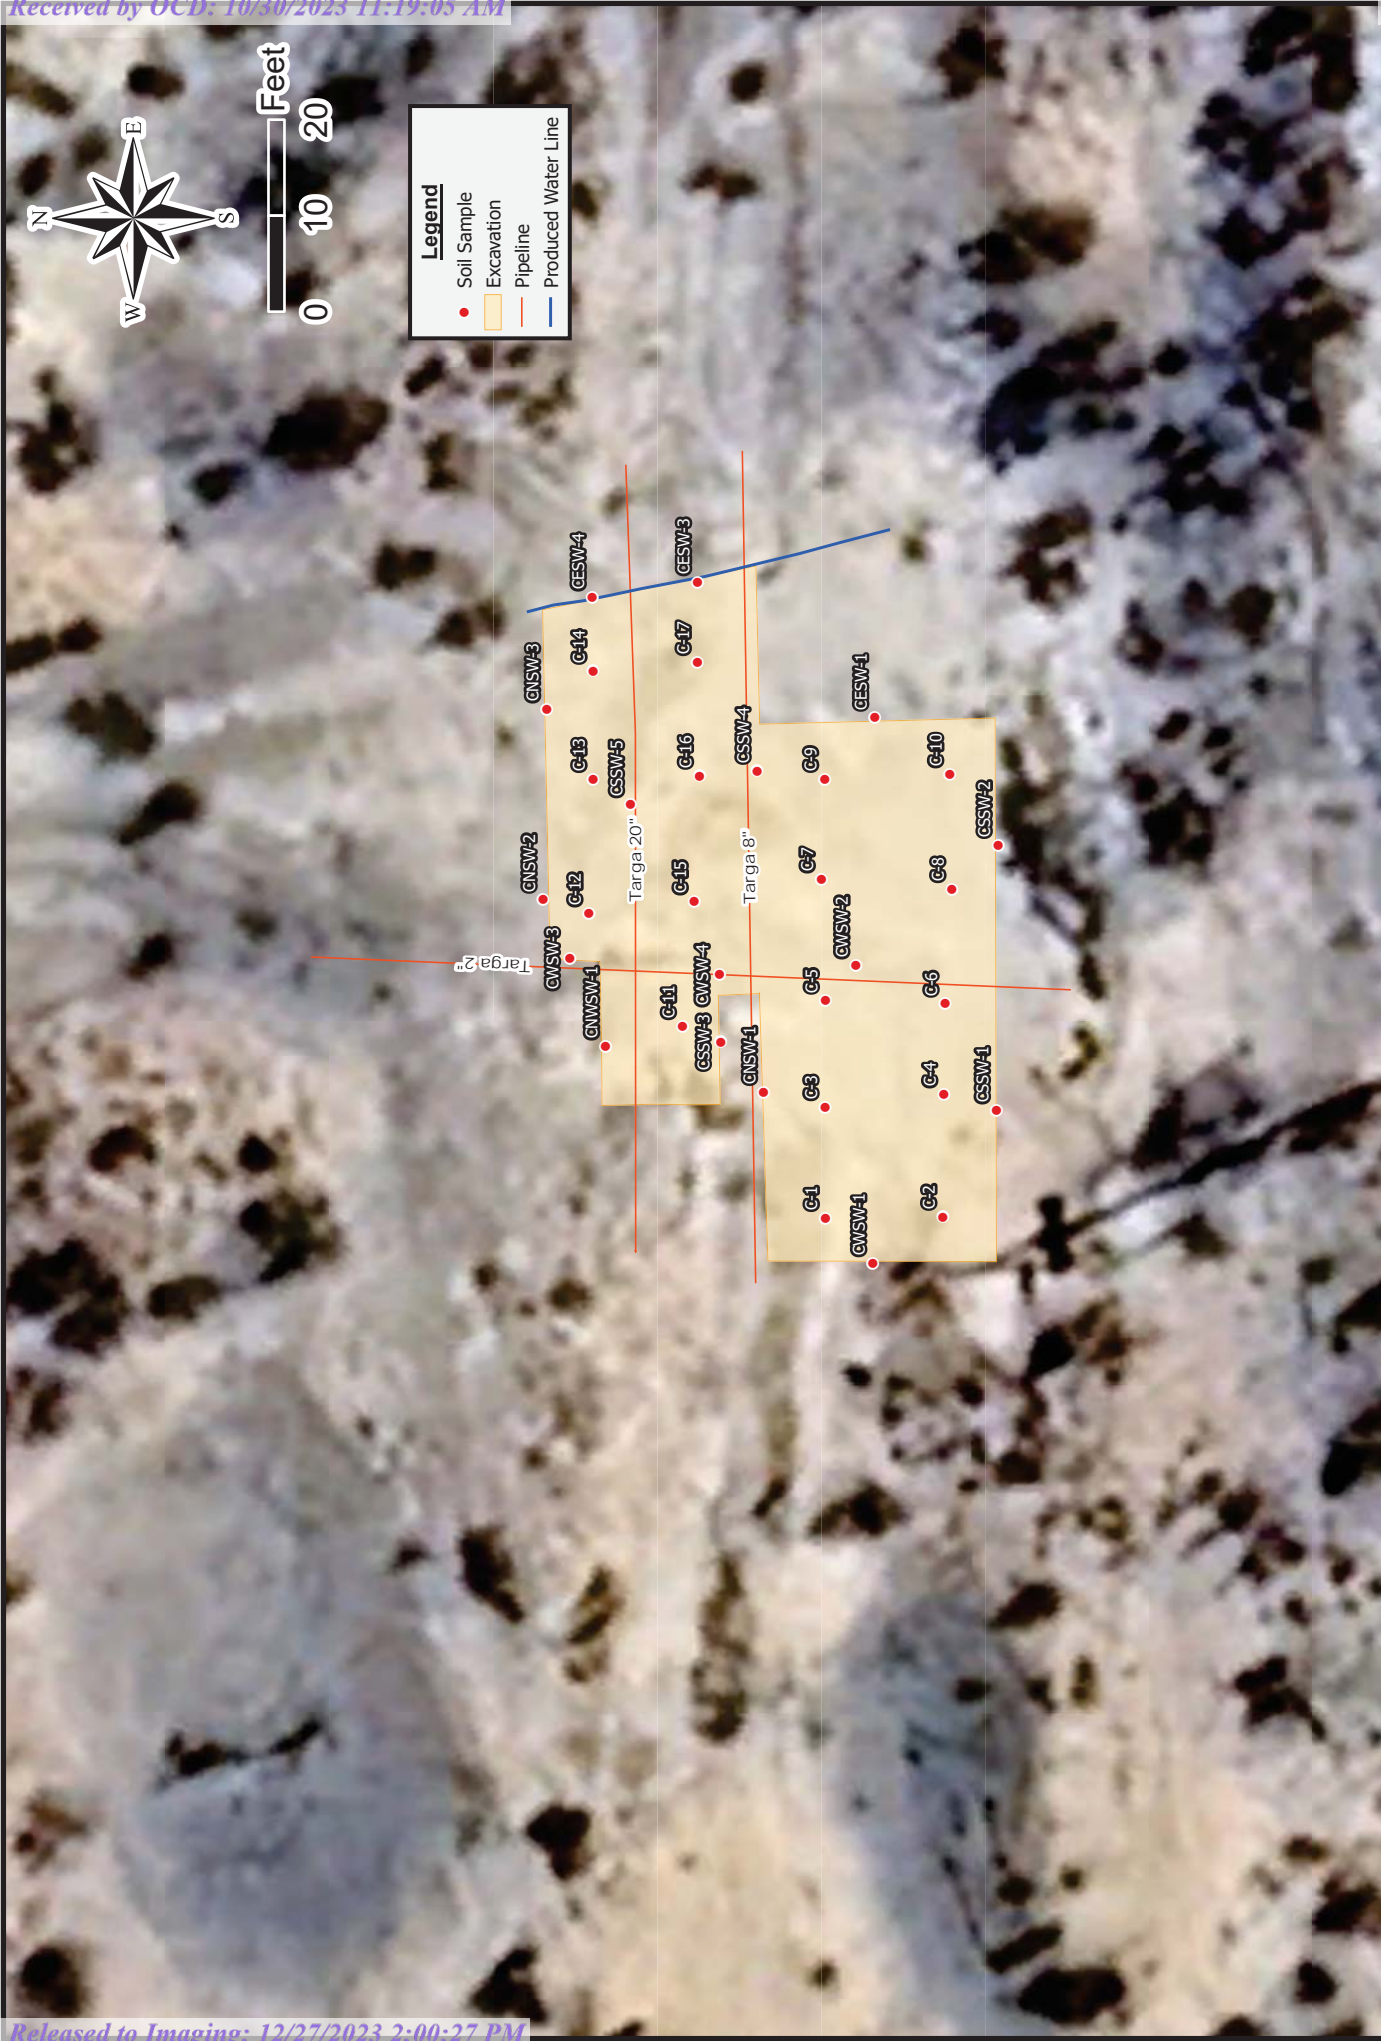
Targa Resources Leak 9  
Unit O, Section 31, T19S, R37E  
Lea County, New Mexico  
GPS Coordinates 32.60986, -103.28888  
Figure 2 - Confirmation Sample Map

Confirmation samples were collected during different phases of the excavation process from May 2 to August 30, 2023, to confirm that NMOCD closure criteria had been met for all excavated areas. The composite samples were collected from gridded areas of 200 square feet or less. Confirmation sample locations and excavation dimensions can be found on the confirmation sample map, Figure 1 in [Appendix I](#).

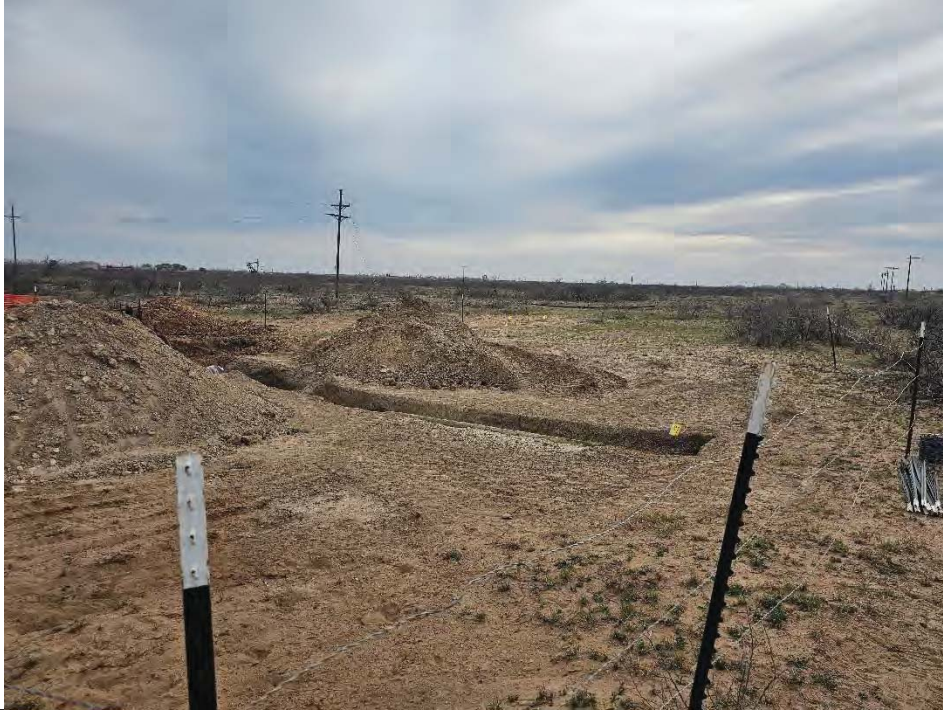
**Photograph No.1**  
**Description:**

Northeast  
Assessment trenches in release area.

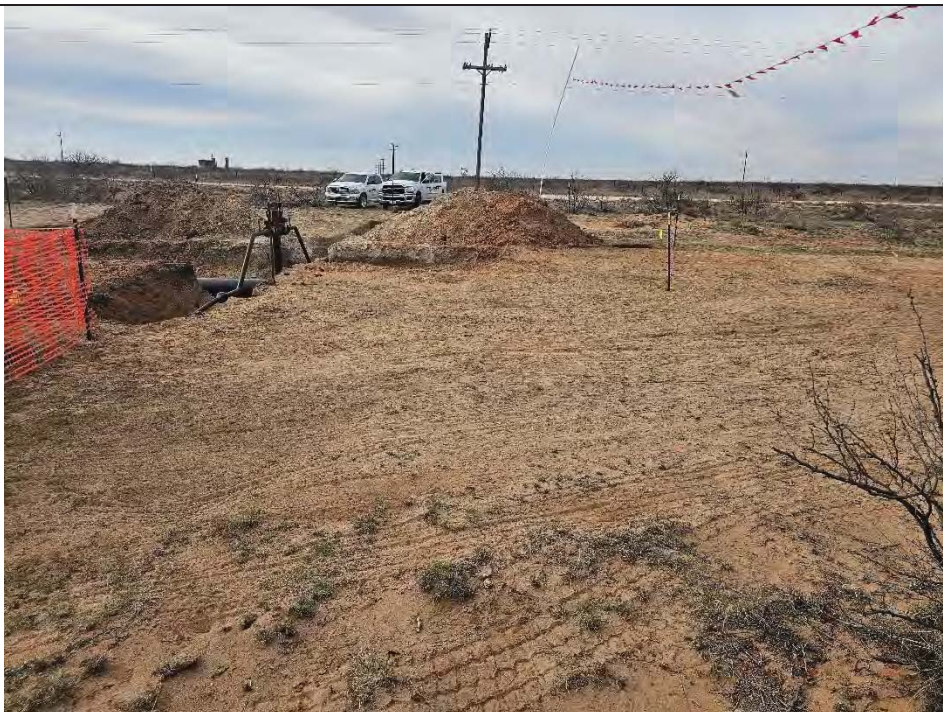
**Photograph No.2**  
**Description:**

South  
Assessment trenches in release area.

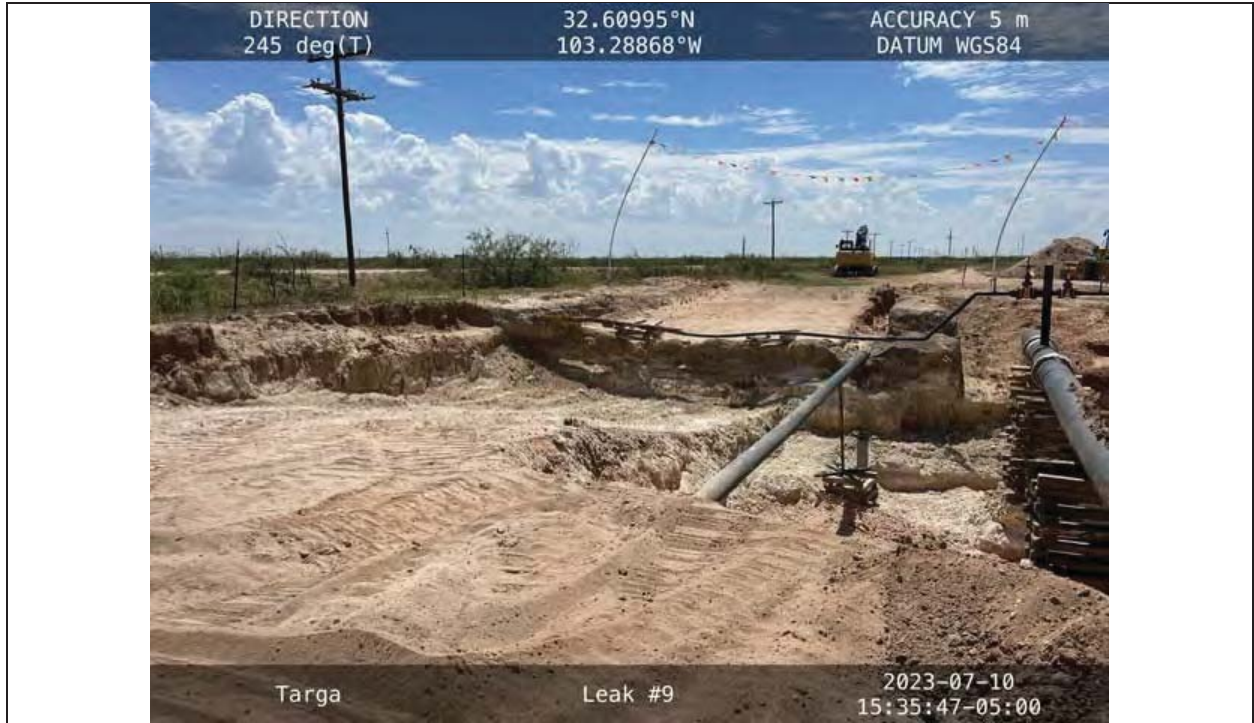
**Photograph No.9**  
**Description:**

Southwest  
Excavation of release area.

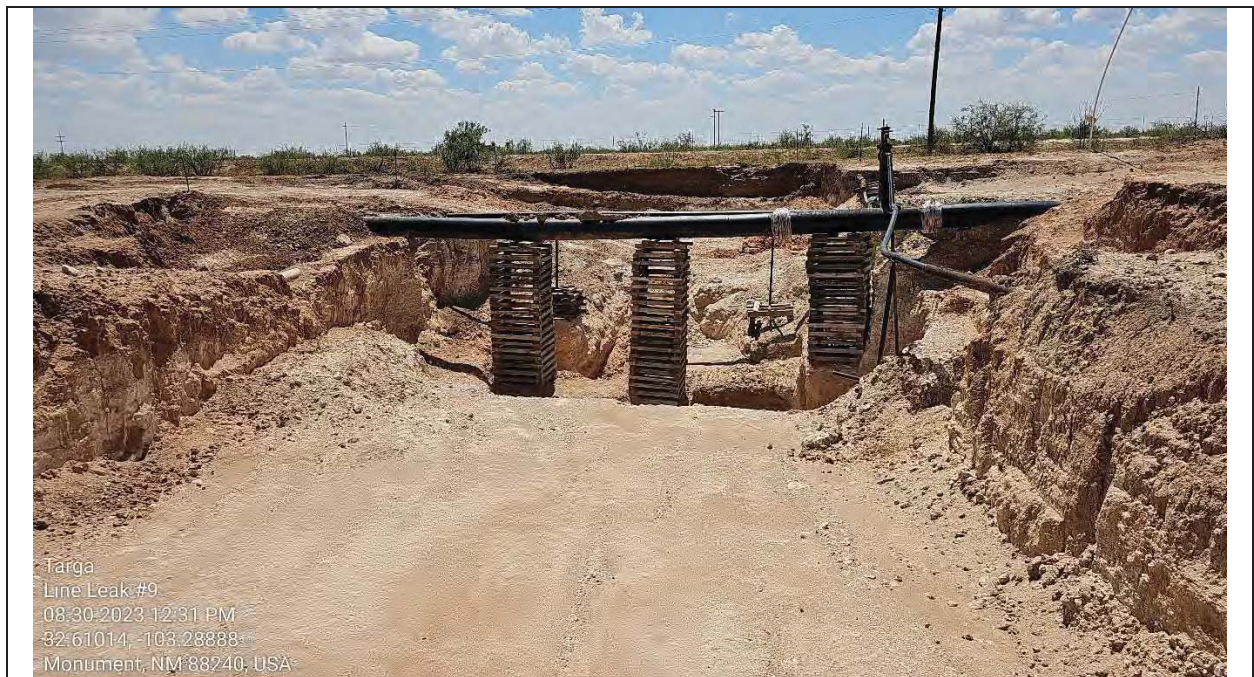
**Photograph No.10**  
**Description:**

South  
Excavation of release area.
