**RE: Liner Inspection and Closure Report
Arenoso 22 Fed Com 1 Wellpad
API No. 30-015-34471
GPS: Latitude 32.641313 Longitude -103.860200
UL- N, Section 22, Township 19S, Range 31E,
Eddy County, NM
NMOCD Reference No. NAPP2302743693**

Devon Energy Production Company (Devon) has contracted Pima Environmental Services, LLC (Pima) to perform a liner inspection and prepare this closure report for a produced water release that happened at the Arenoso 22 Fed Com 1 Wellpad (Arenoso). An initial C-141 was submitted on February 8, 2023, and can be found in Appendix B. This incident was assigned Incident ID NAPP2302743693, by the New Mexico Oil Conservation Division (NMOCD).

SITE PHOTOGRAPHS
DEVON ENERGY
ARENOSE 22 FED COM 1 WELLPAD

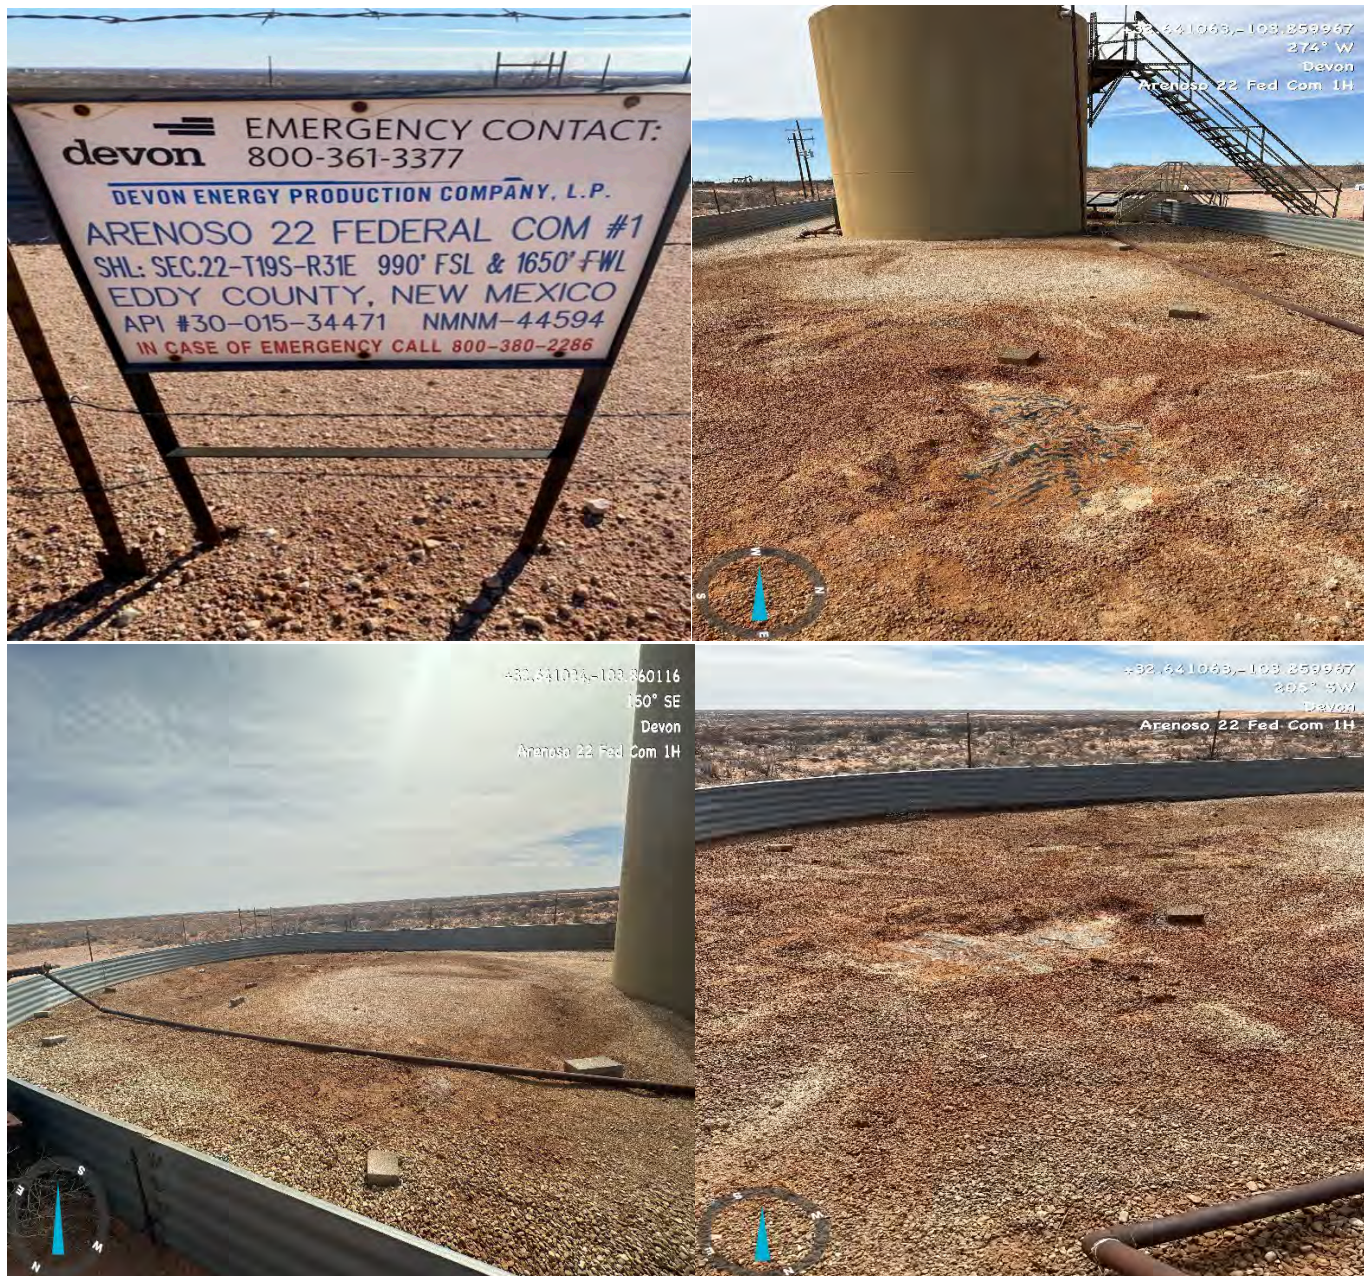
Pre-Excavation

NAPP2302743693: On January 26, 2023. A tank developed a leak inside the containment. Approximately 32 barrels (bbls) of produced water and 13 bbls of crude oil were released from the tank. A vacuum truck was dispatched and recovered 41 bbls of fluid from the earthen lined SPCC containment ring. Once fluids were removed, the liner was visually inspected by Devon field staff for any pinholes or punctures, gravel needed to be removed. Based on this inspection there is no evidence that the spilled fluids left containment. The remaining 4 bbls were recovered during the removal of the gravel.

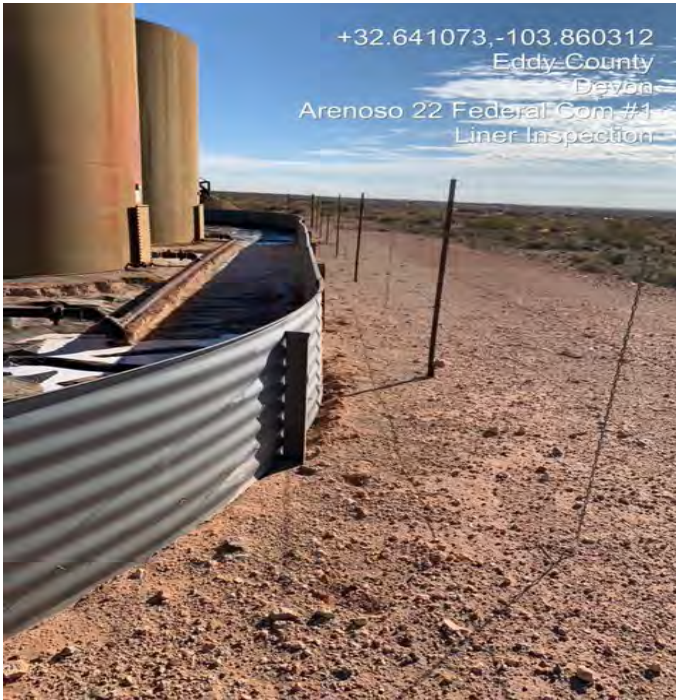
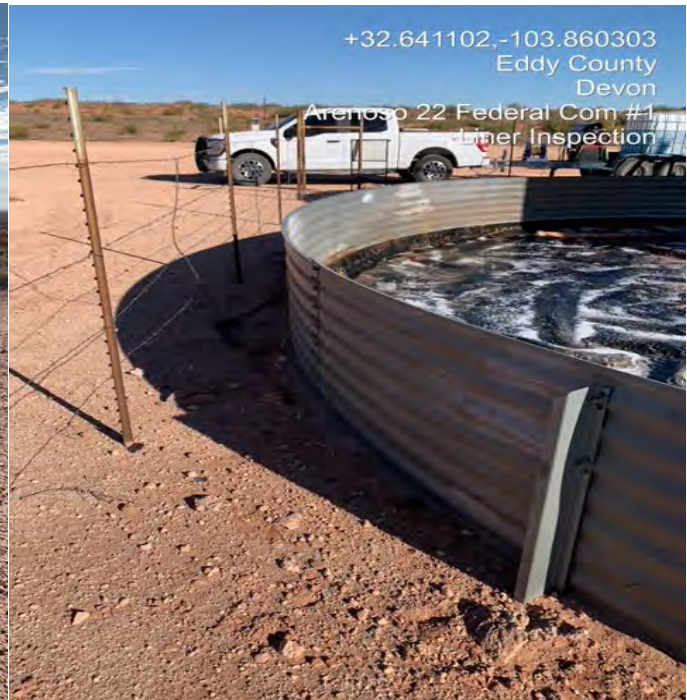
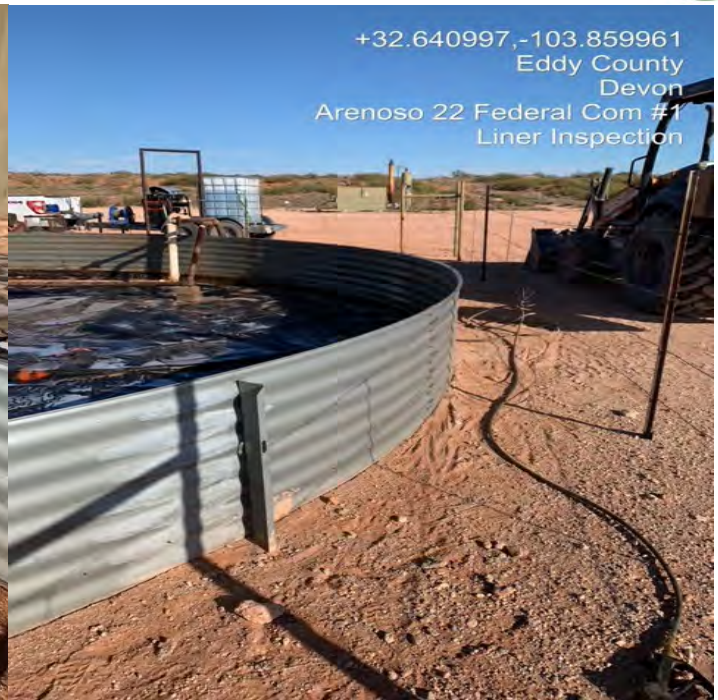
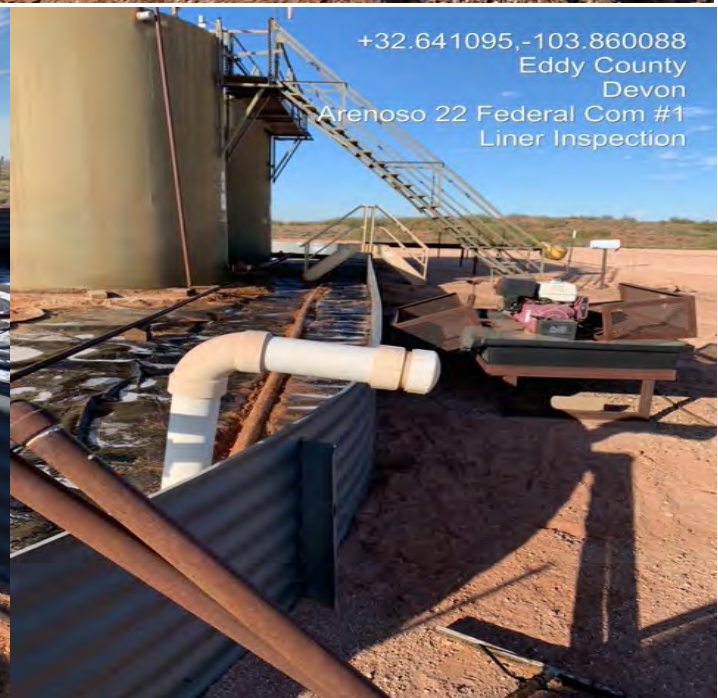
On December 1, 2023, after sending the 48-hour notification via email, Pima Environmental conducted a liner inspection at this location. We concluded that this liner and containment maintained its integrity and was able to retain the fluids. The Liner Inspection Form and Photographic Documentation can be found in Appendix C.

Visualization	Yes	No	Comments
Is there a tear in the liner?		X	
Are there holes in the liner?		X	
Is the liner retaining any fluids?		X	
Does the liner have integrity to contain a leak?	X
