**RE: Liner Inspection and Closure Report**  
**Skelly Unit #989 Battery**  
**API No. 30-015-36498**  
**GPS: Latitude 32.821907 Longitude -103.843357**  
**UL "F", Section 23, Township 17S, Range 31E**  
**NMOCD Reference No. NAPP2113932518**

Pima Environmental Services, LLC (Pima) has been contracted by Spur Energy Partners, LLC. (Spur) to perform a liner inspection and prepare this closure report for a release that happened on the Skelly Unit #989 Battery (Skelly). An initial C141 was submitted on May 27<sup>th</sup>, 2021, and can be found in Appendix B. This incident was assigned Incident ID NAPP2113932518, by the New Mexico Oil Conservation Division (NMOCD).

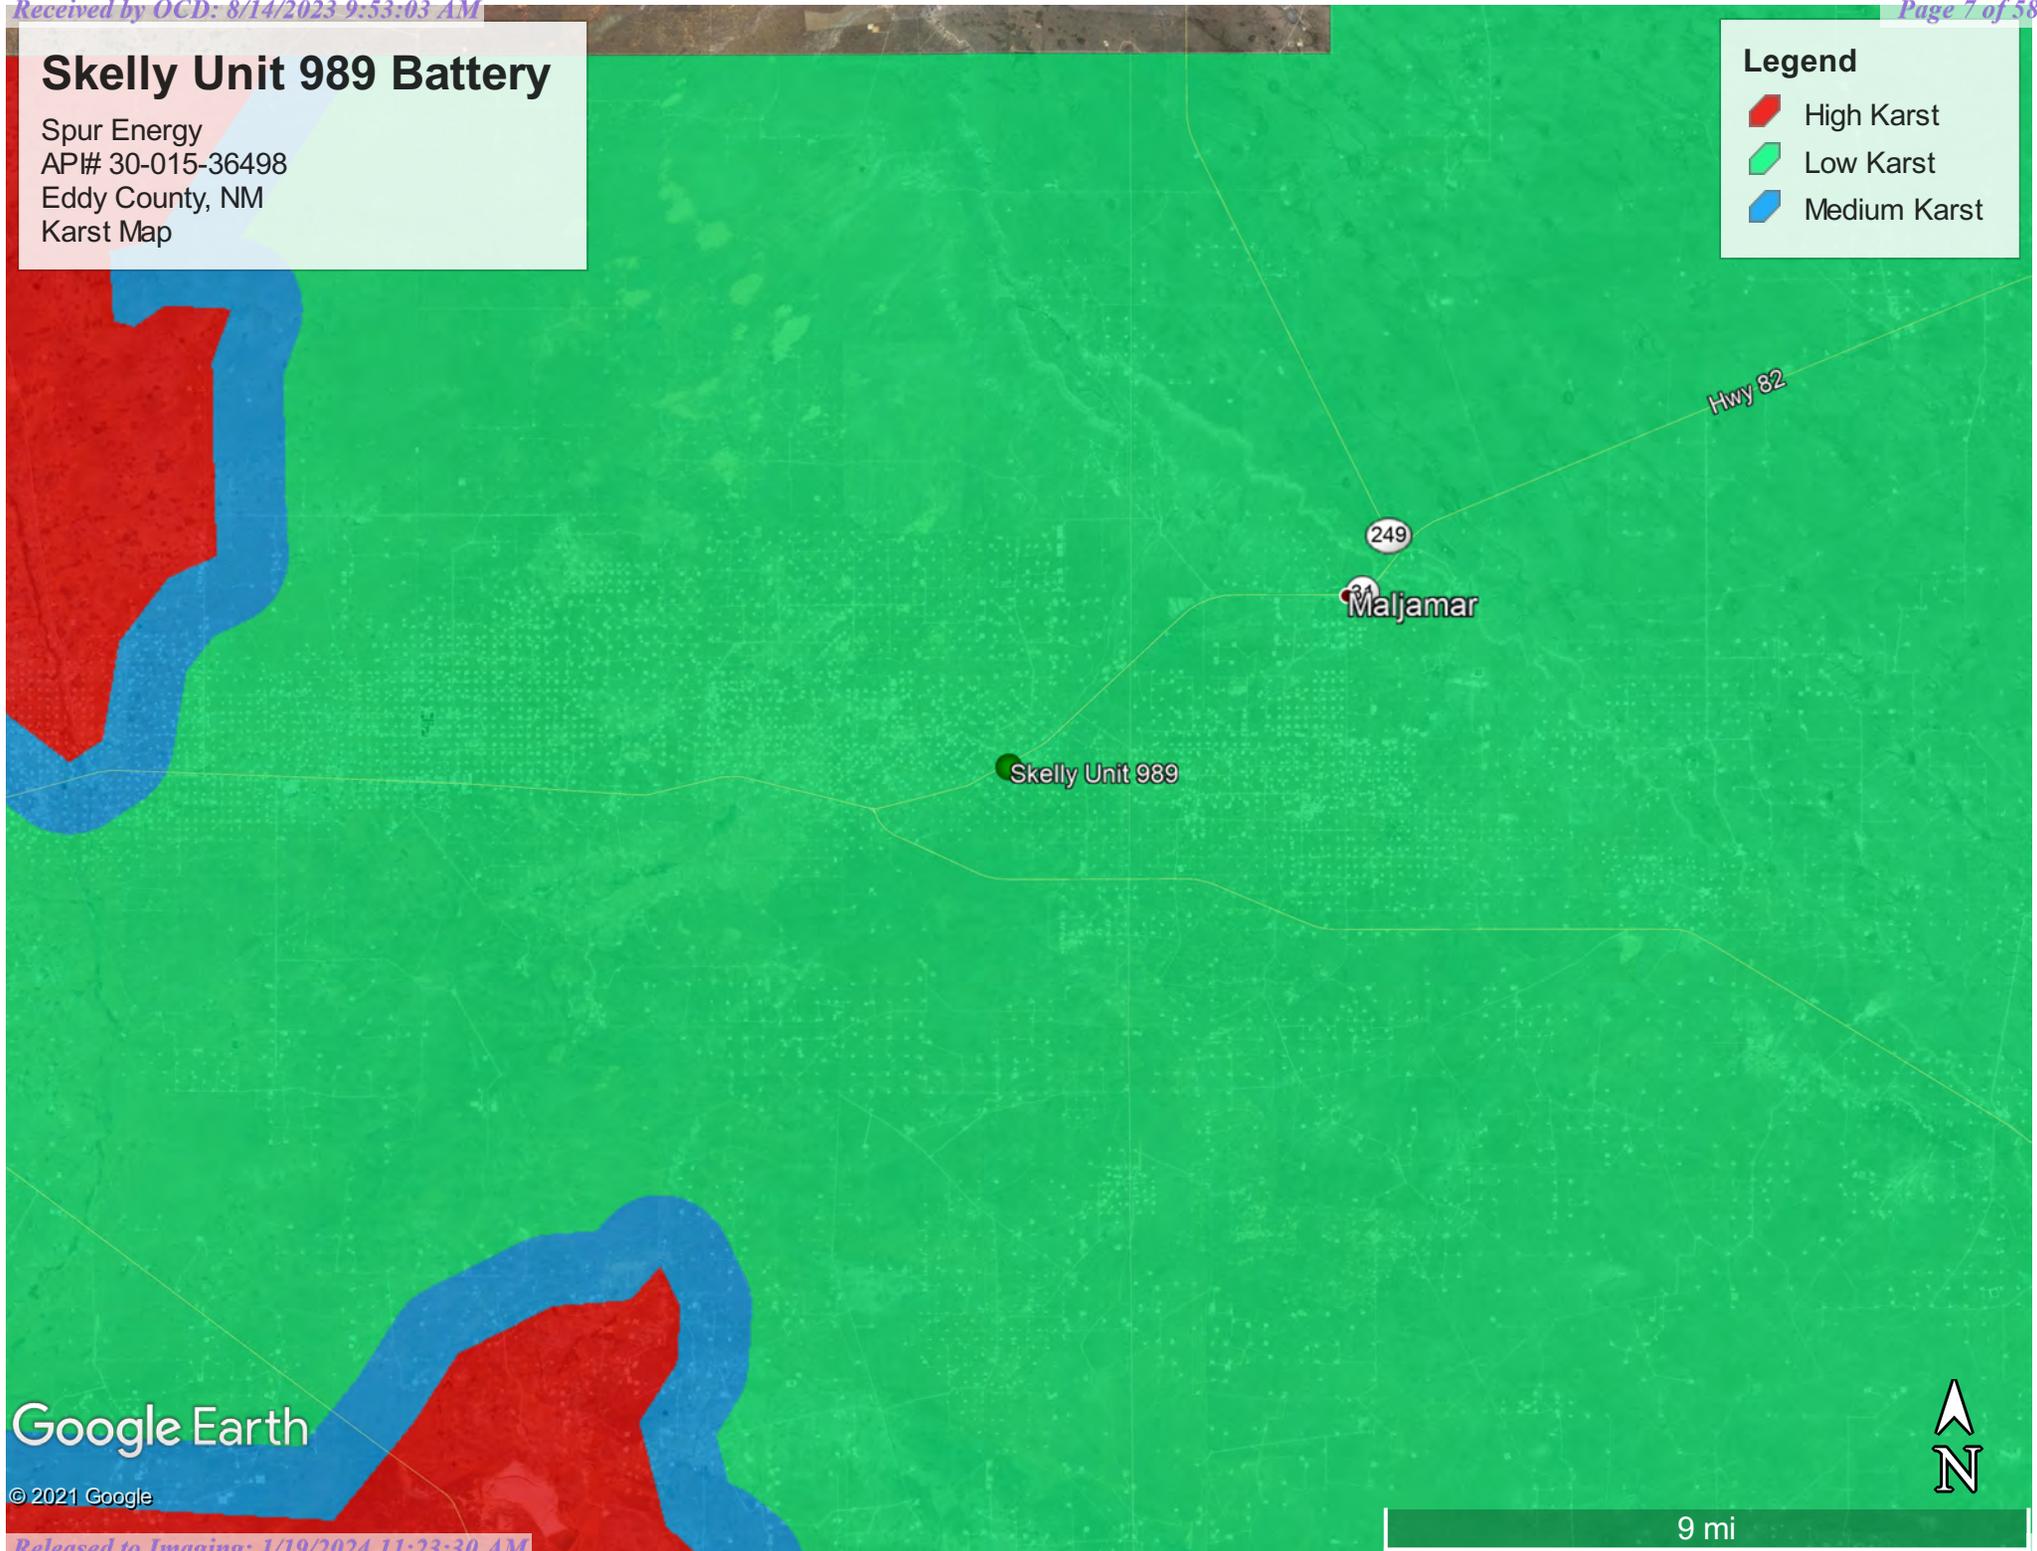
**Skelly Unit 989 Battery**  
 Spur Energy  
 API# 30-015-36498  
 Eddy County, NM  
 Karst Map

Based upon the New Mexico Office of the State Engineer water well data, depth to the nearest groundwater in this area is 96 feet below-grade surface (BGS). According to the United States Geological Survey water well data, depth to the nearest groundwater in this area is greater than 100 feet BGS. See Appendix A for referenced water surveys. The Skelly is in an area that has a low potential for karst geology (Figure 3).

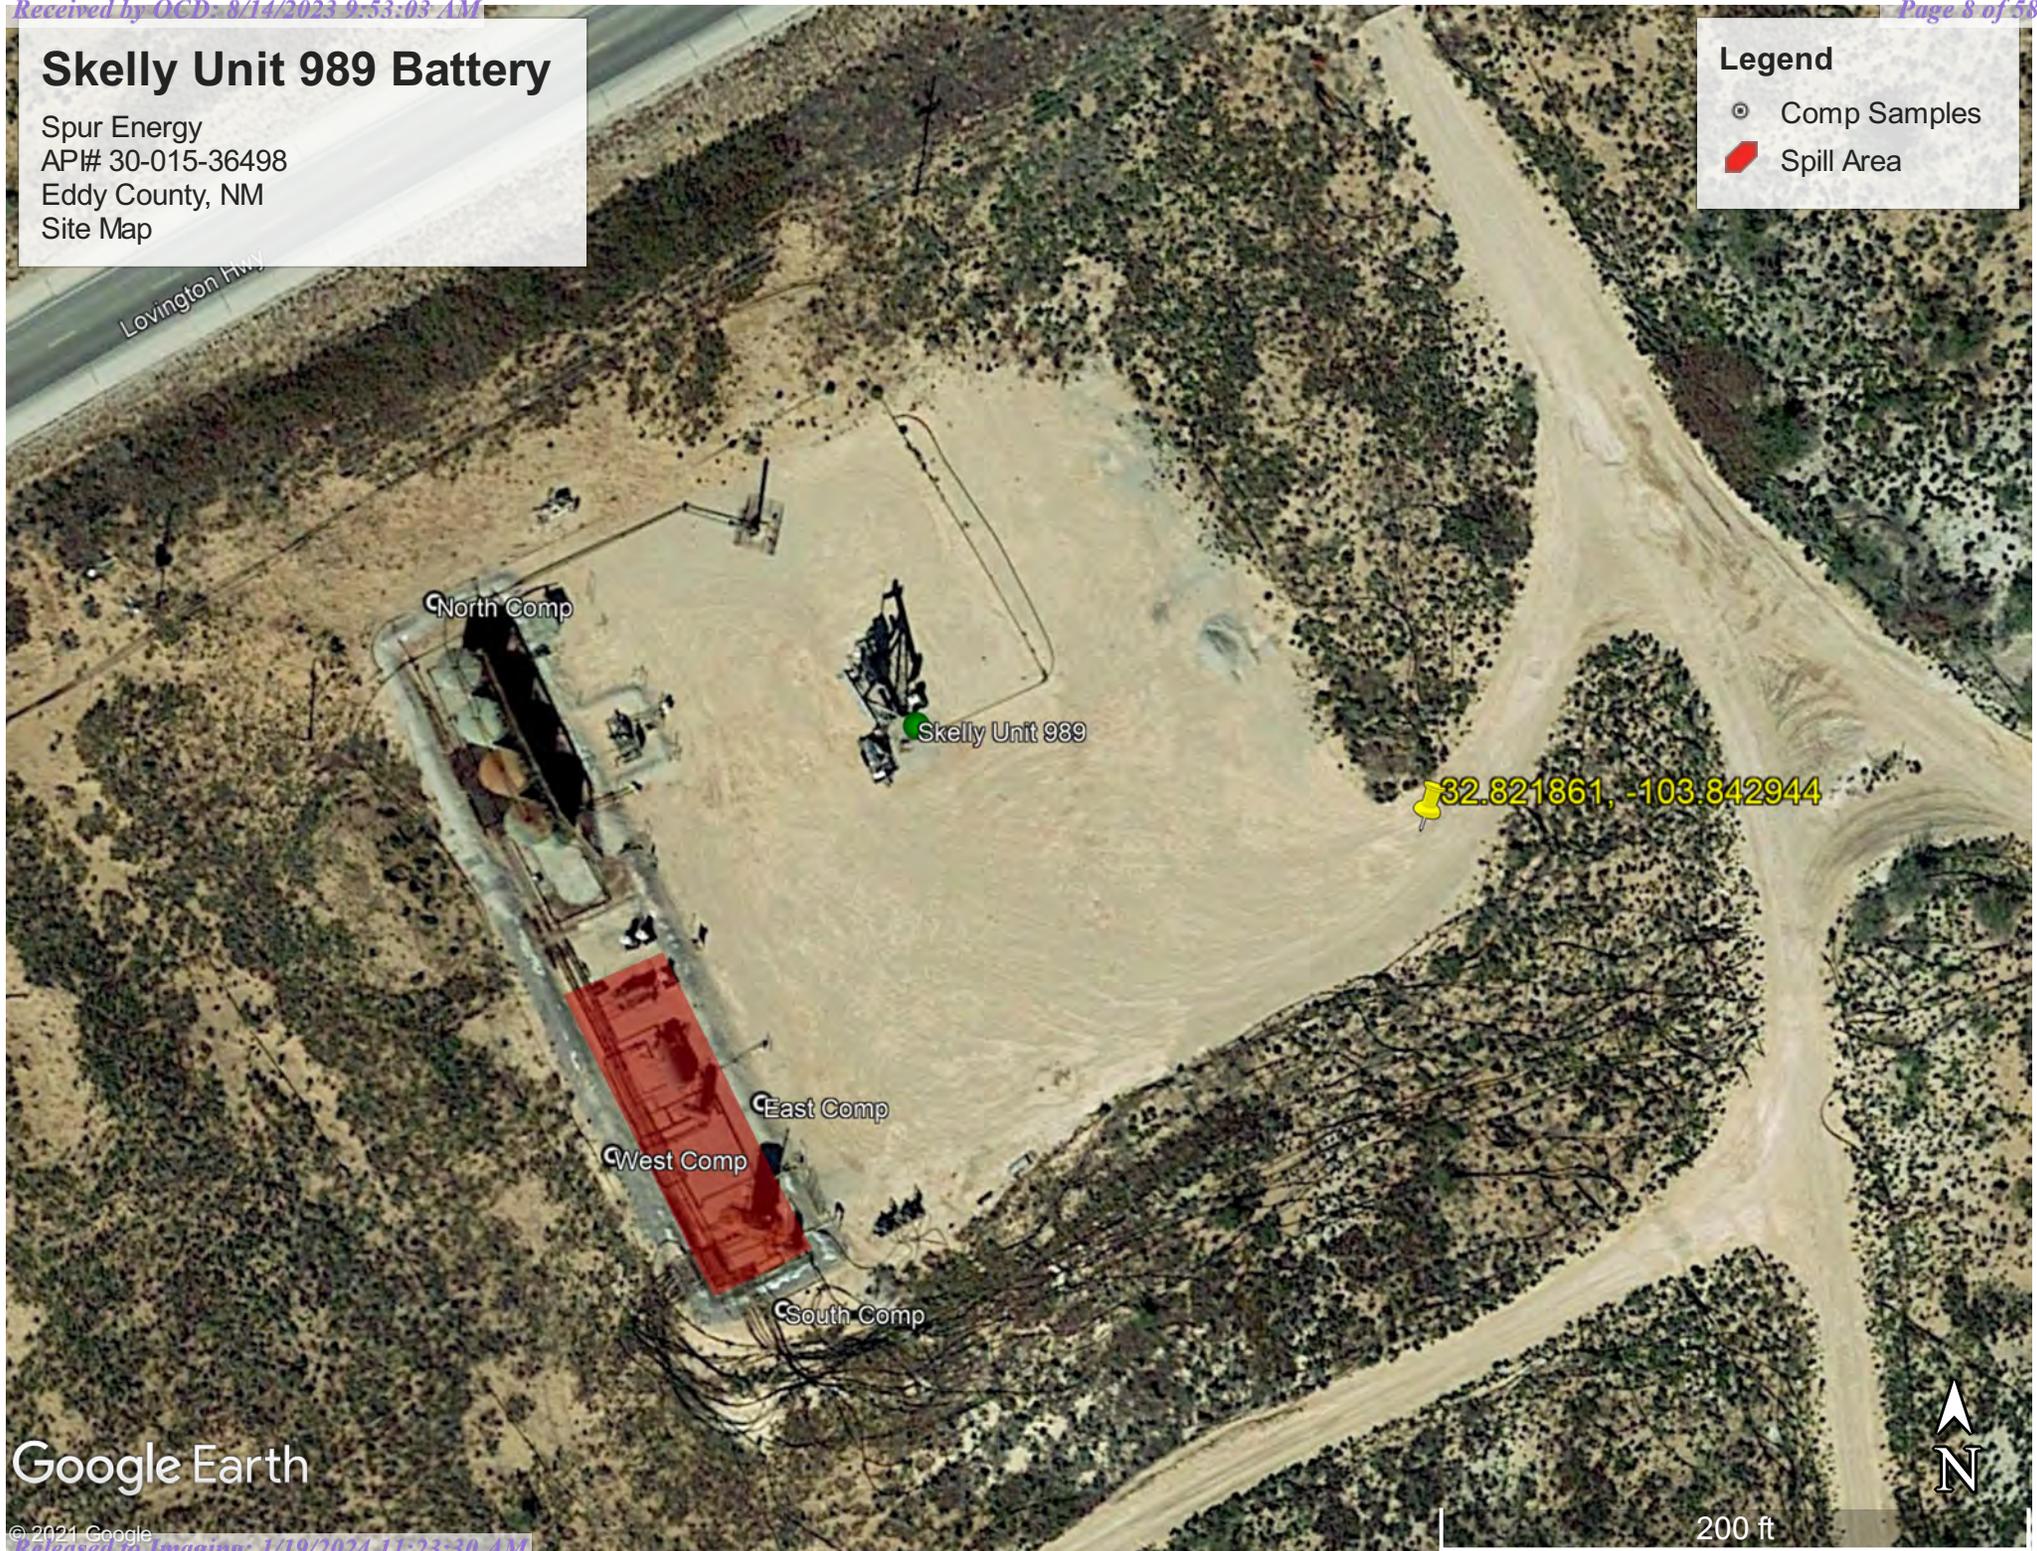
**Skelly Unit 989 Battery**  
 Spur Energy  
 AP# 30-015-36498  
 Eddy County, NM  
 Site Map

On July 8<sup>th</sup>, 2021, after sending the 48-hour notification email, Pima Environmental conducted a liner inspection at this location. The liner inspection form and photographic documentation can be found in Appendix C. Composite samples were collected from each side of the containment to ensure no contamination escaped the containment walls. The results of this sampling event can be found in the following table. A Site map can be found in Figure 4.

- Comp Samples
- Spill Area

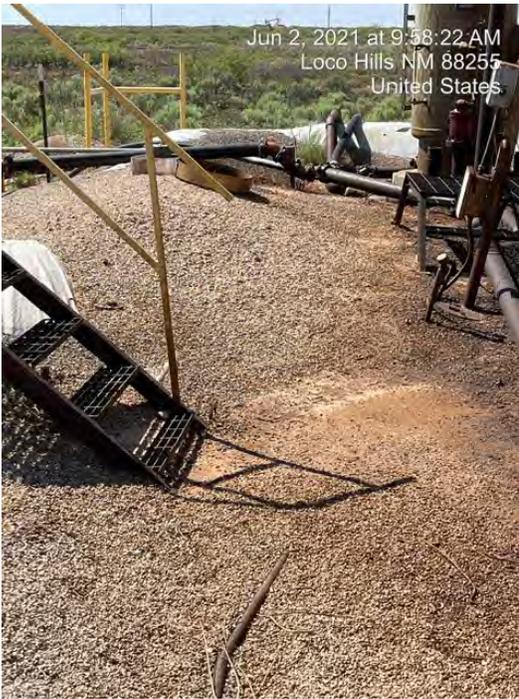
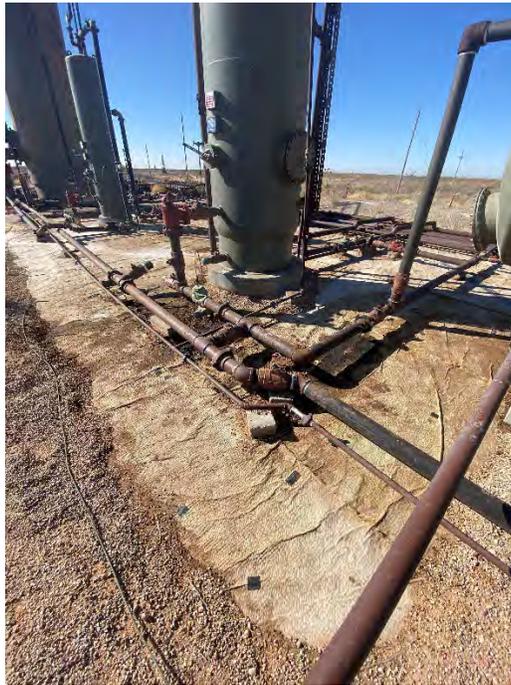
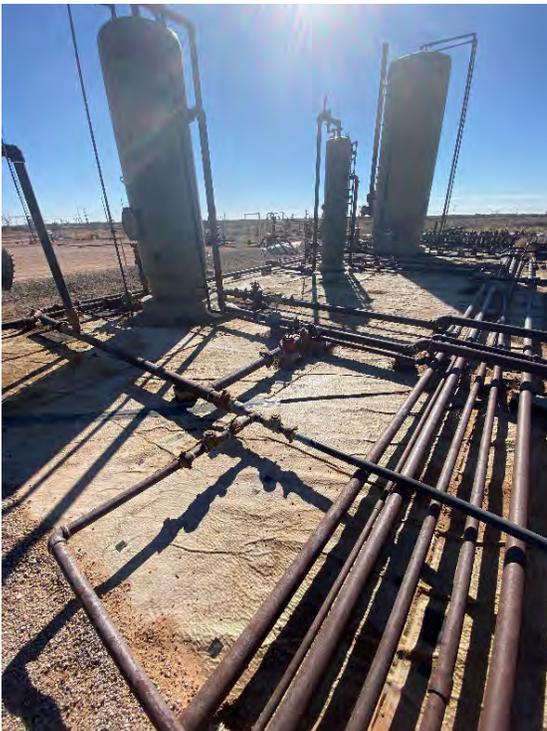
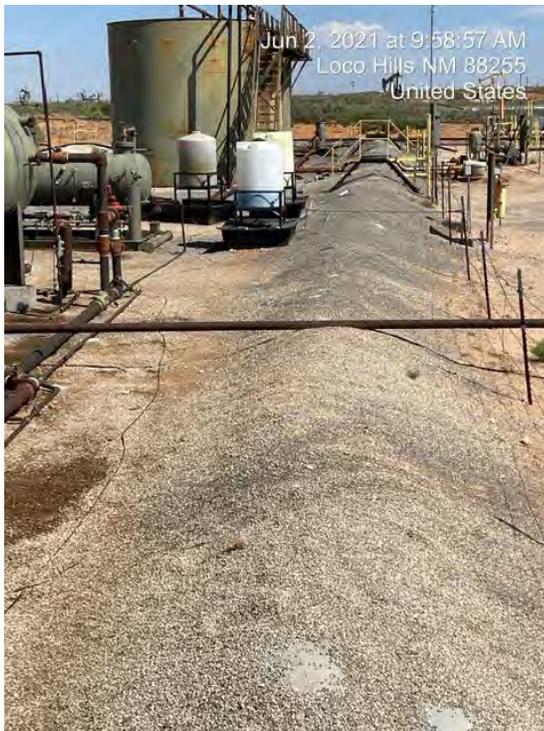
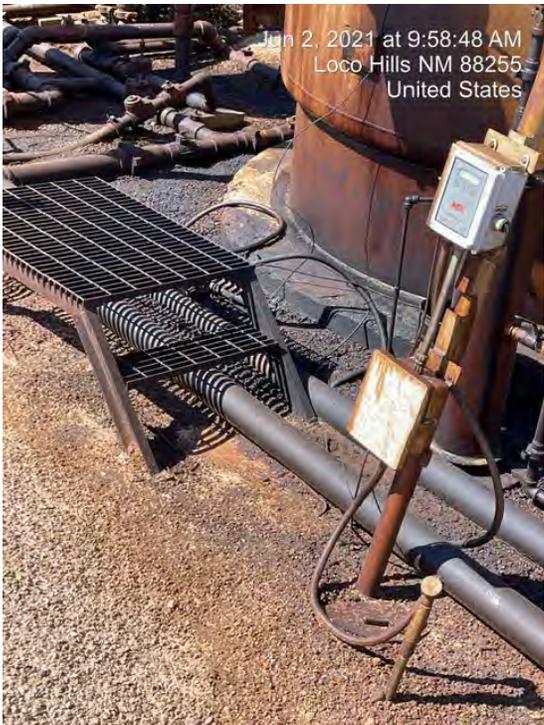
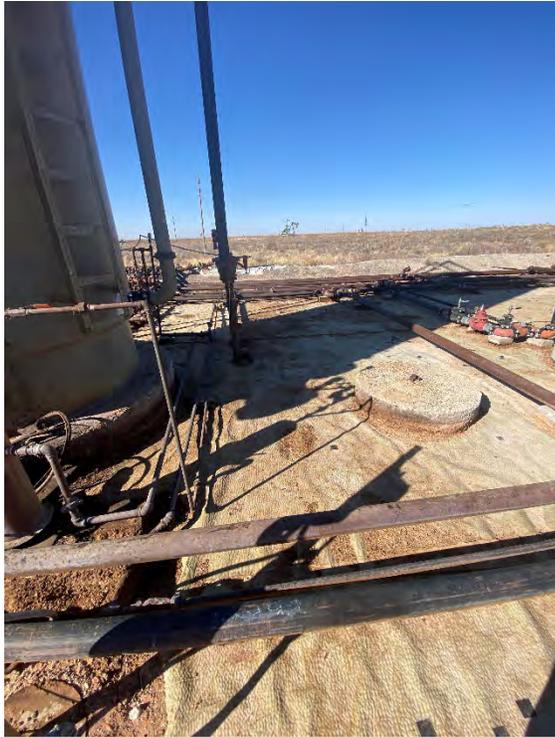
### Liner Inspection

On February 11<sup>th</sup>, 2022, after sending the 48-hour notification email, Pima Environmental conducted a liner inspection at this location. The liner inspection form and photographic documentation can be found in Appendix C.

Visualization	Yes	No	Comments
Is there a tear in the liner?		X	
Are there holes in the liner?		X	
Is the liner retaining any fluids?		X	
Does the liner have integrity to contain a leak?	X

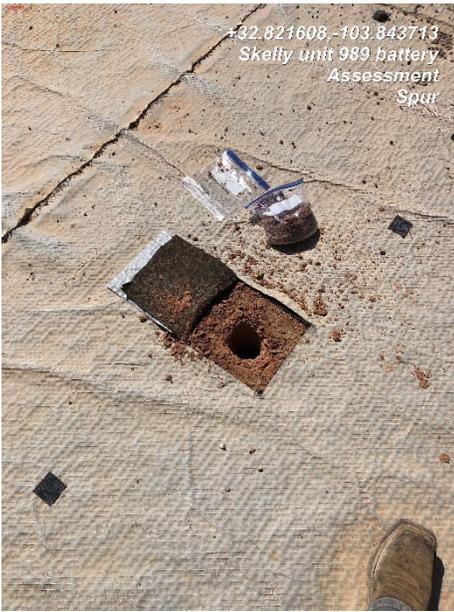
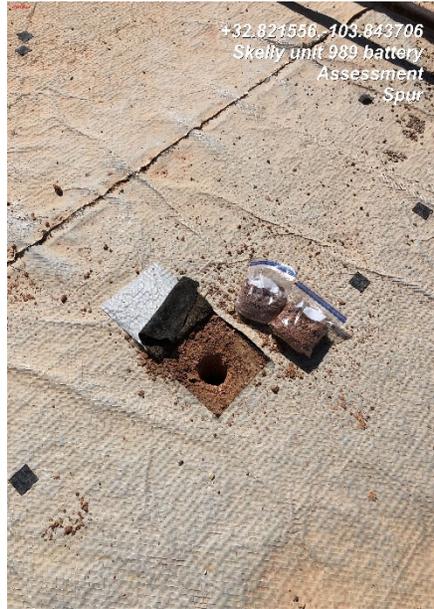
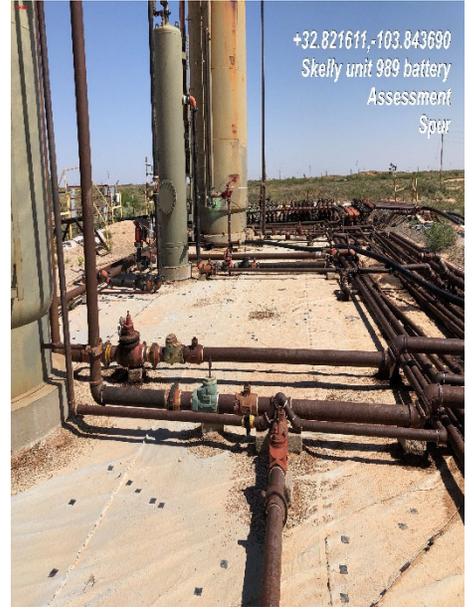
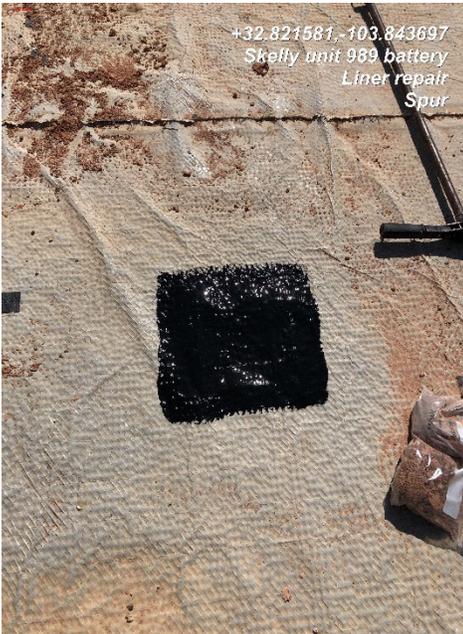
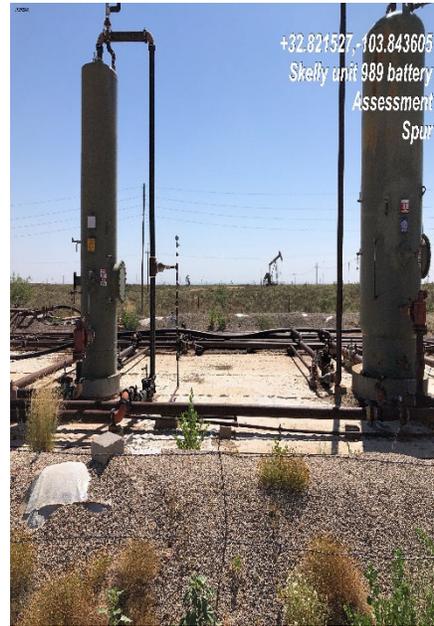
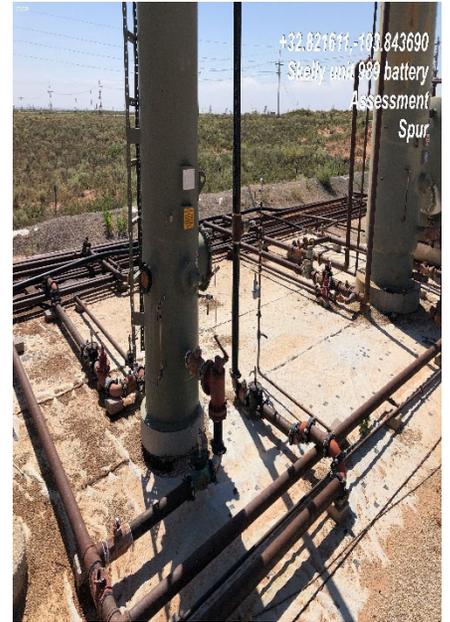
### SITE PHOTOGRAPHS POST GRAVEL REMOVAL AND LINER REPAIR

On July 31<sup>st</sup>, 2023, Pima returned to the site and collected a soil sample from beneath the liner containment to ensure no contamination leached below the liner. We removed approximately 40 cubic yards of contaminated gravel and transported all contaminated material to an NMOCD approved landfill. The liner was patched and repaired after collecting soil sample (S1). The results from this sampling event can be found in the following table. Pictures of the soil sample location and liner repairs can be found in Appendix C.
