Closure Report

Arco 5 Federal #001
Eddy County, New Mexico
API ID # 30-015-26197
Incident # NMCS0314035527

Subject: **Closure Report**
Arco 5 Federal #001
Eddy County, New Mexico
API # 30-015-26197
Incident # NMCS0314035527

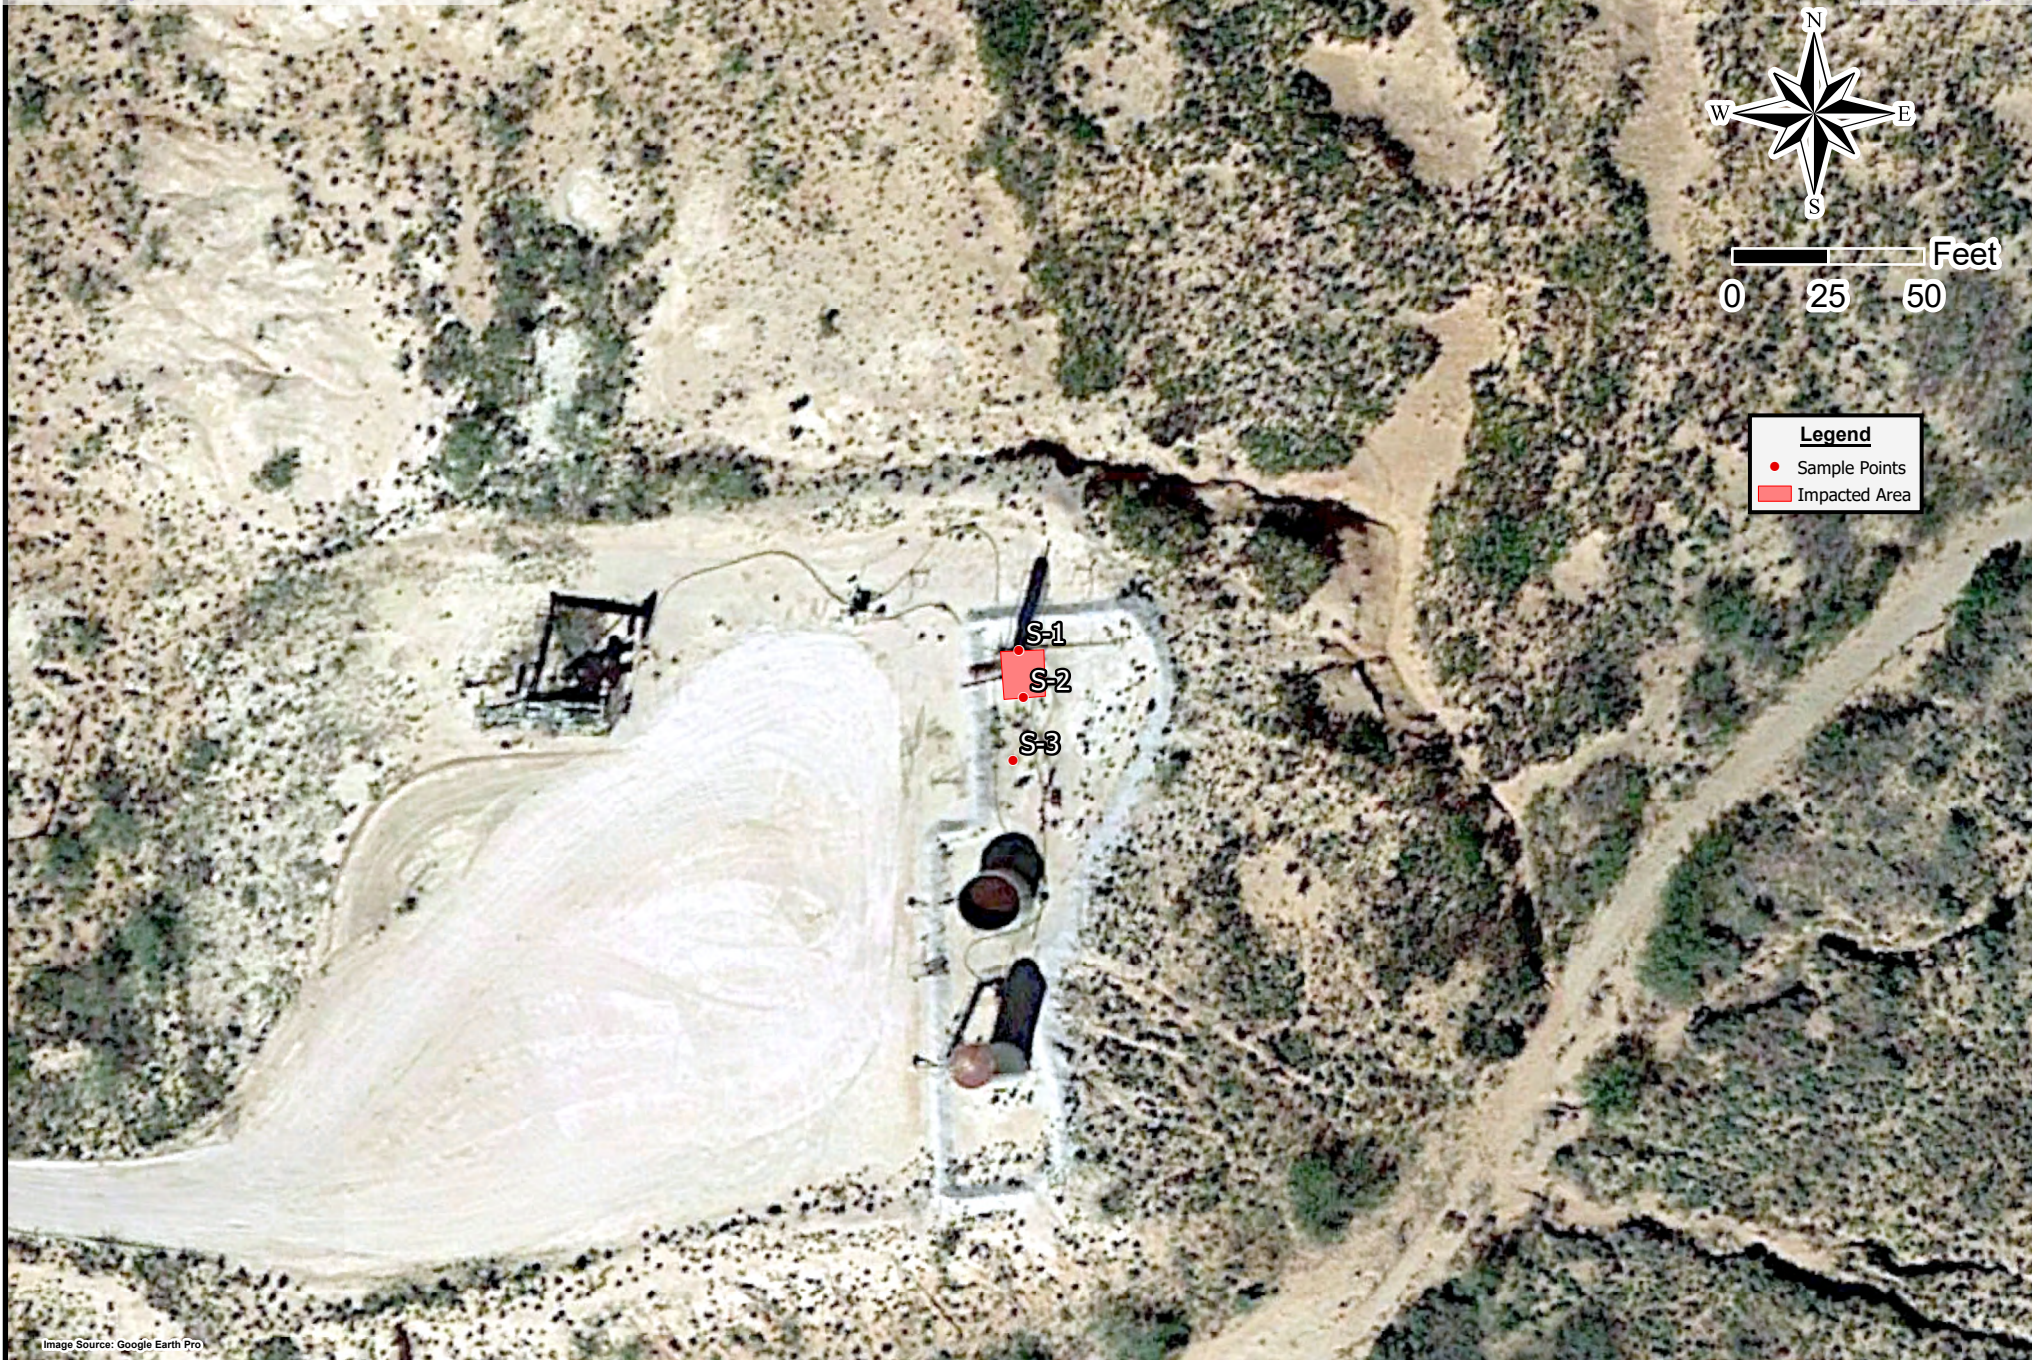
On December 13, 2022, Talon personnel mobilized to the site to conduct an initial site assessment of the area where the former heater treater resided. The impacted area was photographed, sampled utilizing a hand auger, and mapped. All soil samples were properly packaged, preserved on ice, and transported to Cardinal laboratories with the chain of custody for analysis of Total Chlorides (Method SM4500Cl-B), Total Petroleum Hydrocarbons (TPH, EPA Method 8015M), and Volatile Organics (BTEX, EPA Method 8021B). Sample locations are shown on the attached assessment map, Figure 2 ([Appendix I](#)) and the analytical results of our sampling event are presented in the following data table.

Matador Production Co.
Arco 5 Federal #001
Eddy County, NM
Assessment Map

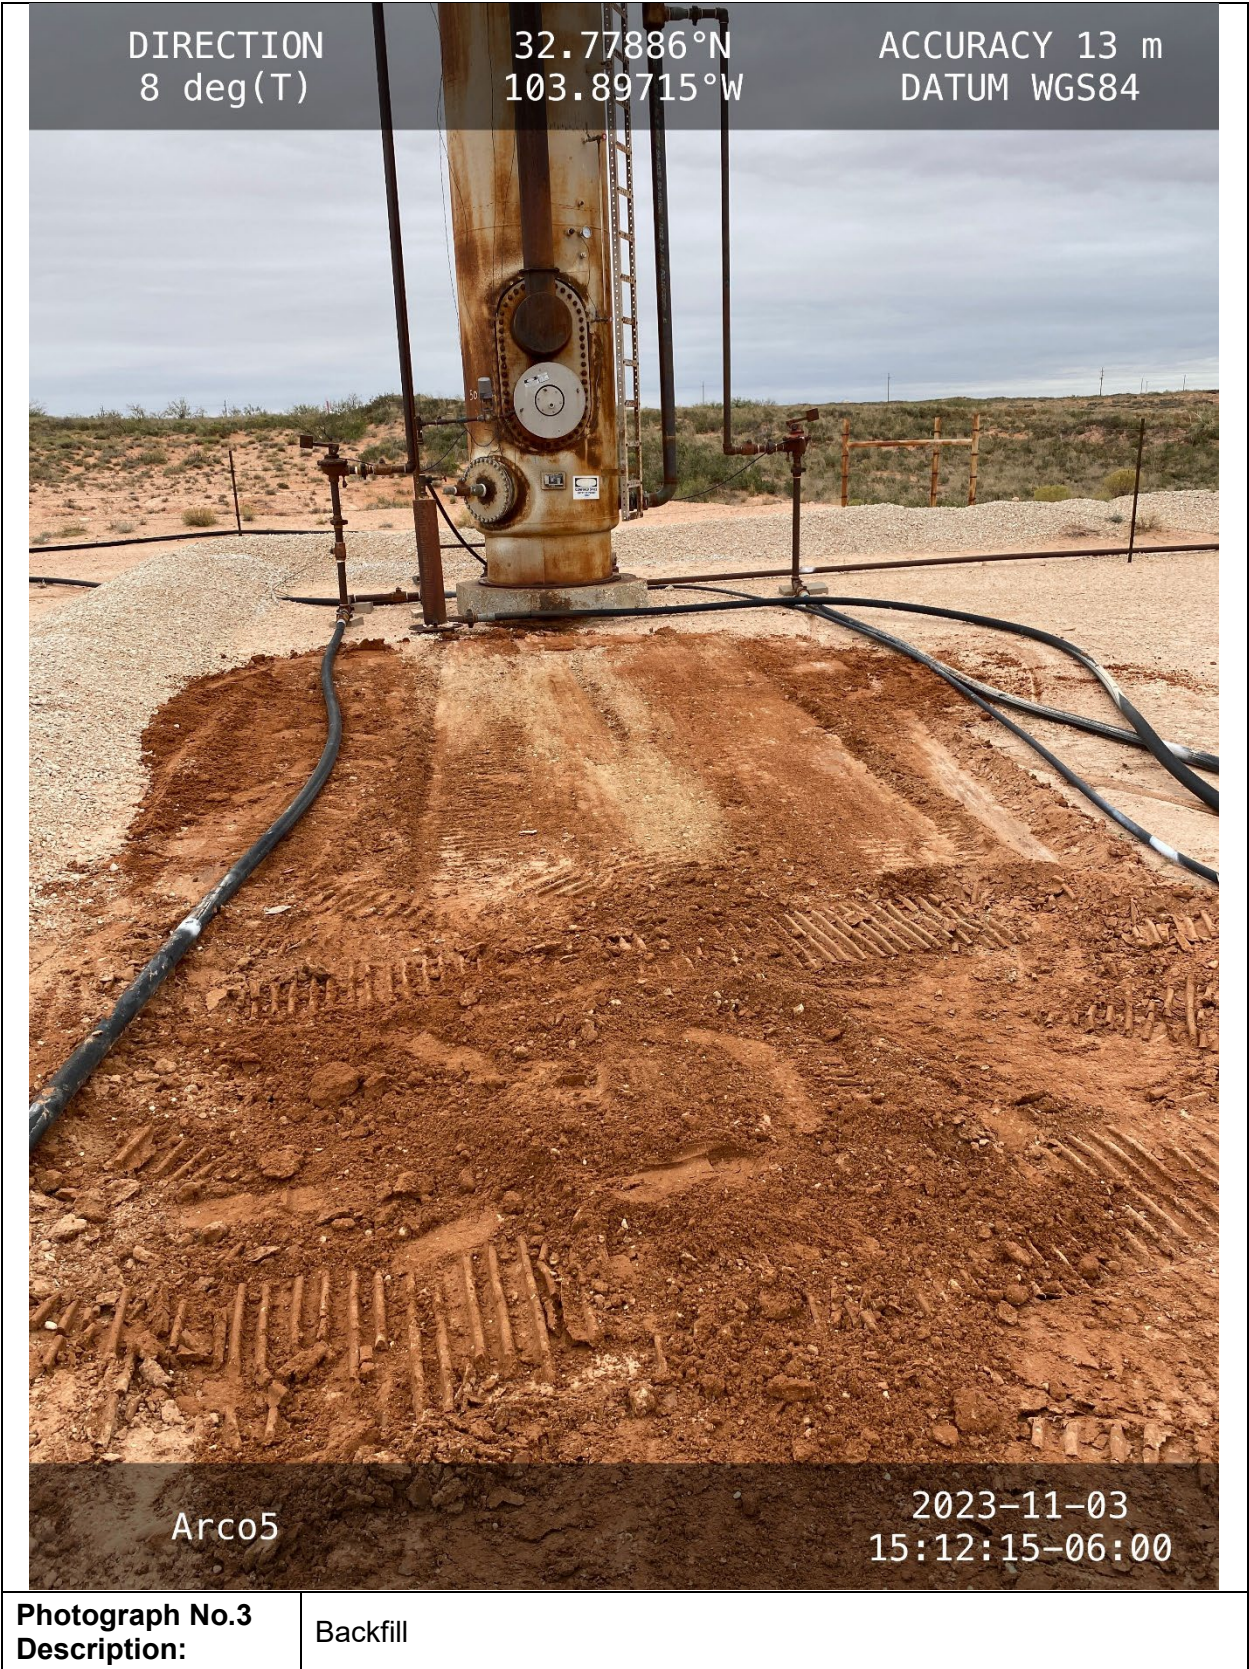
<p>A photograph of an excavation site. The foreground shows a large pile of reddish-brown soil with distinct tire tracks. In the background, a gravel area and some construction equipment are visible. A black pipe runs horizontally across the middle ground. The image is overlaid with white text providing GPS data: "DIRECTION 325 deg(T)", "32.77882°N", "103.89711°W", "ACCURACY 5 m", and "DATUM WGS84". At the bottom left of the image, the text "Arco5" is visible. At the bottom right, the date and time "2023-11-03 11:04:01-06:00" are displayed.</p>	
Photograph No.2 Description:	Excavation
