CLOSURE REPORT

Gallegos Canyon Unit #89 E DK (07/12/23)
Unit Letter F, S6 T27N R12W
San Juan County, New Mexico

New Mexico EMNRD OCD Incident ID No. NAPP2319533826

October 10, 2023

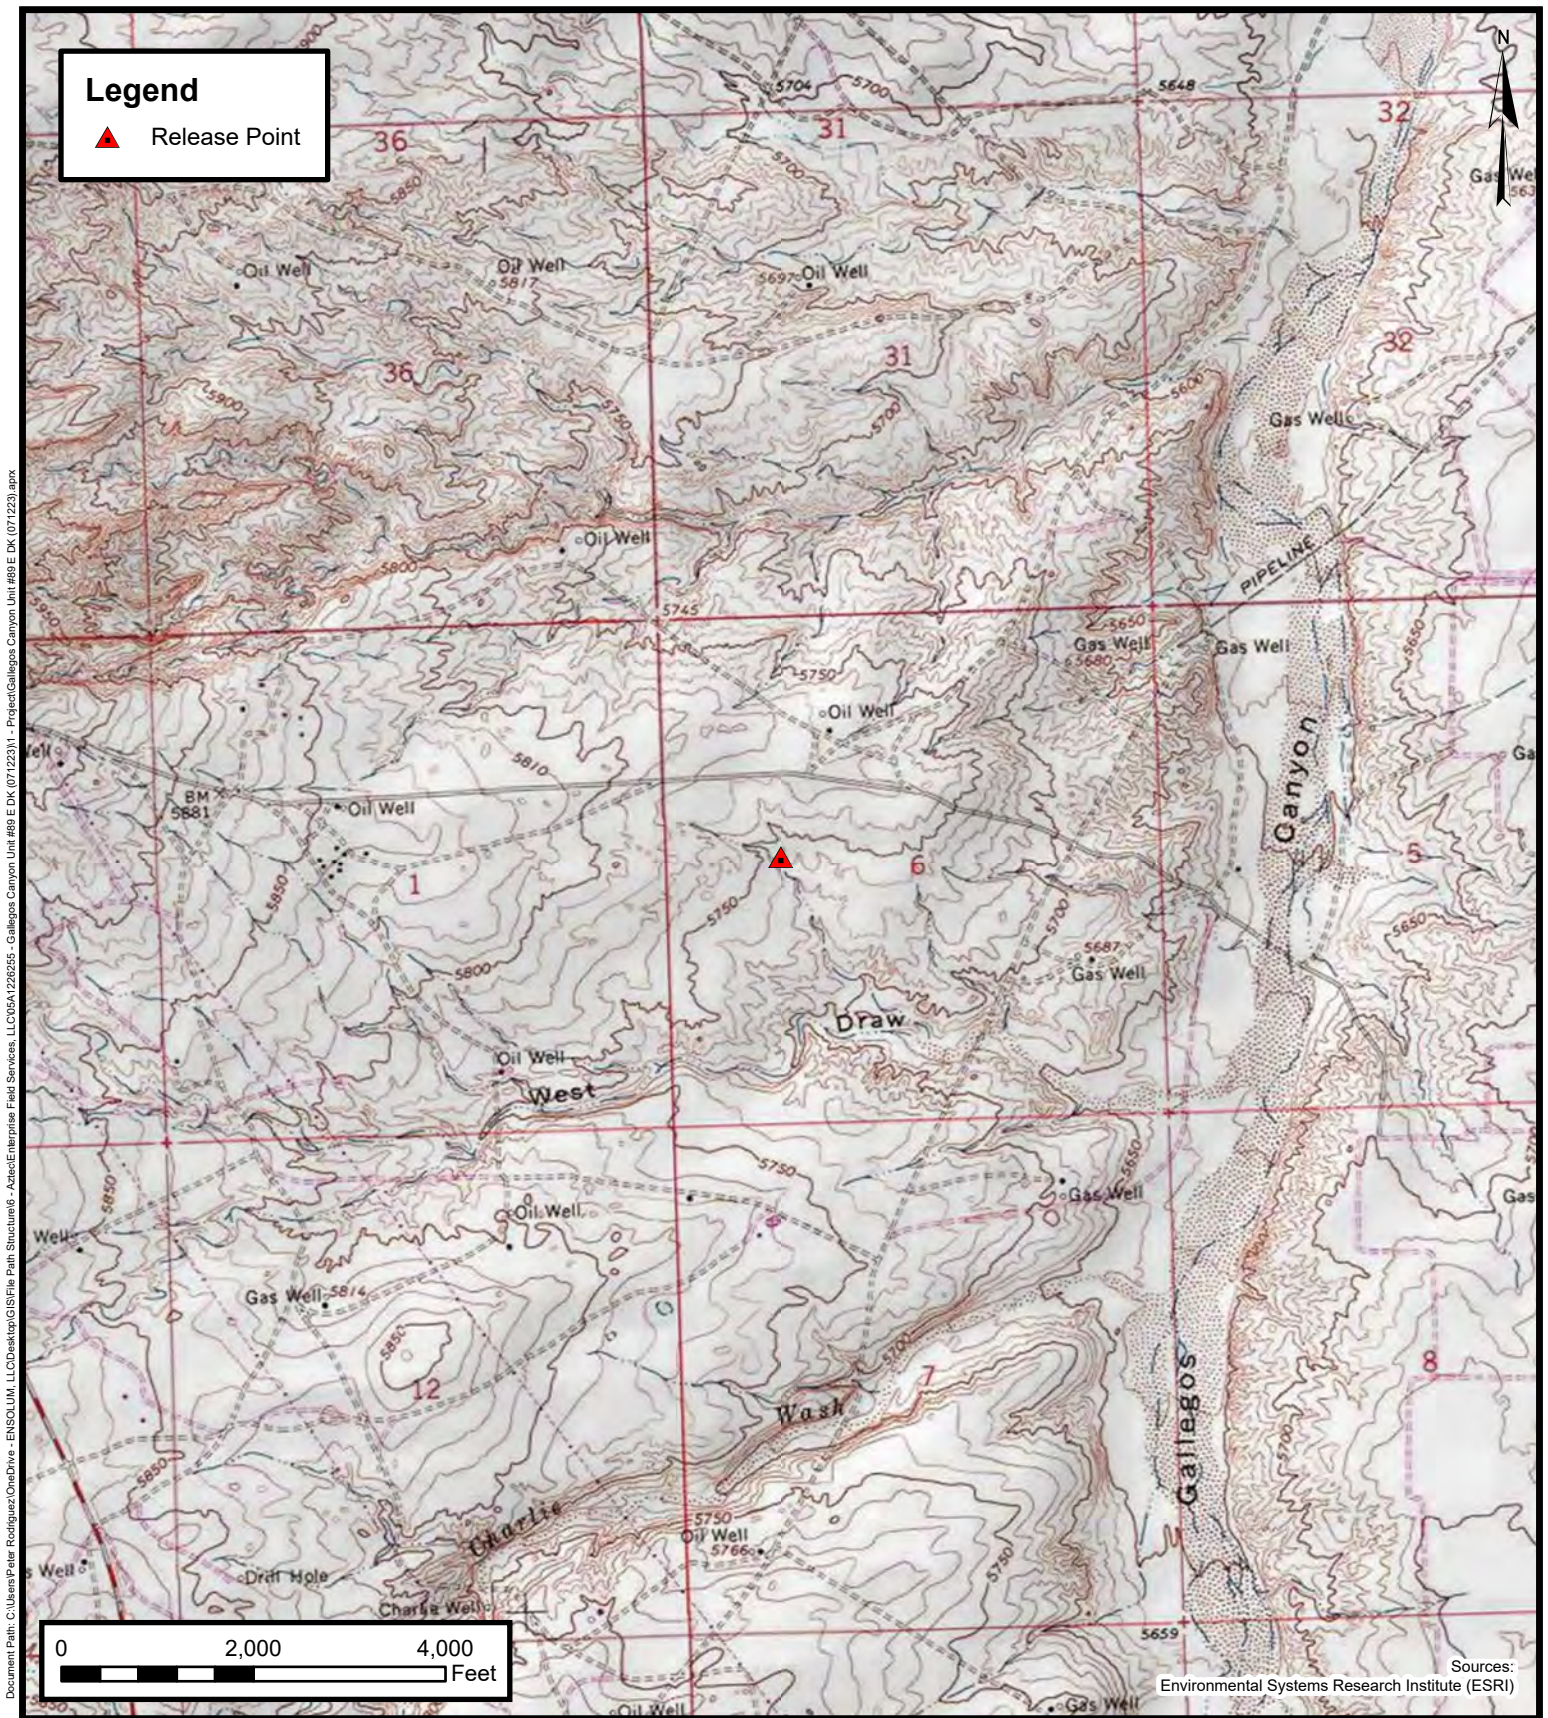
1

Topographic Map

A **Topographic Map** depicting the location of the Site is included as **Figure 1**, and a **Site Vicinity Map** is included as **Figure 2** in **Appendix A**.

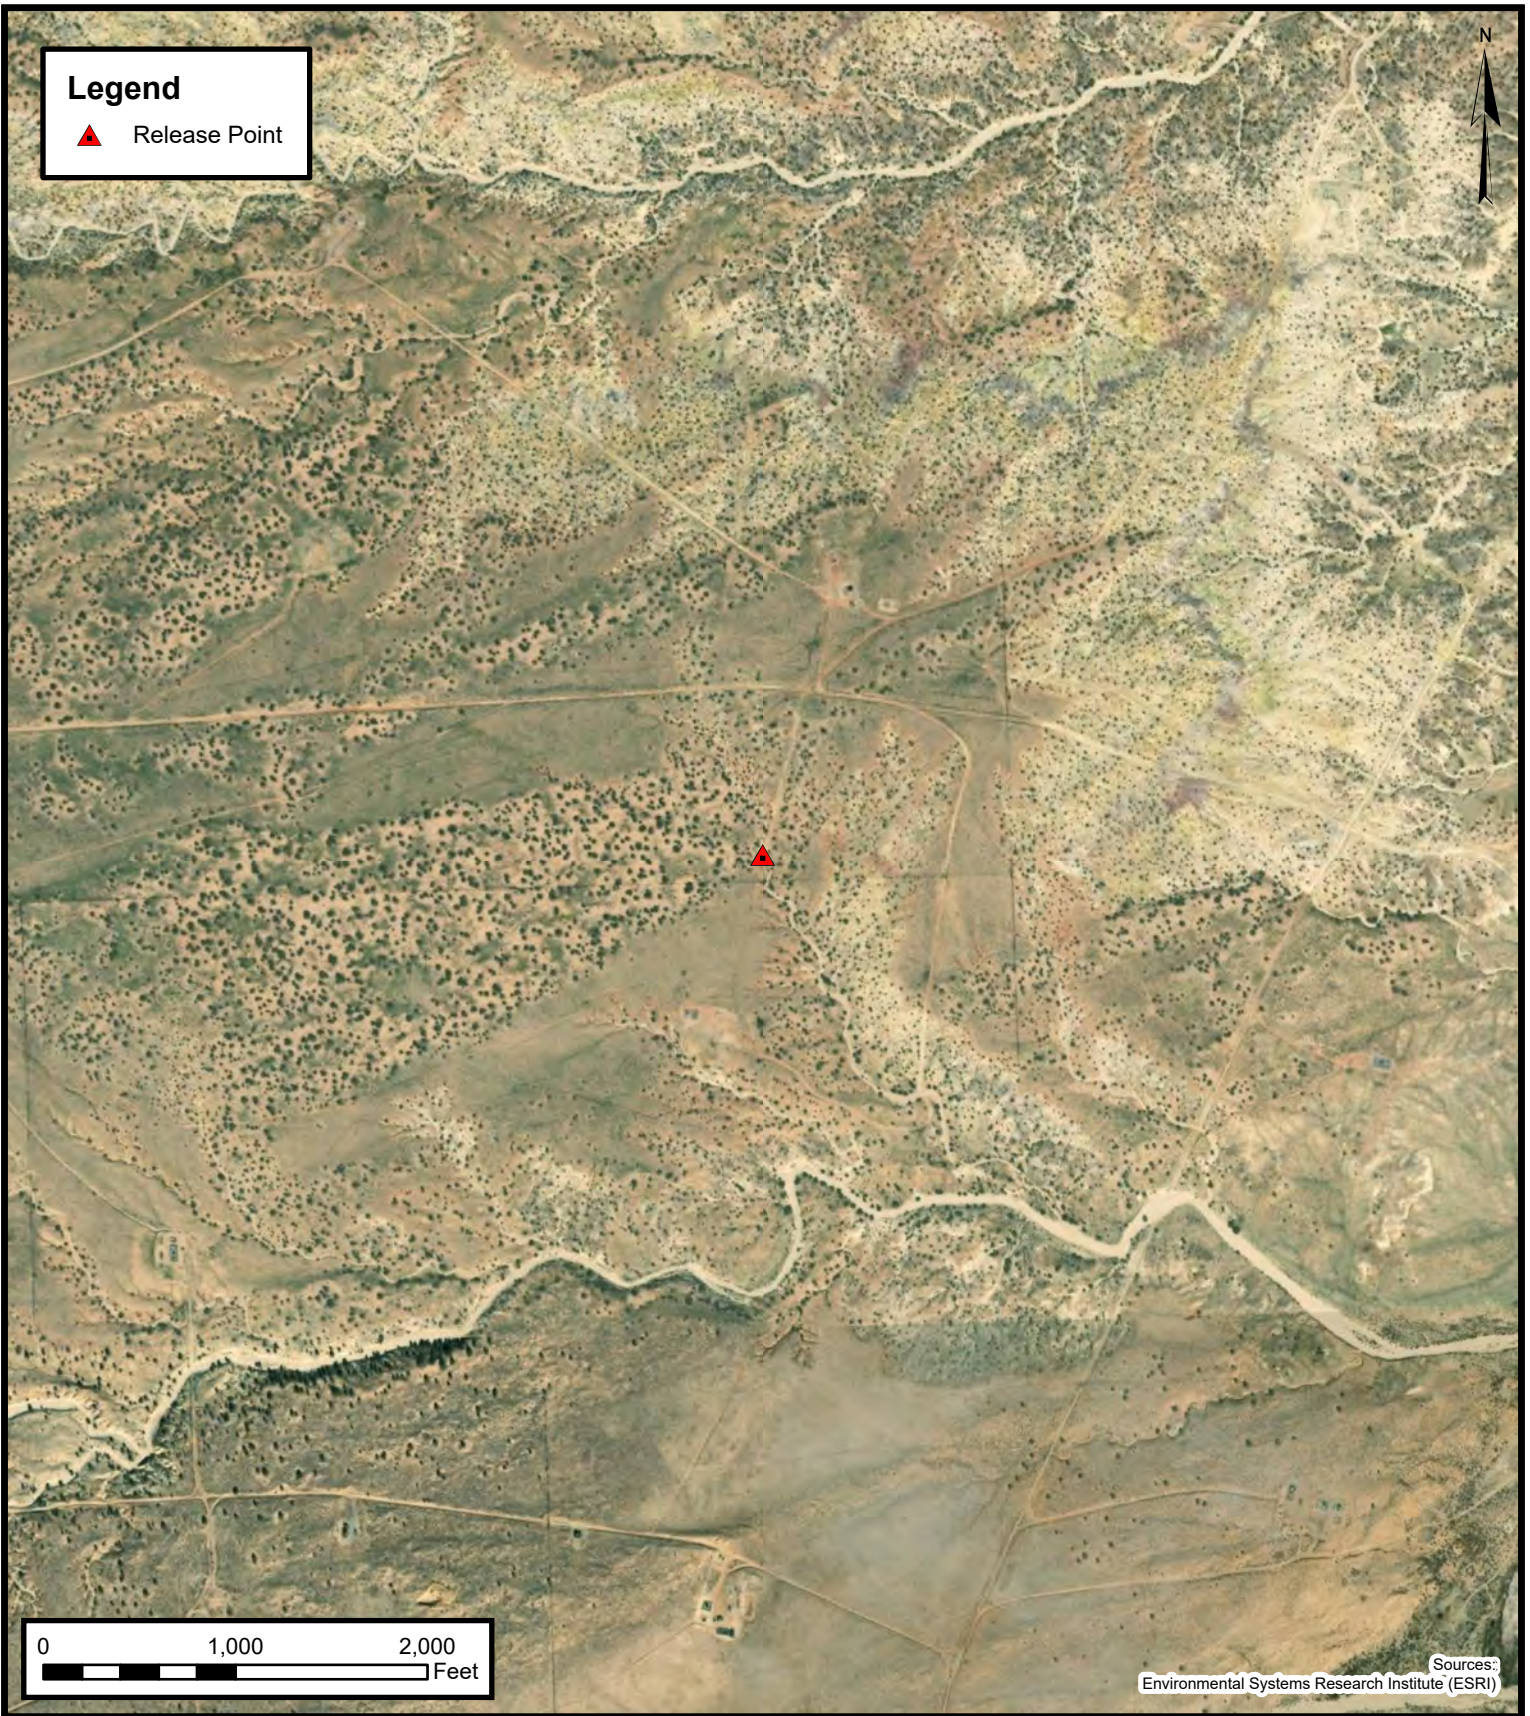
2

Site Vicinity Map

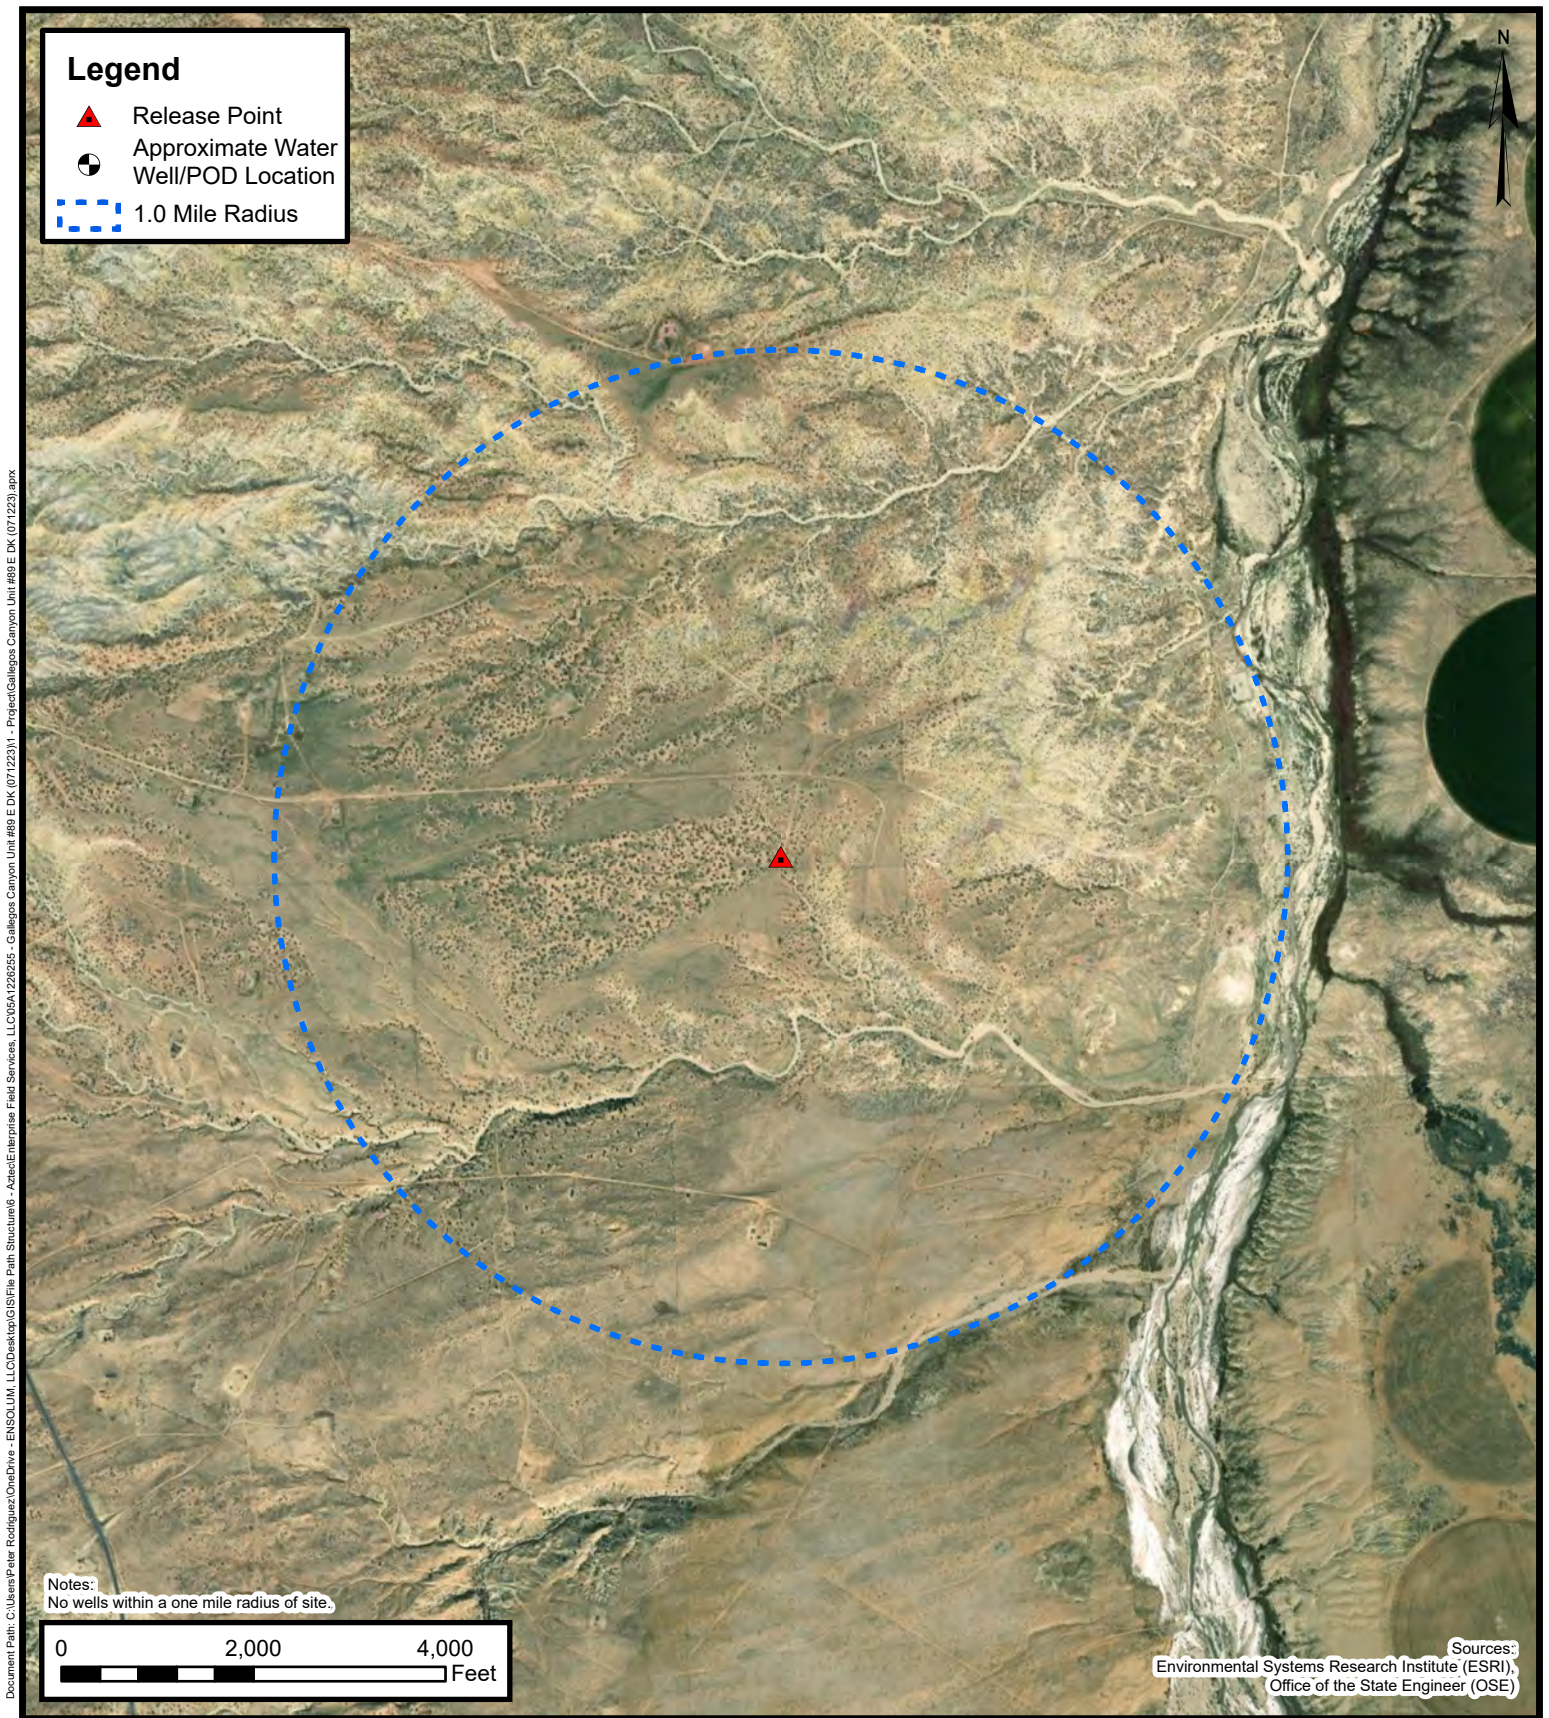
FIGURE
A

1.0 Mile Radius Water Well/POD Location Map

- The NM Office of the State Engineer (OSE) tracks the usage and assignment of water rights and water well installations and records this information in the Water Rights Reporting System (WRRS) database. Water wells and other points of diversion (PODs) are each assigned POD numbers in the database (which is searchable and includes an interactive map). No PODs were identified in the same Public Land Survey System (PLSS) section as the Site or in the adjacent PLSS sections (**Figure A, Appendix B**).
- Two cathodic protection wells (CPWs) were identified in the NM EMNRD OCD imaging database in the adjacent PLSS sections. These CPWs are depicted on **Figure B (Appendix B)**. Documentation for the cathodic protection well located near the Navajo D #1 well location

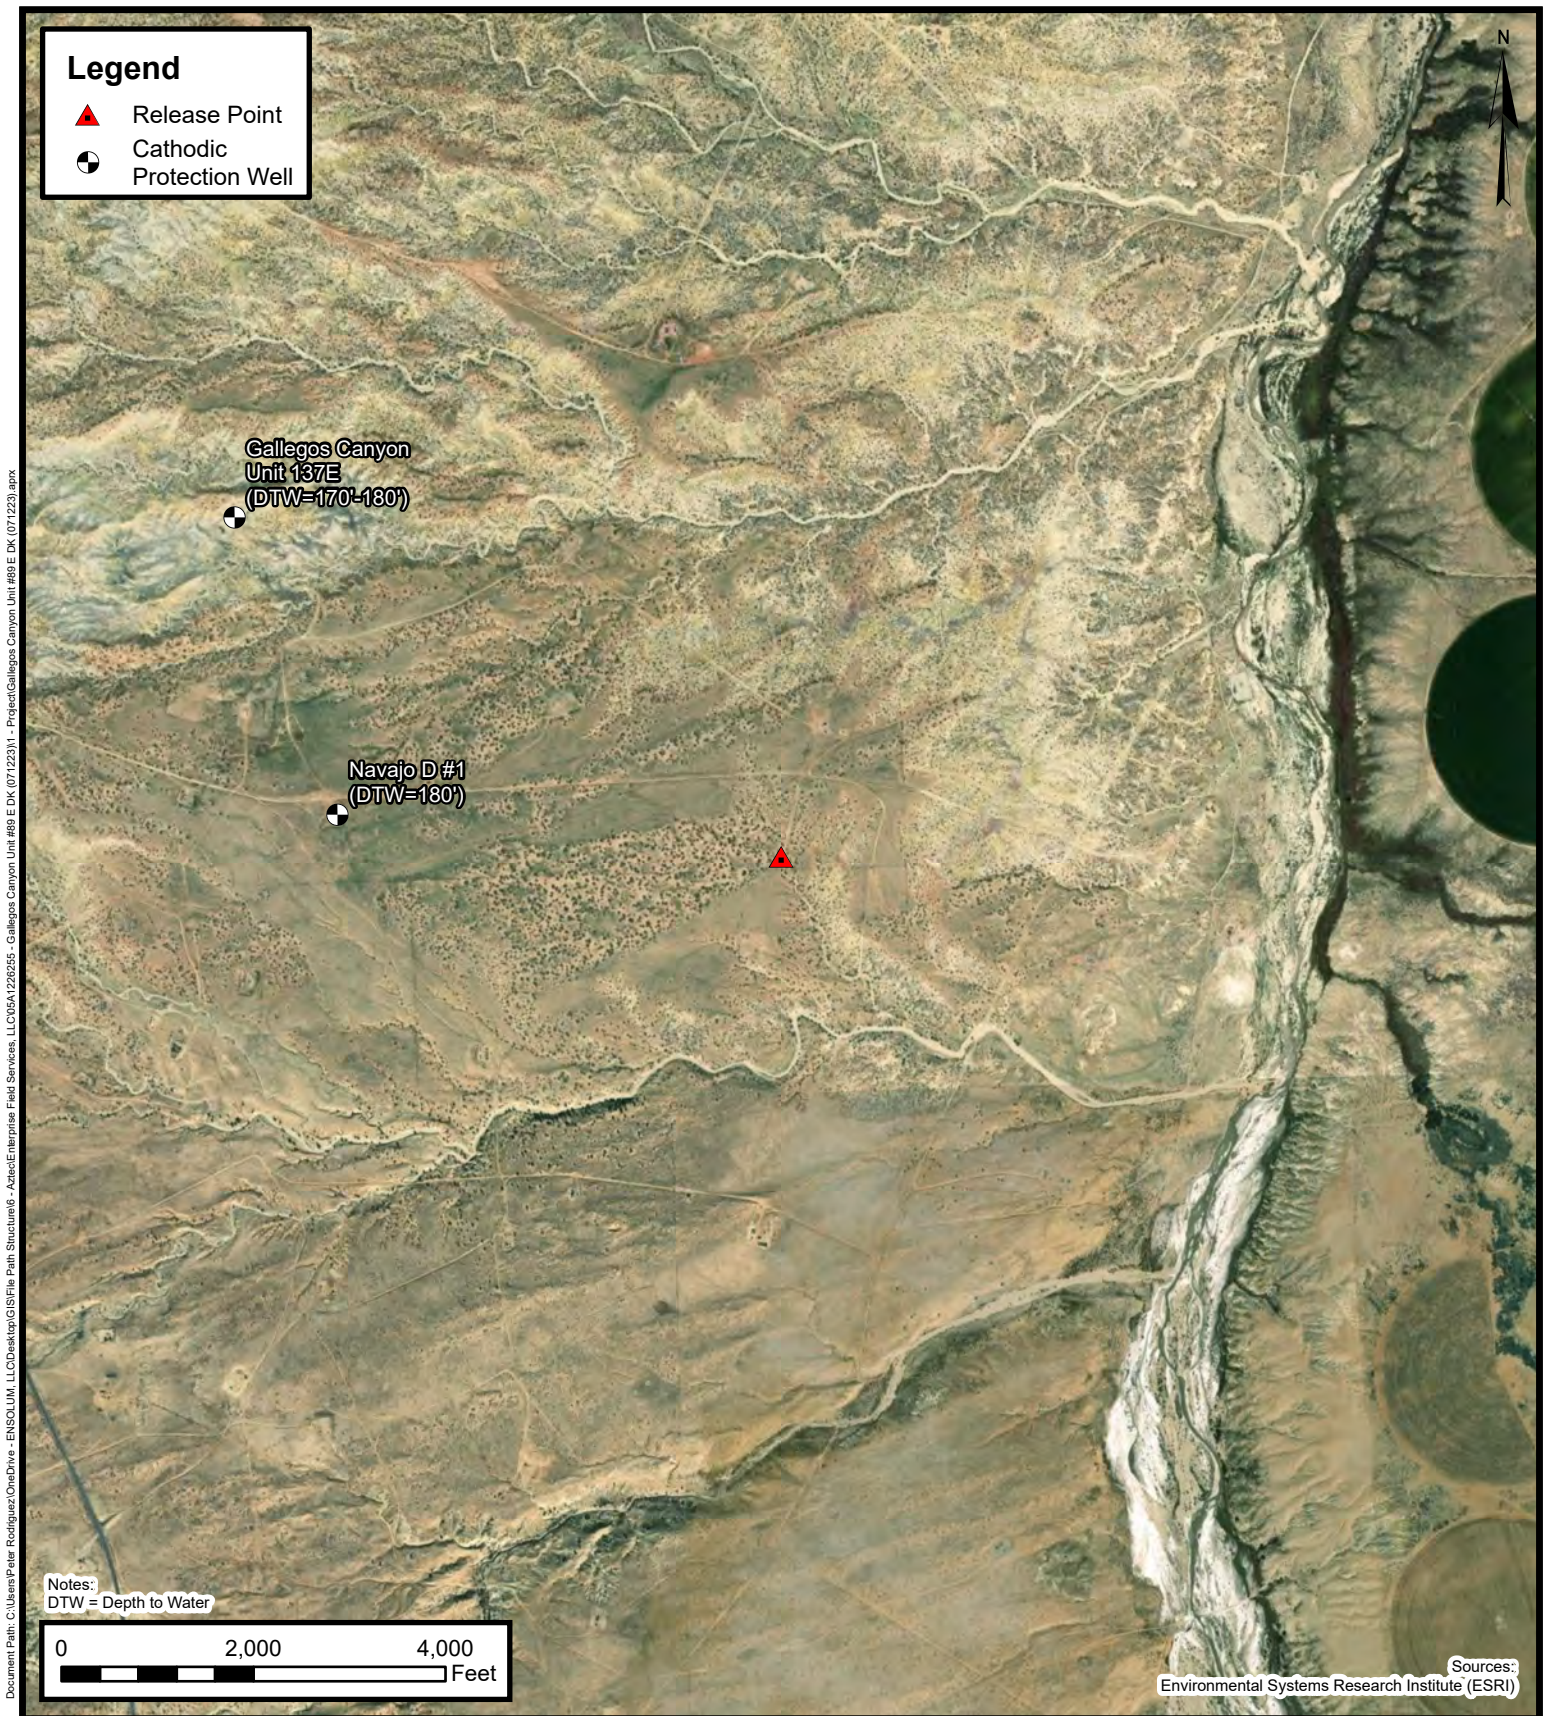
FIGURE
B

Cathodic Protection Well Recorded Depth to Water

indicates a depth to water of 180 feet bgs. This cathodic protection well is located approximately 0.88 miles northwest of the Site and is approximately 98 feet higher in elevation than the Site. Documentation for the cathodic protection well located near the Gallegos Canyon Unit 137E well location indicates a depth to water between 170 feet and 180 feet bgs. This cathodic protection well is located approximately 1.26 miles northwest of the Site and is approximately 105 feet higher in elevation than the Site.

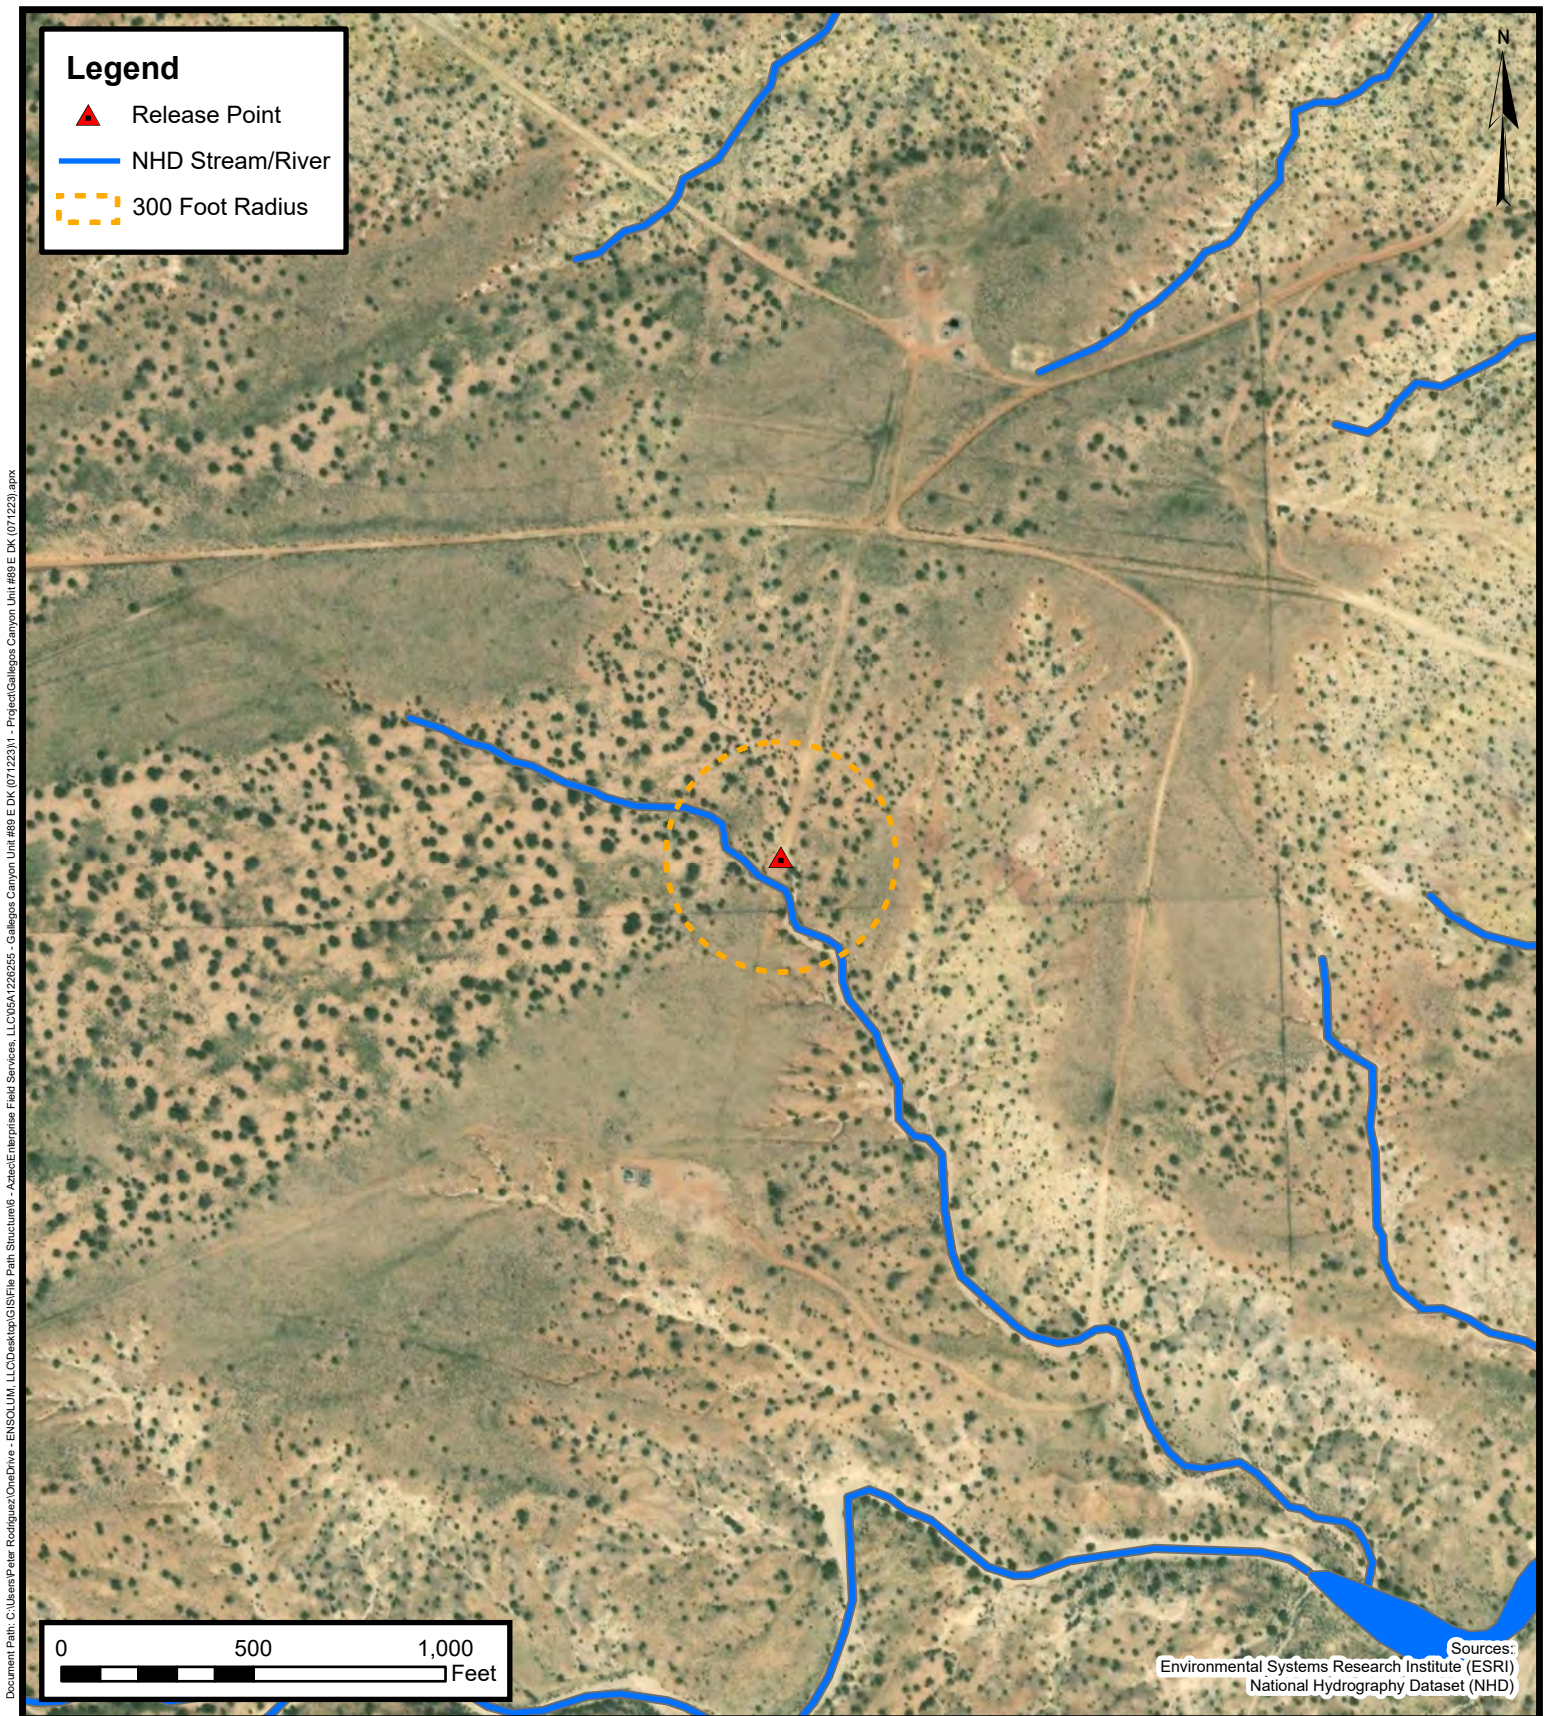
FIGURE
C

300 Foot Radius Watercourse and Drainage Identification

- The Site is located within 300 feet of a NM EMNRD OCD-defined continuously flowing watercourse or significant watercourse (**Figure C, Appendix B**).

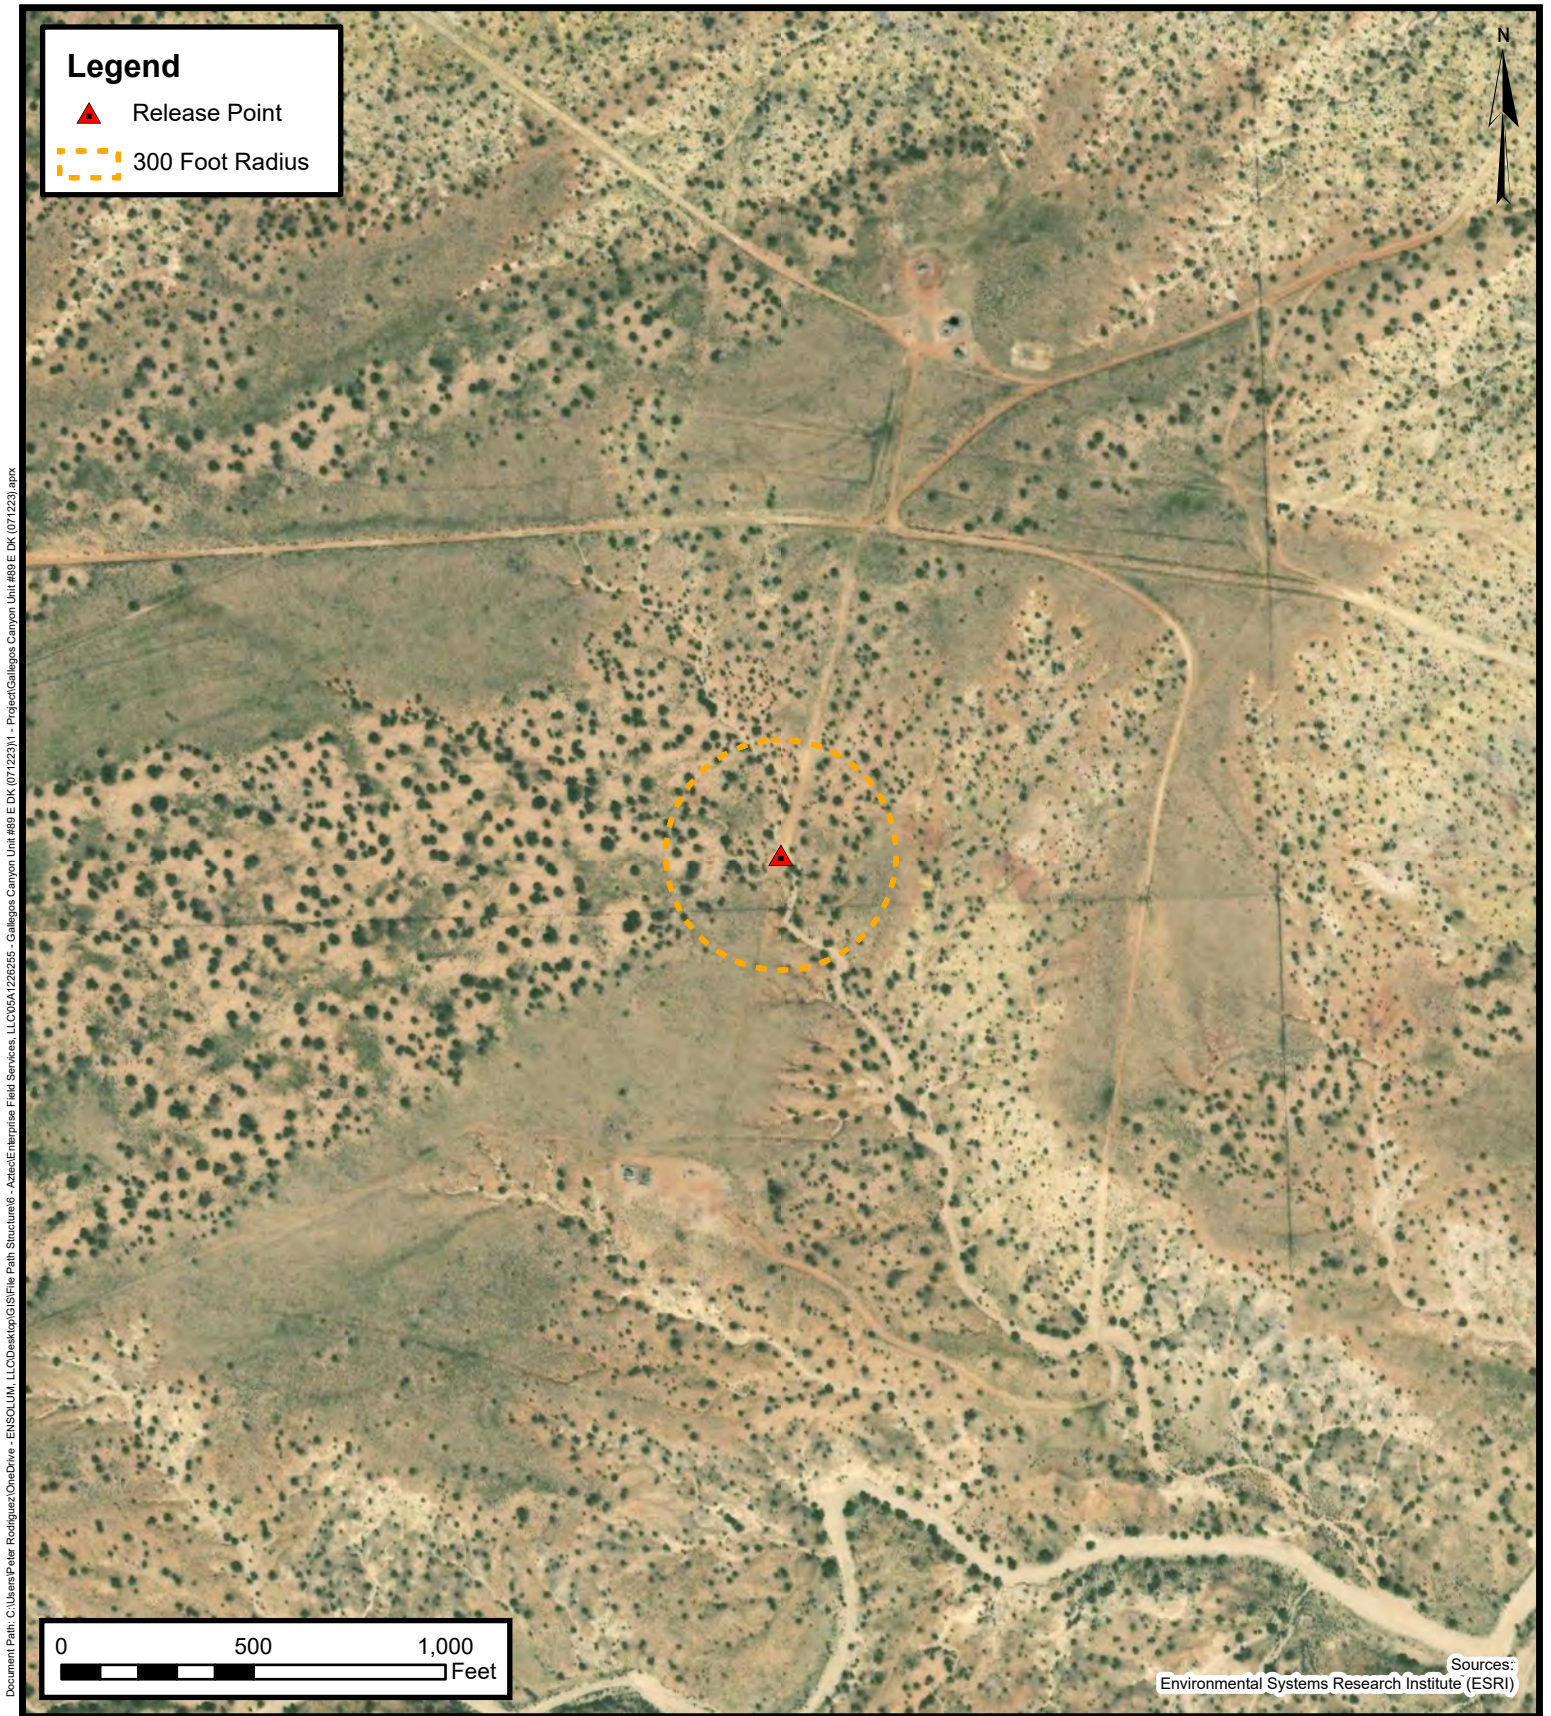
**FIGURE
D**

**300 Foot Radius Occupied
Structure Identification**
Enterprise Field Services, LLC
Gallegos Canyon Unit #89 E DK (07/12/23)
Project Number: 05A1226255
Unit Letter F, S6 T27N R12W, San Juan County, New Mexico
36.60446, -108.15716

- The Site is not located within 200 feet of a lakebed, sinkhole, or playa lake.
- The Site is not located within 300 feet of a permanent residence, school, hospital, institution, or church (**Figure D, Appendix B**).

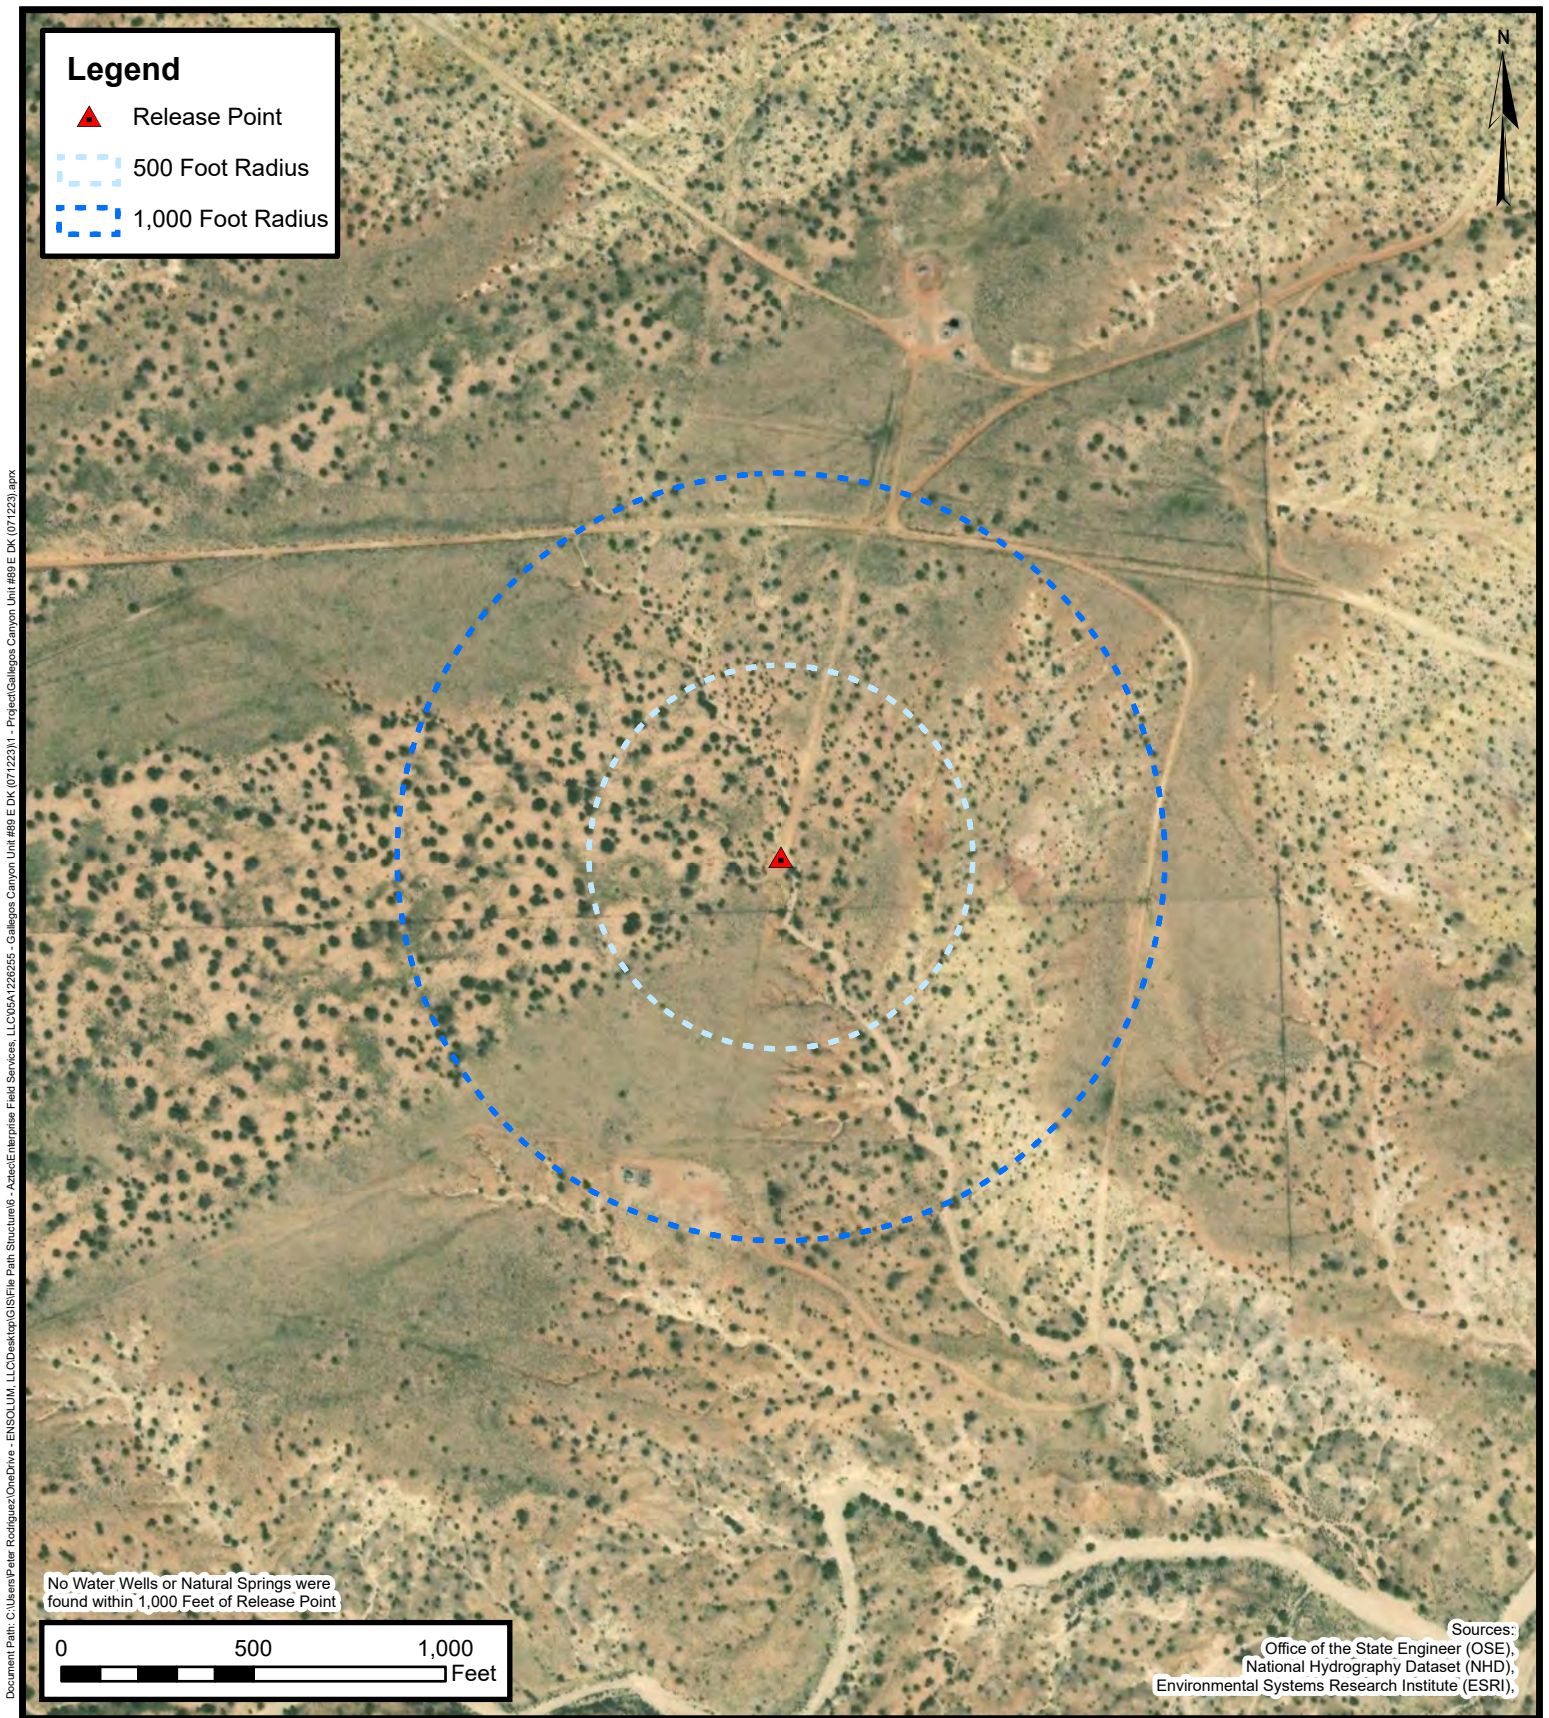
**FIGURE
E**

**Water Well and
Natural Spring Location**
Enterprise Field Services, LLC
Gallegos Canyon Unit #89 E DK (07/12/23)
Project Number: 05A1226255

- No springs, or private domestic freshwater wells used by less than five households for domestic or stock watering purposes were identified within 500 feet of the Site (**Figure E, Appendix B**).

- No freshwater wells or springs were identified within 1,000 feet of the Site (**Figure E, Appendix B**).
- The Site is not located within incorporated municipal boundaries or within a defined municipal fresh water well field covered under a municipal ordinance adopted pursuant to New Mexico Statutes Annotated (NMSA) 1978, Section 3-27-3.

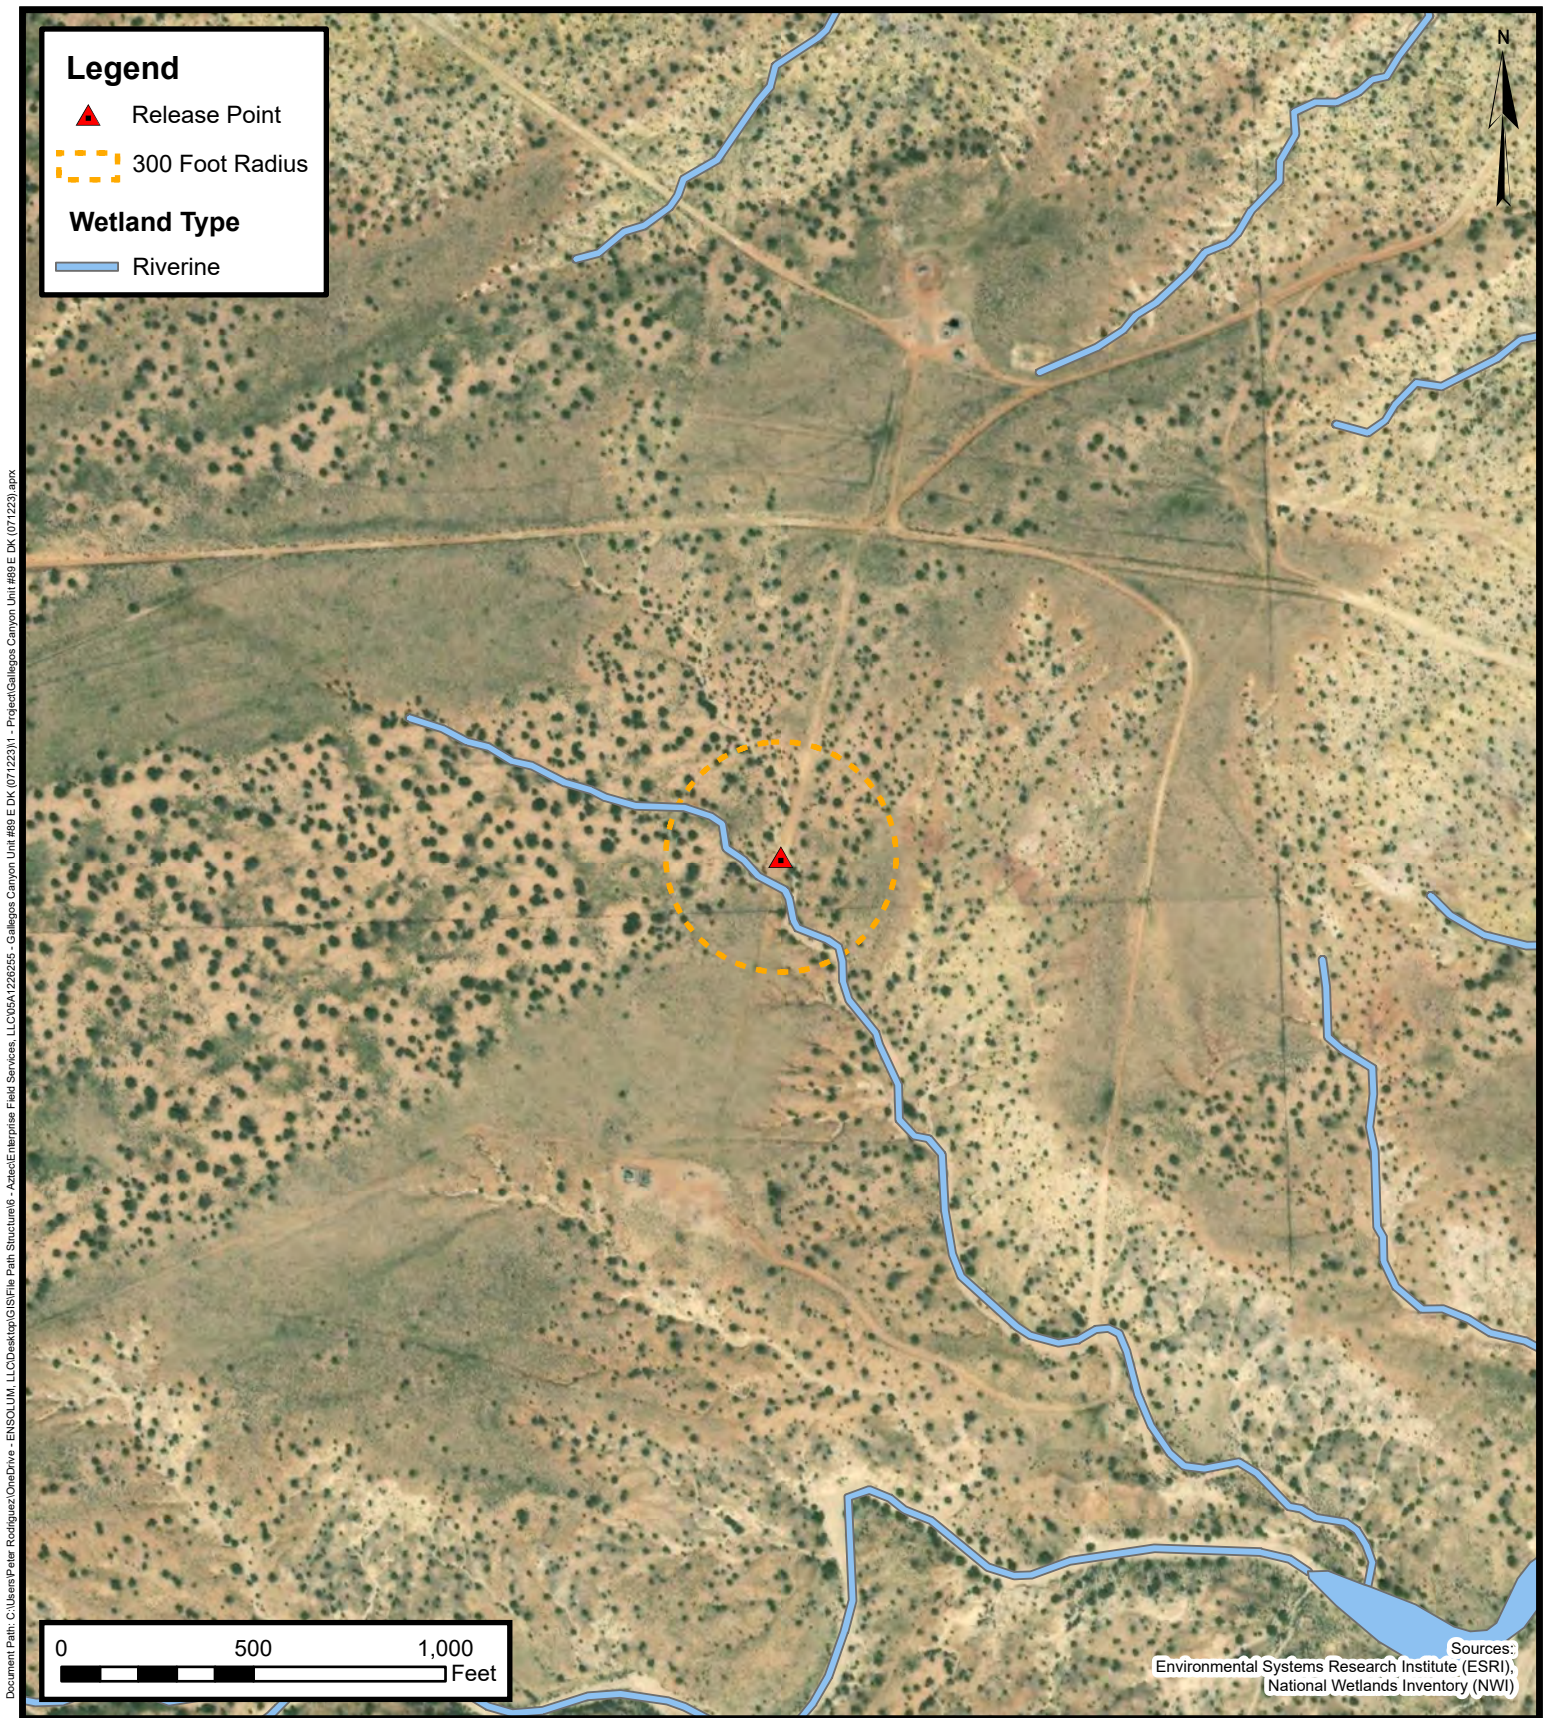
FIGURE
F

Wetlands

- Based on information identified in the U.S. Fish & Wildlife Service National Wetlands Inventory Wetlands Mapper, the Site is not within 300 feet of a wetland (**Figure F, Appendix B**).
