CLOSURE REPORT

Gallegos Canyon Unit #89 E DK (07/12/23)
Unit Letter F, S6 T27N R12W
San Juan County, New Mexico

New Mexico EMNRD OCD Incident ID No. NAPP2319533826

October 10, 2023

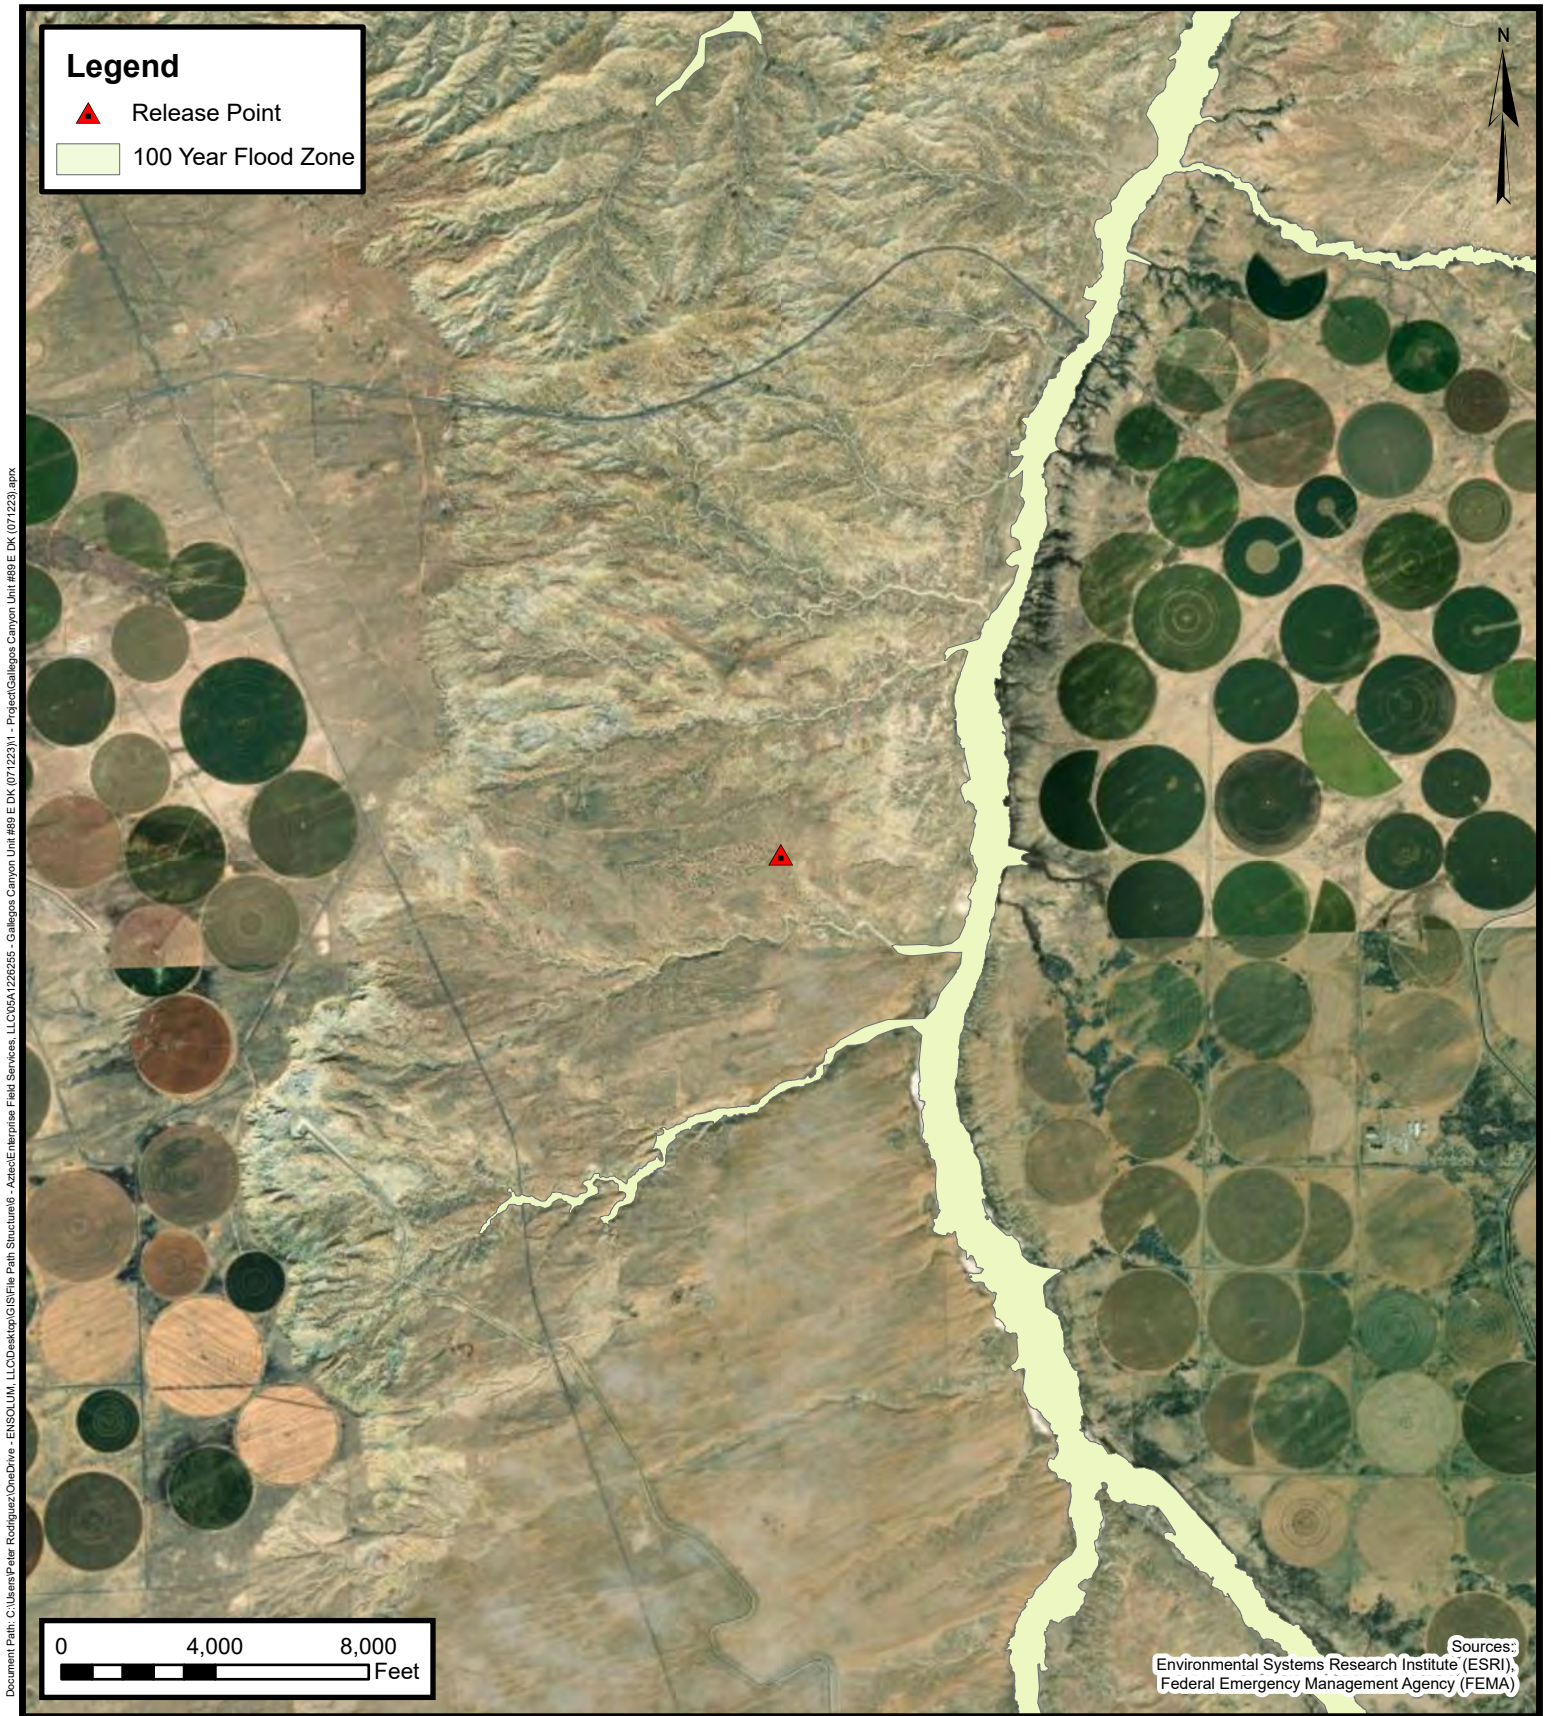
FIGURE
H

100-Year Flood Plain Map

- The Site is not located within an unstable area per Paragraph (6) of Subsection U of 19.15.2.7 NMAC.
- Based on information provided by the Federal Emergency Management Agency (FEMA) National Flood Hazard Layer (NFHL) geospatial database, the Site is not within a 100-year floodplain (**Figure H, Appendix B**).

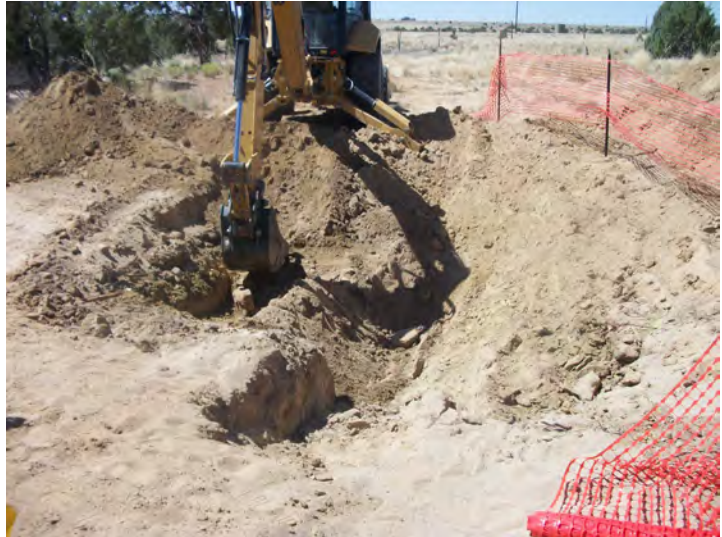
**Photograph 1**

Photograph Description: View of the in-process excavation activities.

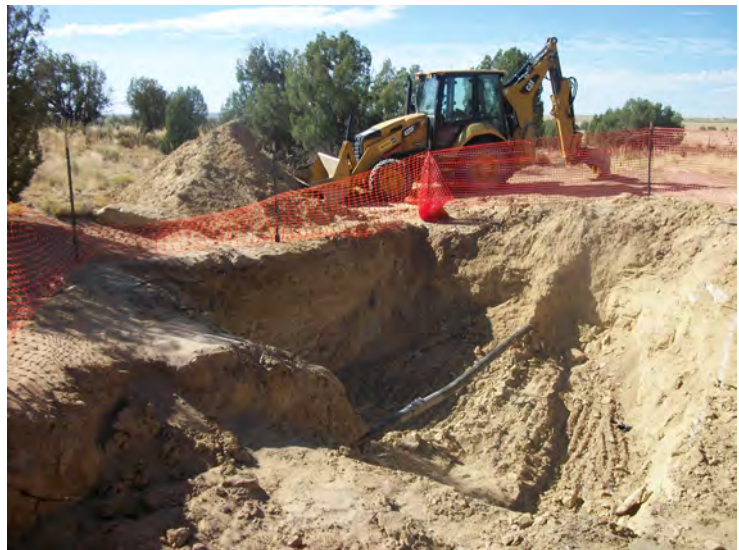
**Photograph 2**

The final excavation measured approximately 24 feet long and 15 feet wide at the maximum extents. The maximum depth of the excavation measured approximately 6 feet bgs. The lithology encountered during the completion of remediation activities consisted primarily of silty sand underlain by weathered sandstone.

Photograph Description: View of the final excavation.

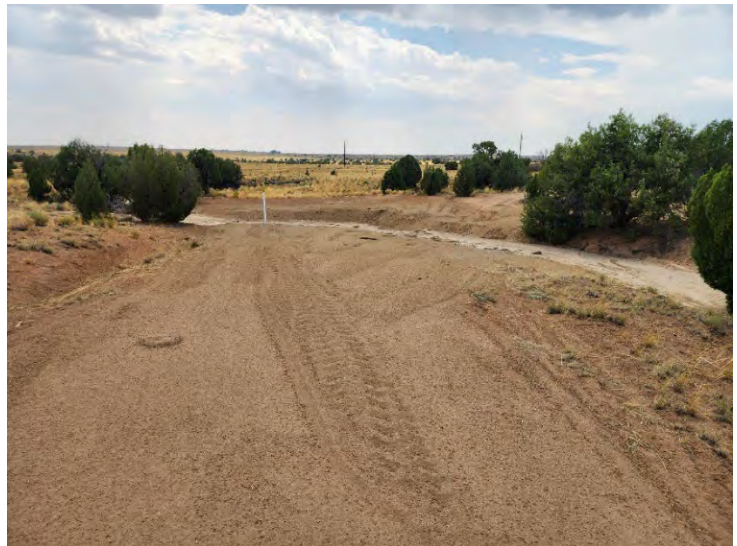
**Photograph 3**

Photograph Description: View of the site after initial restoration.

The excavation was backfilled with imported fill and then contoured to the surrounding topography.

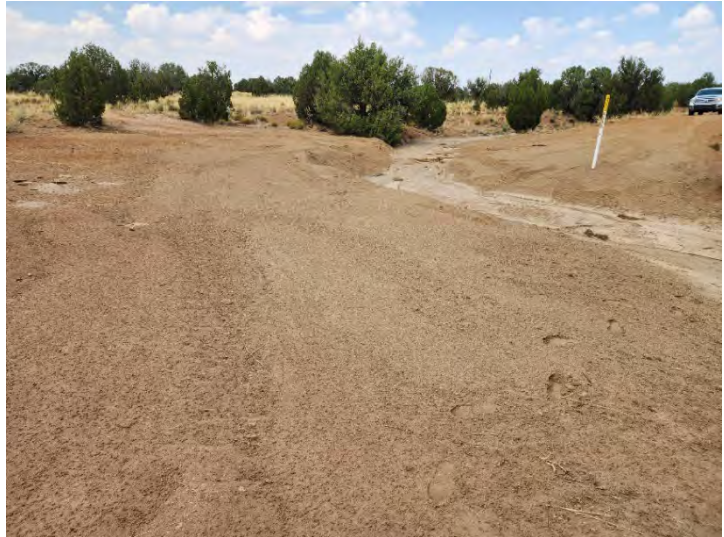
Photograph 4

Photograph Description: View of the site after initial restoration.
