## Site Assessment/Characterization

## Closure

**Re: Site Assessment, and Closure Report**  
**Snapping 2 State 003H**  
**API No. N/A**  
**GPS: Latitude 32.0657463 Longitude -103.7554474**  
**UL -- M, Section 02, T26S, R31E**  
**Eddy County, NM**  
**NMOCD Ref. No. NRM2028154760**

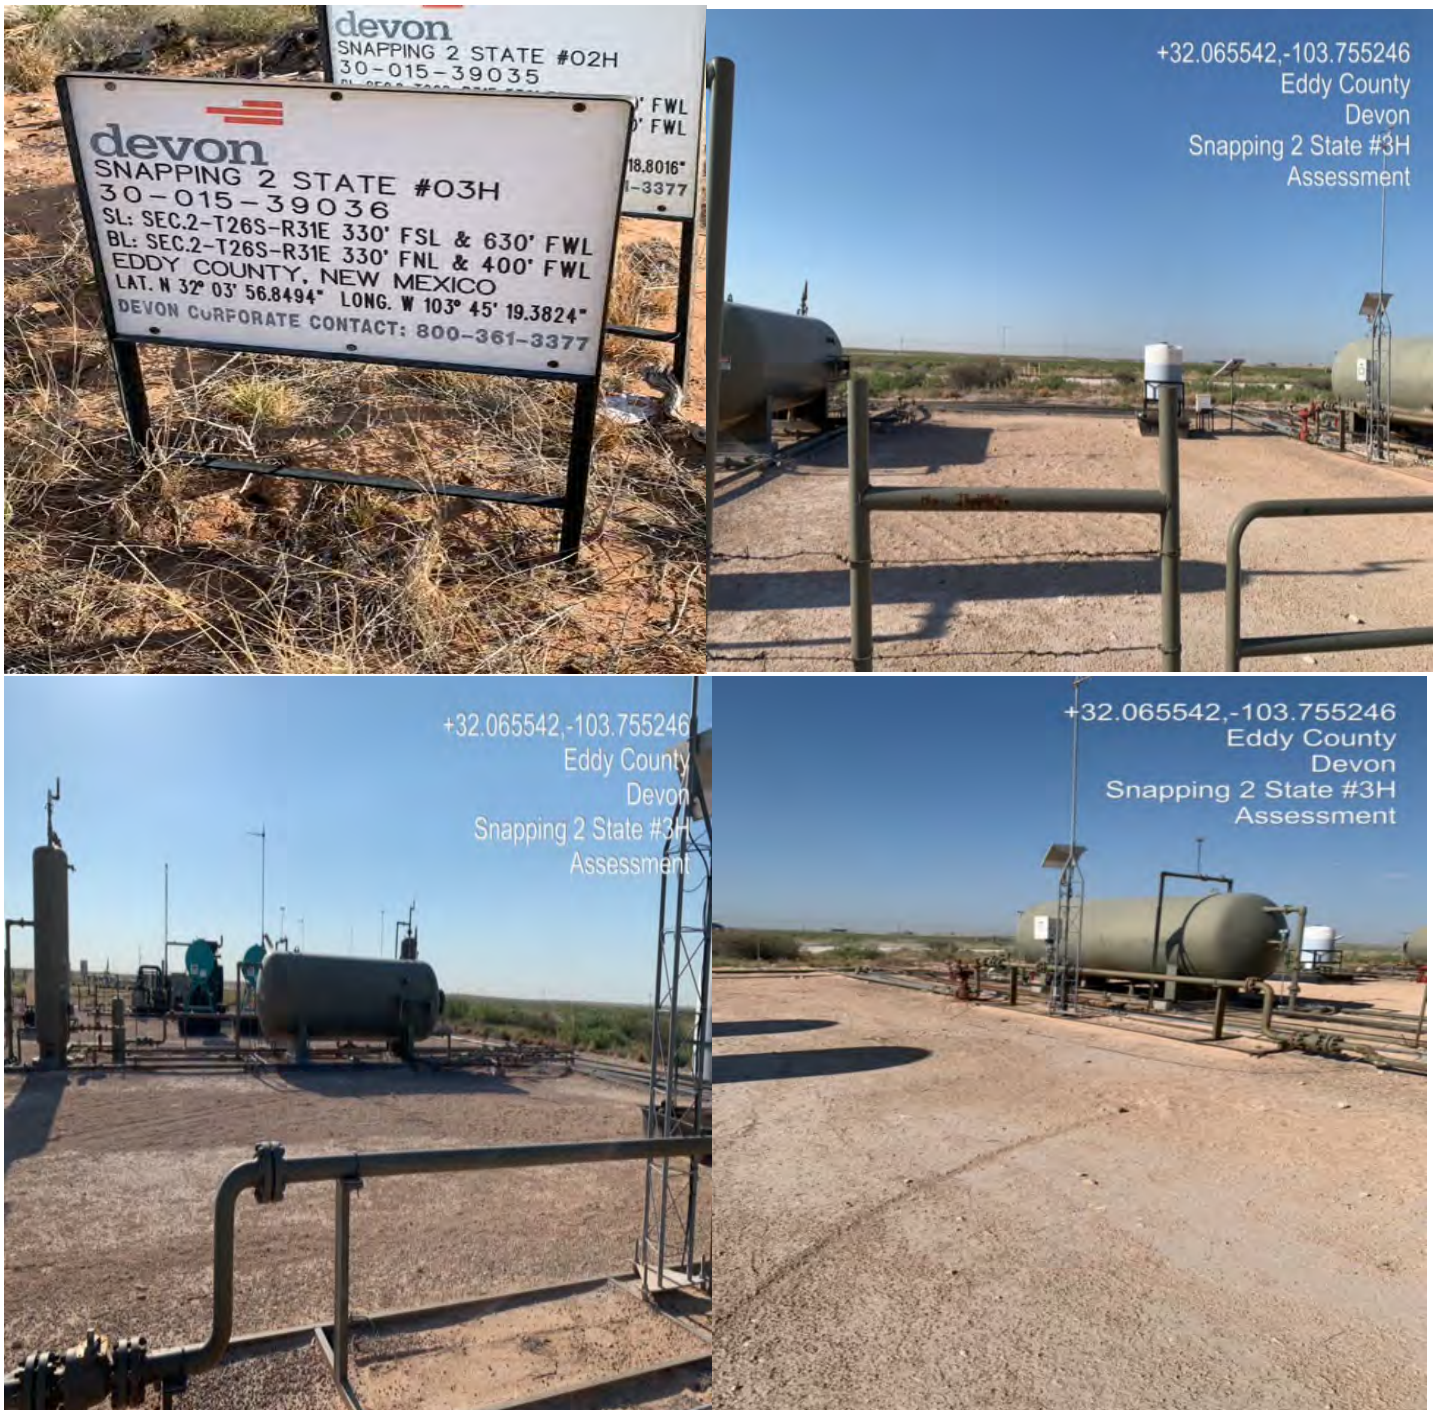
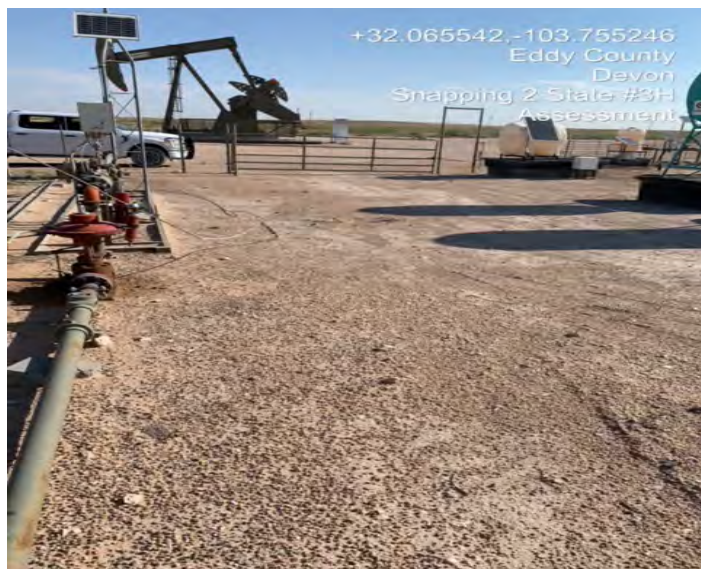
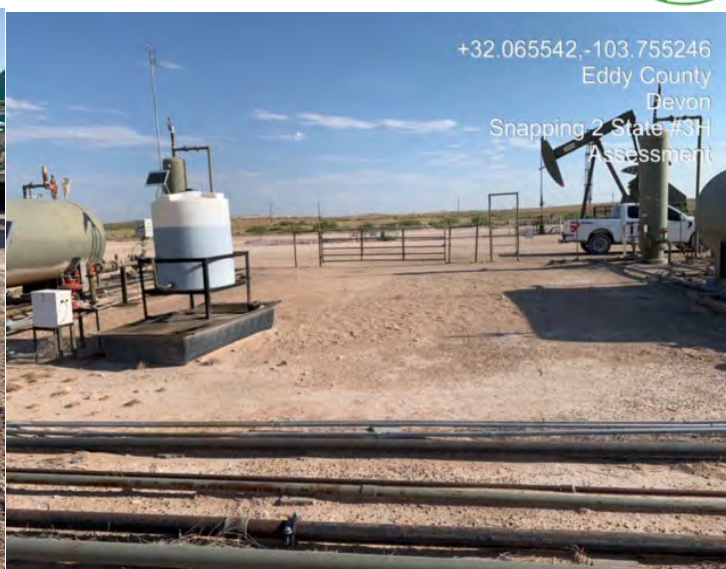
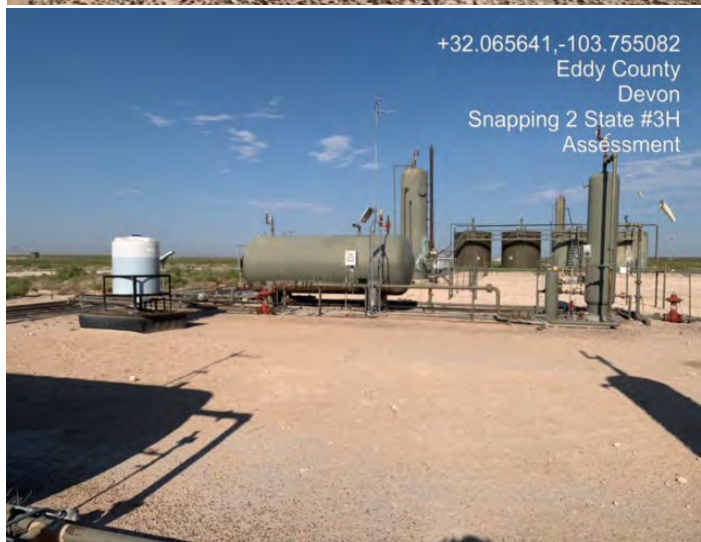
**SITE PHOTOGRAPHS  
DEVON ENERGY  
SNAPPING 2 STATE 003H**

**Site Assessment**

Based on the sample results, the bottoms and sidewalls were below NMOCD Closure Criteria 19.15.29 NMAC. See Appendix D for Photographic Documentation.
