Re: **Closure Request**
Alley Cat 17 CTB 3
Tracking #: NAPP2316766795

Site Information	
Incident ID	NAPP2316766795
Site Name	Alley Cat 17 CTB 3
Company	Devon Energy Production Company, LP
County	Lea
ULSTR	D-17-23S-32E
GPS Coordinates (NAD 83)	32.3086071, -103.6956337
Landowner	Federal

On 6/16/2023, Devon Energy Production Company, LP reported a release at the Alley Cat 17 CTB 3. The release was caused when a water transfer pump. The entire release was in a Lined and Contained Facility, and no liquid escaped the container.

Remediation Map
Devon Energy Production Company, LP
Alley Cat 17 CTB 3
32.3086188, -103.6956526
Lea County, New Mexico
NMOCD Reference #: NAPP2316766795

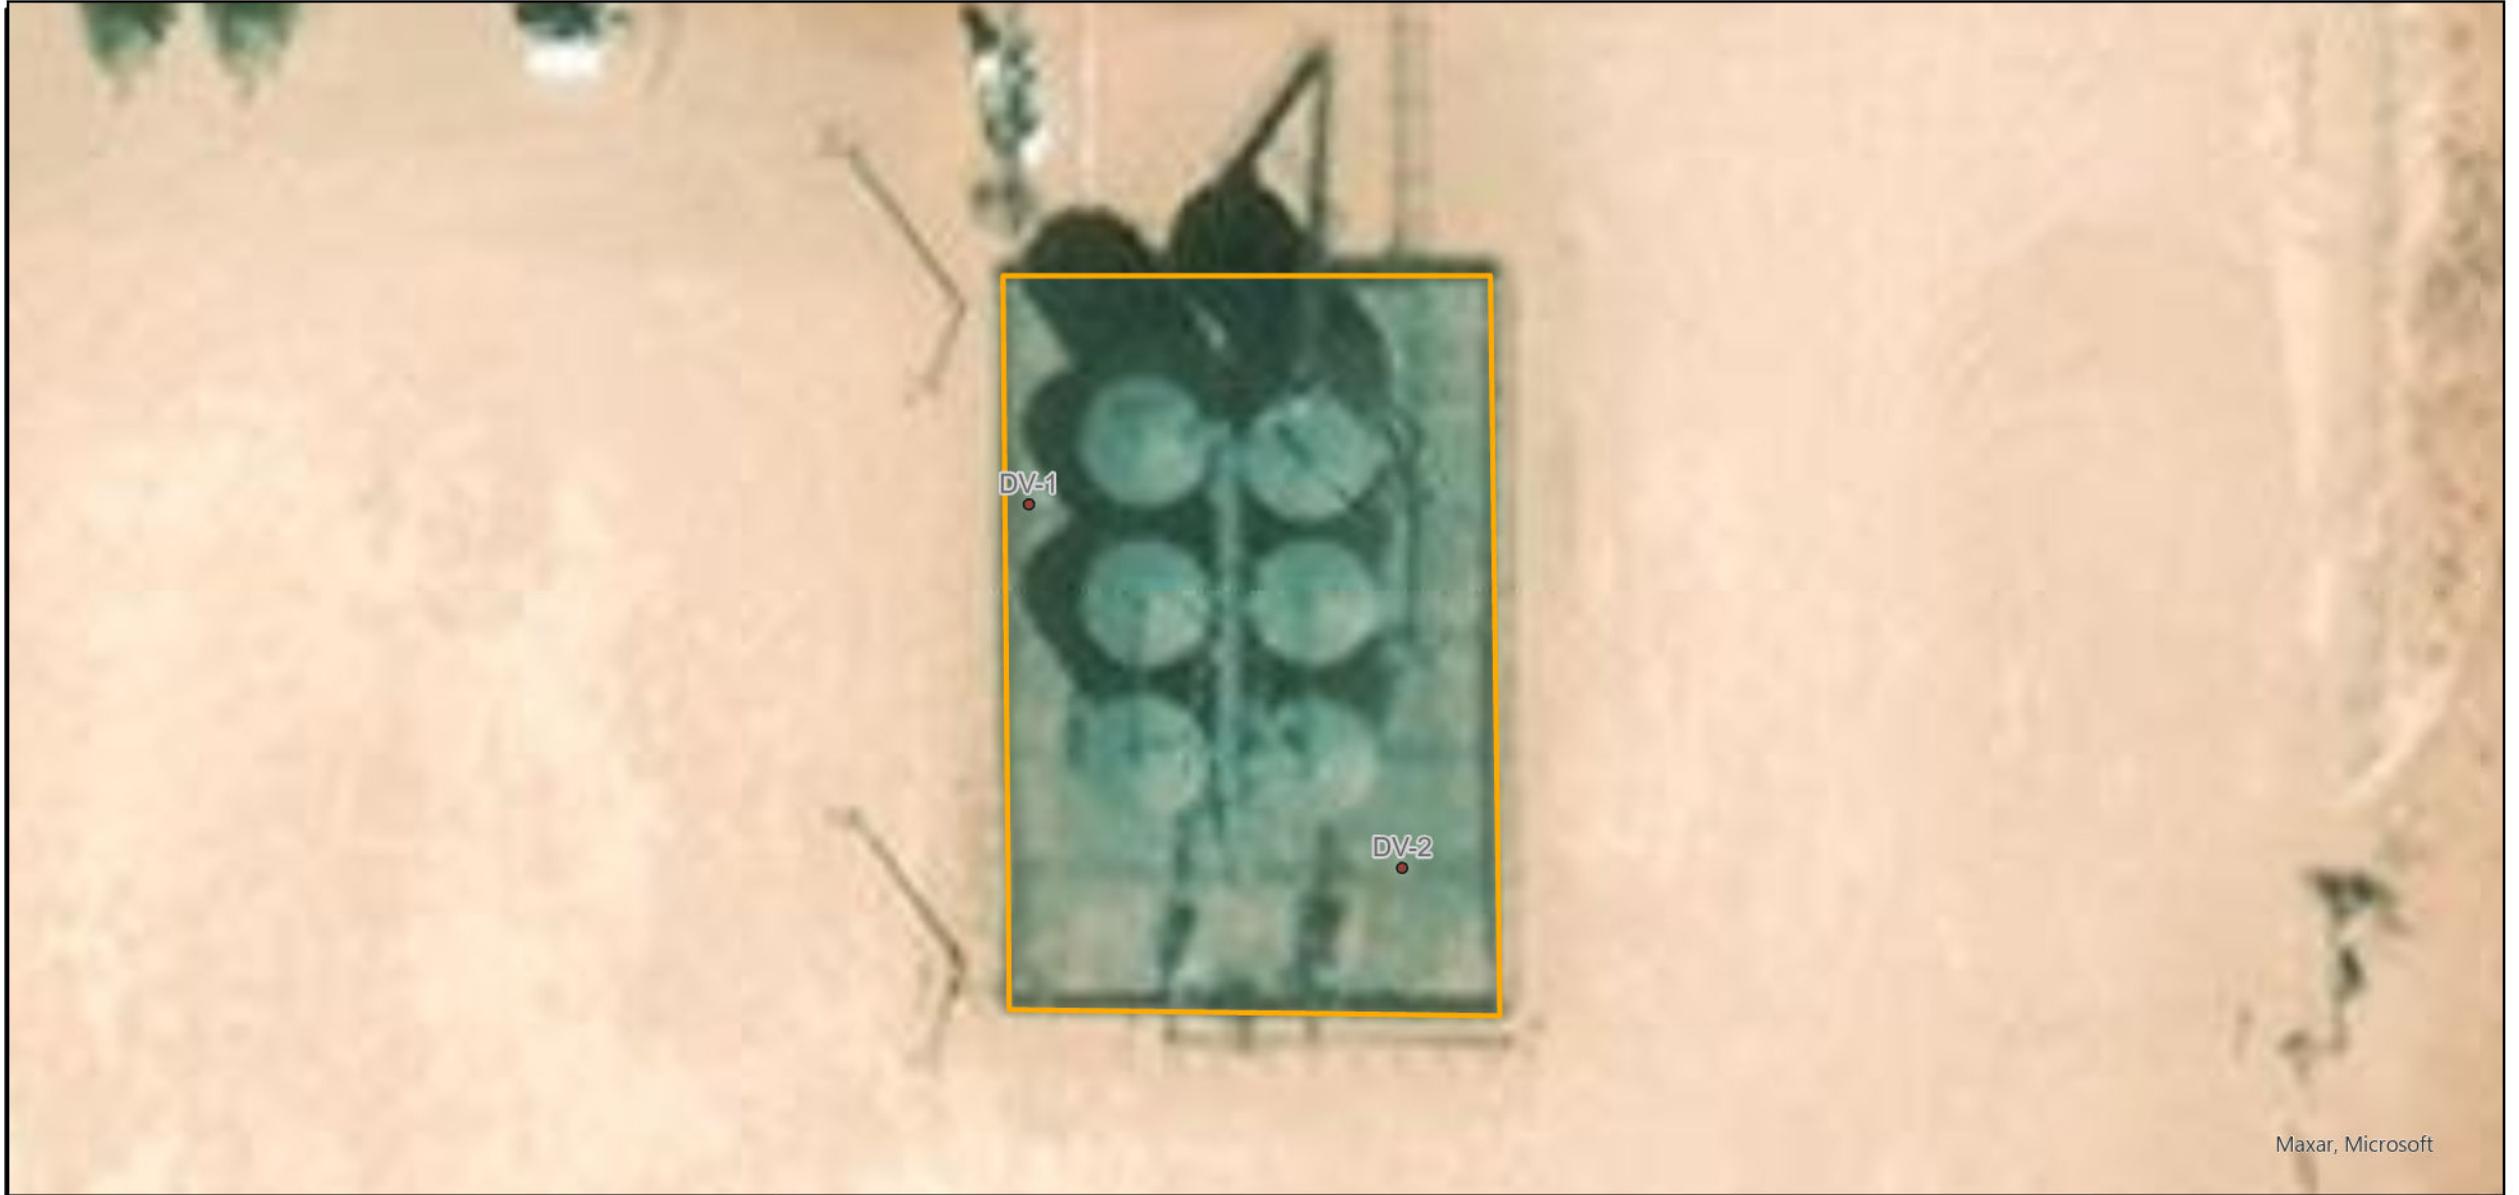
Vertical Delineation

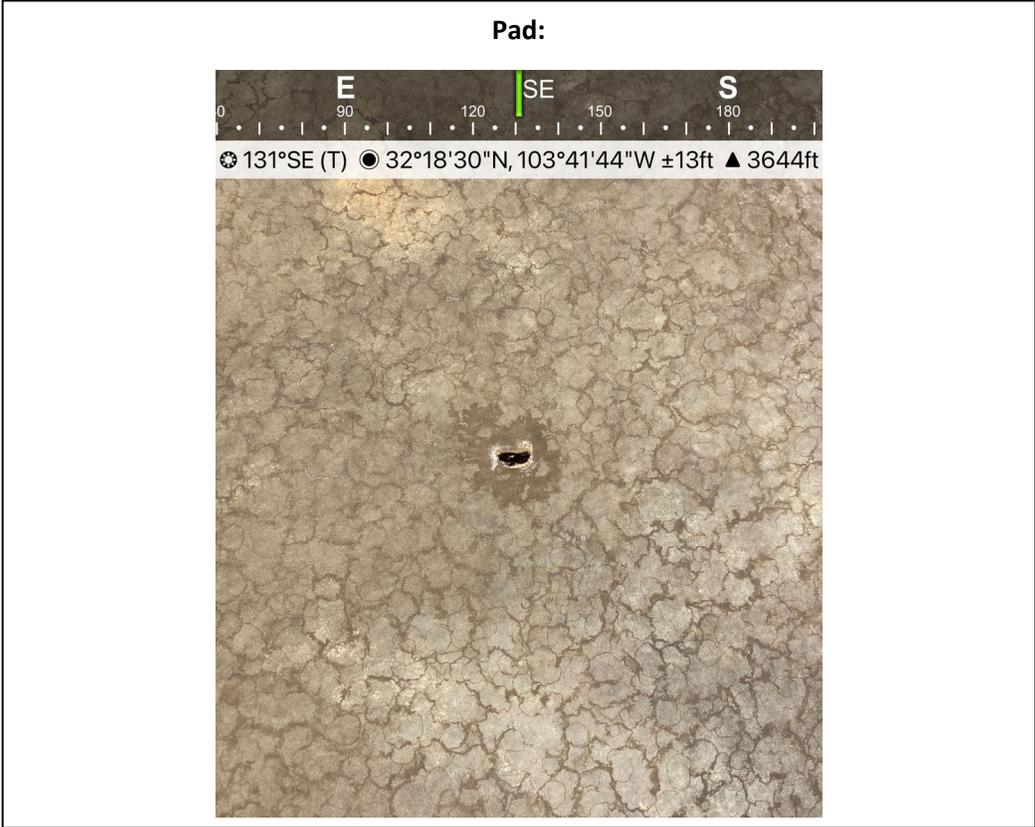
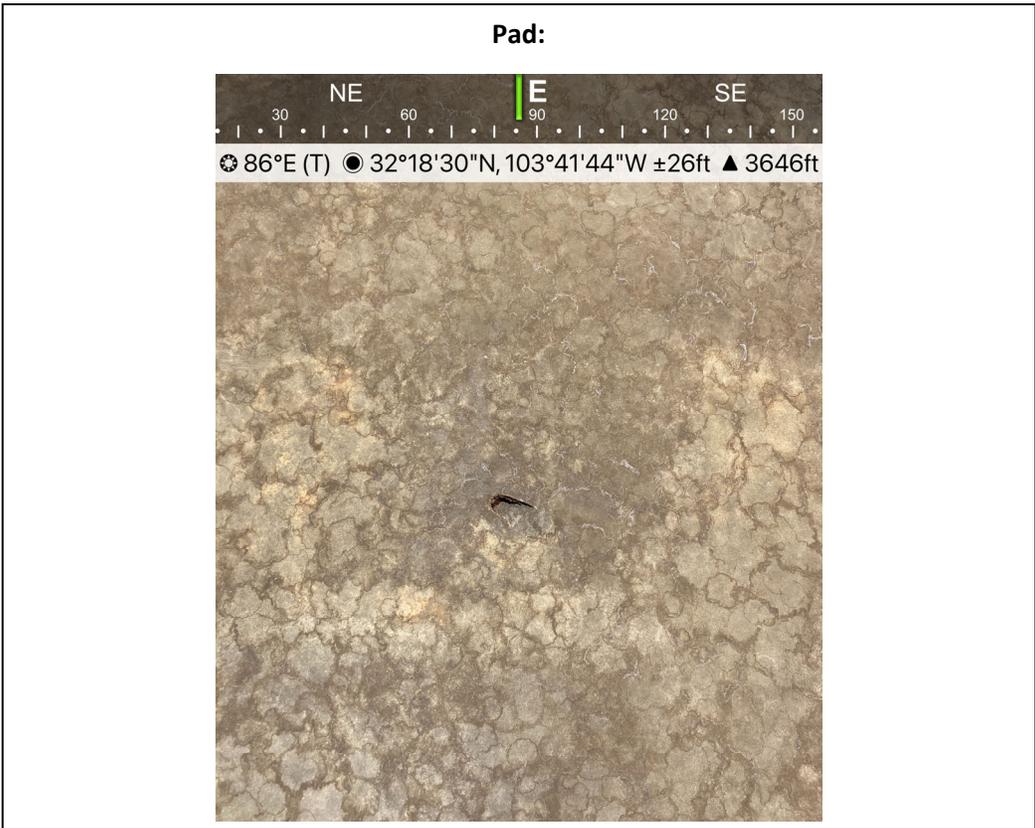
Liner Inspection

Upon initial inspection, the liner was found to be compromised with several holes. Prior to the liner repair, Trinity collected samples from beneath the liner where the holes were found (DV-1 & DV-2).

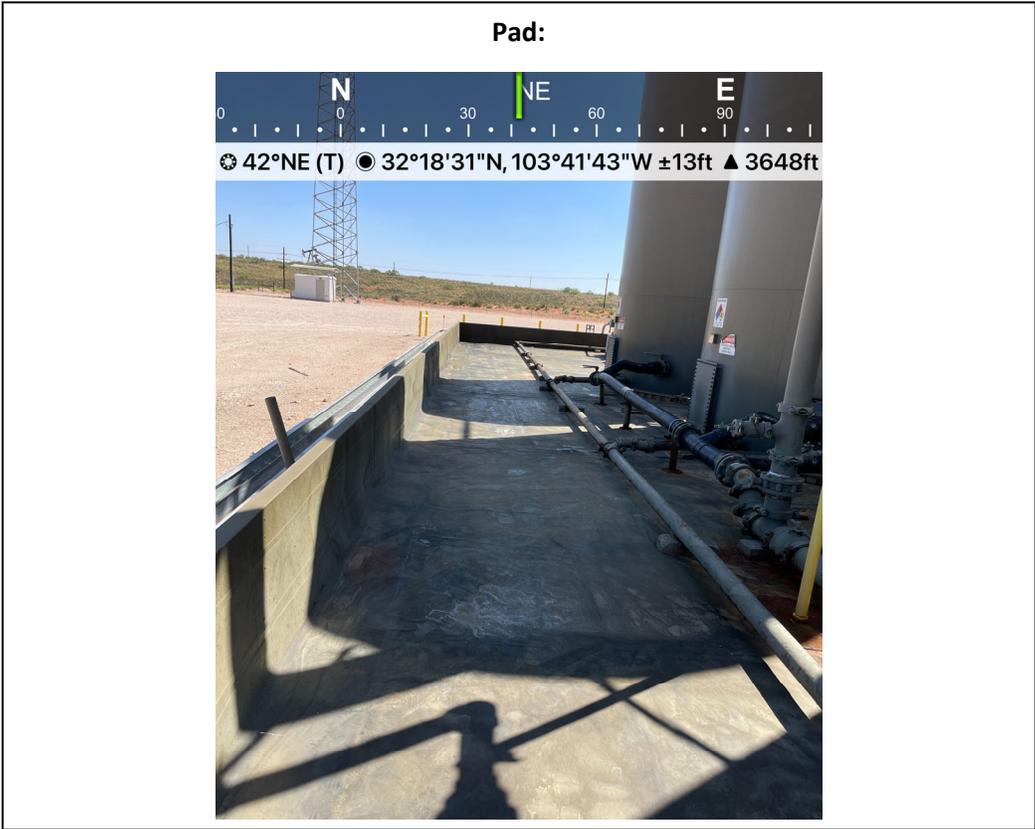
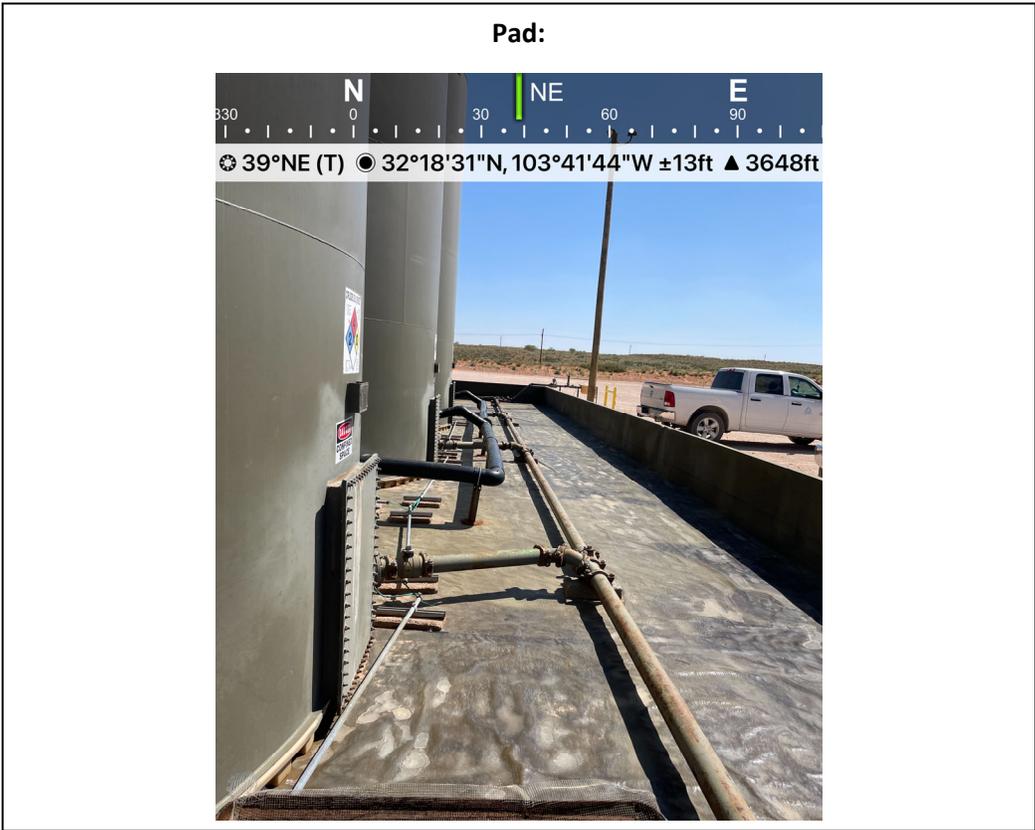
Cleaned Liner

This release was contained within a lined and contained facility, the liner was cleaned with a pressure washer. Upon inspection after repair, the liner is found to be in satisfactory condition.

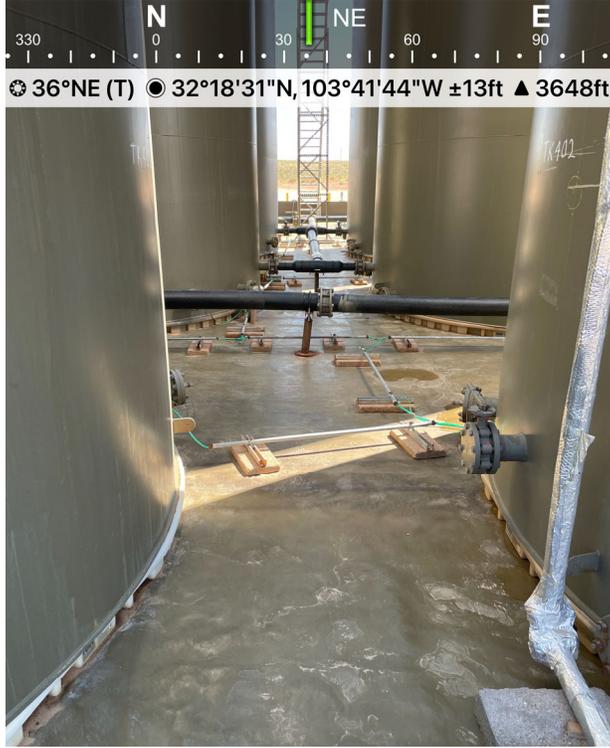
Pad:

Cleaned Liner
