# **LINER INSPECTION AND CLOSURE REPORT**

### **Spur Energy Partners**

Stonewall 9 Fee #1H

Incident ID: nAPP2311032273

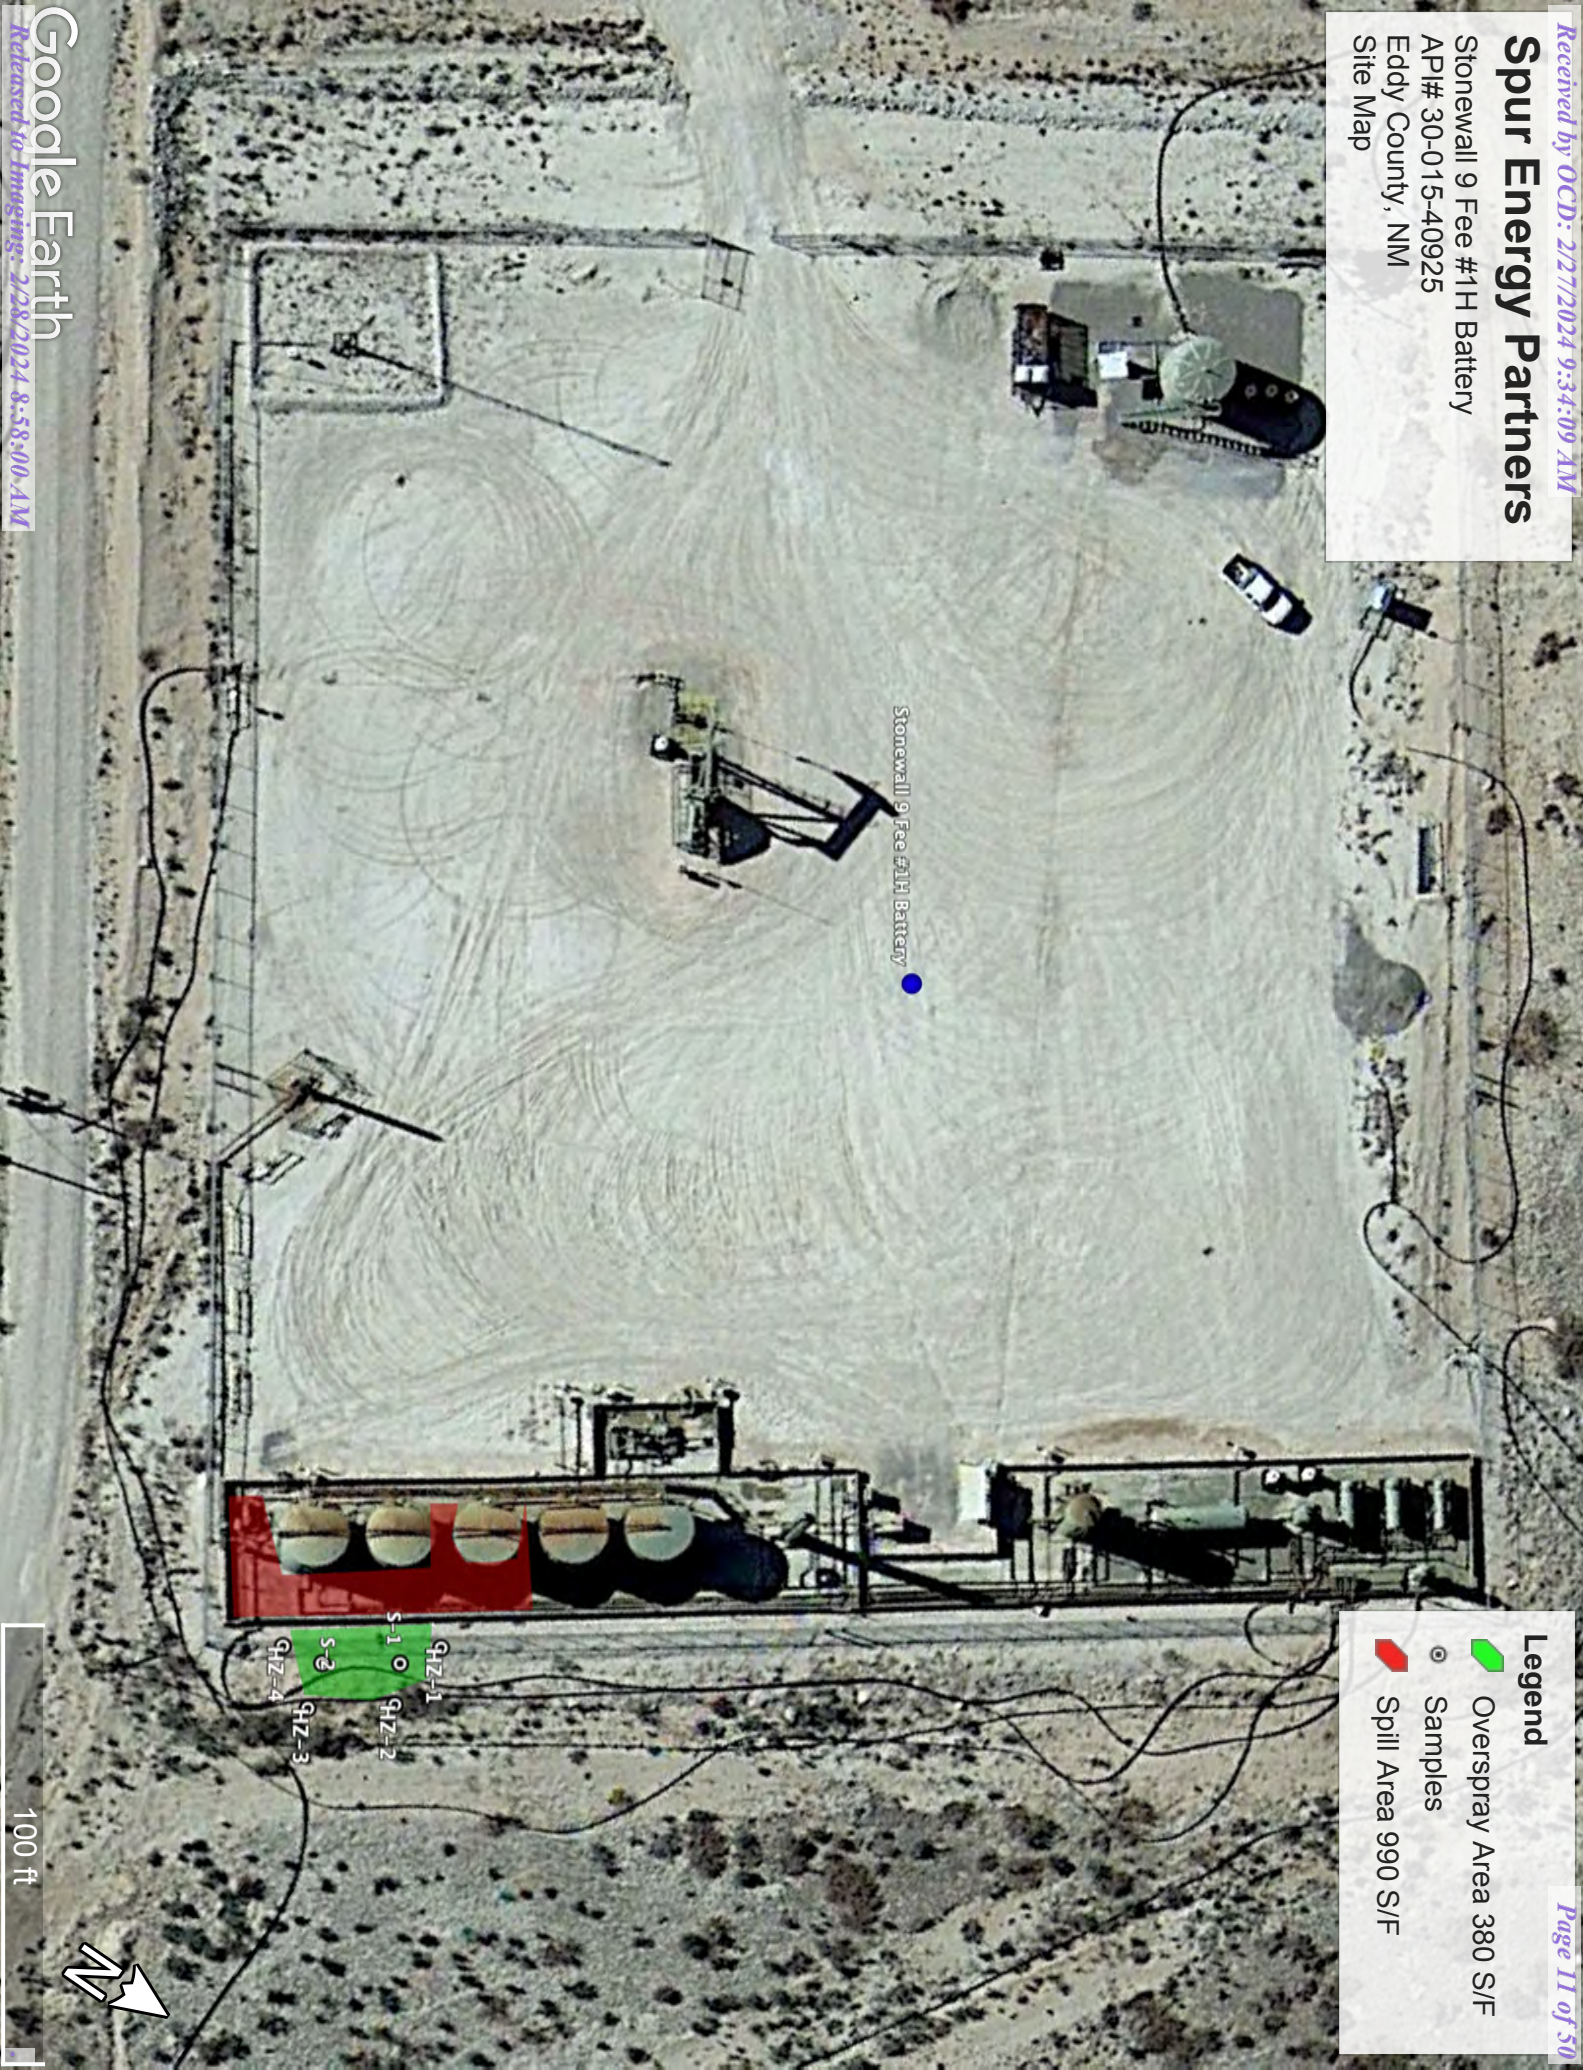
Stonewall 9 Fee #1H Battery  
API# 30-015-40925  
Eddy County, NM  
Site Map

On April 21st, 2023, Paragon went to the Stonewall and conducted an initial assessment. There was obvious staining on the liner from the spill. The surface area affected was approximately 990 s/f. There were no signs outside the containment that the liner had been breached. Therefore, no samples were taken.

On November 27, 2023, Paragon returned to the site to obtain samples from the overspray area coming at the request of the NMOCD. The area of the overspray was measured at approximately 380 s/f of surface area affected. The results of the samples are in the following data table, with the laboratory report attached in Appendix E.

Overspray Area 380 S/F
-

Spill Area 990 S/F

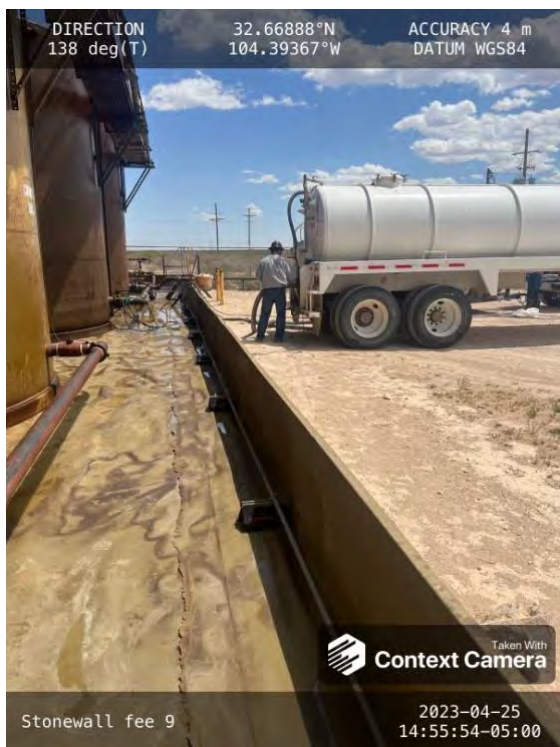
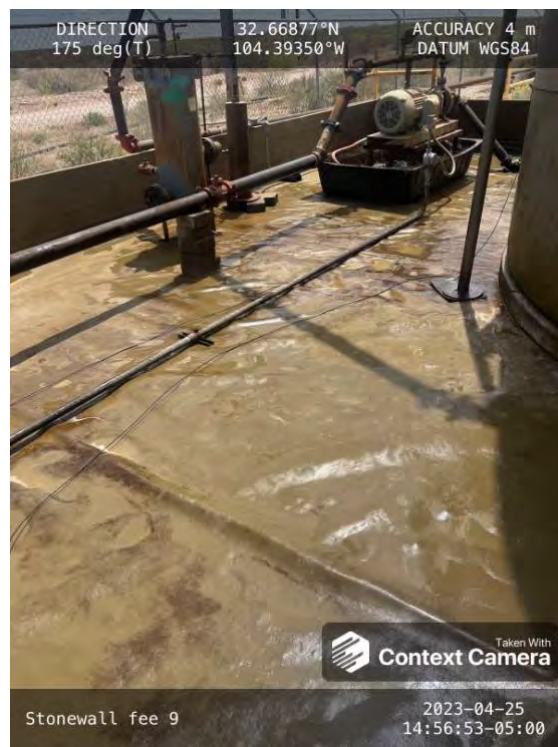
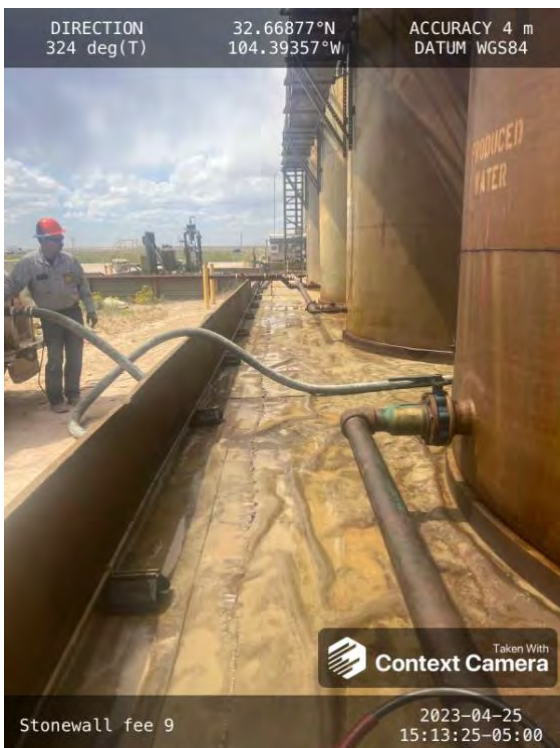
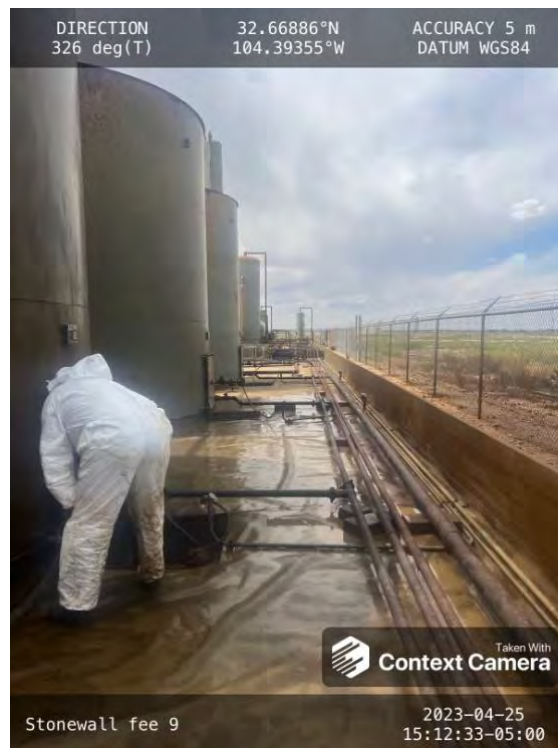
Post Remediation

On April 24, 2023, Paragon returned to the site with equipment and personnel to conduct cleanup activities. We initially sprayed the affected area with a degreaser. We then power washed and squeegeed the runoff to where the vacuum truck could capture the fluids.

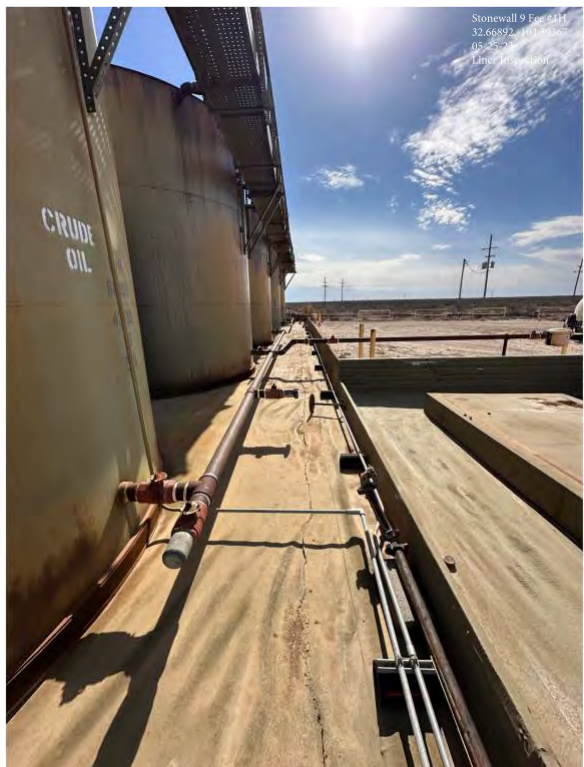
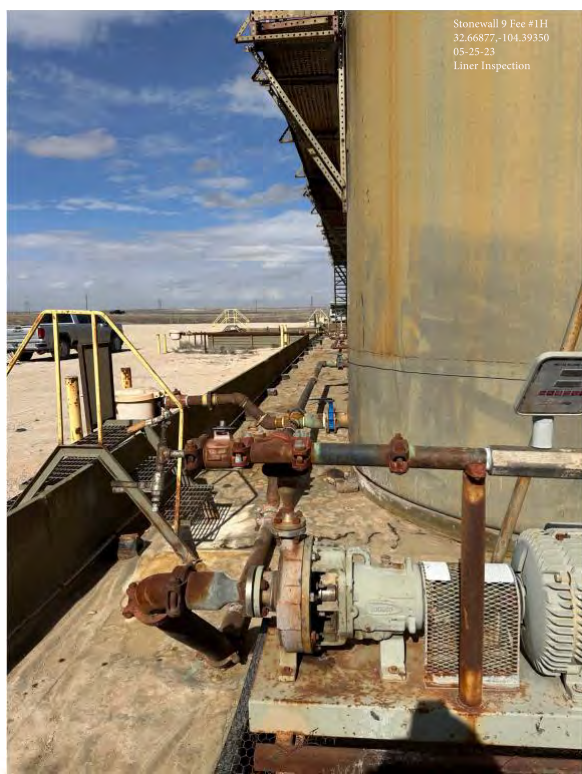
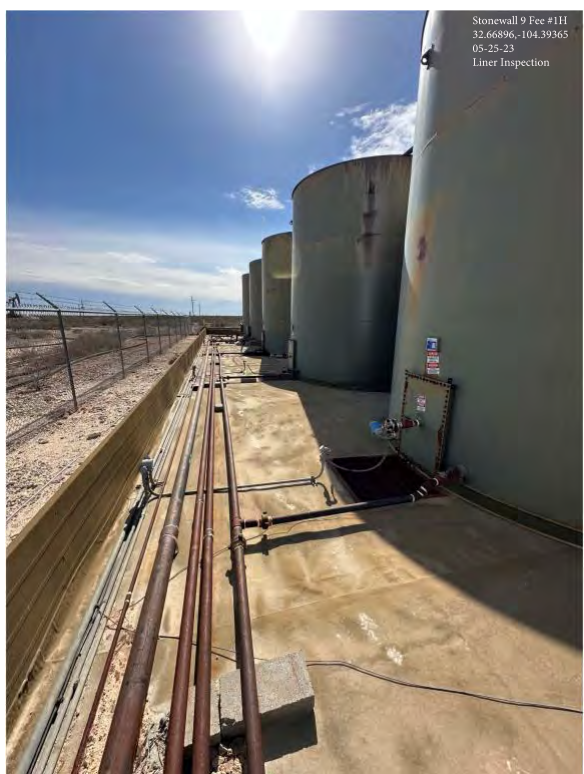
## Liner Inspection

On May 25, 2023, Paragon returned to the site to conduct a liner inspection. A 48-hour notification was sent out to the NMOCD on May 22, 2023. The inspection concluded that the liner was intact and in good condition. The integrity of the liner appears to have the ability to contain spills. See Appendix D for the email notification and liner report.

Visualization	Yes	No	Comments
Is there a tear in the liner?		x	
Are there holes in the liner?		x	
Is the liner retaining any fluids?		x	
Does the liner have integrity to contain a leak?	x

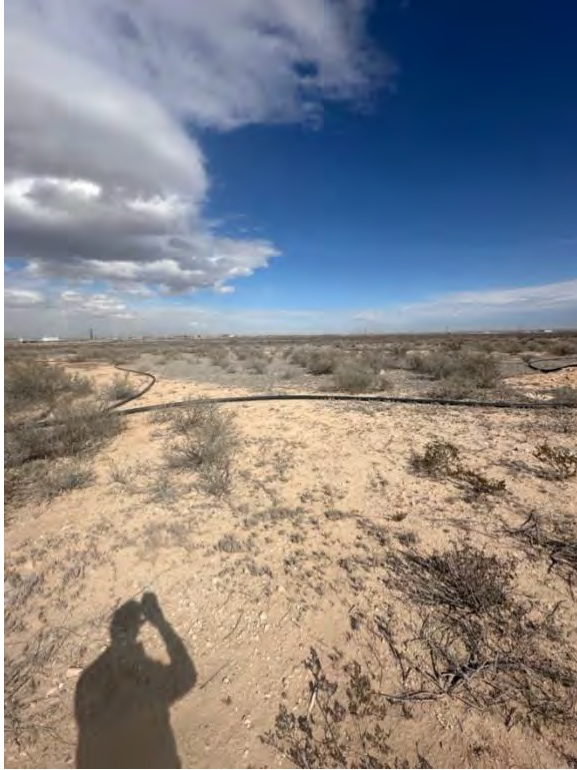
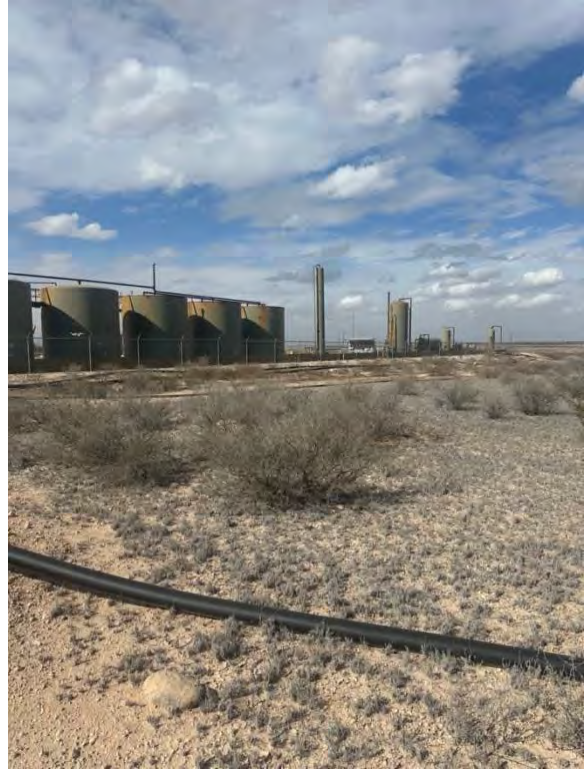
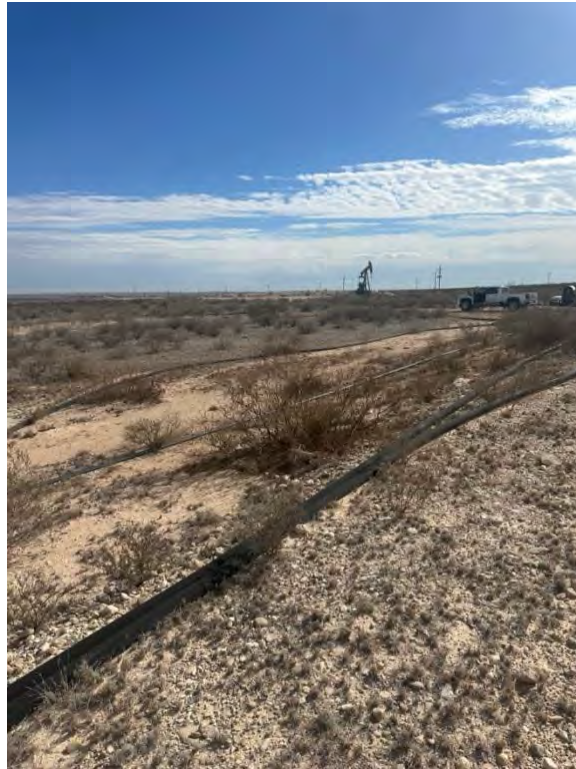
### Overspray Area

During the review of the closure report, it was determined that horizontal samples from the overspray area would be obtained to ensure all data was obtained for closure. On February 16, 2024, we returned to the site and obtained 4 horizontal samples from the overspray area. The results of these samples are in the following data table.
