**RE: Termination Request****Rice Operating Company – BD SWD System****BD L-36 EOL (1R426-278): UL/L, Sec. 36, T21S, R37E**

**ROC - BD L-36 EOL (1R426-278)****Unit Letter L, Section 36, T21S, R37E**

# BD L-36 EOL

Unit L, Section 36, T21S, R37E

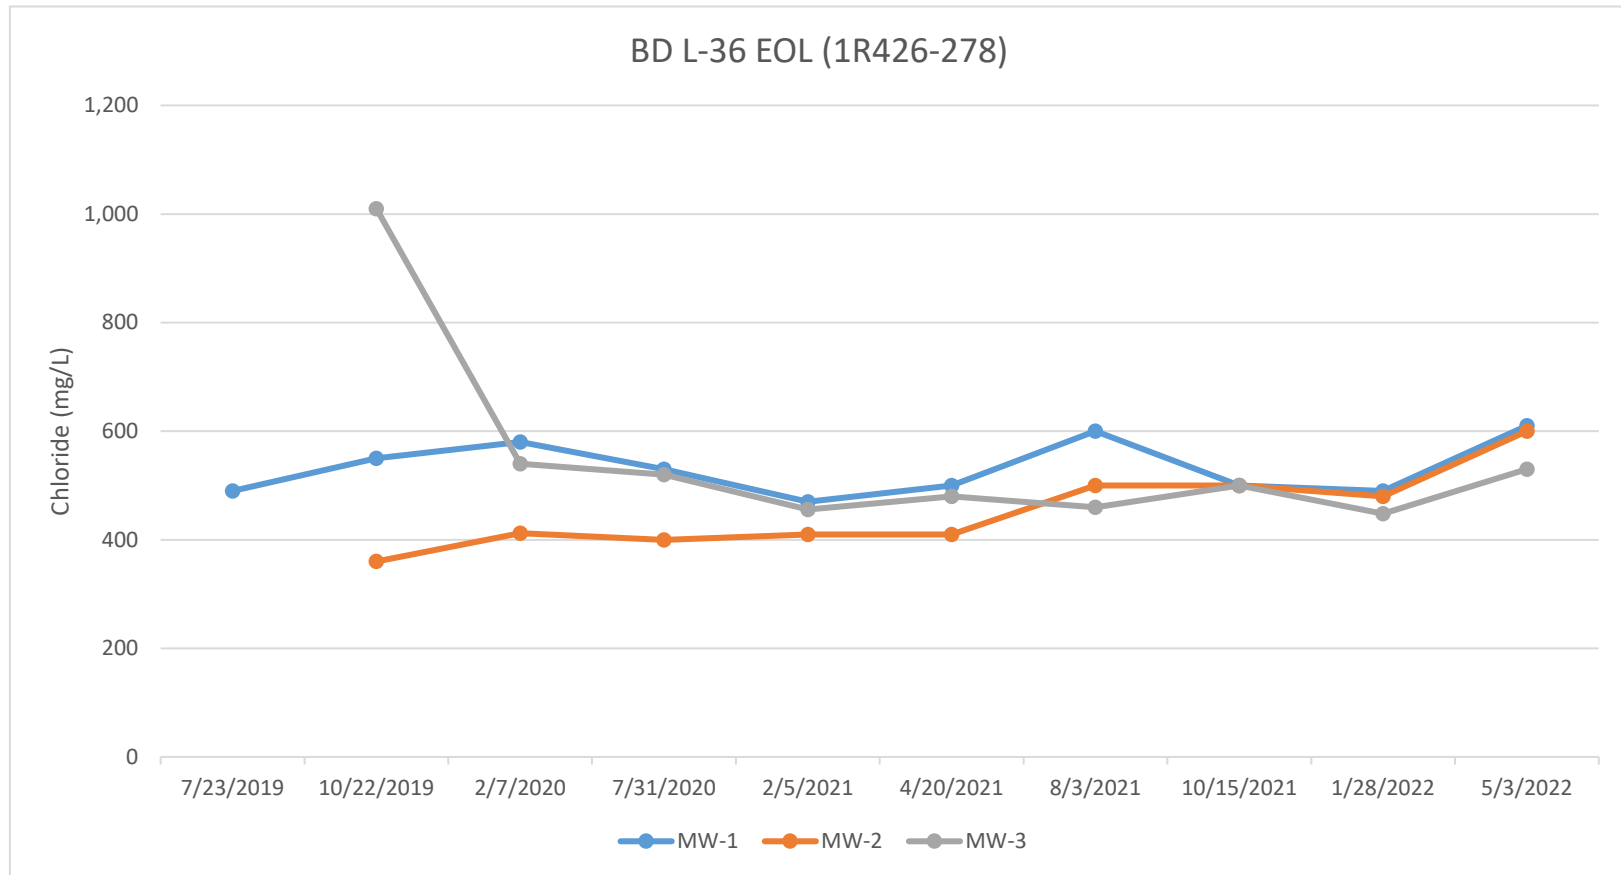
The quarterly groundwater monitoring results indicate there is a non-ROC source contributing to the degradation of groundwater up-gradient of the site. The most recent sampling event resulted in a chloride concentration of 600 mg/L in the up-gradient well (MW-2), while the near-source well (MW-1) returned a chloride concentration of 610 mg/L. The down-gradient well (MW-3) returned a chloride concentration of 530 mg/L in the same sampling event. This suggests that the impact of the former junction box was minimal as compared to that of the up-gradient source. A table summarizing the quarterly monitoring well data is included in the attachments. Also included in the attachments are historical aerial photos, which show other oil field activity in the area.

MW	Depth to Water	Total Depth	Well Volume	Volume Purged	Sample Date	Cl	TDS	Benzene	Toluene	Ethyl Benzene	Total Xylenes	Sulfate	Comments
3	43.94	63.93	3.2	10	12/16/2019	1,010	2,940	<0.001	<0.001	<0.001	<0.003	557	Clear No odor
3	43.9	63.93	3.2	10	2/7/2020	540	2,100	<0.001	<0.001	<0.001	<0.003	552	Clear No odor
3	43.88	63.93	3.2	10	7/31/2020	520	2,000	<0.001	<0.001	<0.001	<0.003	324	Clear No odor
3	43.84	63.93	3.2	12	2/5/2021	456	1,880	<0.001	<0.001	<0.001	<0.003	522	Clear No odor
3	43.78	63.93	3.2	12	4/20/2021	480	1,830	<0.001	<0.001	<0.001	<0.003	464	Clear No odor
3	43.77	63.93	3.2	12	8/3/2021	460	1,920	<0.001	<0.001	<0.001	<0.003	639	Clear No odor
3	43.72	63.93	3.2	12	10/15/2021	500	1,960	<0.001	<0.001	<0.001	<0.003	406	Clear No odor
3					1/28/2022	448	1,910	<0.001	<0.001	<0.001	<0.003	640	
3					5/3/2022	530	1,960	<0.001	<0.001	<0.001	<0.003	532

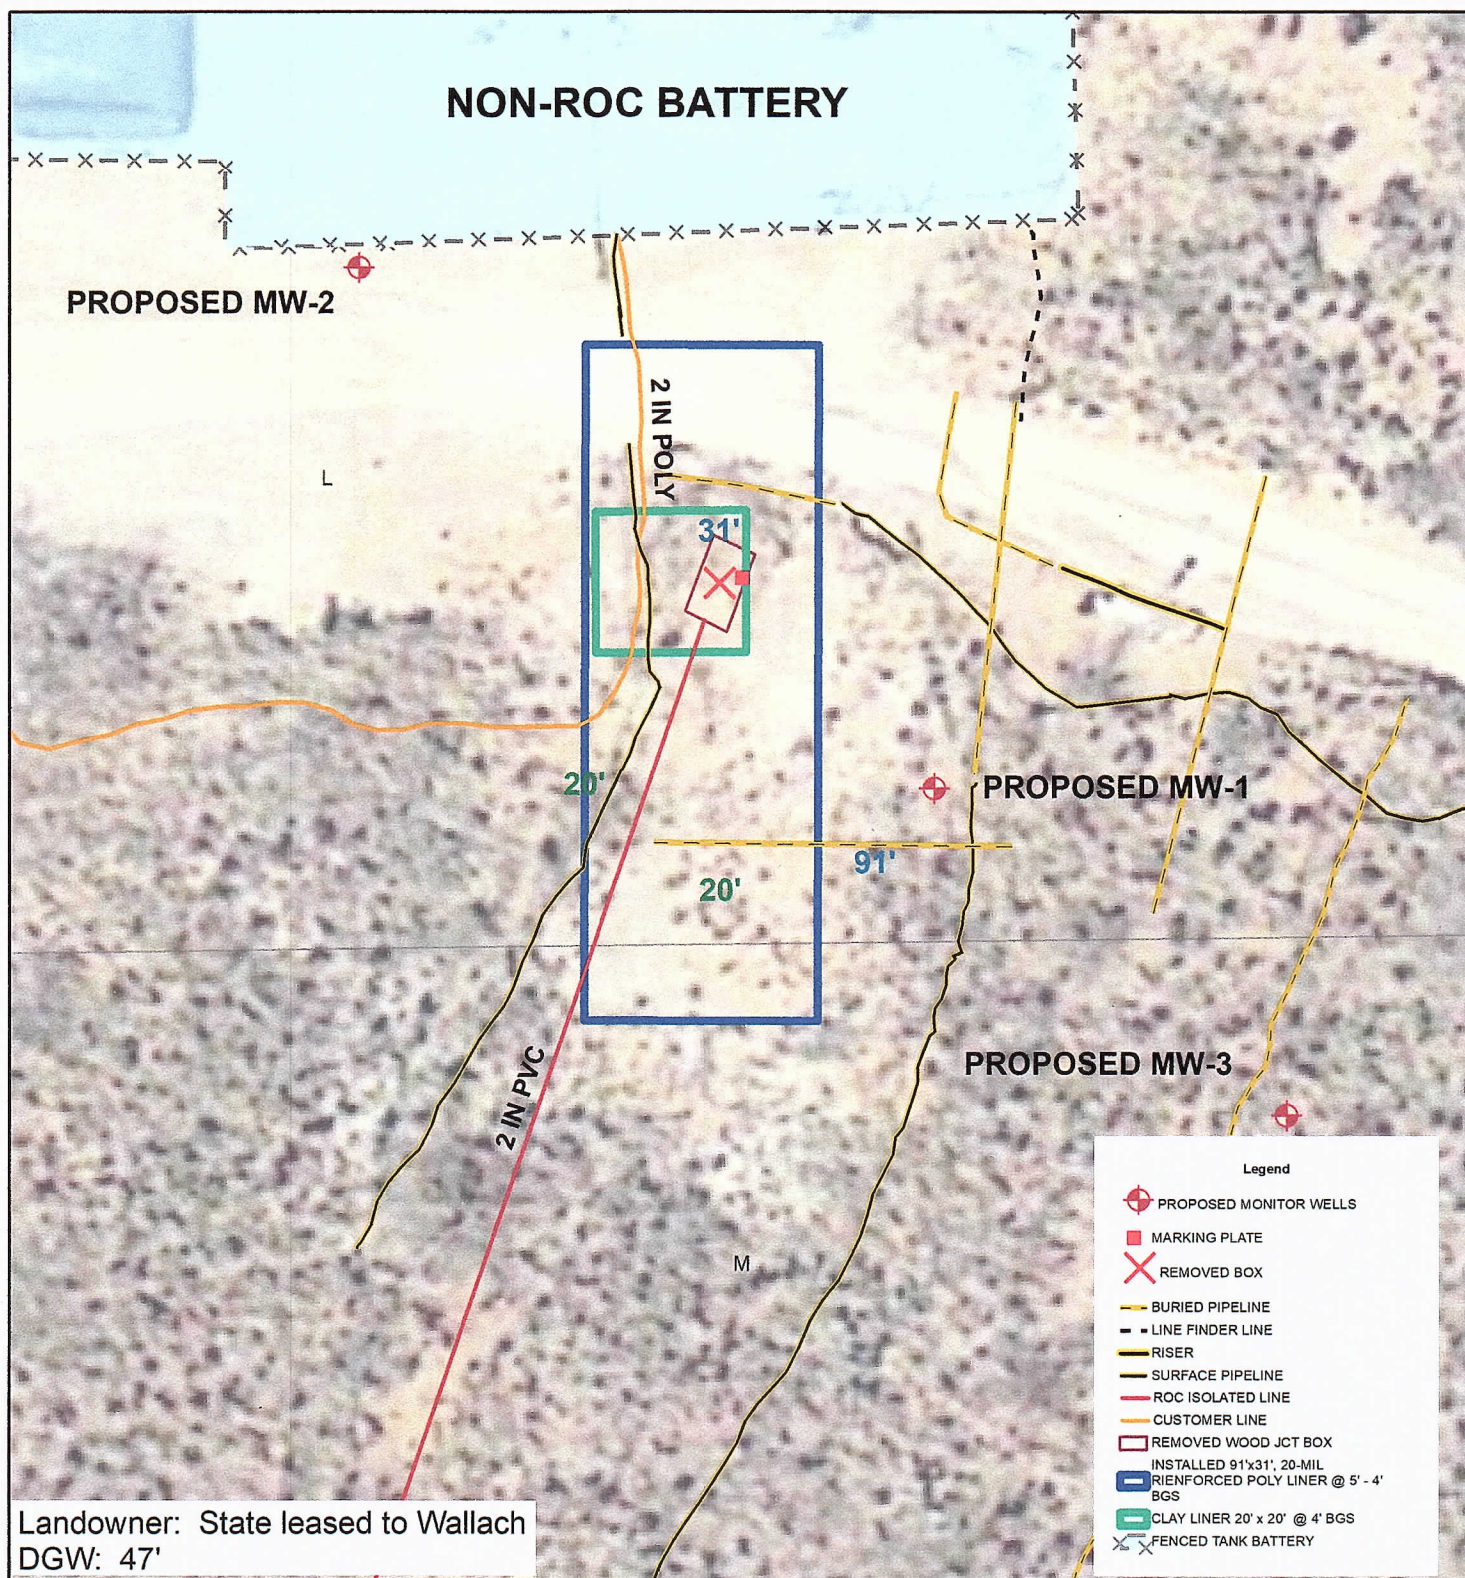
# Proposed Monitor Wells

In order to determine what affect the residual chlorides may have had on the groundwater quality below the site, BEST recommends that ROC install a near-source monitor well (MW-1) located approximately 45 feet down-gradient of the former junction box. To determine if there is an up-gradient source of contaminants coming onto the site, MW-2 will be installed approximately 75 feet up-gradient of the former junction box. Also, an additional monitoring well (MW-3) will be installed approximately 100 feet down-gradient of the former junction box (see Proposed Monitoring Wells). Additional monitoring wells may be required to fully delineate groundwater quality. The monitor wells will be installed to NMOCD and EPA standards and then sampled quarterly. Once groundwater quality has been determined, ROC will either submit a groundwater remedy to NMOCD to address groundwater quality at the site or submit a termination request for site closure.

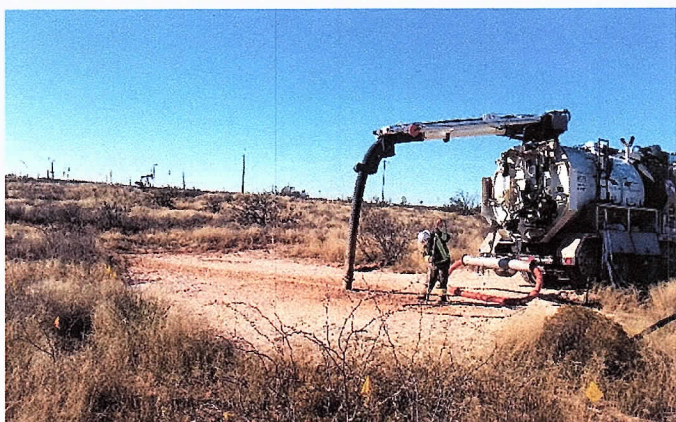
12/13/2017

Spotting lines with hydrovac,  
facing southwest

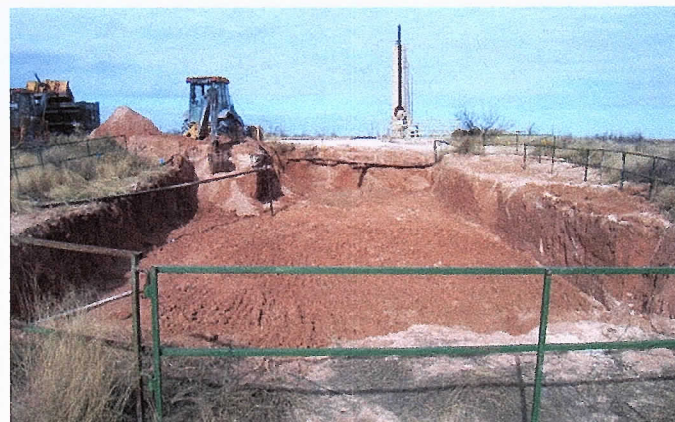
12/18/2017

Excavating the site to 5 ft bgs,  
facing north

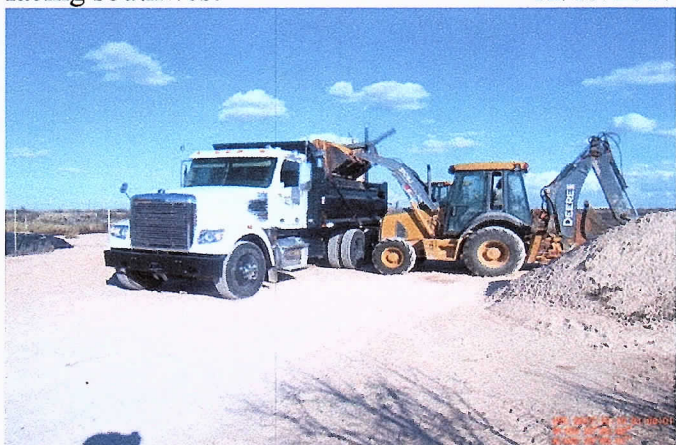
12/19/2017

Exporting excavated soil,  
facing northeast

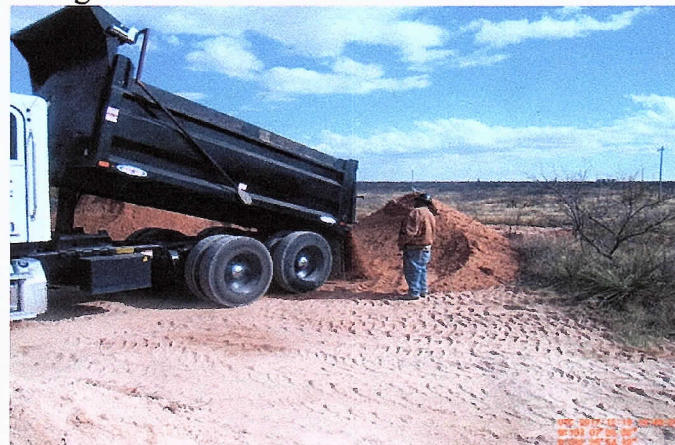
12/19/2017

Importing blow sand,  
facing south

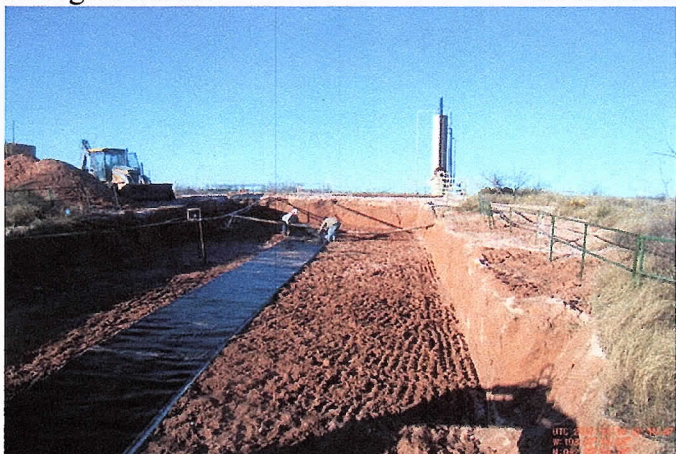
12/19/2017

Installing 20-mil, reinforced liner at 4.5 ft bgs,  
facing north

Based on the additional soil data, Basin recommended that ROC install a 91 ft x 31 ft (rather than a 42 ft x 31 ft), 20-mil reinforced poly liner at 5 – 3.5 ft bgs, depending on the actual depth of the existing clay liner. The liner will inhibit the downward migration of residual constituents through the vadose zone, and will cover the existing 20x20-ft clay liner. The soils placed above the liner will have a laboratory chloride reading no greater than 500 mg/kg and a field PID measurement below 100 ppm. Excavated soils was evaluated for use as backfill and any soils that do not meet requirements was properly disposed of at a NMOCD approved facility. The excavation was backfilled to ground surface and contoured to the surrounding location.

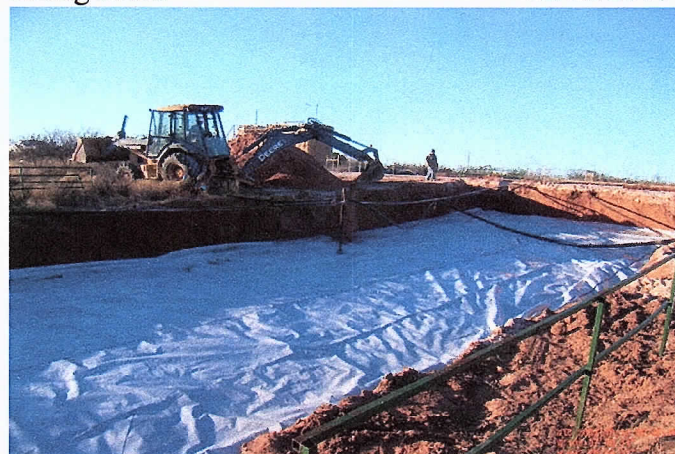
12/19/2017

Padding the 20-mil, reinforced liner with imported  
soil, facing northeast

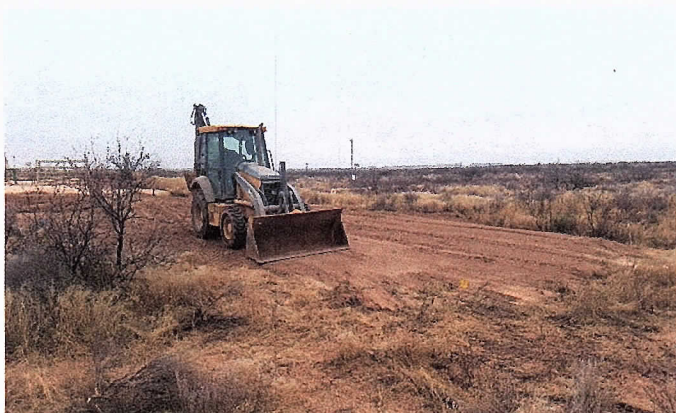
Backfilling and contouring the site with imported soil, facing west  
12/27/2017

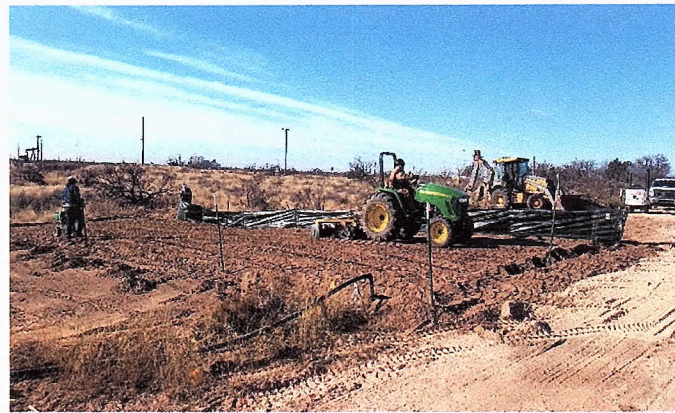
Tilling and seeding backfilled site, facing southwest  
12/28/2017

Custom Seed Mix	X	Prescribed Mix	<input type="checkbox"/>	Seed Mix Name: 5 lbs Lea County Mix & 50 lbs Winter Wheat Seed Mix	Date: 12/28/2017
Method: broadcast with seeder					
Soil conditions during seed:		Dry	X	Damp	<input type="checkbox"/>
Wet		<input type="checkbox"/>	<input type="checkbox"/>		
Observations: Seed was tilled into the soil

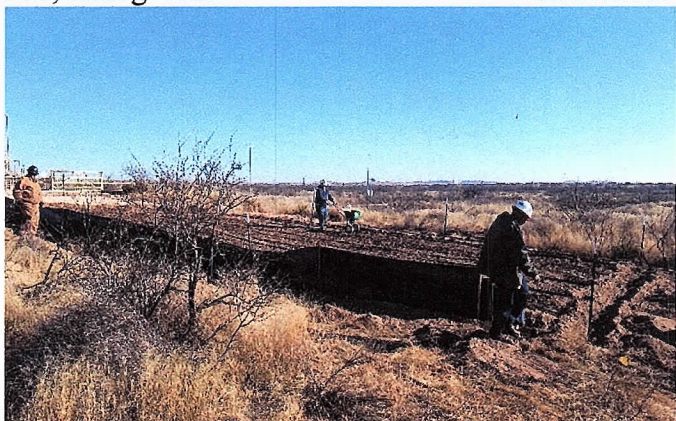
Seeding site, completing silt net fencing, facing northeast  
12/28/2017

The soils over and surrounding the site was prepared with soil amendments as necessary and seeded with a native vegetative mix. Vegetation above the liner will also provide a natural infiltration barrier for the site since plants capture water through their roots thereby reducing the volume of water moving through the vadose zone.

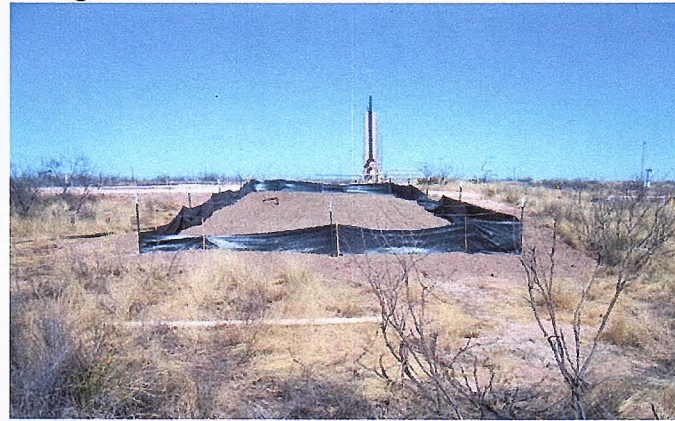
Site complete, facing north
