**RE: Closure Report  
ConocoPhillips  
James A Com #001 Release  
Unit Letter O, Section 2, Township 22 South, Range 30 East  
Eddy County, New Mexico  
Incident ID# NAB1722132401**

Tetra Tech, Inc. (Tetra Tech) was contacted by ConocoPhillips Company (ConocoPhillips) to assess a historic release that occurred on the James A Com #001 well lease pad (API No. 30-015-10806). The release footprint is located in Public Land Survey System (PLSS) Unit Letter O, Section 2, Township 22 South, and Range 30 East, in Eddy County, New Mexico (Site). The approximate release point occurred at coordinates 32.415738°, -103.849866°, as shown on Figures 1 and 2.

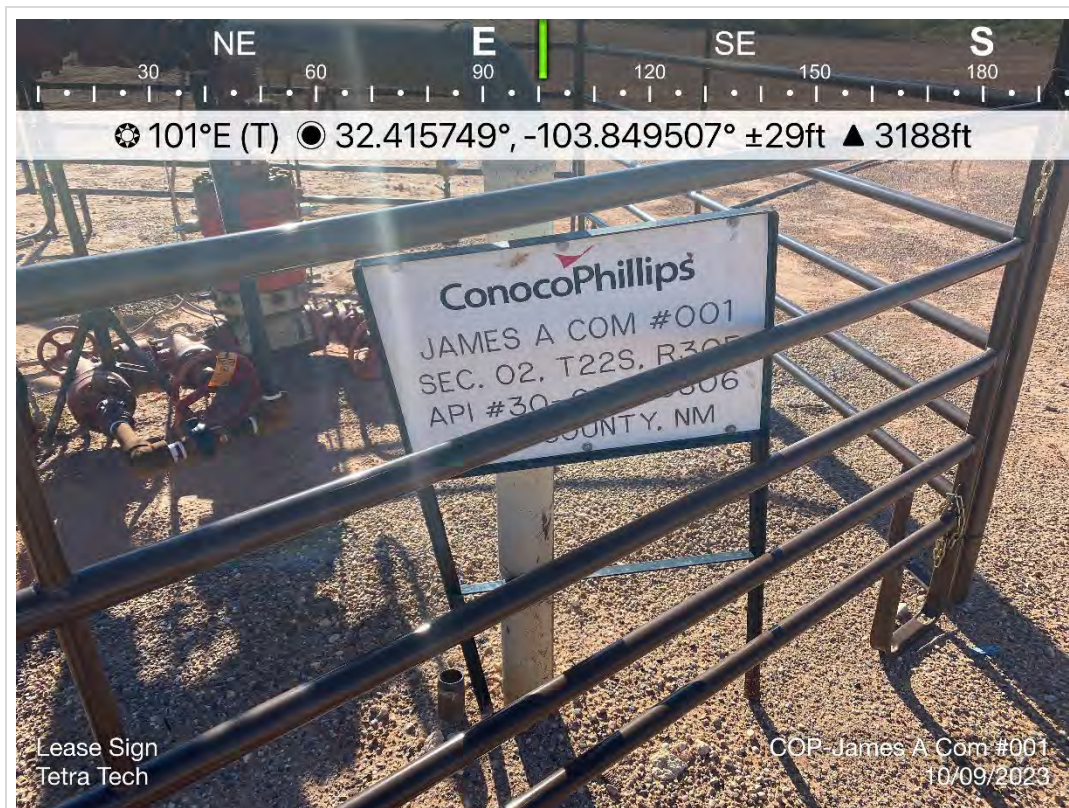
TETRA TECH, INC. PROJECT NO. 212C-MD-03239	DESCRIPTION	View of sight signage. James A Com #001.	1
	SITE NAME	JAMES A COM #001 TANK RELEASE	10/9/2023

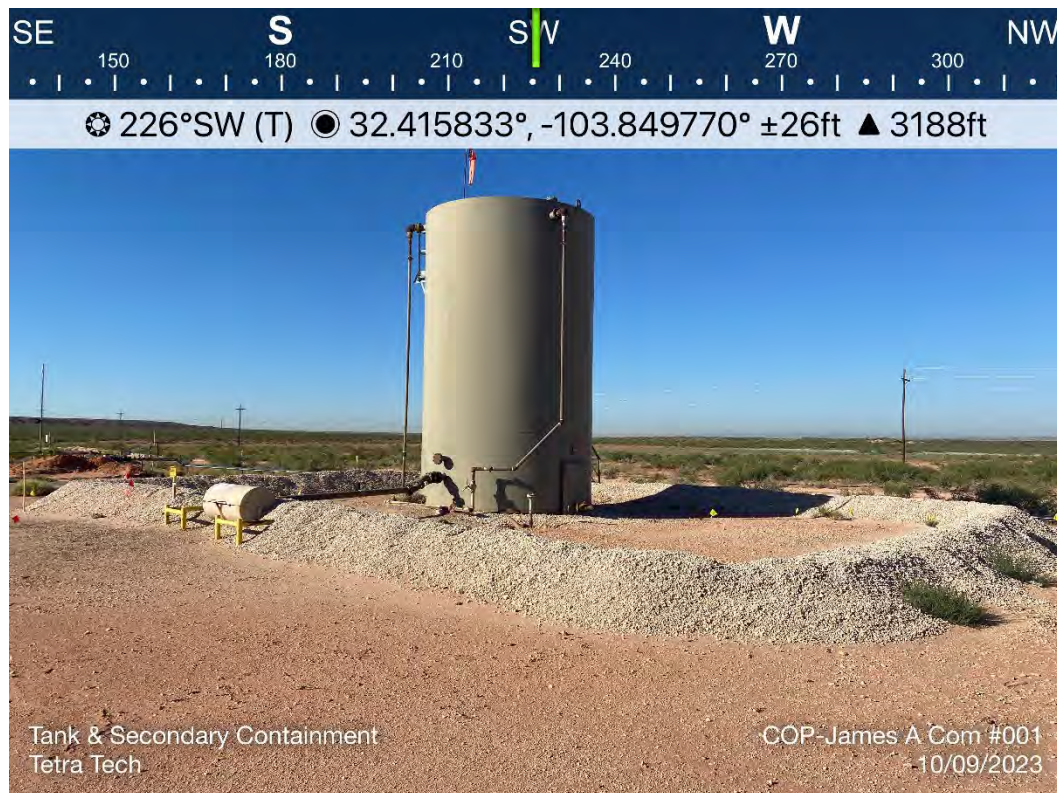
TETRA TECH, INC. PROJECT NO. 212C-MD-03239	DESCRIPTION	View southwest of tank and secondary containment berm.	2
	SITE NAME	JAMES A COM #001 TANK RELEASE	10/9/2023

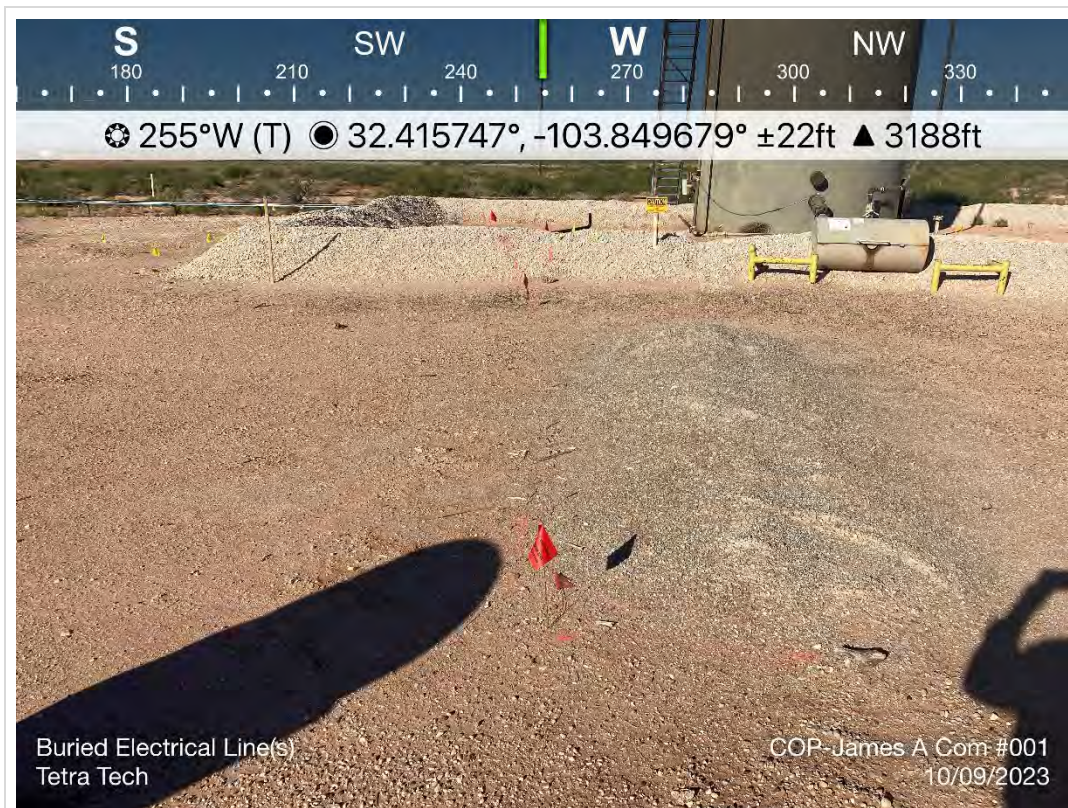
TETRA TECH, INC. PROJECT NO. 212C-MD-03239	DESCRIPTION	View west-southwest of tank and secondary containment berm. Subsurface electrical lines and pipeline.	3
	SITE NAME	JAMES A COM #001 TANK RELEASE	10/9/2023

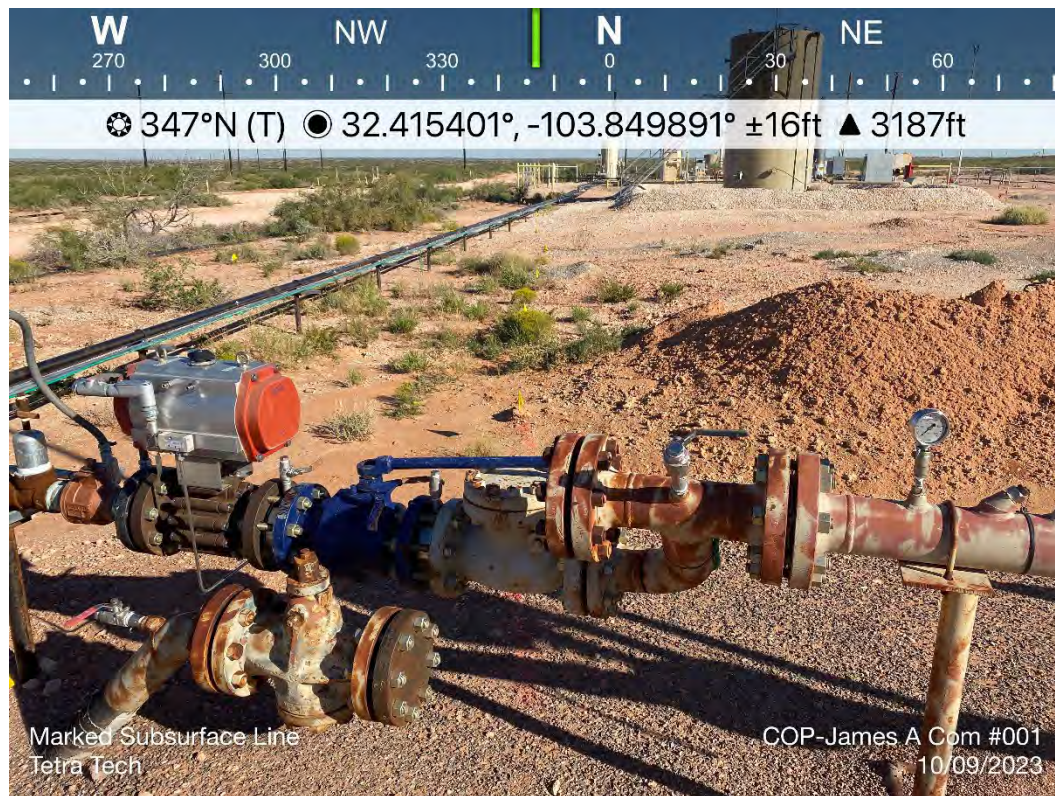
TETRA TECH, INC. PROJECT NO. 212C-MD-03239	DESCRIPTION	View north of marked subsurface line and surface steel lines.	4
	SITE NAME	JAMES A COM #001 TANK RELEASE	10/9/2023

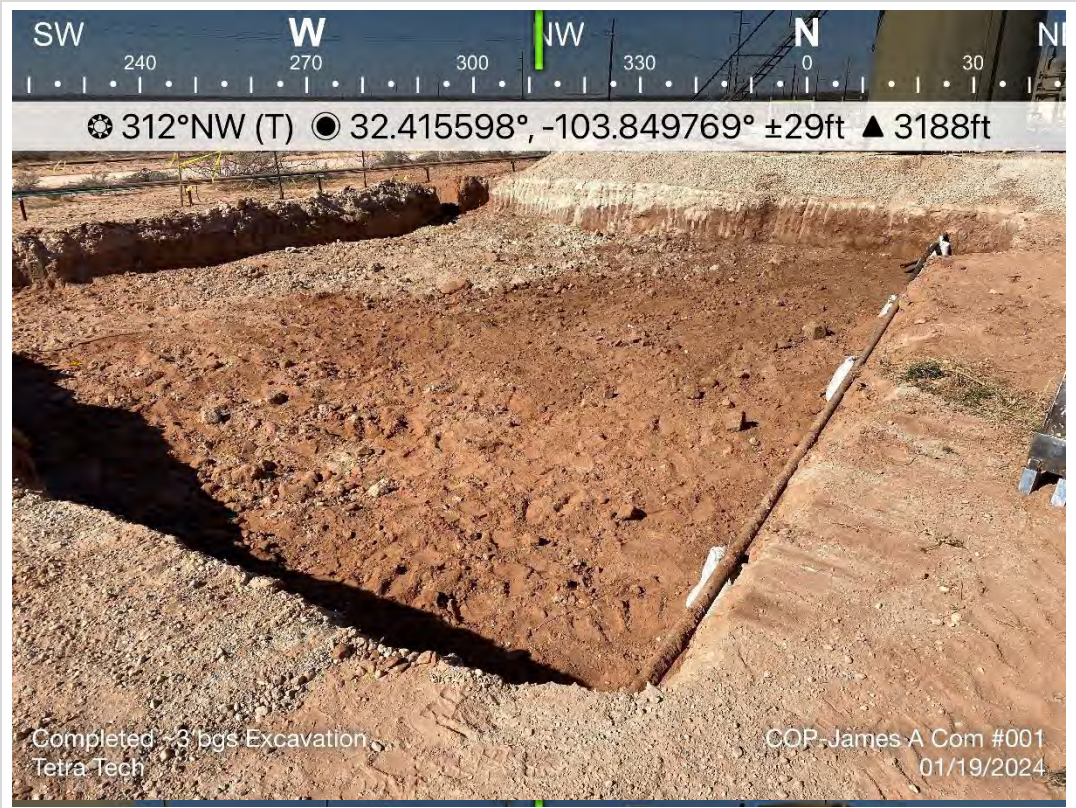
TETRA TECH, INC. PROJECT NO. 212C-MD-03239	DESCRIPTION	View northwest of excavated area of approximately 3 ft bgs near exposed subsurface line.	5
	SITE NAME	JAMES A COM #001 TANK RELEASE	1/19/2024

Per the conditions of the NMOCD approval of the Work Plan, confirmation samples were collected such that each discrete sample (sidewall and floor) were representative of no more than 400 square feet of excavated area. A total of four (4) floor sample locations and six (6) sidewall sample locations were used during the remedial activities. Due to multiple non-aggressive excavation / buffer zones in the release area buffer zone samples were collected. Confirmation sidewall sample locations were labeled with "SW"-#, confirmation floor sample locations were labeled with "FS"-#, and confirmation buffer zone sample locations were labeled "BZ-#". Analytical results for all confirmation soil samples (floor, sidewall, and buffer zone) were below the respective RRALs for chloride, BTEX, and TPH. The results of the January 2024 confirmation sampling events are summarized in Table 2. Laboratory analytical data is included in Appendix E. Excavated areas, depths and confirmation sample locations are shown in Figure 4.

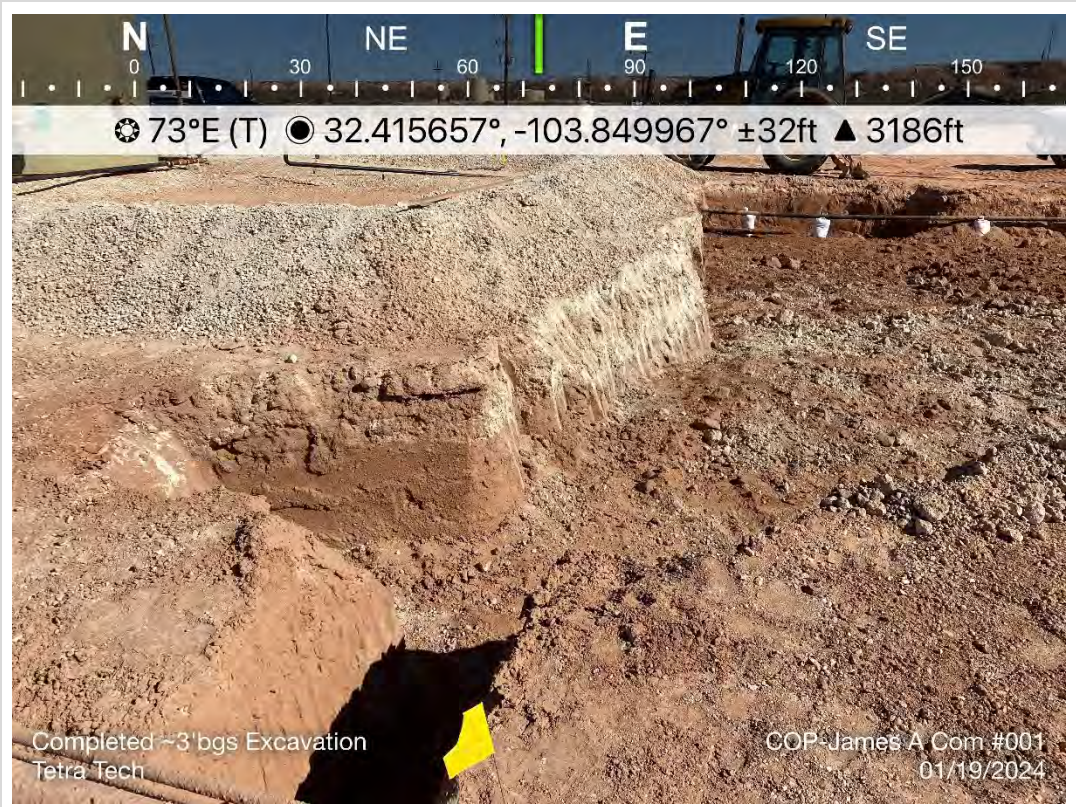
TETRA TECH, INC. PROJECT NO. 212C-MD-03239	DESCRIPTION	View east-northeast of excavated area of approximately 3 ft bgs near exposed subsurface line.	6
	SITE NAME	JAMES A COM #001 TANK RELEASE	1/19/2024

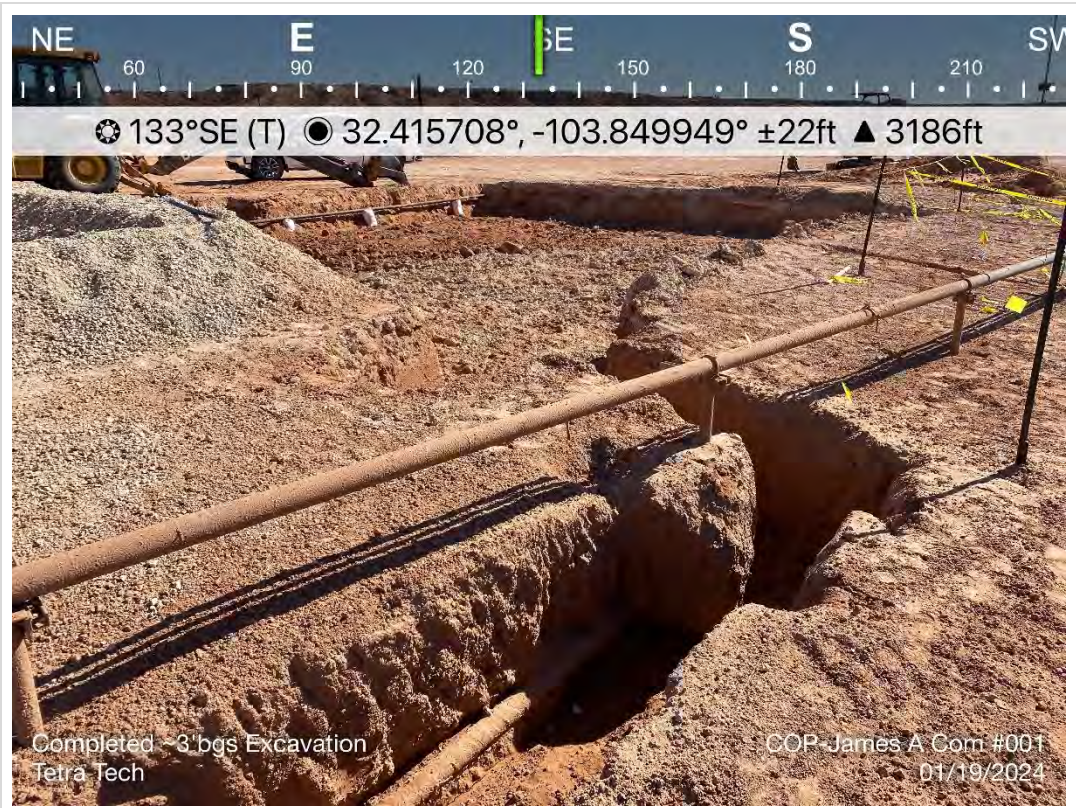
TETRA TECH, INC. PROJECT NO. 212C-MD-03239	DESCRIPTION	View southeast of excavated area of approximately 3 ft bgs near exposed surface and subsurface lines.	7
	SITE NAME	JAMES A COM #001 TANK RELEASE	1/19/2024

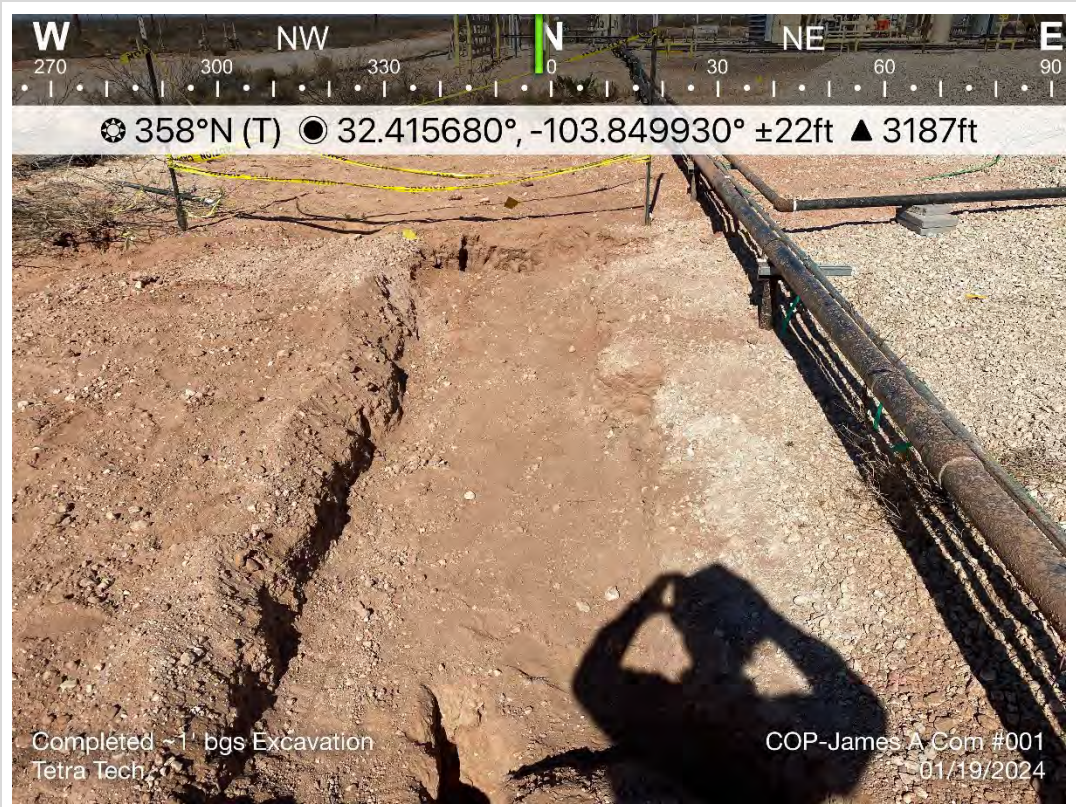
TETRA TECH, INC. PROJECT NO. 212C-MD-03239	DESCRIPTION	View north of excavated area of approximately 1 ft bgs near raised surface lines.	8
	SITE NAME	JAMES A COM #001 TANK RELEASE	1/19/2024

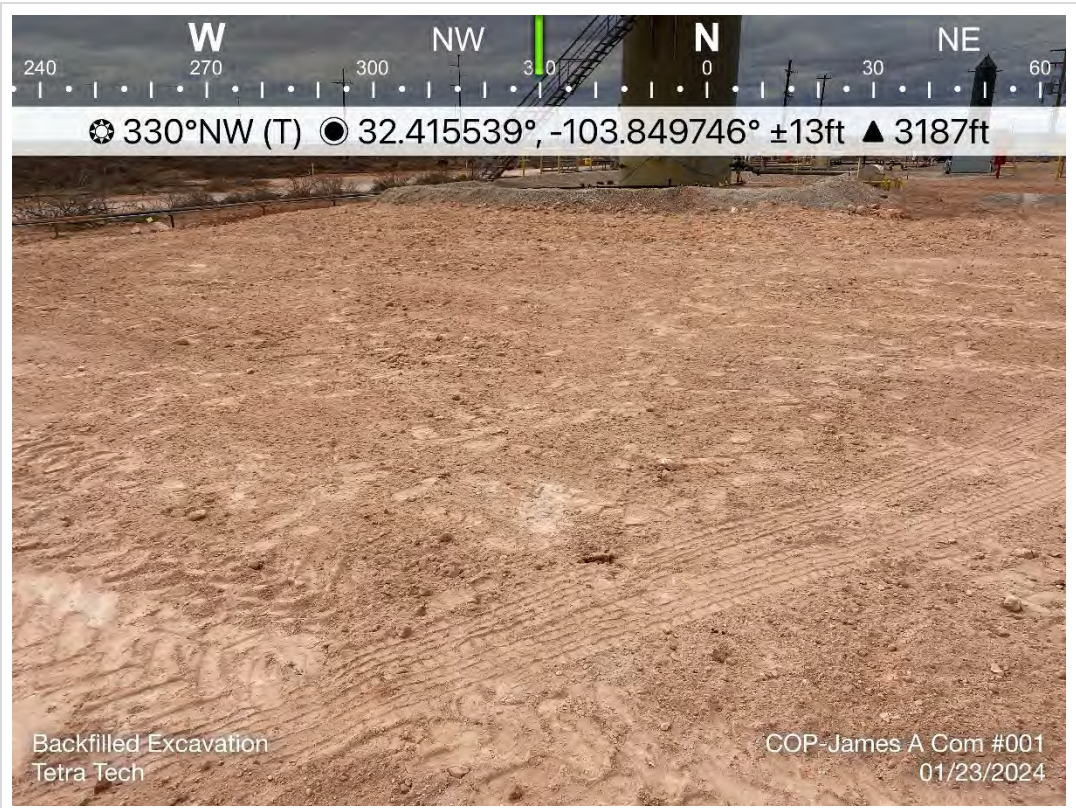
TETRA TECH, INC. PROJECT NO. 212C-MD-03239	DESCRIPTION	View north-northwest of backfilled excavation.	9
	SITE NAME	JAMES A COM #001 TANK RELEASE	1/23/2024

Backfilled areas were restored to the original condition or the final land use. Portions of the reclaimed areas west of the tank berm were reseeded. The remainder of this release footprint was within an active pad, so those areas were not seeded. Copies of laboratory analysis and chain-of-custody documentation are included in Appendix E.

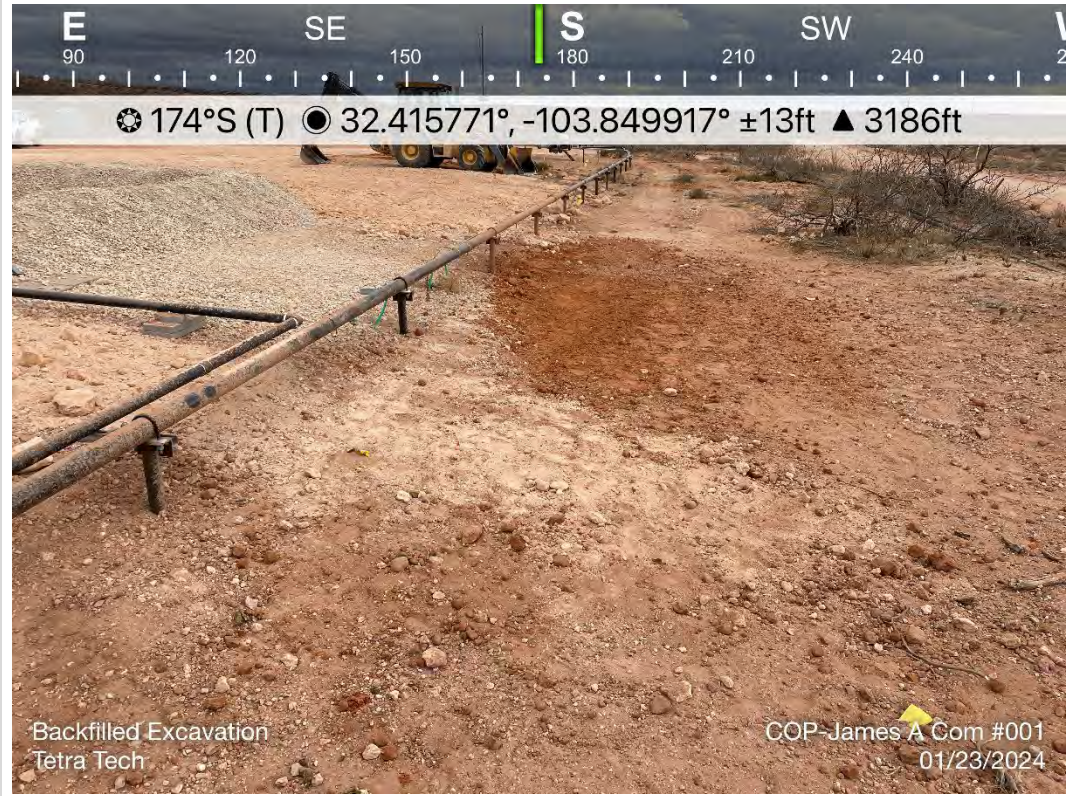
TETRA TECH, INC. PROJECT NO. 212C-MD-03239	DESCRIPTION	View south of backfilled excavation.	10
	SITE NAME	JAMES A COM #001 TANK RELEASE	1/23/2024

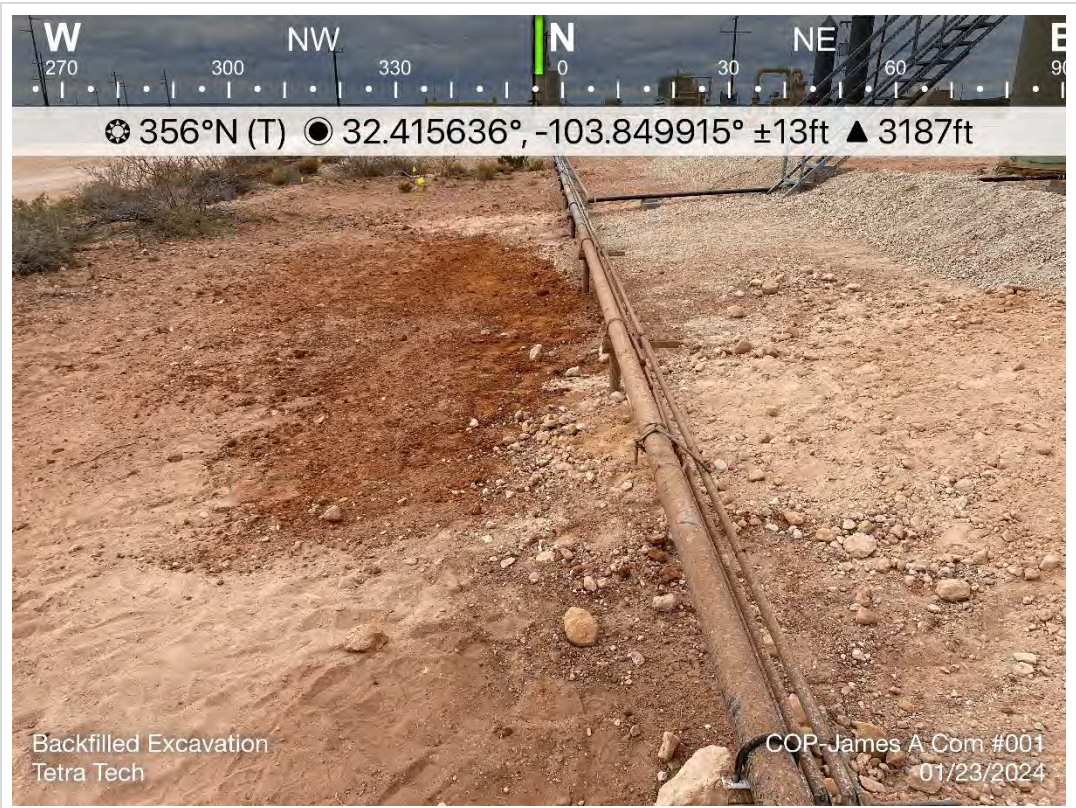
TETRA TECH, INC. PROJECT NO. 212C-MD-03239	DESCRIPTION	View north of backfilled excavation.	11
	SITE NAME	JAMES A COM #001 TANK RELEASE	1/23/2024
