Based on laboratory analytical results and field activities conducted to date, Etech recommends Spur Energy provide copies of this *Remediation Summary & Soil Closure Request* to the appropriate agencies and request closure be granted to the Holstun SWD #001 release site.

## **Figure 1**

### **Topographic Map**

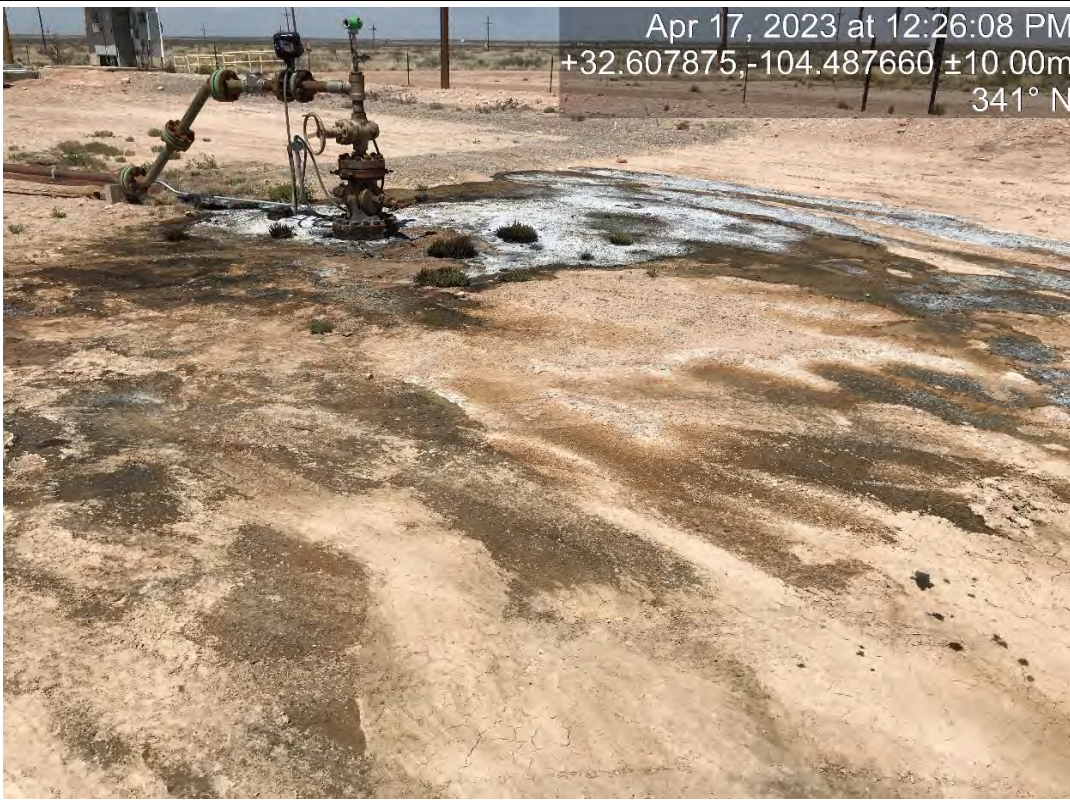
<b>Photo Number:</b> 1

<p>Apr 17, 2023 at 12:26:08 PM +32.607875,-104.487660 ±10.00m 341° N</p>
<b>Photo Direction:</b> North-Northwest	
<b>Coordinates:</b> 32.607875,-104.487660	
<b>Photo Description:</b>  View of the affected area.

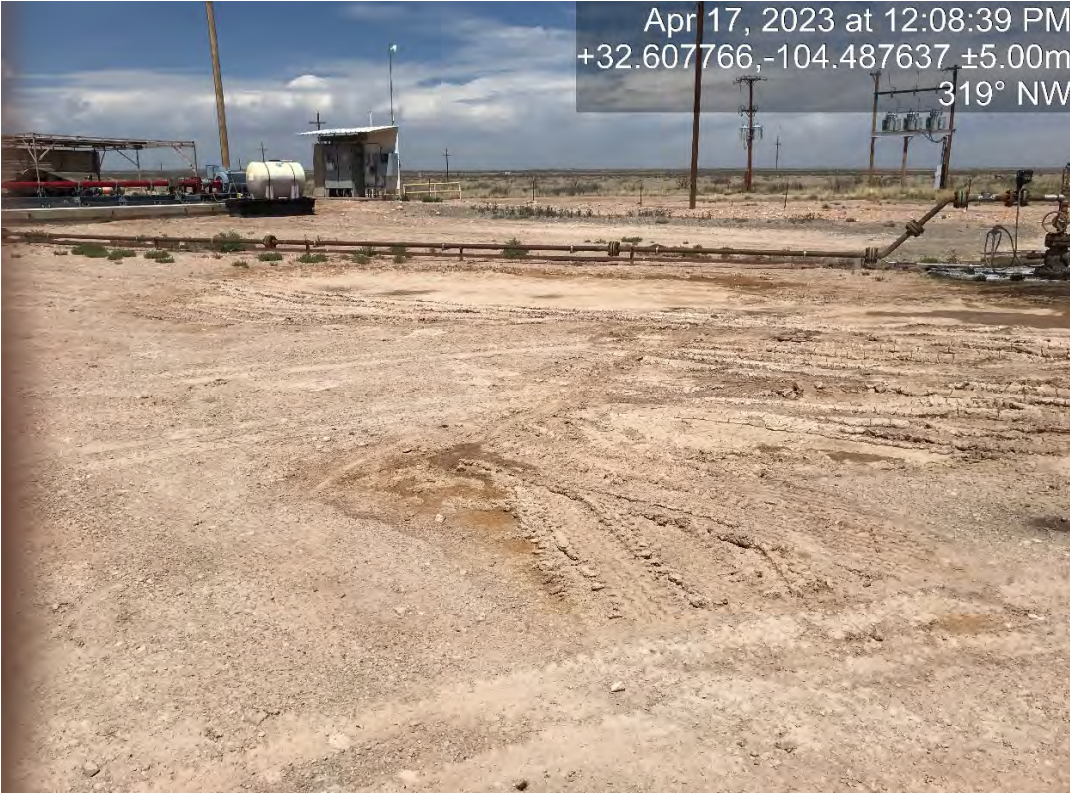
<b>Photo Number:</b> 2

<p>Apr 17, 2023 at 12:08:39 PM +32.607766,-104.487637 ±5.00m 319° NW</p>
<b>Photo Direction:</b> Northwest	
<b>Coordinates:</b> 32.607766,-104.487637	
<b>Photo Description:</b>  View of the affected area.

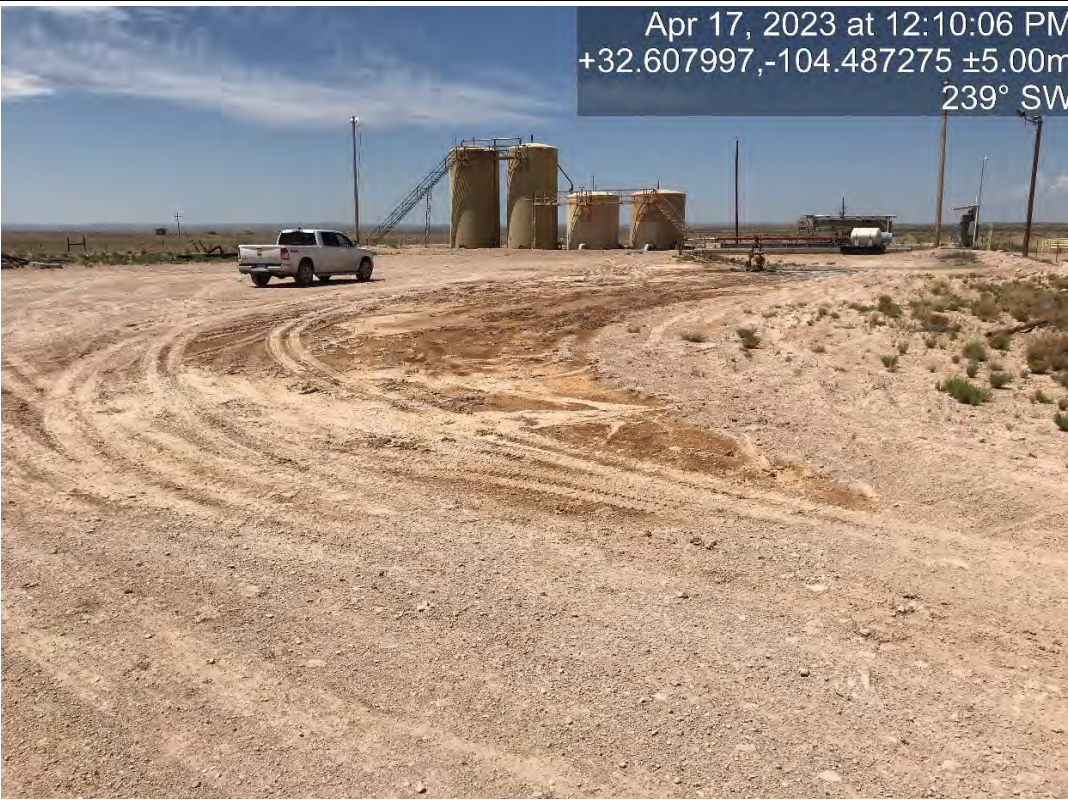
<b>Photo Number:</b> 3	<div>Apr 17, 2023 at 12:10:06 PM +32.607997,-104.487275 ±5.00m 239° SW</div>

A wide-angle photograph of an industrial site. In the background, there are several large, cylindrical storage tanks. A white pickup truck is parked on a dirt road in the middle ground. The foreground is a flat, sandy area with some sparse vegetation. The sky is clear and blue.
<b>Photo Direction:</b> West-Southwest	
<b>Coordinates:</b> 32.607997,-104.487275	
<b>Photo Description:</b>  View of the affected area.

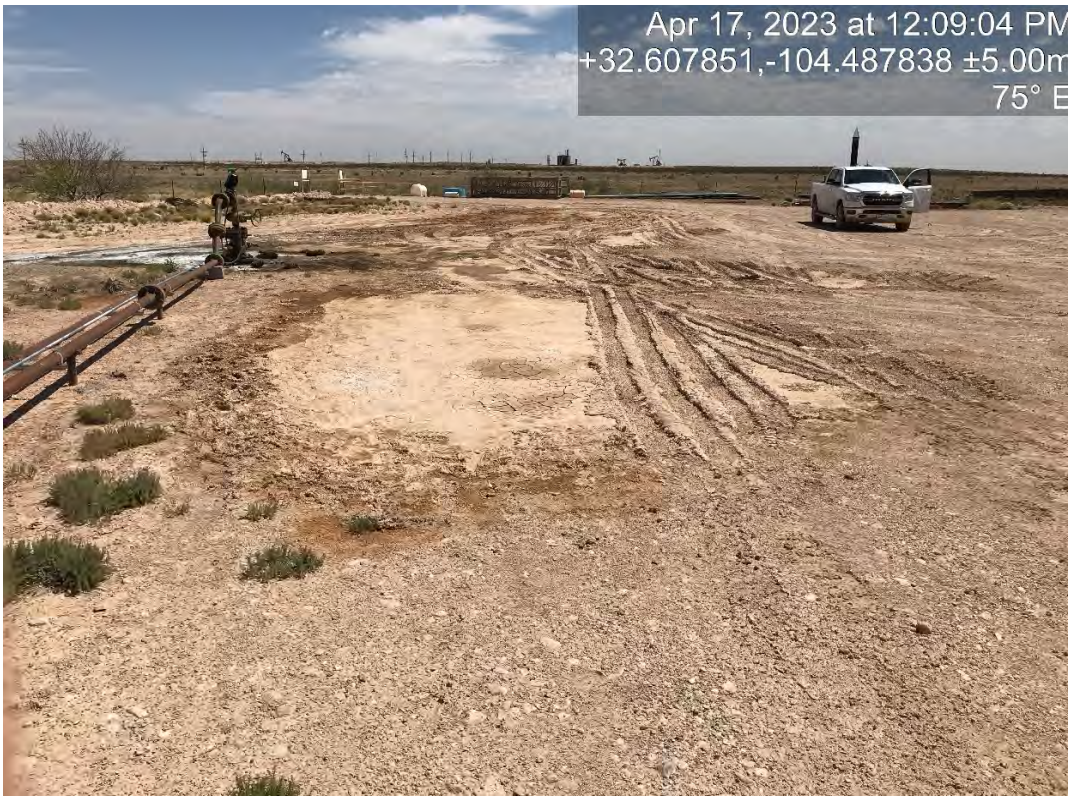
<b>Photo Number:</b> 4	<div>Apr 17, 2023 at 12:09:04 PM +32.607851,-104.487838 ±5.00m 75° E</div>

A photograph of an industrial site. A large, dark-colored pipe runs diagonally across the foreground. In the background, a white pickup truck is parked on a dirt road. The ground is sandy and sparsely vegetated. The sky is clear and blue.
<b>Photo Direction:</b> East-Northeast	
<b>Coordinates:</b> 32.607851,-104.487838	
<b>Photo Description:</b>  View of the affected area.

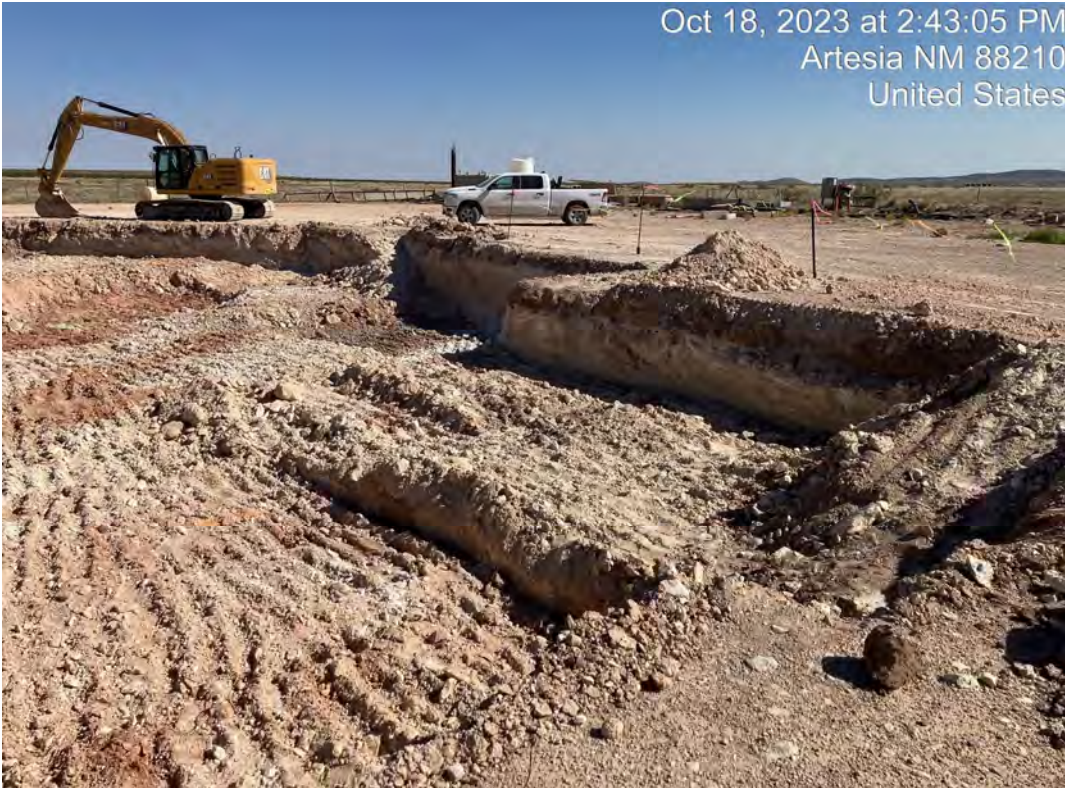
<b>Photo Number:</b> 6	<div>Oct 18, 2023 at 2:43:05 PM Artesia NM 88210 United States</div>

<b>Photo Direction:</b> Southeast	
<b>Coordinates:</b> 32.607857,-104.487847	
<b>Photo Description:</b>  View of the excavated area.

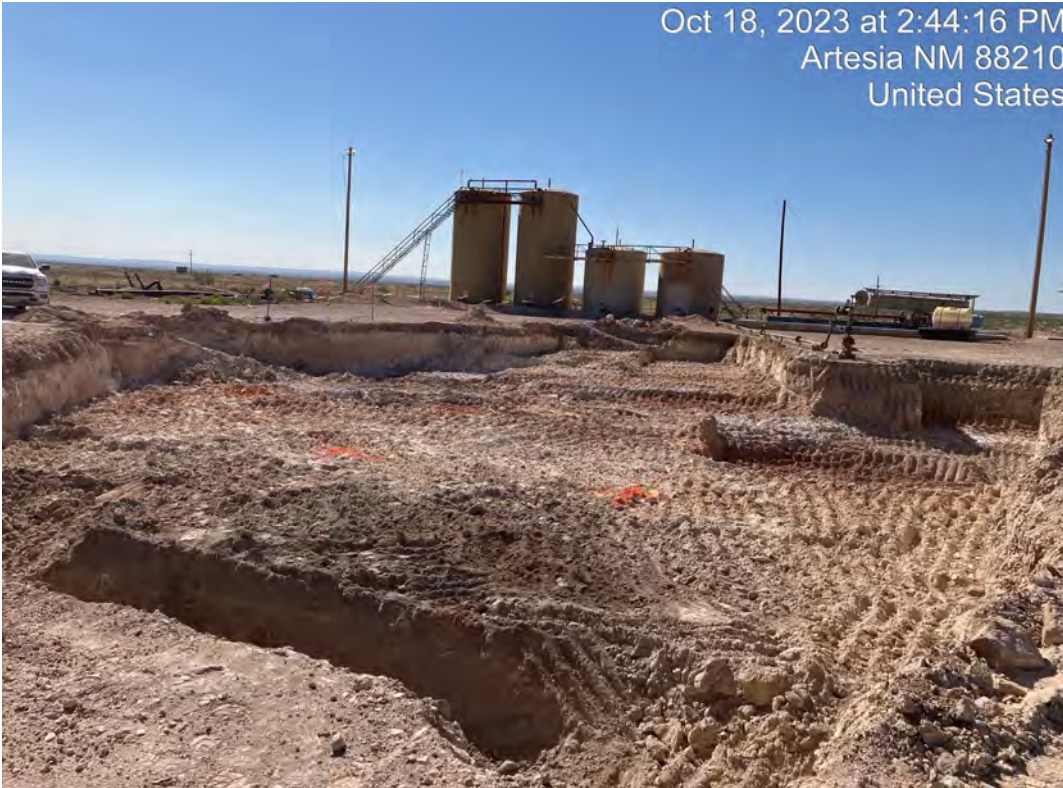
<b>Photo Number:</b> 8

<b>Photo Direction:</b> Southwest	
<b>Coordinates:</b> 32.607973,-104.487298	
<b>Photo Description:</b>  View of the excavated area.
