Re: Closure Request

Shinnery Oaks SWD #003

Incident Number nAPP2332560159

Eddy County, New Mexico

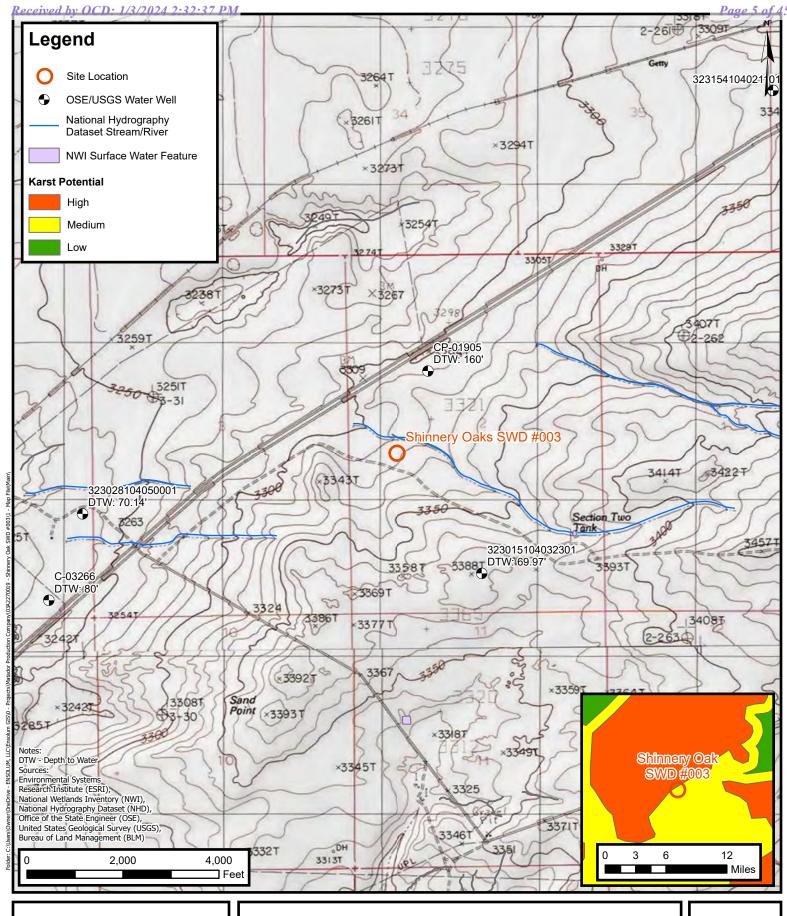
Site Receptor Map

The Site was characterized to assess the applicability of Table I, Closure Criteria for Soils Impacted by a Release, of Title 19, Chapter 15, Part 29 (19.15.29) of the New Mexico Administrative Code (NMAC). Results from the characterization desktop review are presented on page 3 of the Form C-141, Site Assessment/Characterization. Potential Site receptors are identified on Figure 1.

The closest permitted groundwater well with depth to groundwater data is New Mexico Office of the State Engineer (NMOSE) well CP 01905POD1 with a depth to water measurement of 160 feet below ground surface (bgs). The well is located 0.35 miles northeast of the Site and the most recent documented water level measurement was collected on April 8, 2022. All wells used for depth to groundwater determinations are depicted on Figure 1 and the referenced well records are included in Appendix B.

The closest continuously flowing or significant watercourse to the Site is an intermittent dry wash, located approximately 318 feet northeast of the Site. The Site is greater than 200 feet from a lakebed, sinkhole, or playa lake and greater than 300 feet from an occupied residence, school, hospital, institution, church, or wetland. The Site is greater than 1,000 feet to a freshwater well or spring and is not within a 100-year floodplain or overlying a subsurface mine. The Site is not underlain by unstable geology (medium potential karst designation area). Site receptors are identified on Figure 1.

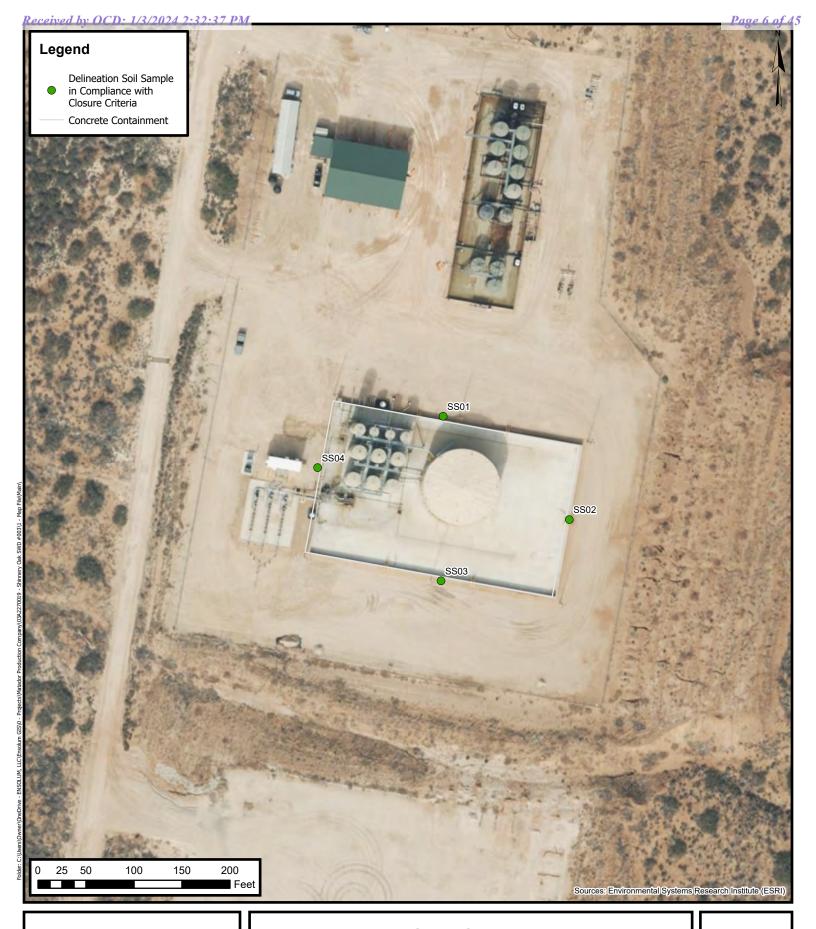
Delineation Soil Sample Locations San Mateo Stebbins Water Management, LLC

On December 4, 2023, Ensolum personnel competent in conducting liner inspections, arrived onsite to visually inspect the integrity of the containment liner. Prior to conducting the inspection, NMOCD was provided with a 48-hour liner inspection notification via email on November 29, 2023 (Appendix C). Ensolum personnel verified there was no visual evidence of a breach in the concrete containment or the sprayed in liner or any visible staining in the areas immediately surrounding the containment walls. It was determined the liner remains intact and had to the ability to contain the release in question. Photographs taken during the liner inspection are included in Appendix D. Four lateral delineation sample points (SS01 through SS04) were collected on all sides of the concrete containment at ground surface to verify the release remained inside the concrete containment.

Delineation soil samples were field screened for chloride using Mohr Method titration. The delineation sample locations were mapped utilizing a handheld Global Positioning System (GPS) unit and are depicted on Figure 2. The delineation soil samples were placed directly into pre-cleaned glass jars, labeled with the location, date, time, sampler name, method of analysis, and immediately placed on ice. The soil samples were transported under strict chain-of-custody procedures to Envirotech, Inc. (Envirotech) in Farmington, New Mexico, for analysis of the following contaminants of concern (COCs): BTEX following United States Environmental Protection Agency (EPA) Method 8021B; TPH-GRO, TPH-DRO, and TPH-oil range organics (ORO) following EPA Method 8015M/D; and chloride following EPA Method 300.0.

Laboratory analytical results for all lateral delineation soil samples (SS01 through SS04) indicated all COC concentrations were in compliance with strictest Closure Criteria per NMOCD Table I and with the

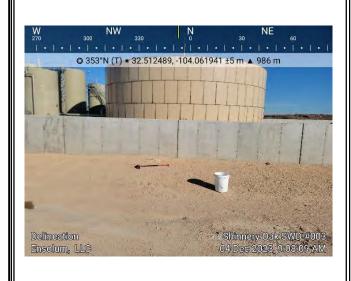
Photograph 5 Date: 12/04/2023

Description: Delineation Sampling

View: North
