**Re: Closure Request
Vaca West Tank Battery
Incident Number nAPP2202849030
Lea County, New Mexico**

Ensolum, LLC (Ensolum), on behalf of BTA Oil Producers, LLC (BTA), has prepared this *Closure Request* to document assessment, excavation, and soil sampling activities performed at the Vaca West Tank Battery (Site). The purpose of the Site assessment, excavation, and soil sampling activities was to address impacts to soil resulting from a produced water release at the Site. Based on field observations, excavation activities, and soil sample laboratory analytical results, BTA is submitting this *Closure Request*, requesting no further action for Incident Number nAPP2202849030.

BTA Oil Producers, LLC
Closure Request
Vaca West Tank Battery

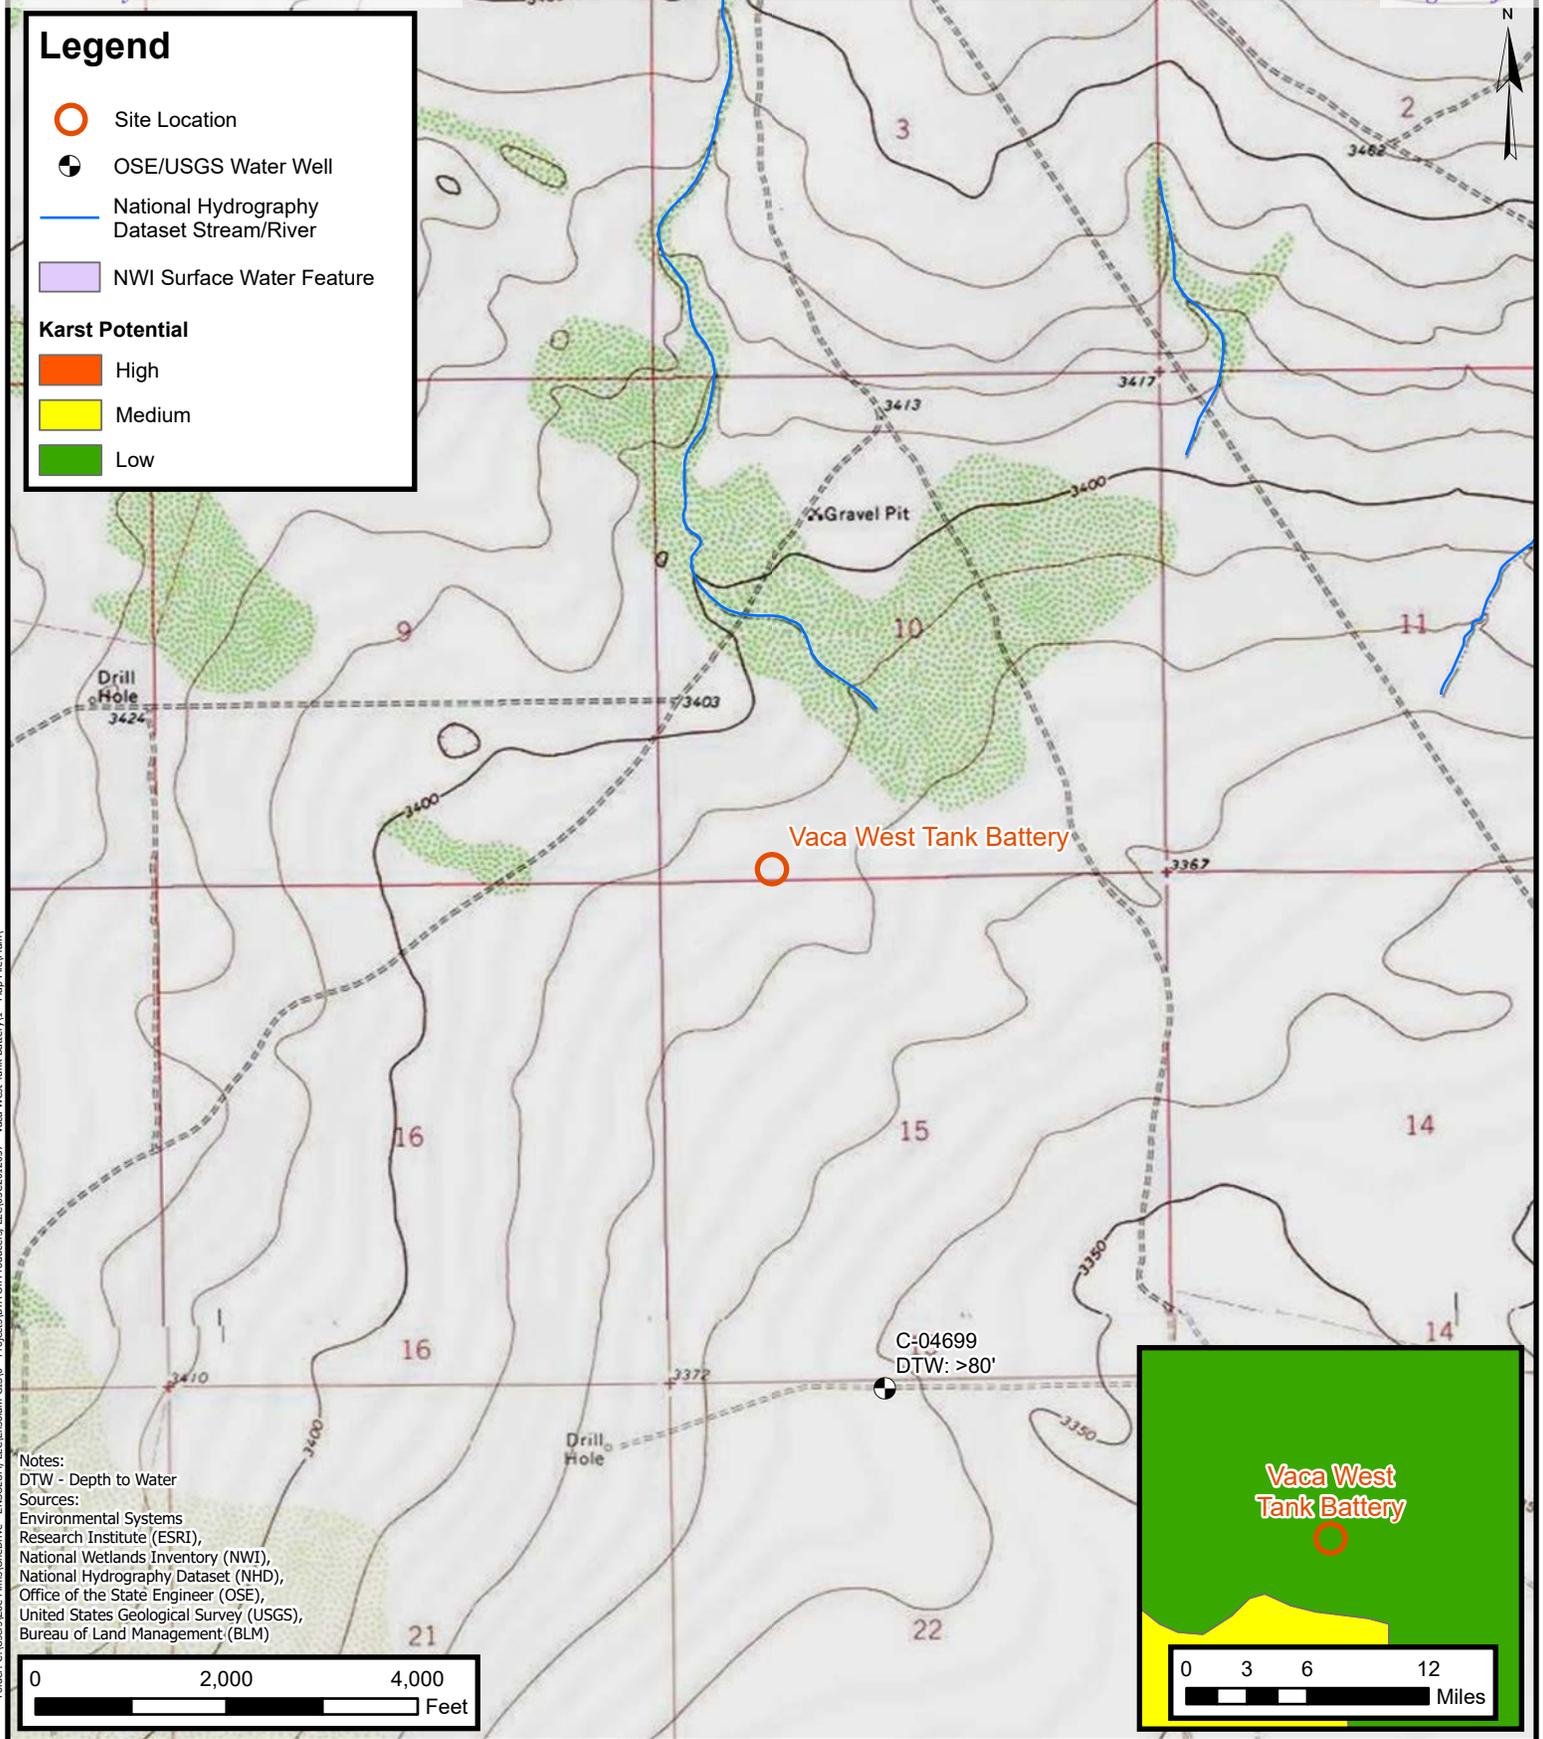
FIGURE
 1

The Site was characterized to assess the applicability of Table I, Closure Criteria for Soils Impacted by a Release, of Title 19, Chapter 15, Part 29 (19.15.29) of the New Mexico Administrative Code (NMAC). Results from the characterization desktop review are presented on page 3 of the Form C-141, Site Assessment/Characterization. Potential Site receptors are identified on Figure 1.

The closest continuously flowing or significant watercourse to the Site is an intermittent stream, located approximately 1,932 feet northeast of the Site. The Site is greater than 200 feet from a lakebed, sinkhole, or playa lake and greater than 300 feet from an occupied residence, school, hospital, institution, church, or wetland. The Site is greater than 1,000 feet to a freshwater well or spring and is not within a 100-year floodplain or overlying a subsurface mine. The Site is not underlain by unstable geology (low potential karst designation area). Site receptors are identified on Figure 1.

Site Receptor Map
 BTA Oil Producers, LLC
 Vaca West Tank Battery
 Incident Number: nAPP2202849030
 Unit M, Sec 10, T25S R33E
 Lea County, New Mexico

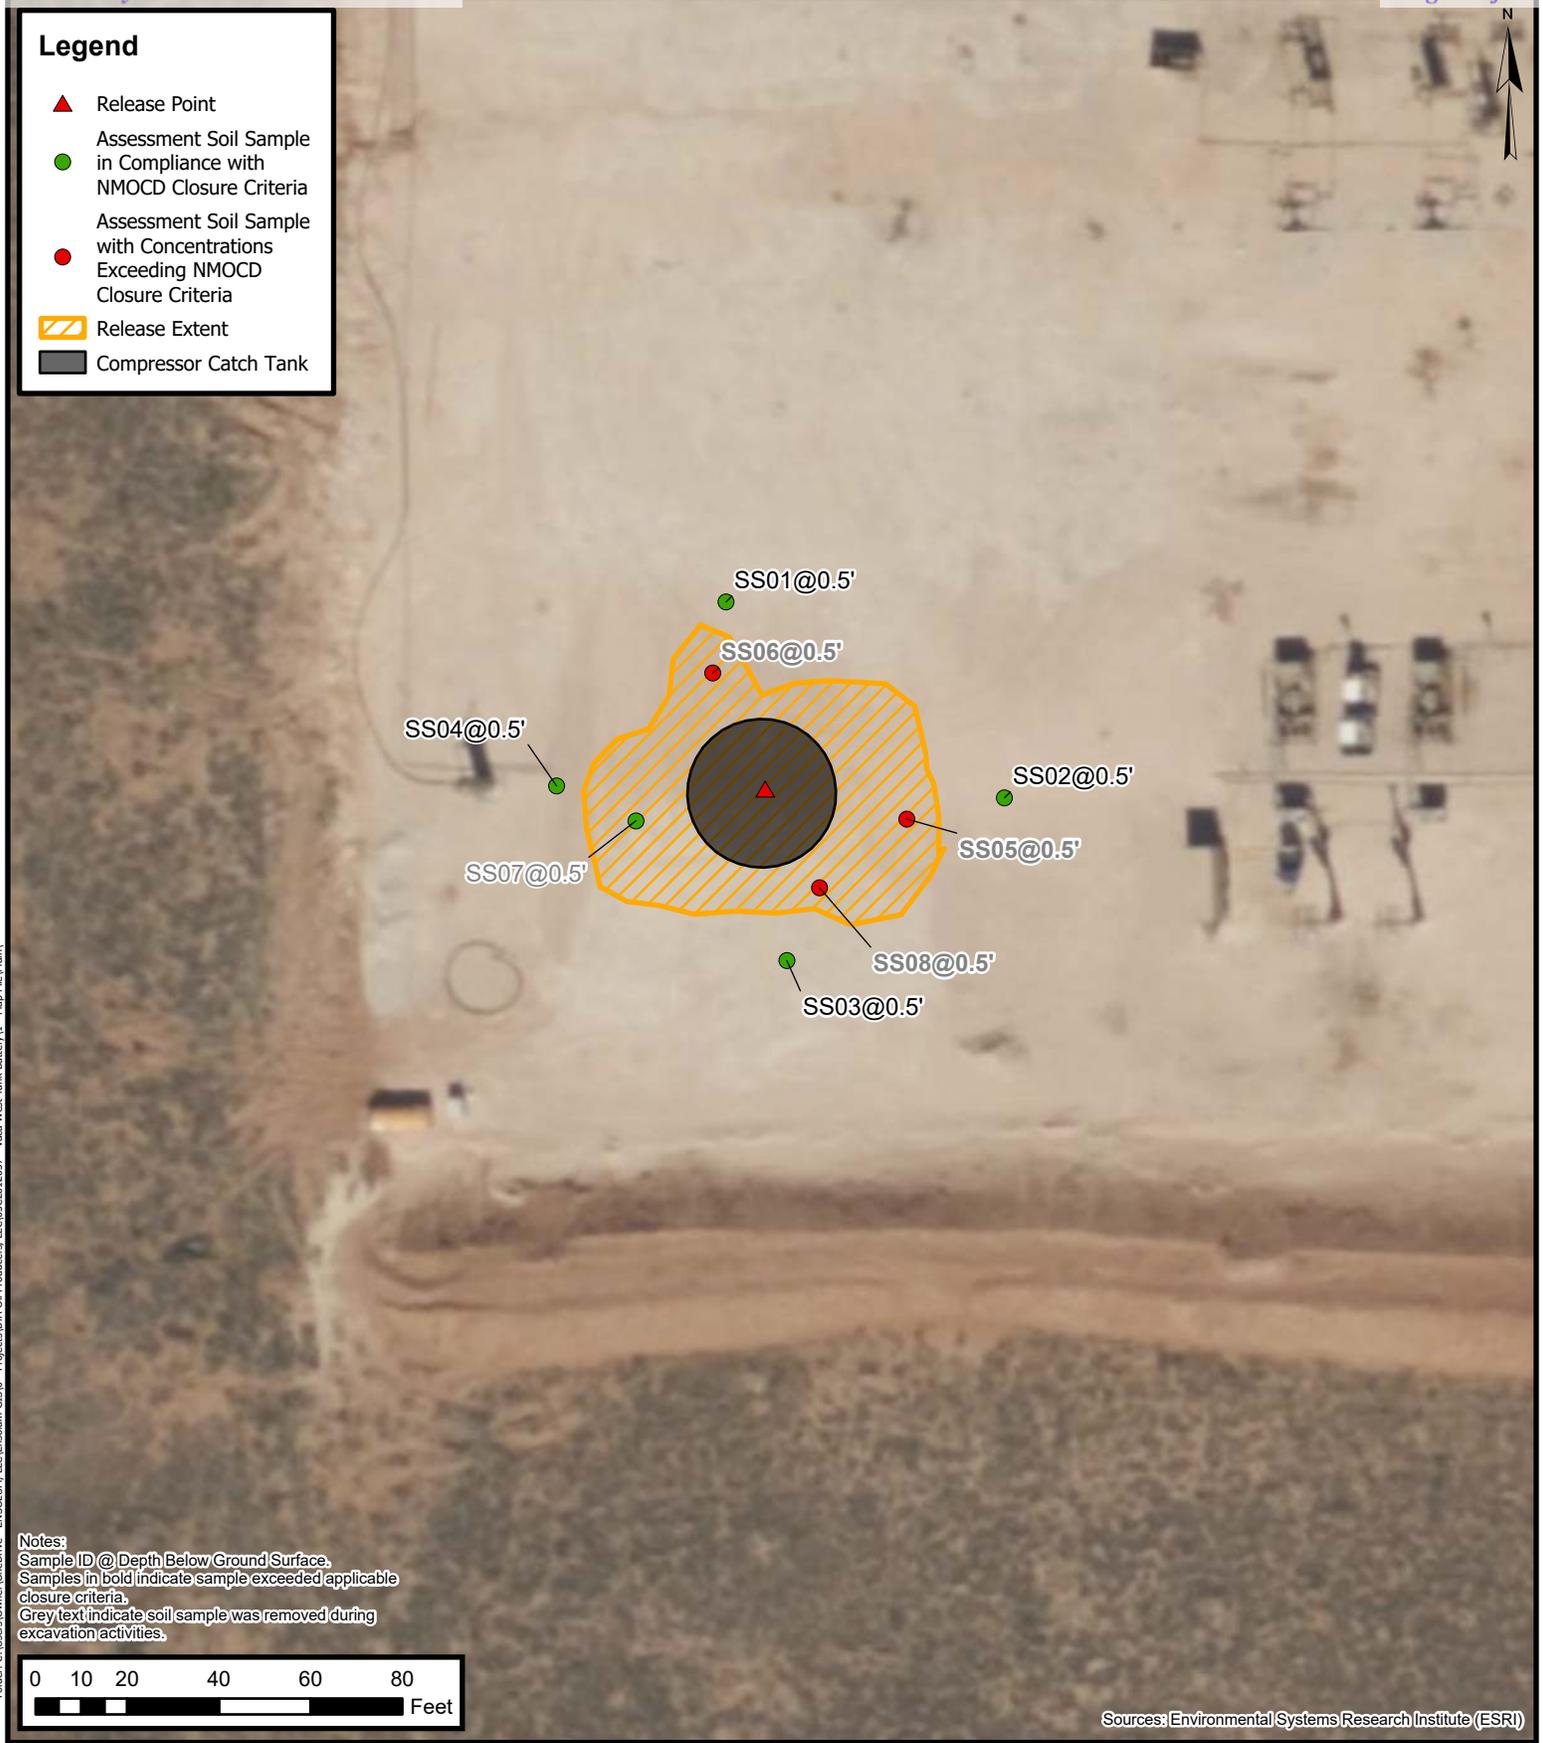
Notes:
 Sample ID @ Depth Below Ground Surface.
 Samples in bold indicate sample exceeded applicable closure criteria.
 Grey text indicate soil sample was removed during excavation activities.

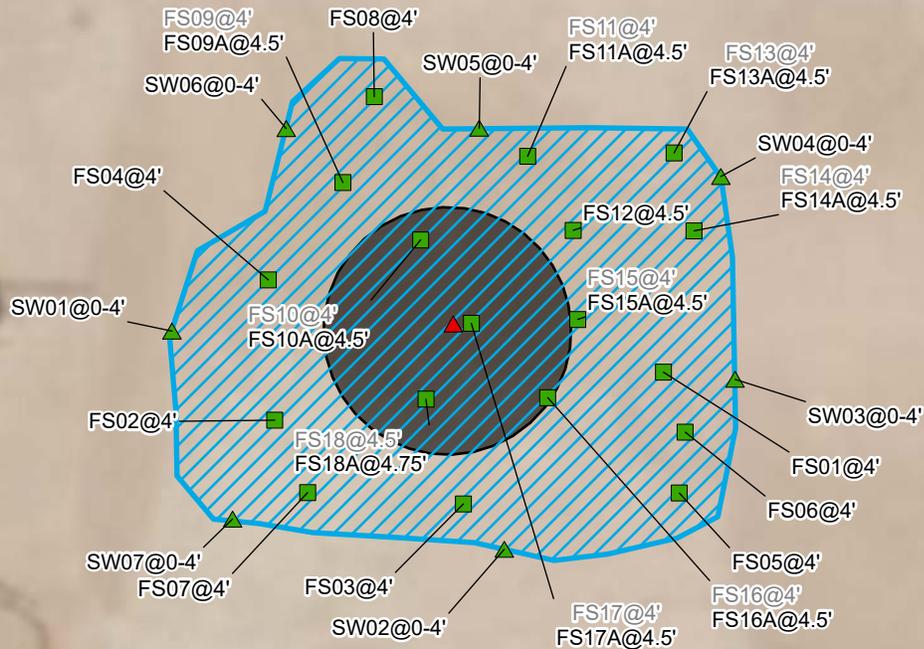
Notes:
 Sample ID @ Depth Below Ground Surface.
 Grey text indicate soil sample was removed during excavation activities

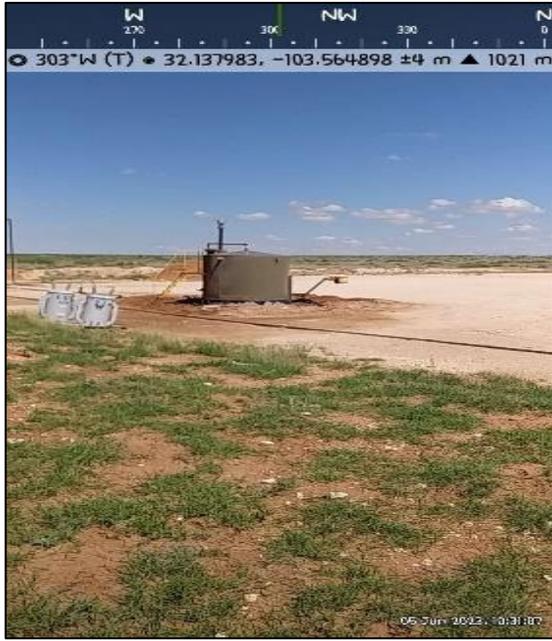
Photograph: 1 Date: 6/5/2023
Description: Soil staining during initial assessment
View: Northwest

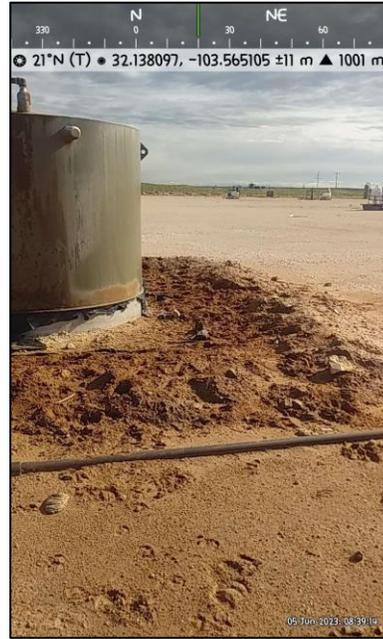
Photograph: 2 Date: 6/5/2023
Description: Soil staining during initial assessment
View: North

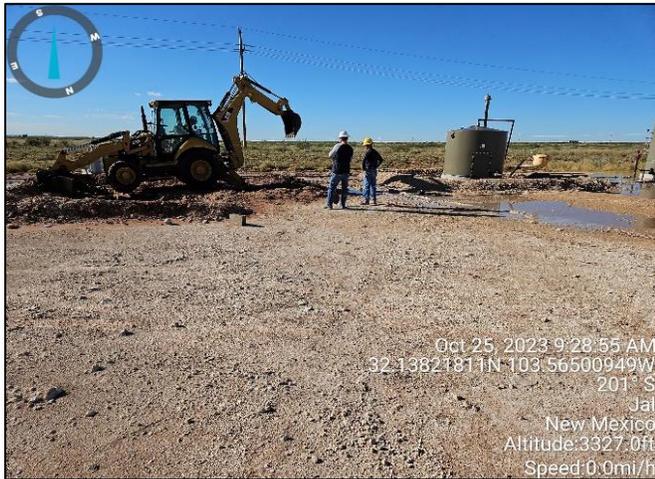
Photograph: 3 Date: 10/25/2023
Description: Excavation activities
View: South

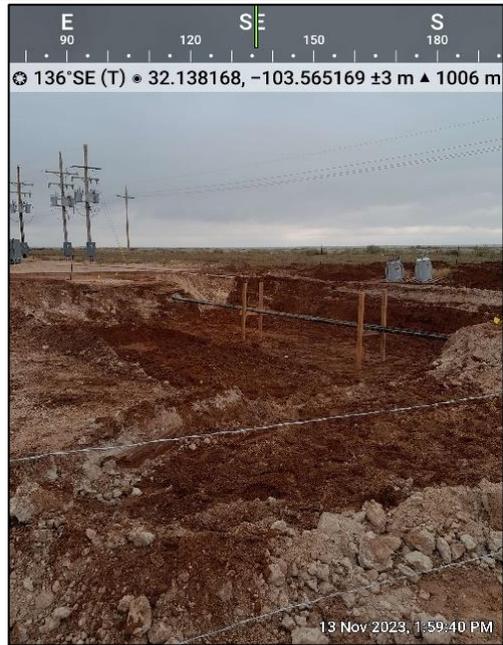
Photograph: 4 Date: 11/13/2023
Description: Excavation activities
View: Southeast
